Sewage and Water Works Technical Evaluation – Phase 1

**Hamlet of Resolute Bay, Nunavut
CGSHQ-09023-01**

Project No: OTCD00020312A
Report date: March, 2010

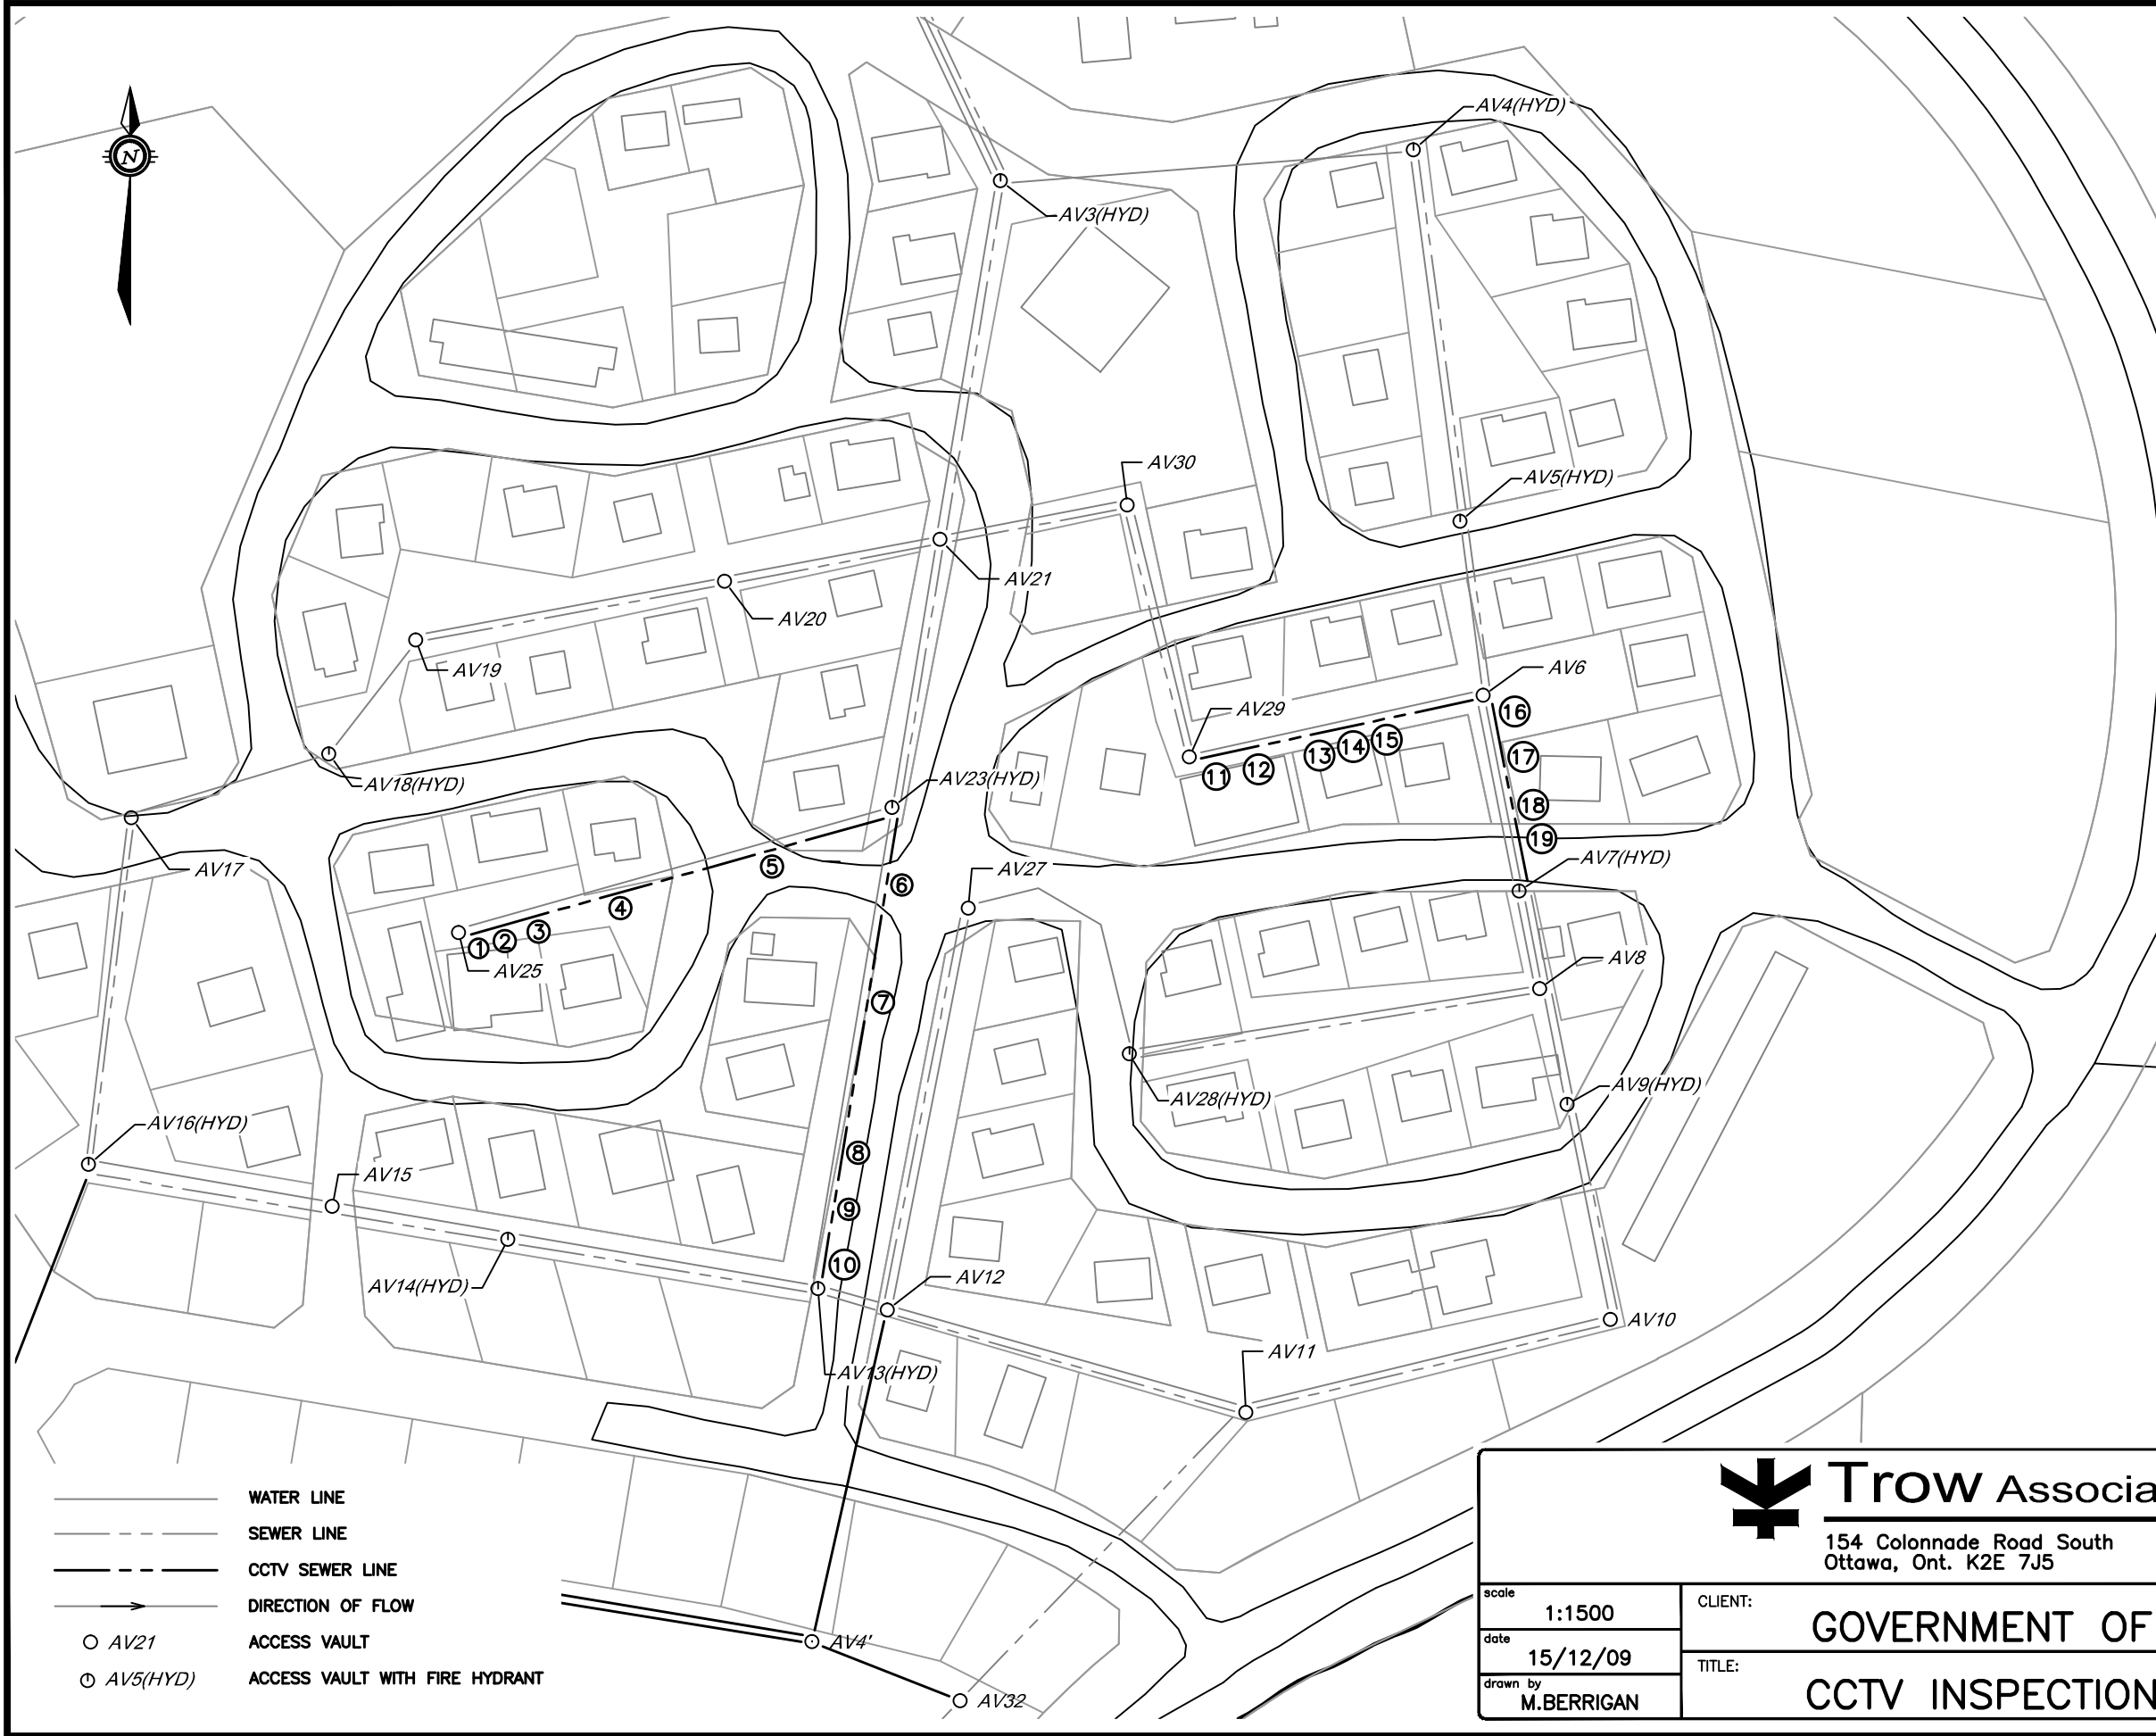
C3

- AV25 TO AV23
- ① APPEARS TO BE PRESSURE ALONG THE SIDES OF THE PIPE DEFORMING THE PIPE INWARDS AT THE 9 O'CLOCK.
 - ② PIPE DEFLECTS DOWNWARD, APPEARS TO BE PRESSURE DEFORMING THE PIPE INWARD AT THE 3 O'CLOCK.

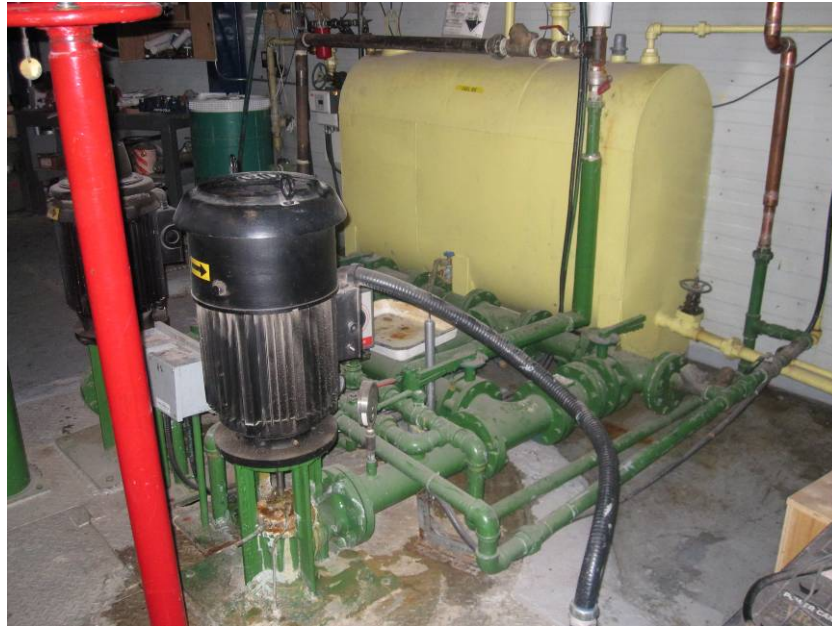
- The fuel system at the Char Lake Pump House does not conform to codes and represents a contamination risk for the community water supply. The system should be replaced at the first opportunity.

Picture 6.1.3.4.a – Diesel day tank and potable water transfer pumps

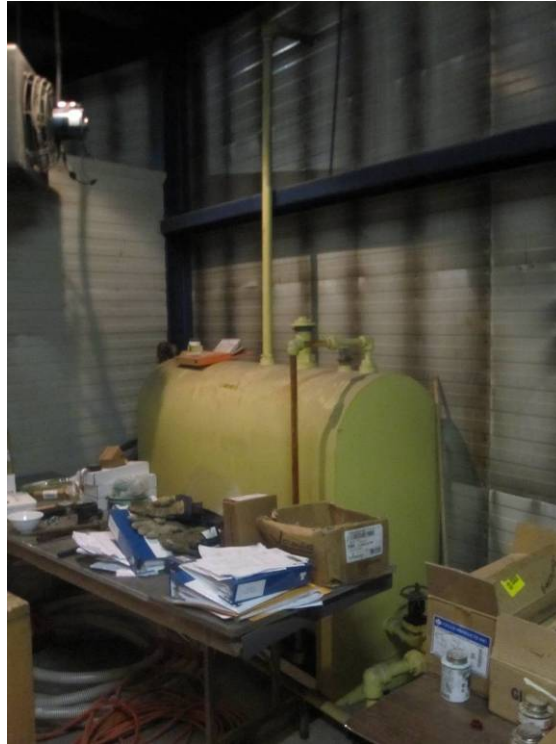
Picture 6.2.3.3.a – Water Treatment Plant diesel fuel day tank

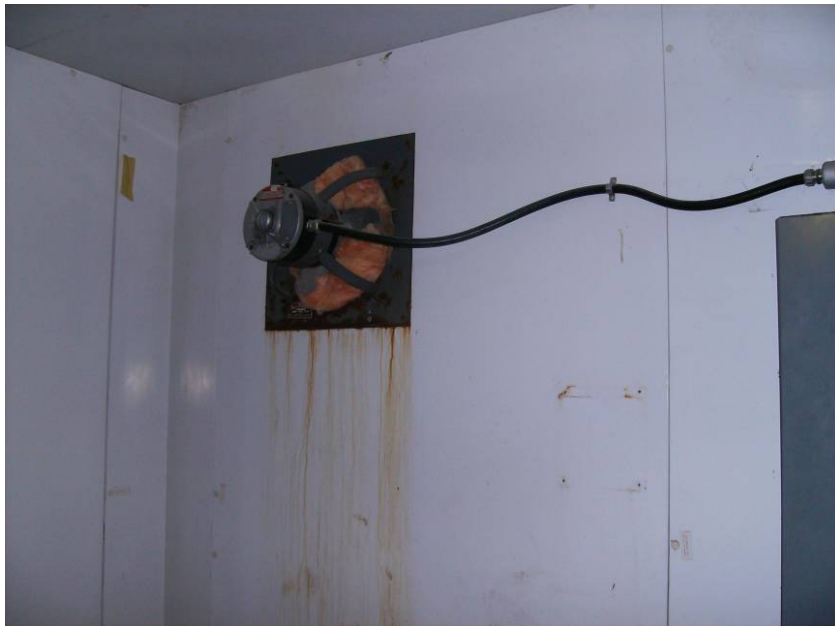
Picture 6.3.2.a – Macerator de-commissioned exhaust fan

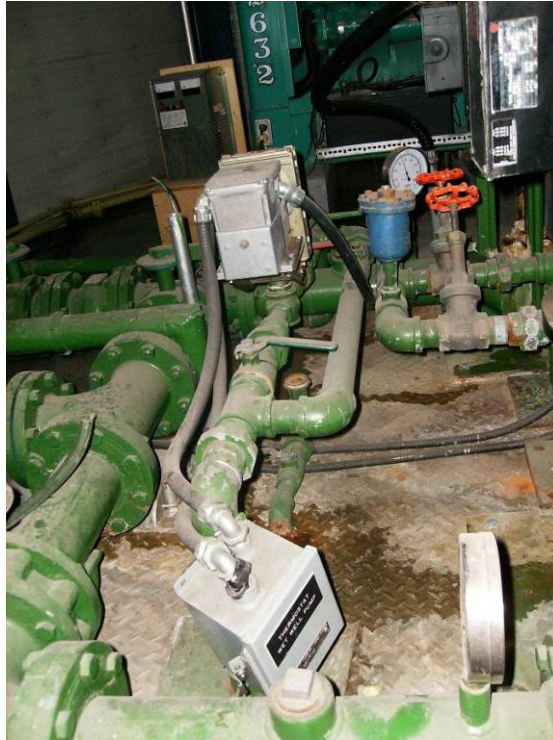
Photograph No. 7.1.6.c - Instrumentation Control and Annunciation: Redundant and Unused piping and old control valve
