- **Community & Government Services,
Government of Nunavut**

**Designated Substances Survey,
Signal Hill Water Treatment Plant,
Resolute Bay, Nunavut**

Type of Document:
Final

Project Number:
OTT-00206333-B0

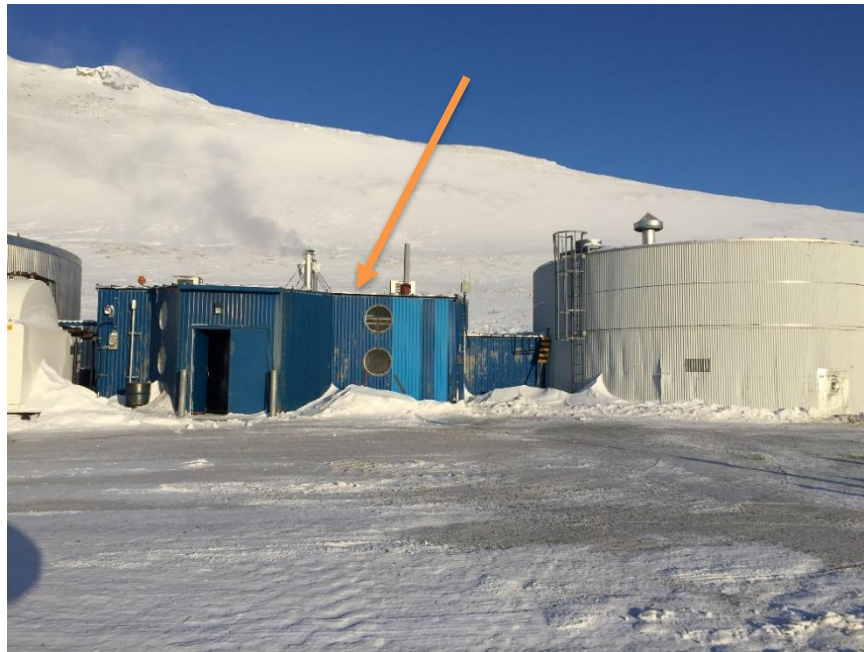
Photograph No. 1

Overview of the Signal Hill Water Treatment system building (blue structure).
The white water tanks seen to the left and right were not part of the survey scope.

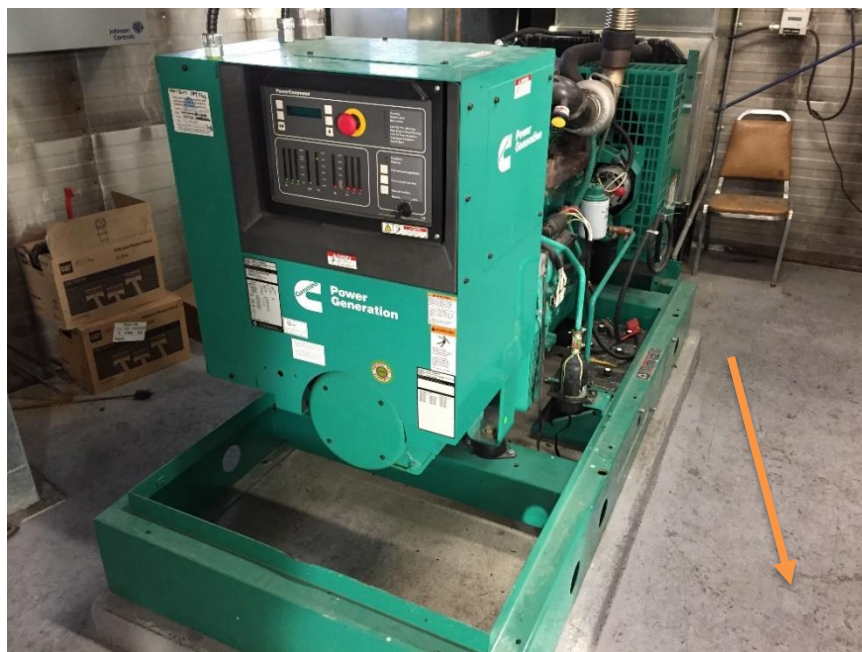
Photograph No. 4

- SH-PS-01 (1390 ppm): Grey floor paint. The paint was deemed to be in fair to poor condition with areas of excessive peeling / flaking.
- SH-PS-03 (943 ppm): Dark grey wooden backing board paint. The paint was deemed to be in good condition with no evidence of excessive peeling / flaking.

Grey on grey floor paint (SH-PS-1)

Recommendations: As part of any renovations or demolitions, site personnel should be provided with necessary protective equipment to reduce the risk of lead-dust inhalation to any workers if the painted surfaces are being disturbed. Activities involving abrasion or sanding of painted surfaces should be minimized. Appropriate personal protective equipment (i.e., respirators, gloves, and eye protection) should be worn when undertaking any such activities. It is recommended that the WSCC *Code of Practice, Working with Lead Guideline, May 2017*, be referred to when dealing with any painted surface.

Prior to the disposal of building materials with lead-based paint firmly bound to the substrate, a leachate test (TCLP analysis) of representative demolition debris is recommended to determine the material's leachable concentration of lead. Potential disposal locations for demolition waste should be advised of the TCLP analytical results.

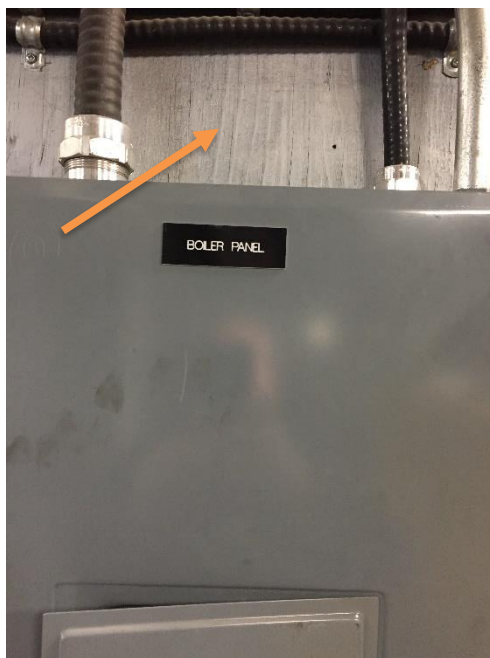
Photograph No. 5

Silver paint on electrical equipment mounting backboard (SH-PS-2)

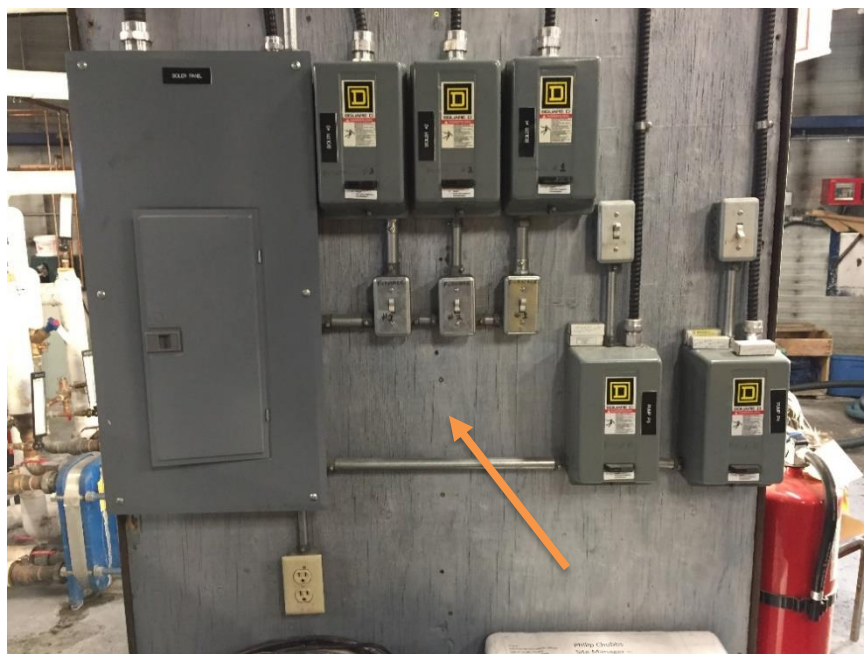
Photograph No. 6

Dark grey paint on electrical equipment mounting backboard (SH-PS-3)

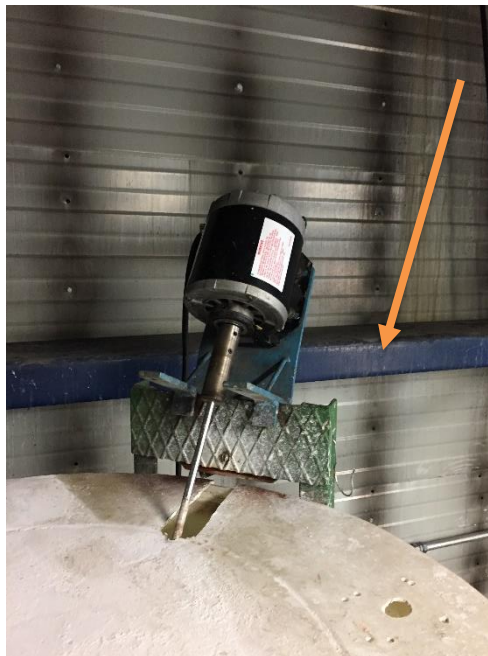
Photograph No. 7

Note: As no suitable location for the sampling of the exterior blue paint was available at this building, the visual similar exterior paint sample from the Char Lake Pump House was used. Laboratory analysis of this sample of the exterior blue paint (CL-PS-1) required an increase to mean detection limit that exceeded the regulatory baseline criteria for lead. As such, this paint coating can be assumed to be lead-based until further analysis is conducted.

Dark blue paint on metal beams (SH-PS-4)

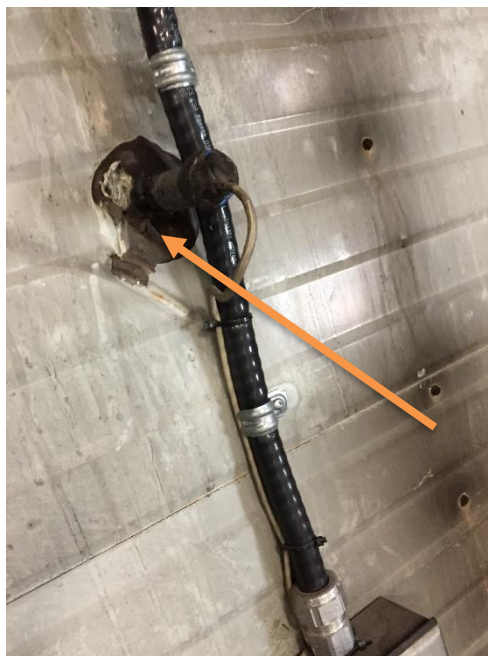
Photograph No. 8

- The black firestop putty observed around a few wall penetrations by power lines was determined to contain 10% chrysotile asbestos.

Black fire-stop putty (SH-AS-1)

Recommendations: In the event of the disturbance or removal of the fire stop putty, a Low Risk procedure is to be followed as per the WSCC's *Code of Practice, Asbestos Abatement, September 2018, Section 5.2 - Low Risk Abatement Activities*.

Disposal of the fire-stop putty must conform with Government of Nunavut *Environmental Guideline for Waste Asbestos*, January 2011.

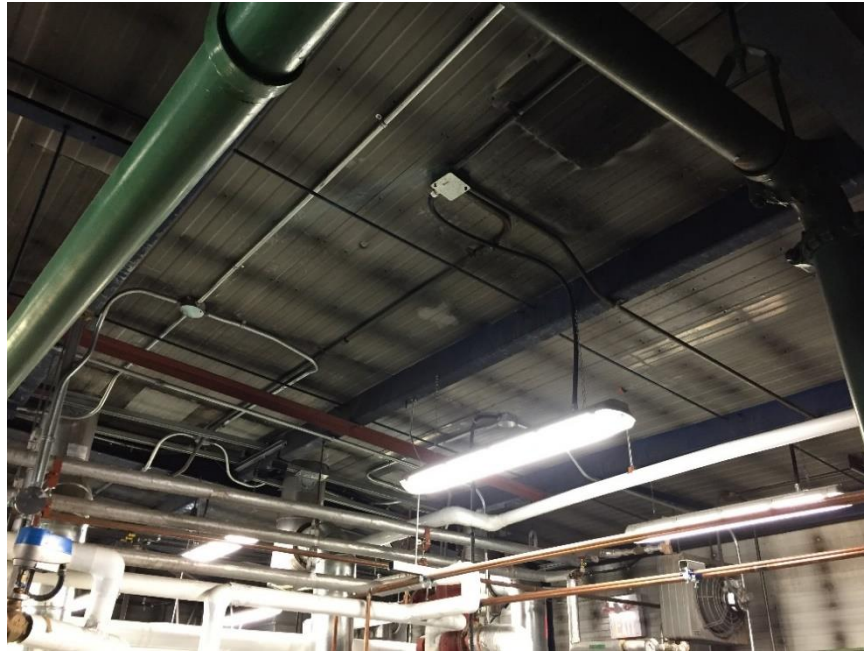
Photograph No. 9

Approximately twenty-eight (28) T12 fluorescent light tubes were observed during the survey. No other mercury-containing equipment was identified during the site visit.

Example of fluorescent tube lighting unit

Recommendations: As per the Government of Nunavut *Environmental Guideline for Mercury-Containing Products and Waste Mercury, November 2010*, due to the lack of any recycling facility in proximity to the territory, the disposal of fluorescent light tubes in the municipal landfills is at the discretion of that municipality. The Resolute Bay Hamlet Office is required to be consulted prior to disposal of any mercury equipment in the local landfill.

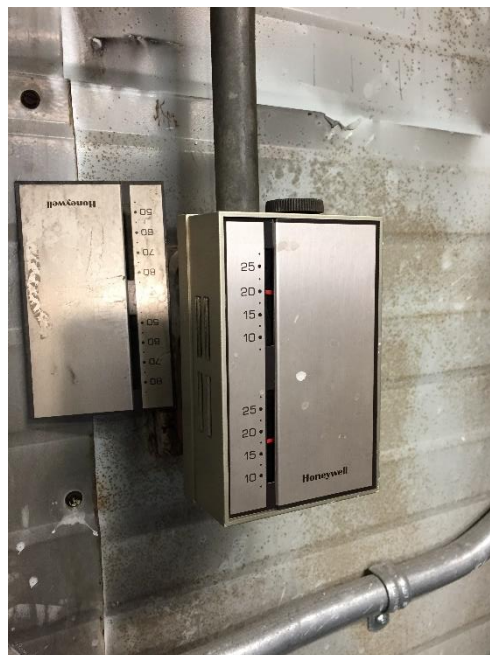
Photograph No. 10

Non-mercury containing thermostat
