# DECOMMISSIONING PLAN

## CHAR LAKE PUMP HOUSE AND SIGNAL HILL WATER TREATMENT PLANT RESOLUTE BAY, NUNAVUT

Final Plan

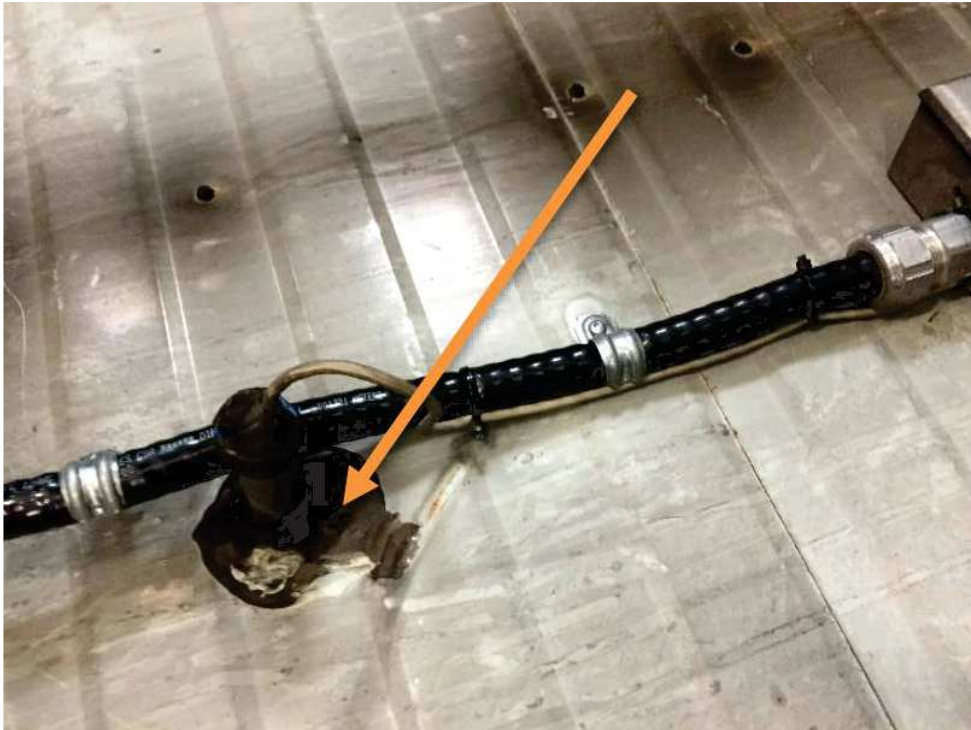
**Photo 3**

- The black non-friable firestop putty observed around a few wall penetrations by power lines was determined to contain 10% chrysotile asbestos.

The non-friable  
firestop black putty  
observed in the Signal  
Hill building.

The black non-friable firestop putty observed at Signal Hill, around a few wall penetrations by power lines and determined to contain 10% chrysotile asbestos, will be securely collected and disposed of following a Low-Risk procedure in accordance with the WSCC's *Code of Practice, Asbestos Abatement*, September 2018, Section 5.2 - Low Risk Abatement Activities.

Removal of asbestos-containing black non-friable firestop putty will be performed with manual tools, no power tools or abrasive methods will be used during the abatement. A decontamination facility will be constructed adjacent to the work area for workers to dress, and for asbestos debris to be removed from the work area.

The identified asbestos-containing material to be removed is presented in photograph 3 of the Photographic Report of Appendix A.

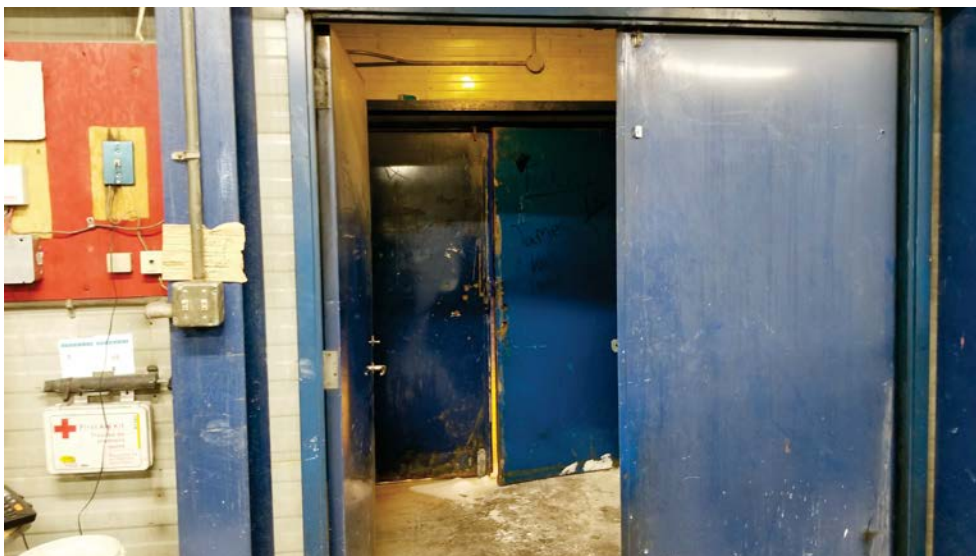
**Photo 4**

View of the possible  
lead-containing blue  
paint on the exterior  
of both buildings.

Dark grey wooden backing board, the exterior blue painted metal sheets and the green water pipes will be securely collected and stored.

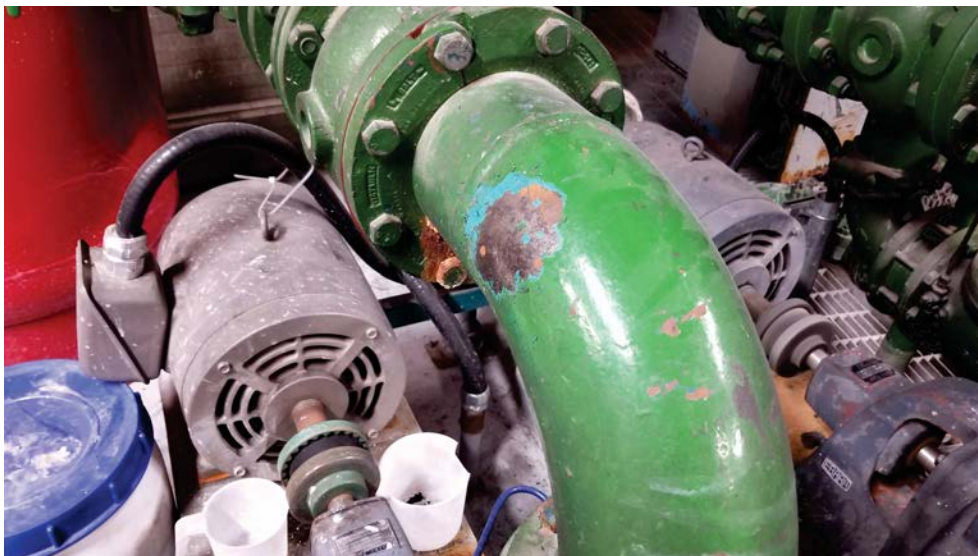
**Photo 5**

- The green paint on the majority of the uninsulated water pipes at the treatment plant is not considered hazardous to human health based on the laboratory results for total lead. However, in the absence of confirmatory results for leachable lead, it is considered hazardous to the environment. Confirmatory leachate analysis results will be available by July 21, 2020.

View of the possible lead-containing green paint on the interior piping of both buildings.

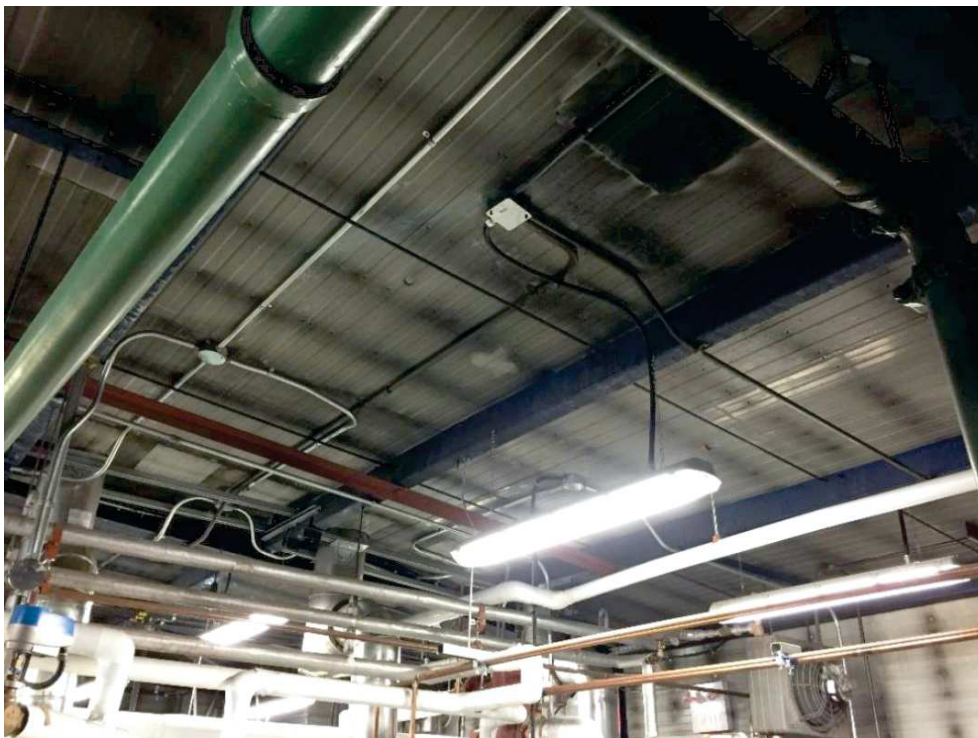
**Photo 7**

Typical fluorescent  
light fixtures.

The approximately 14 (Char Lake) and 28 (Signal Hill) T12 fluorescent light tubes will be securely collected and disposed to a recycling facility.

An example of the mercury-containing fluorescent light tubes is presented in the photographic report of Appendix A.

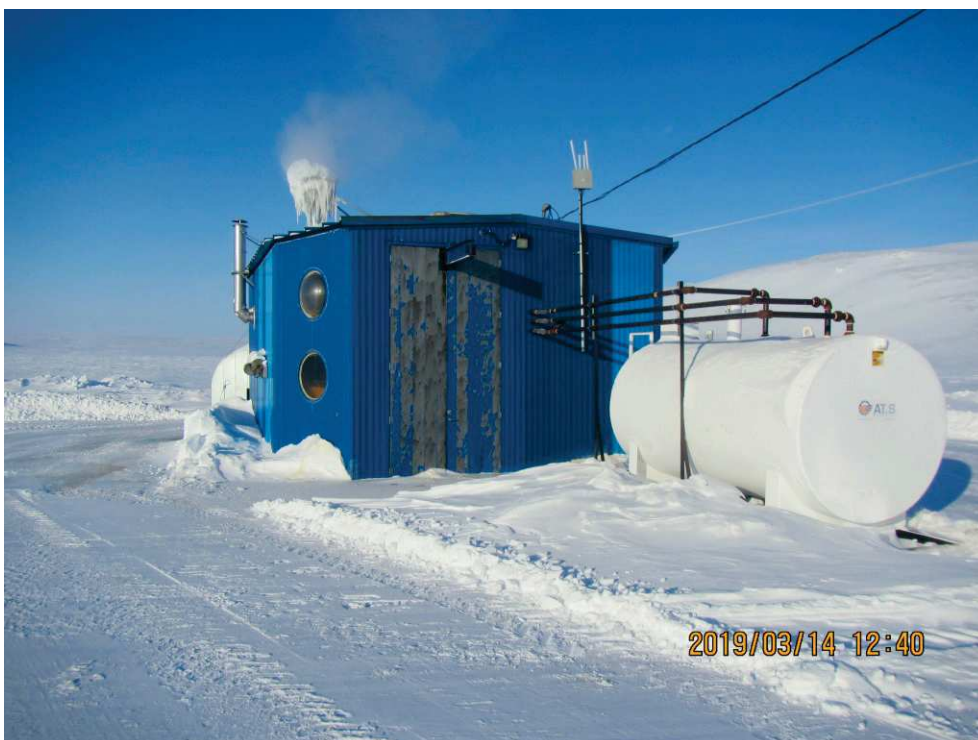
**Photo 8**

View of the exterior  
fuel tank of Char  
Lake House Pump.

The existing above storage tanks (AST) will be inspected, securely removed and disposed of following the procedure presented below:

- Perform a complete inspection of the AST;
- If it is not empty, safely transfer the contents to a temporary storage tank by gravity, if possible, or by using a pump;
- Measure gas with a 4 gas detector to assess explosive limits - ventilate as required to eliminate explosive vapours and then record the data;
- Enlarge the tank opening using a reciprocating saw or by contact with the tank while keep monitoring the explosive limits;
- Cleaning and washing the tank using a vacuum truck;
- Visual inspection of the AST;
- Removing the AST from the site;
- Disposal of the AST at the community metal land field.

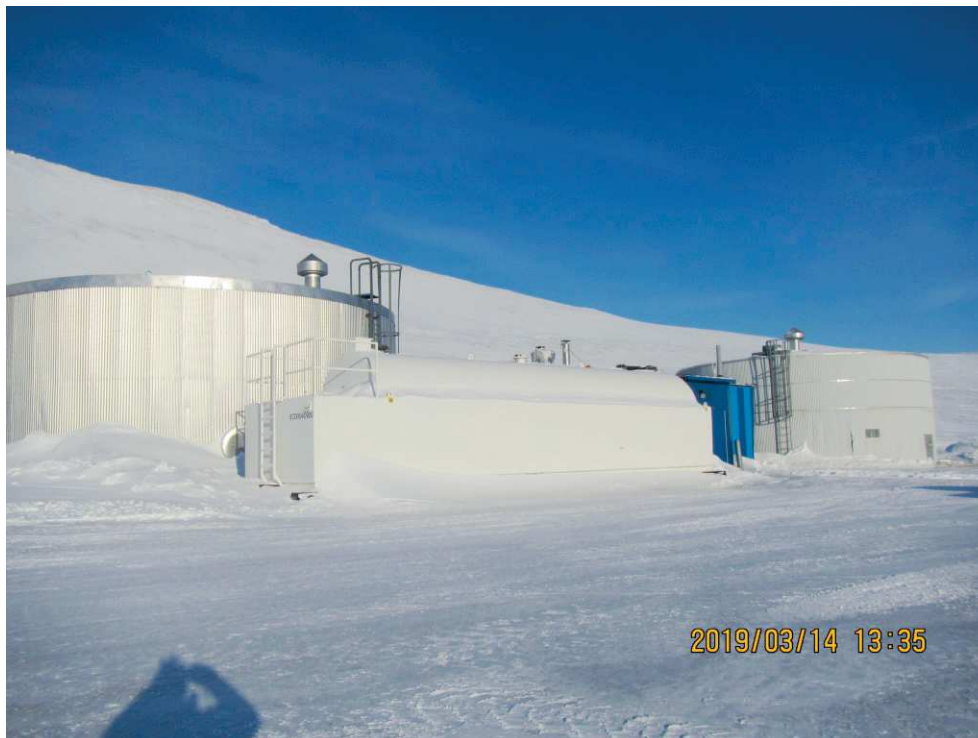
**Photo 9**

View of the exterior  
fuel tank of Signal  
Hill Water Treatment  
Plant.
