WATER LICENCE INSPECTION FORM

Licensee		Licensee Representative	
Department of Community Government and Services Government of Nunavut		Bhabesh Roy –	
Licence No. / Expiry		Representative's Title	
3BM-RUT1520		Regional Engineer	
Land / Other Authorizations		Land / Other Authorizations	
Date of Inspection		Inspector	
July 7,2016		A.Keim	
Activities Inspected			
<input type="checkbox"/> Camp	<input type="checkbox"/> Drilling	<input type="checkbox"/> Mining	<input type="checkbox"/> Construction
<input type="checkbox"/> Roads/Hauling	<input type="checkbox"/> Other: Water Discharge	<input checked="" type="checkbox"/> Other: Municipal	<input type="checkbox"/> Reclamation
<input type="checkbox"/> Fuel Storage

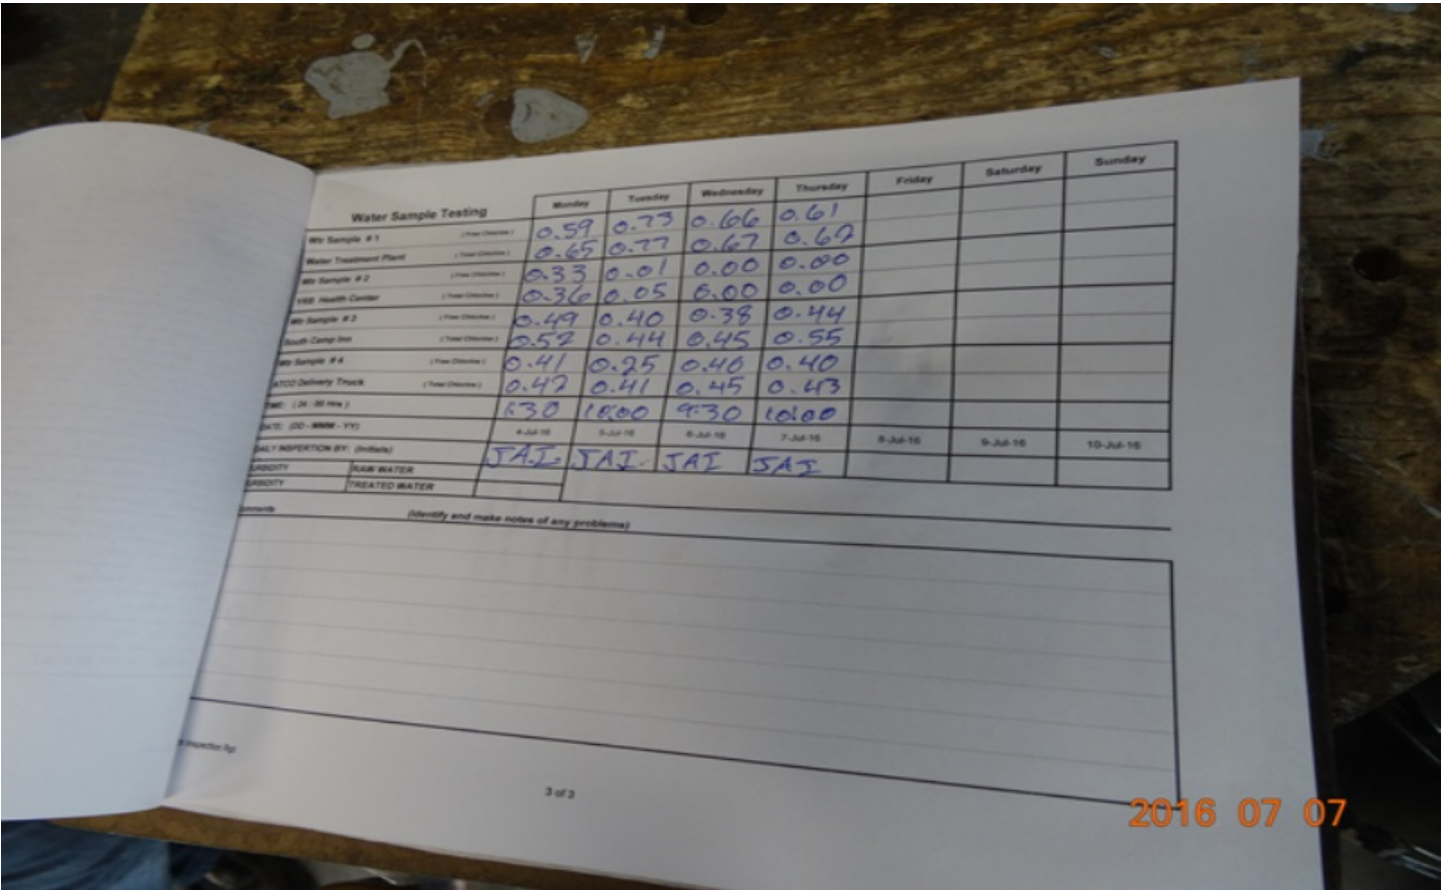
Figure 1 Records at pumping station

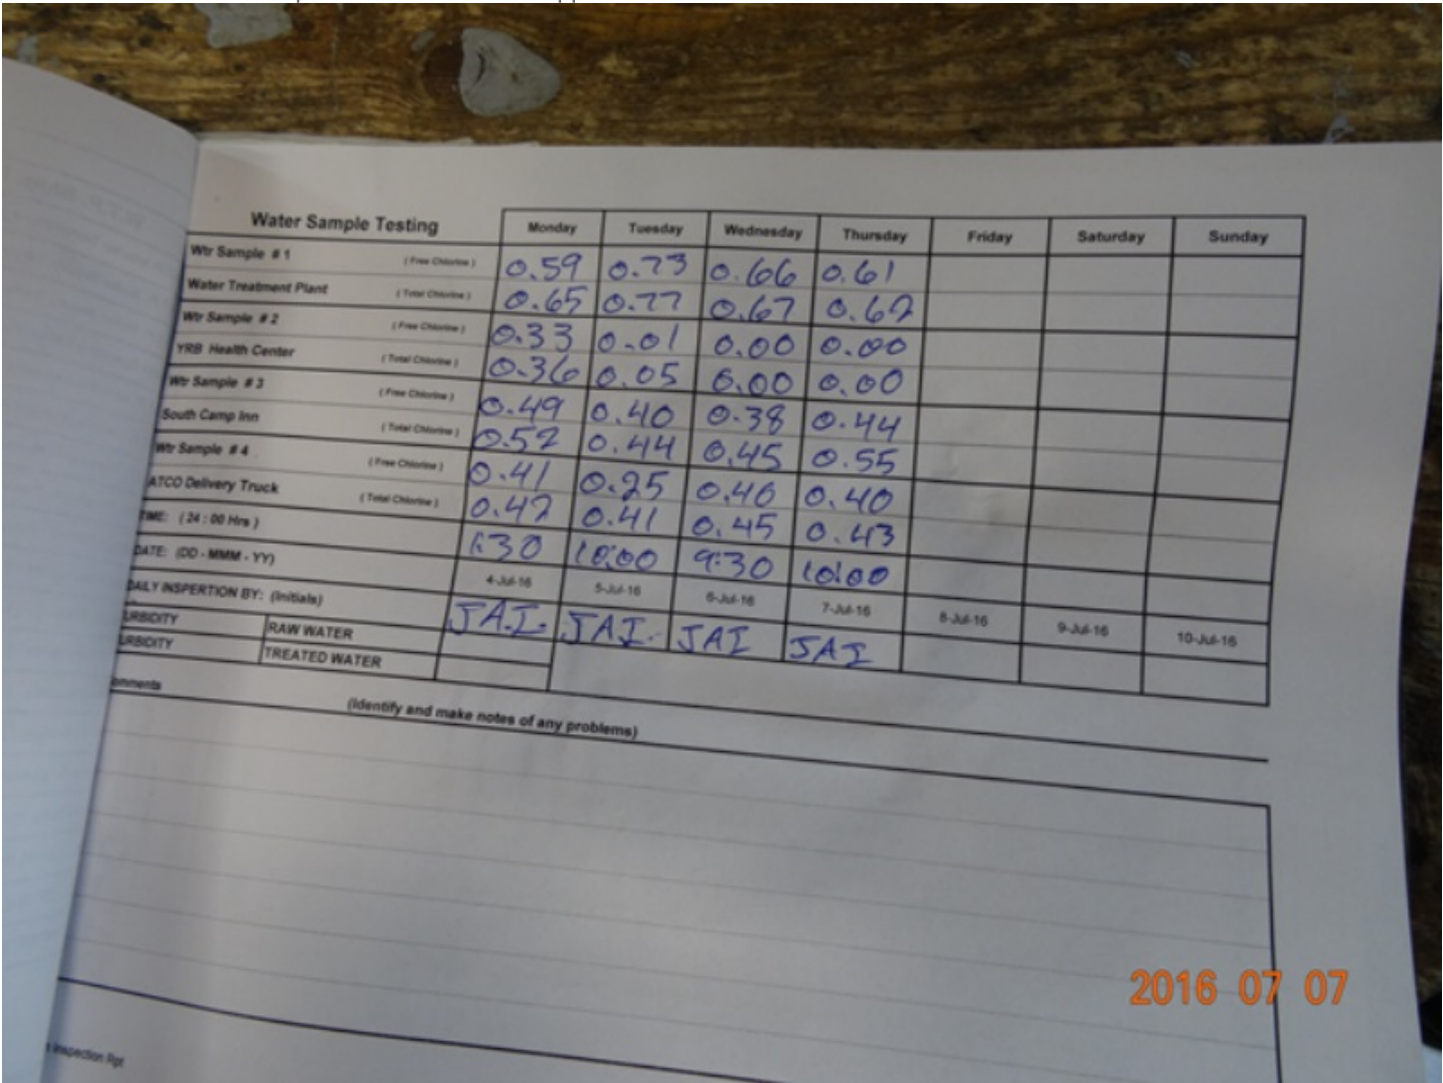
Figure 2Records at pumping station (2)

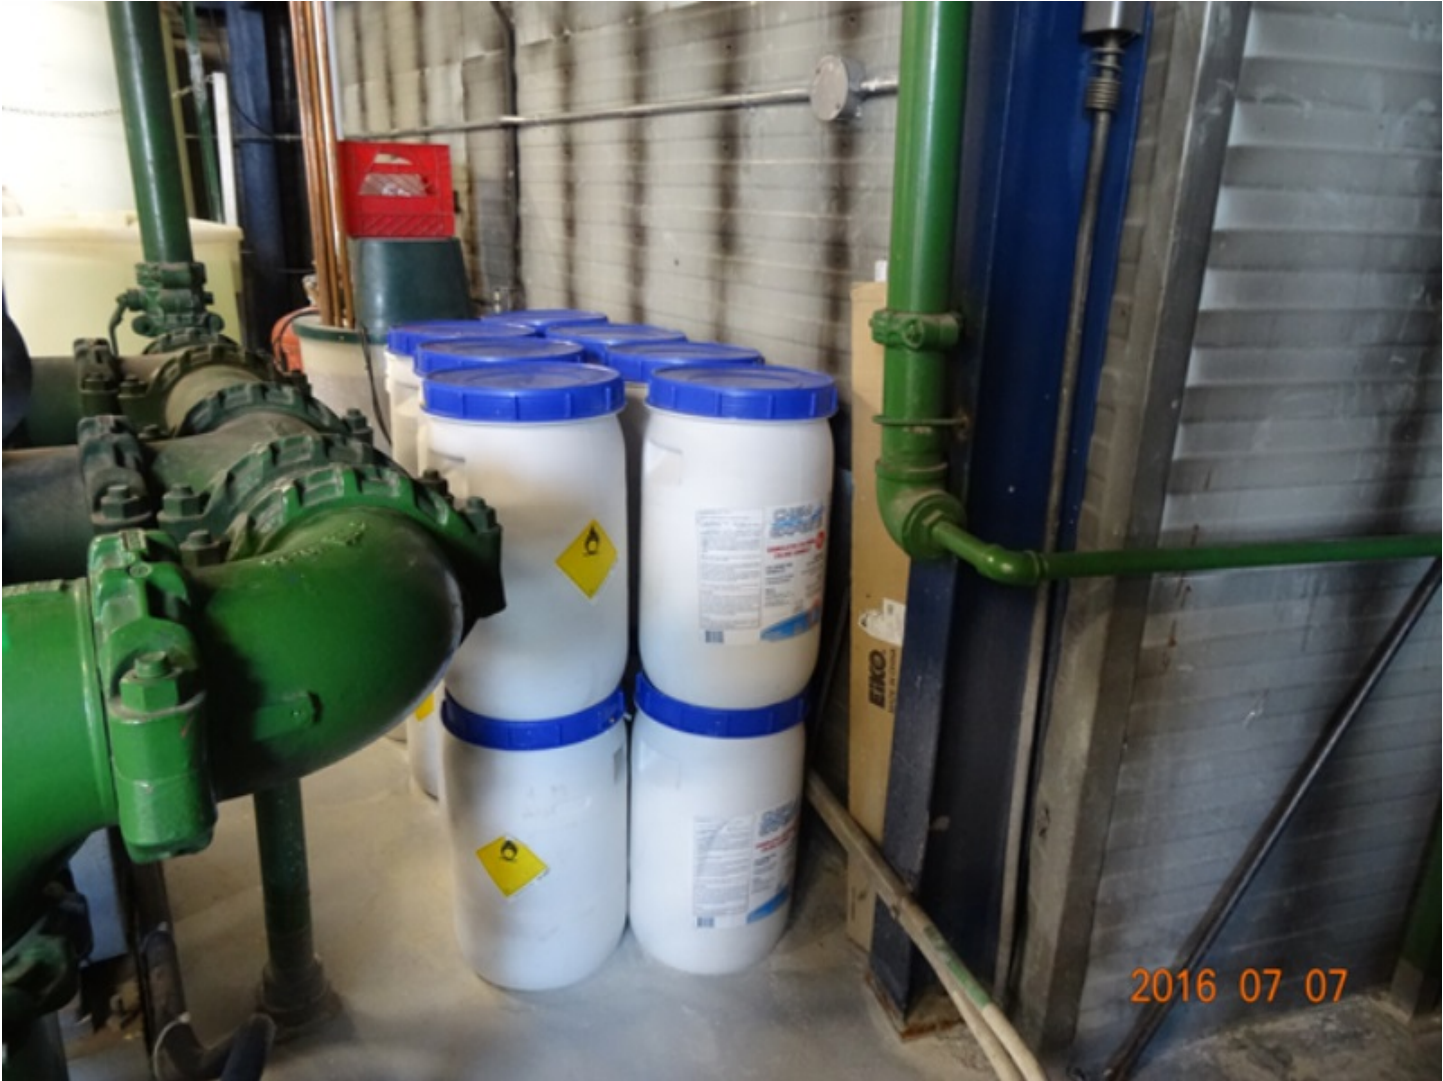
Figure 3 Chlorine/ chemical storage

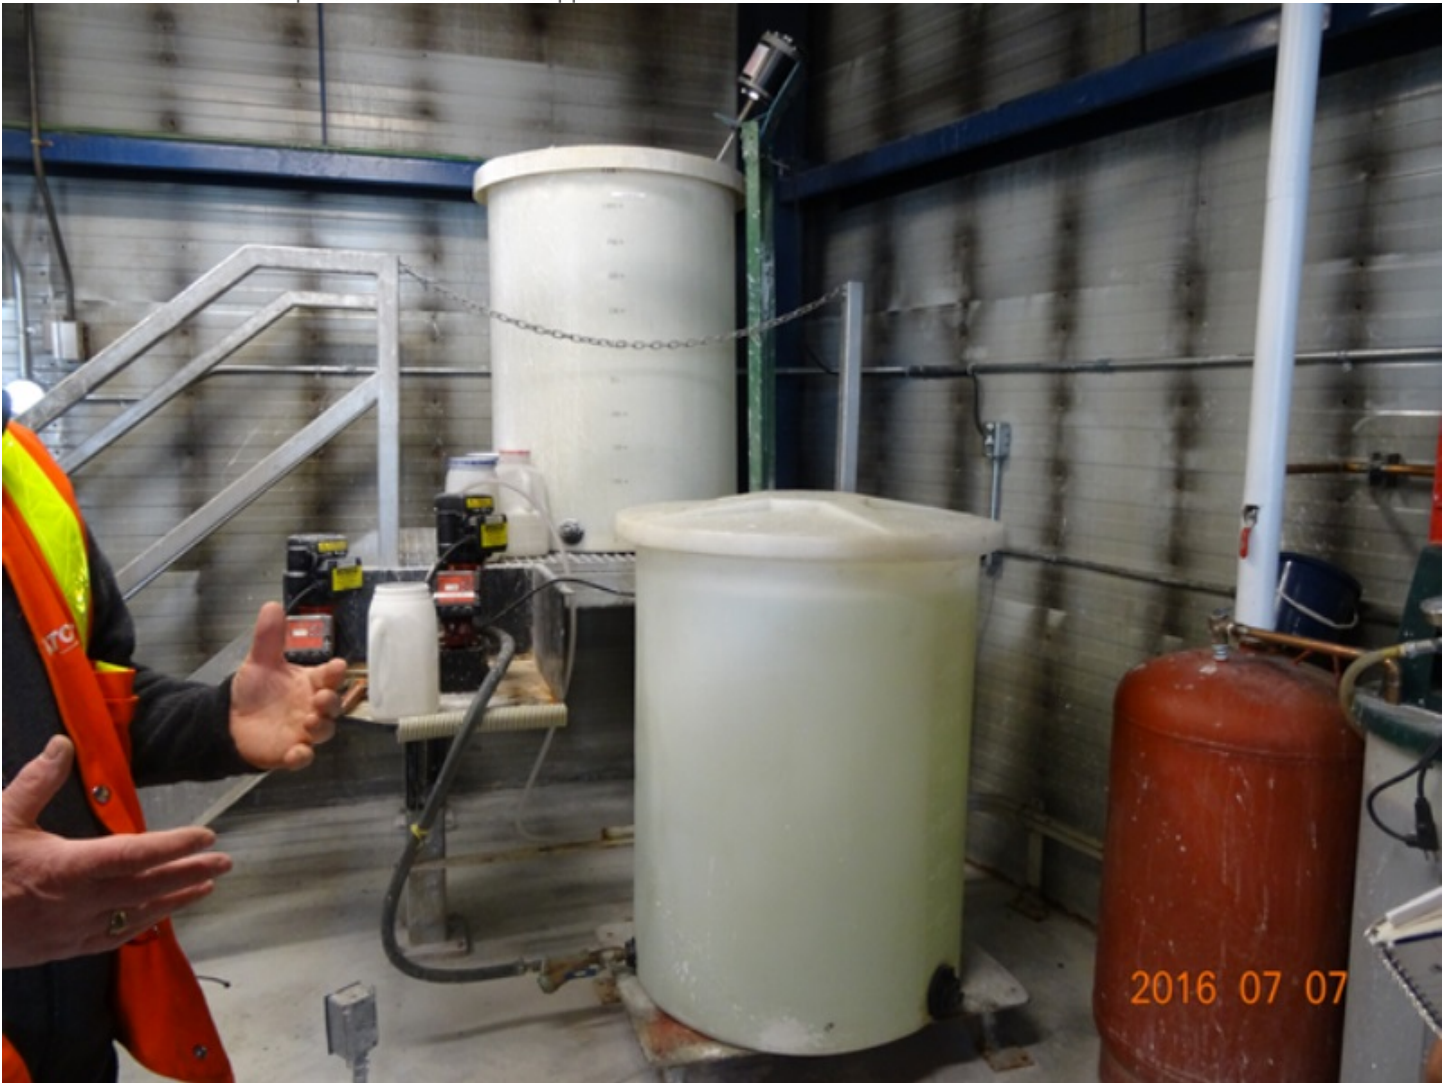
Figure 4 Chlorination system

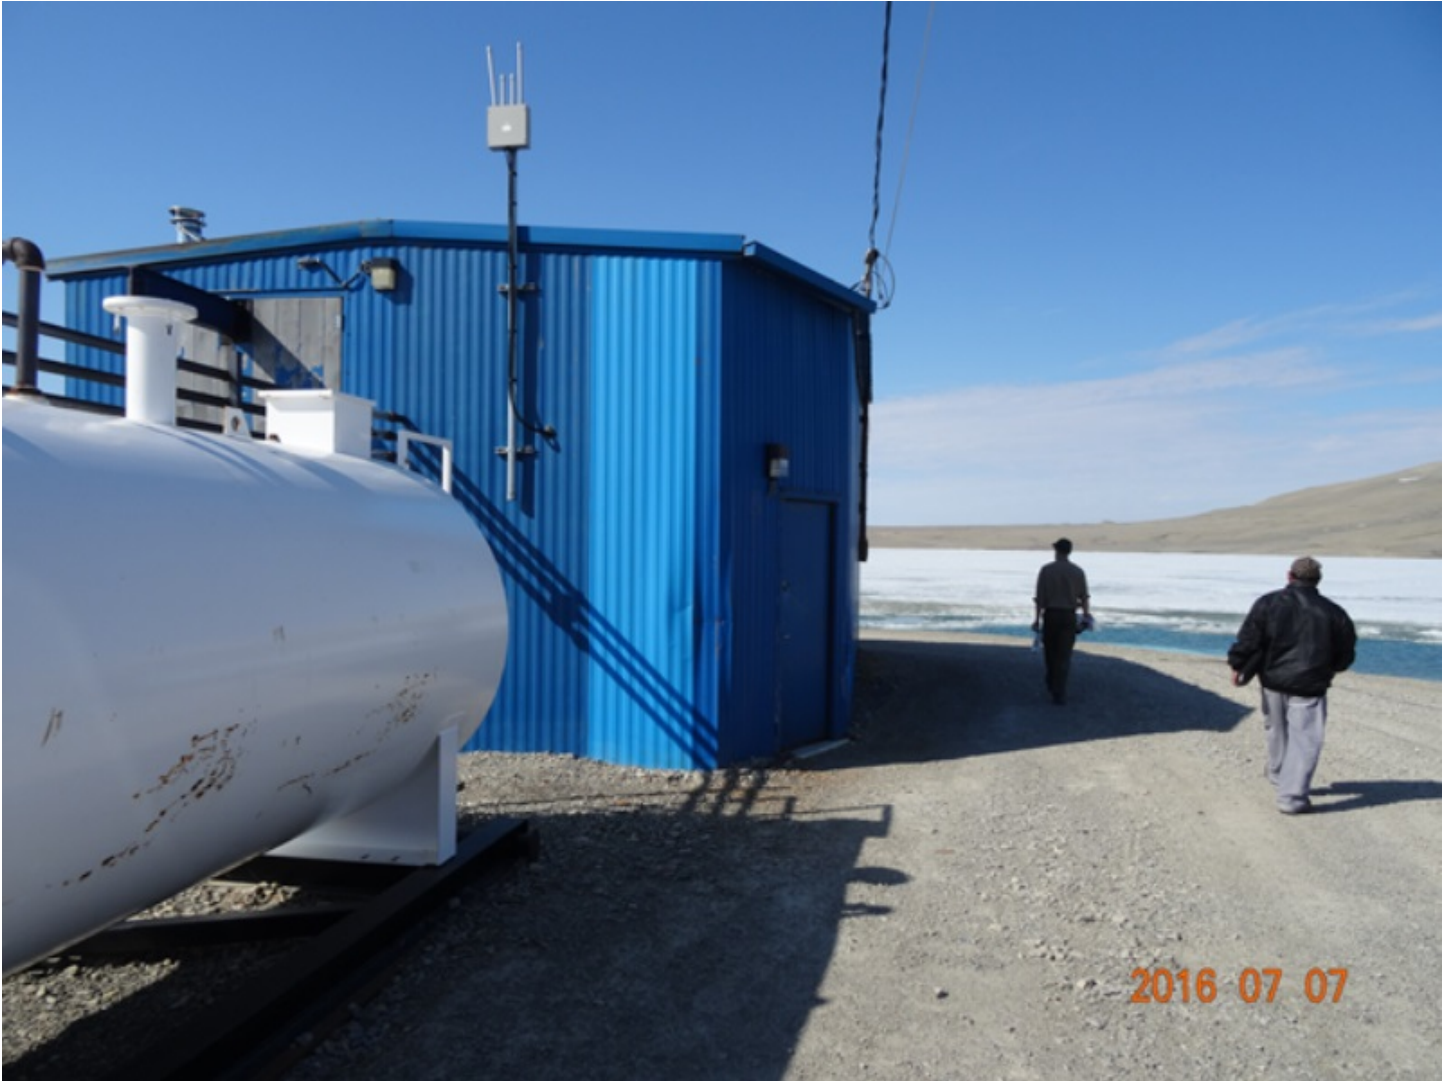
Figure 5 Raw water intake building at char lake

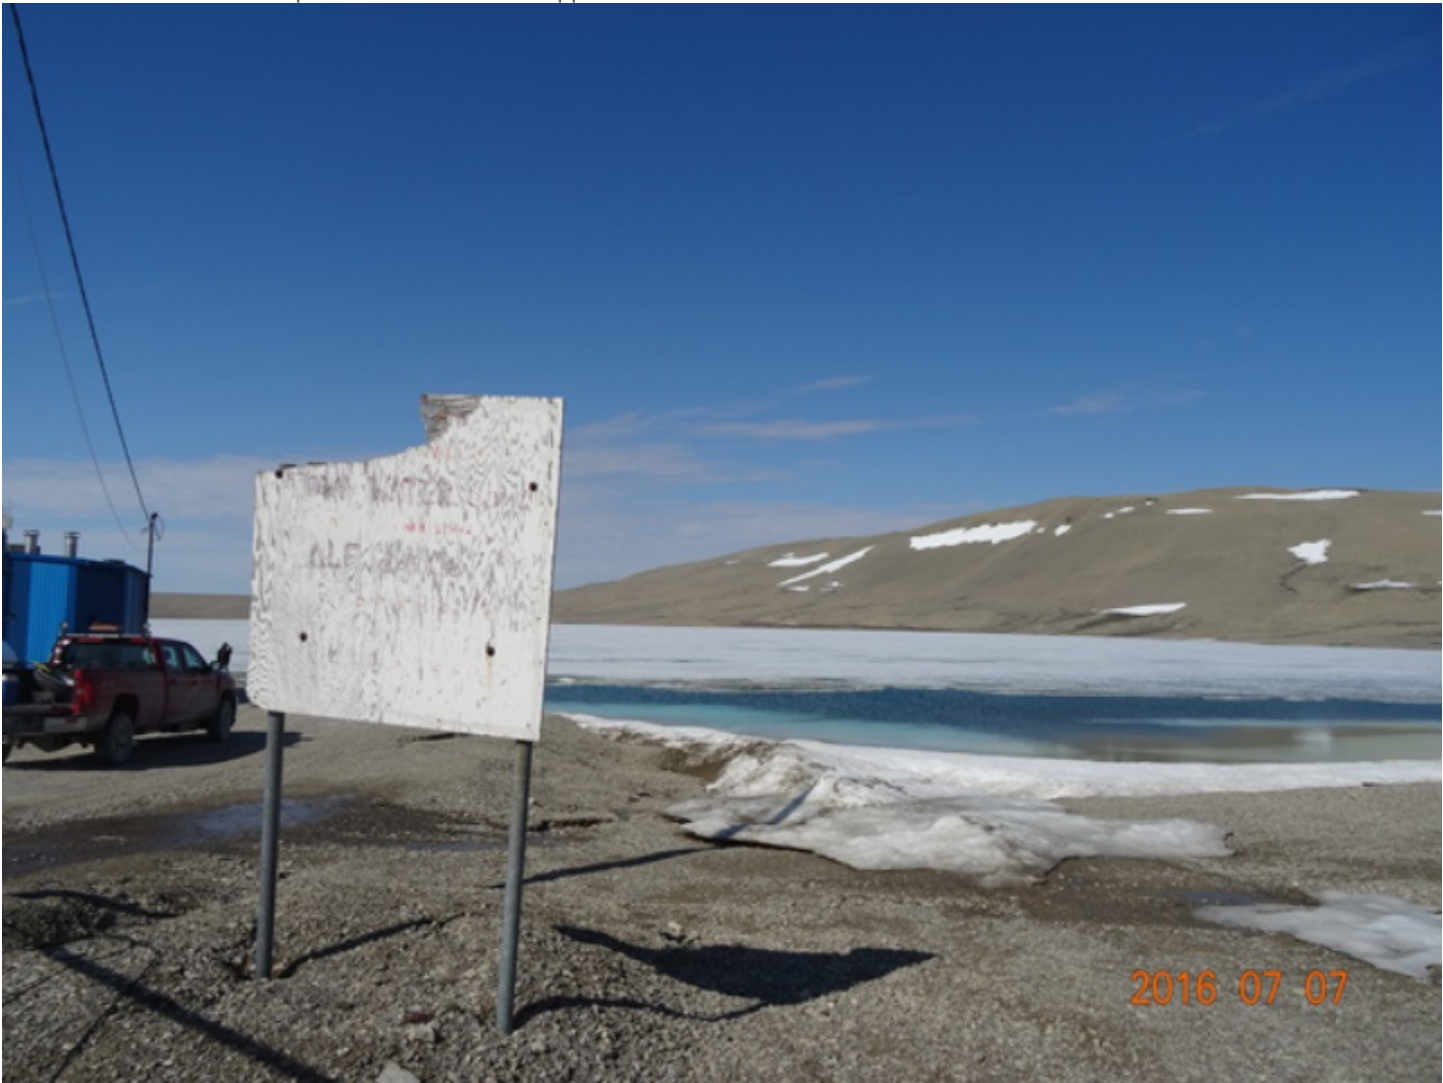
Figure 6 Signage at char lake

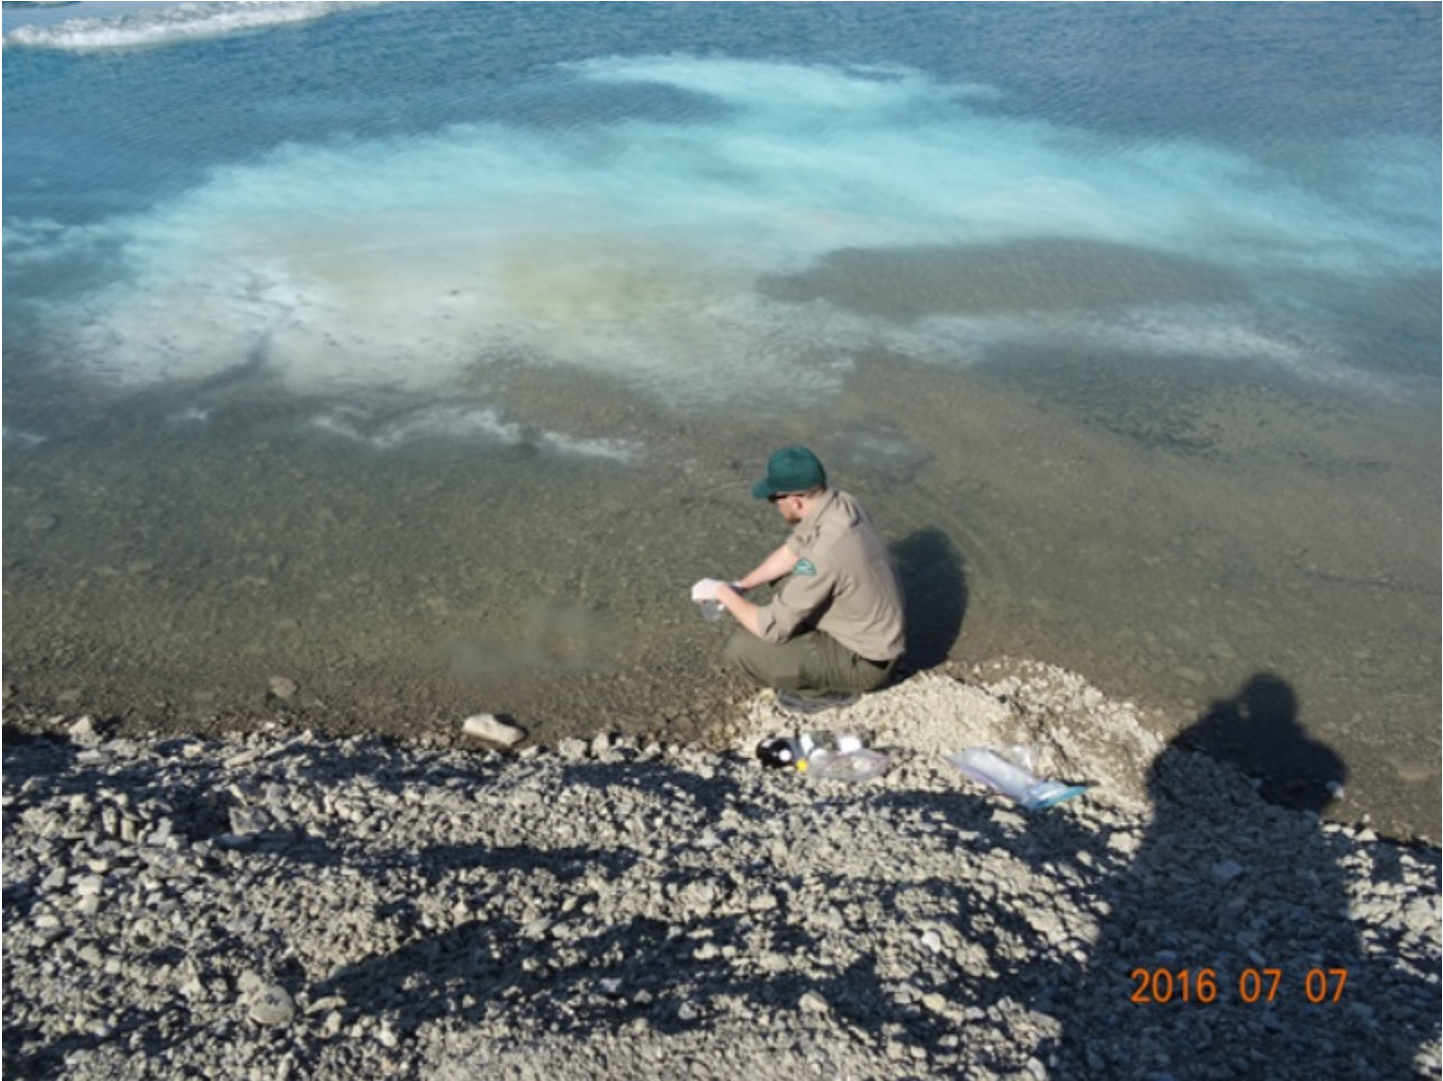
Figure 7 Raw water sampling

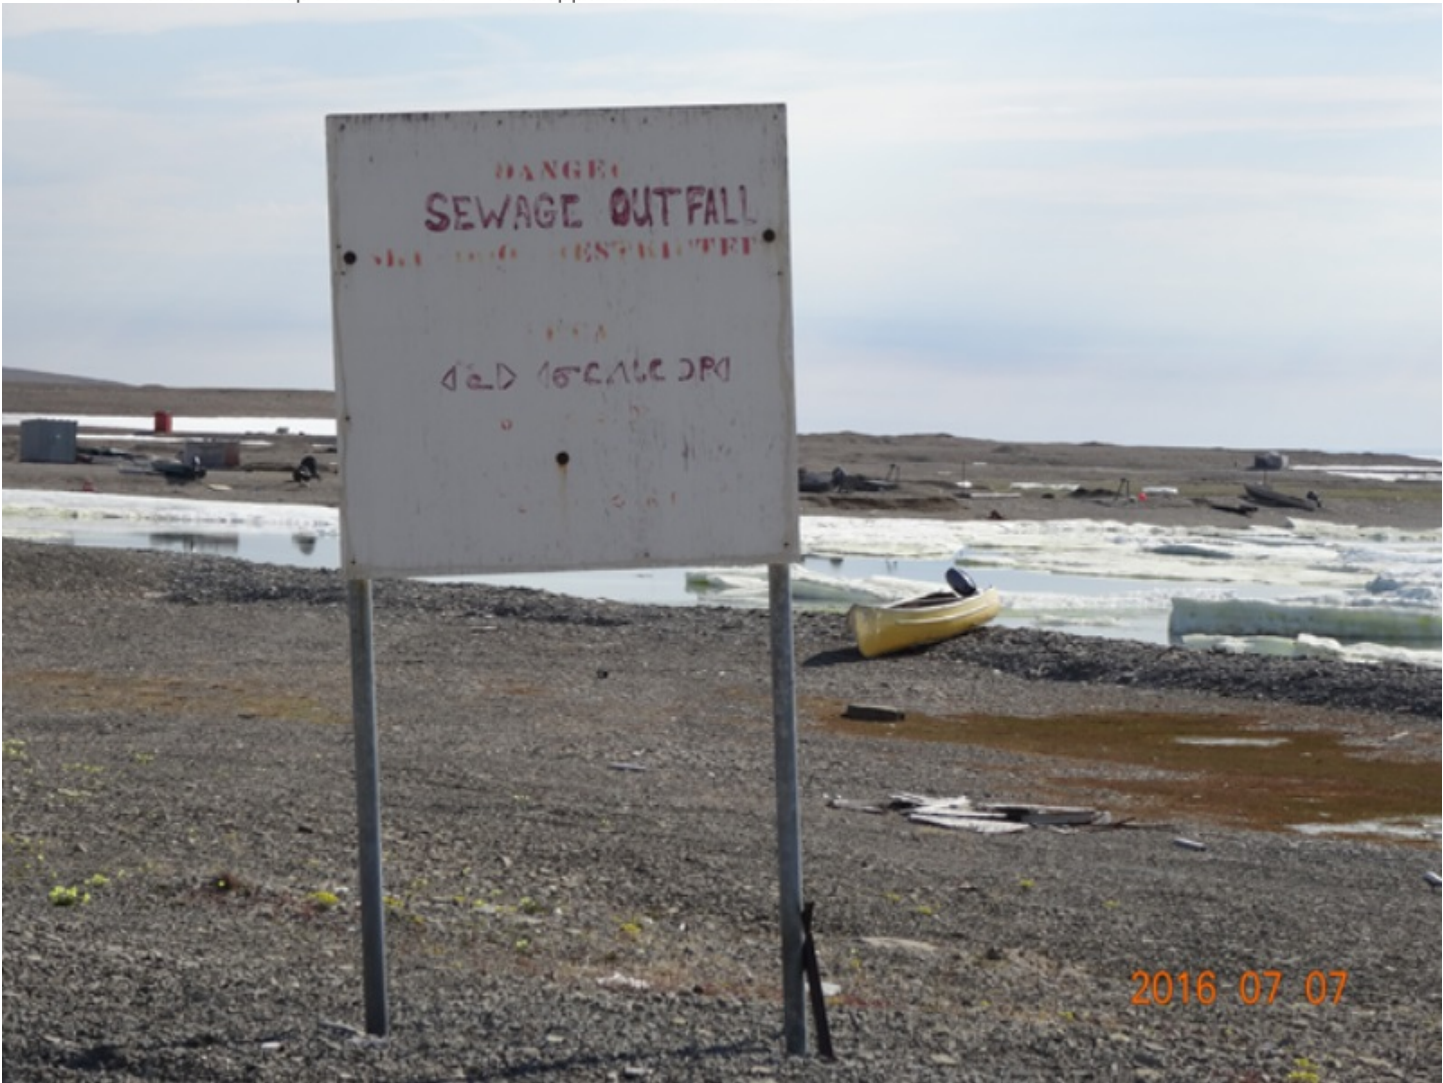
Figure 8 Signage at outfall

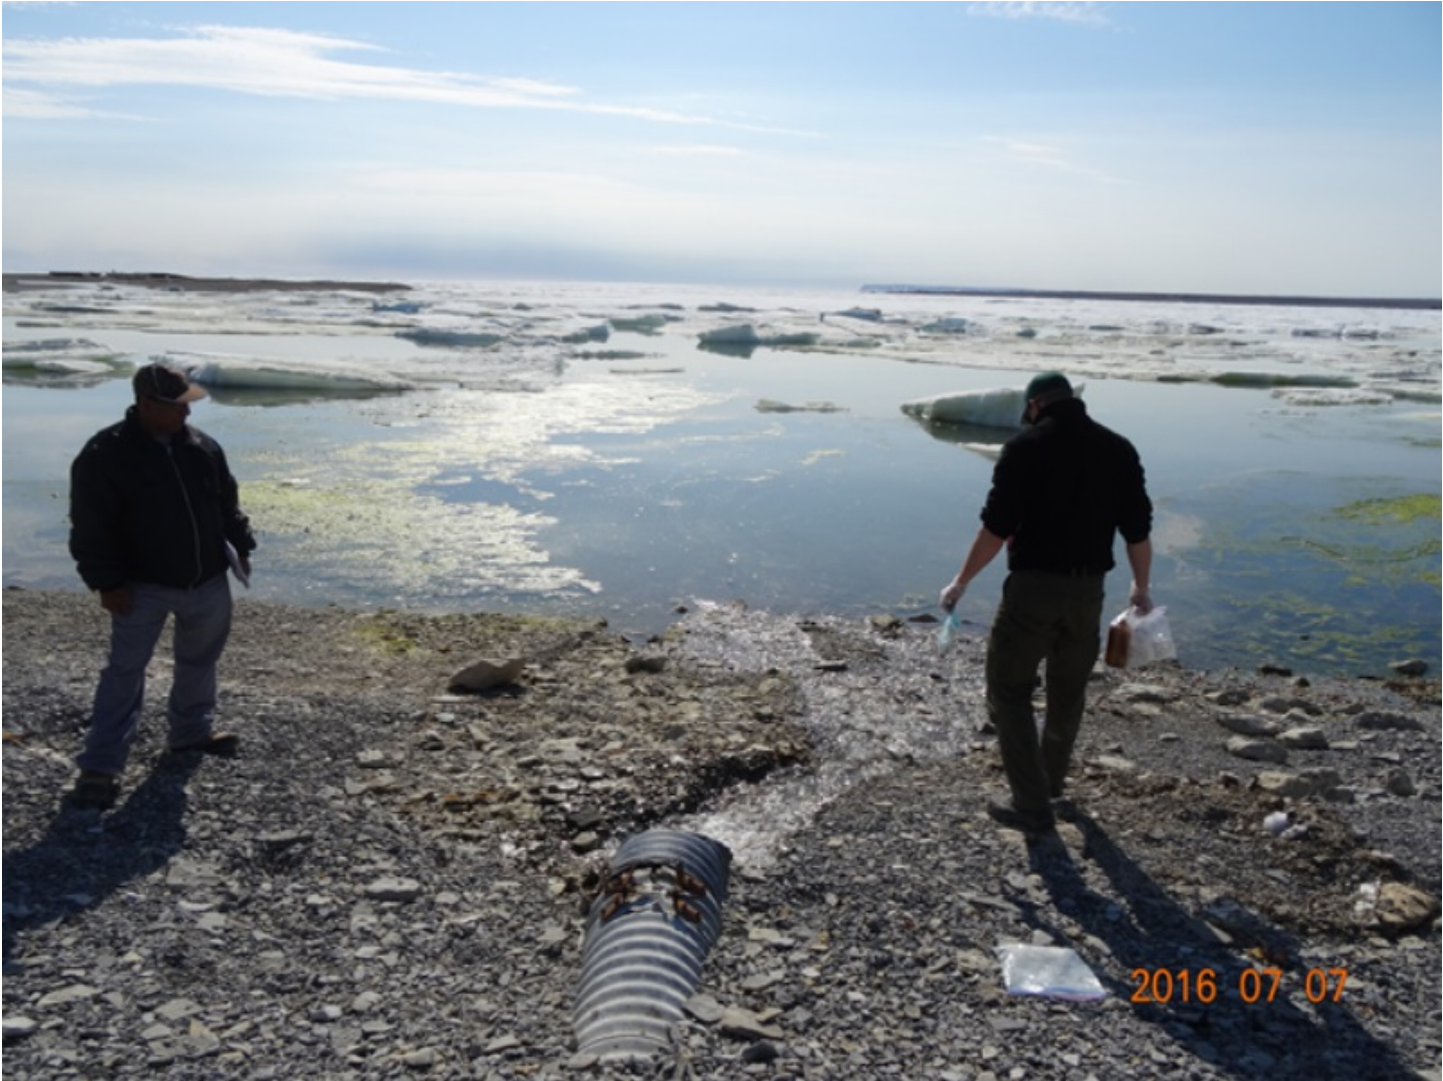
- Sewage from community is continuously pumped onto the shoreline in front of town. Obvious nutrient loading is present along shoreline as identified by the algae growing on the ice and on the surface of the water.
- Noted at outfall were; Waste paper, Food particles and other detritus from the outfall.

Figure 9 Algae bloom on ice at outfall

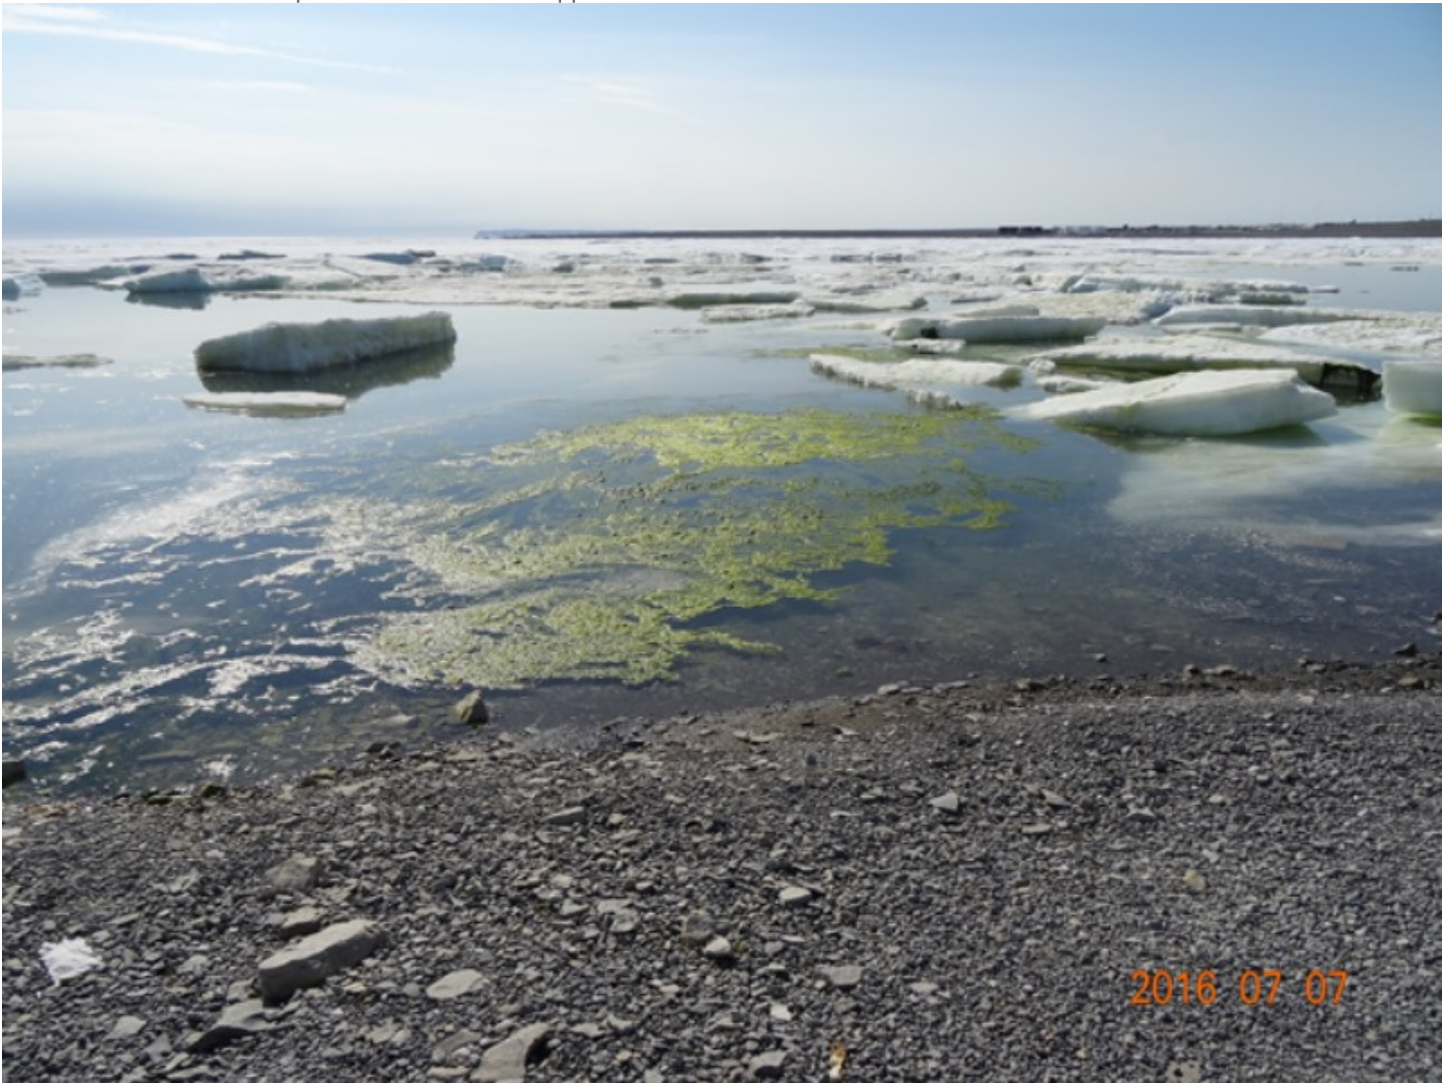
Waste water is a direct discharge to the shoreline in from of the community

Figure 10 Shoreline at outfall

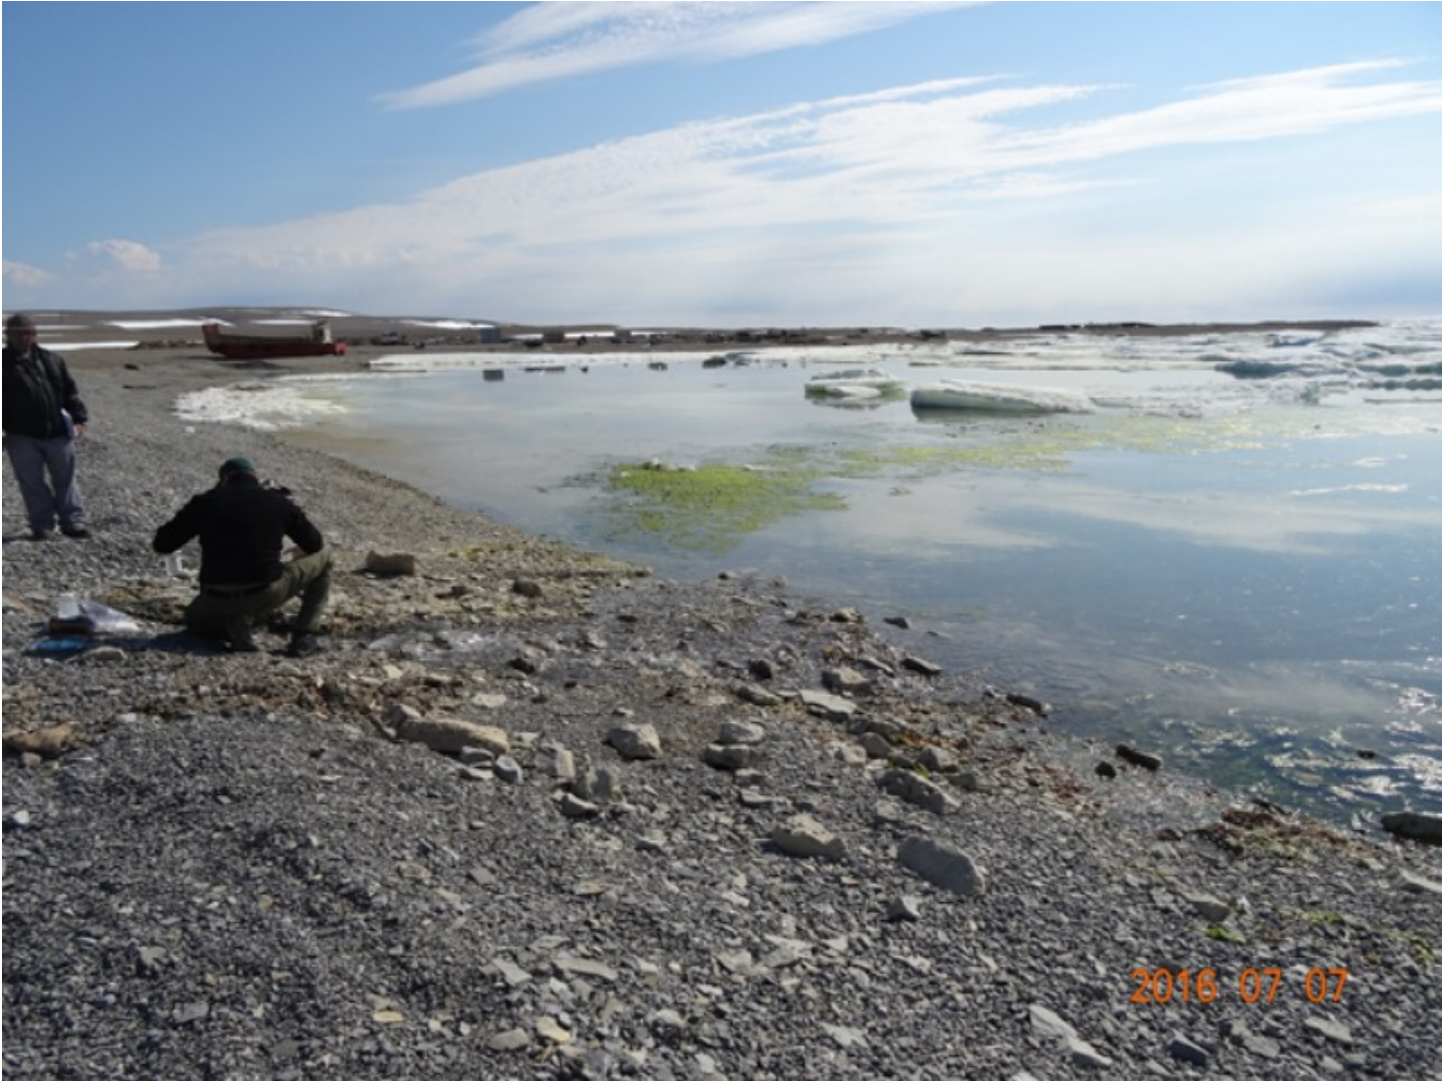
Figure 11 Sampling at outfall

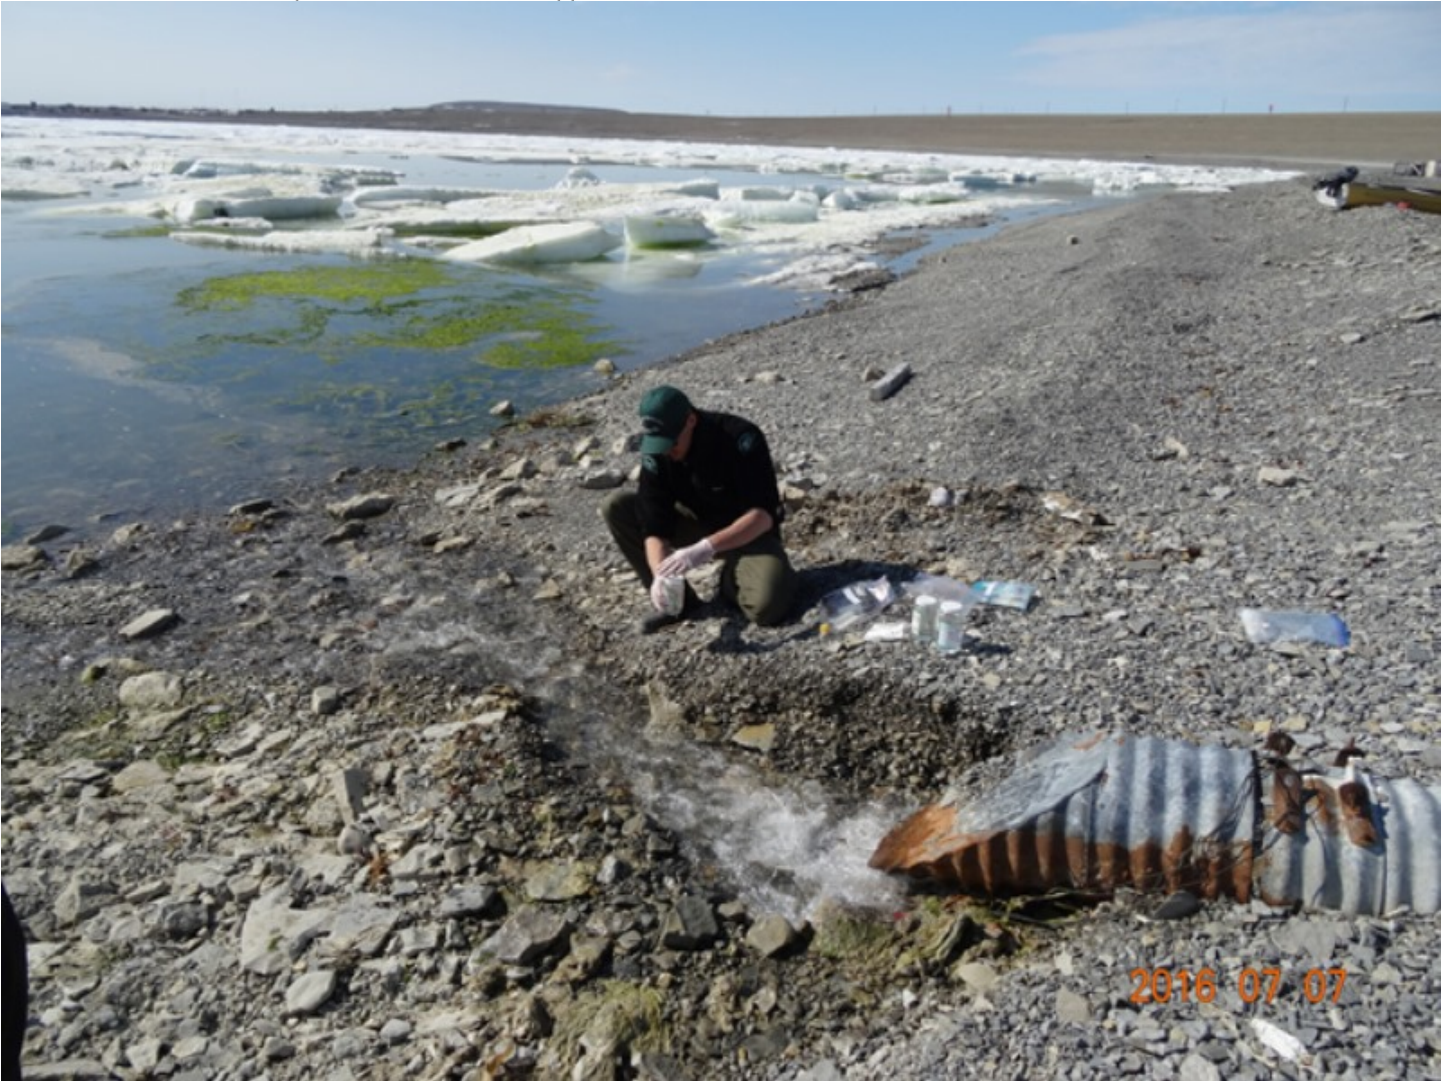
Figure 12 Sampling at outfall #2
