CMRC - NRC

CHARACTERIZATION OF CONTAMINATED SITES AT CFS-ALERT AND CFS-EUREKA, NUNAVUT

Final Report

March 31, 2007

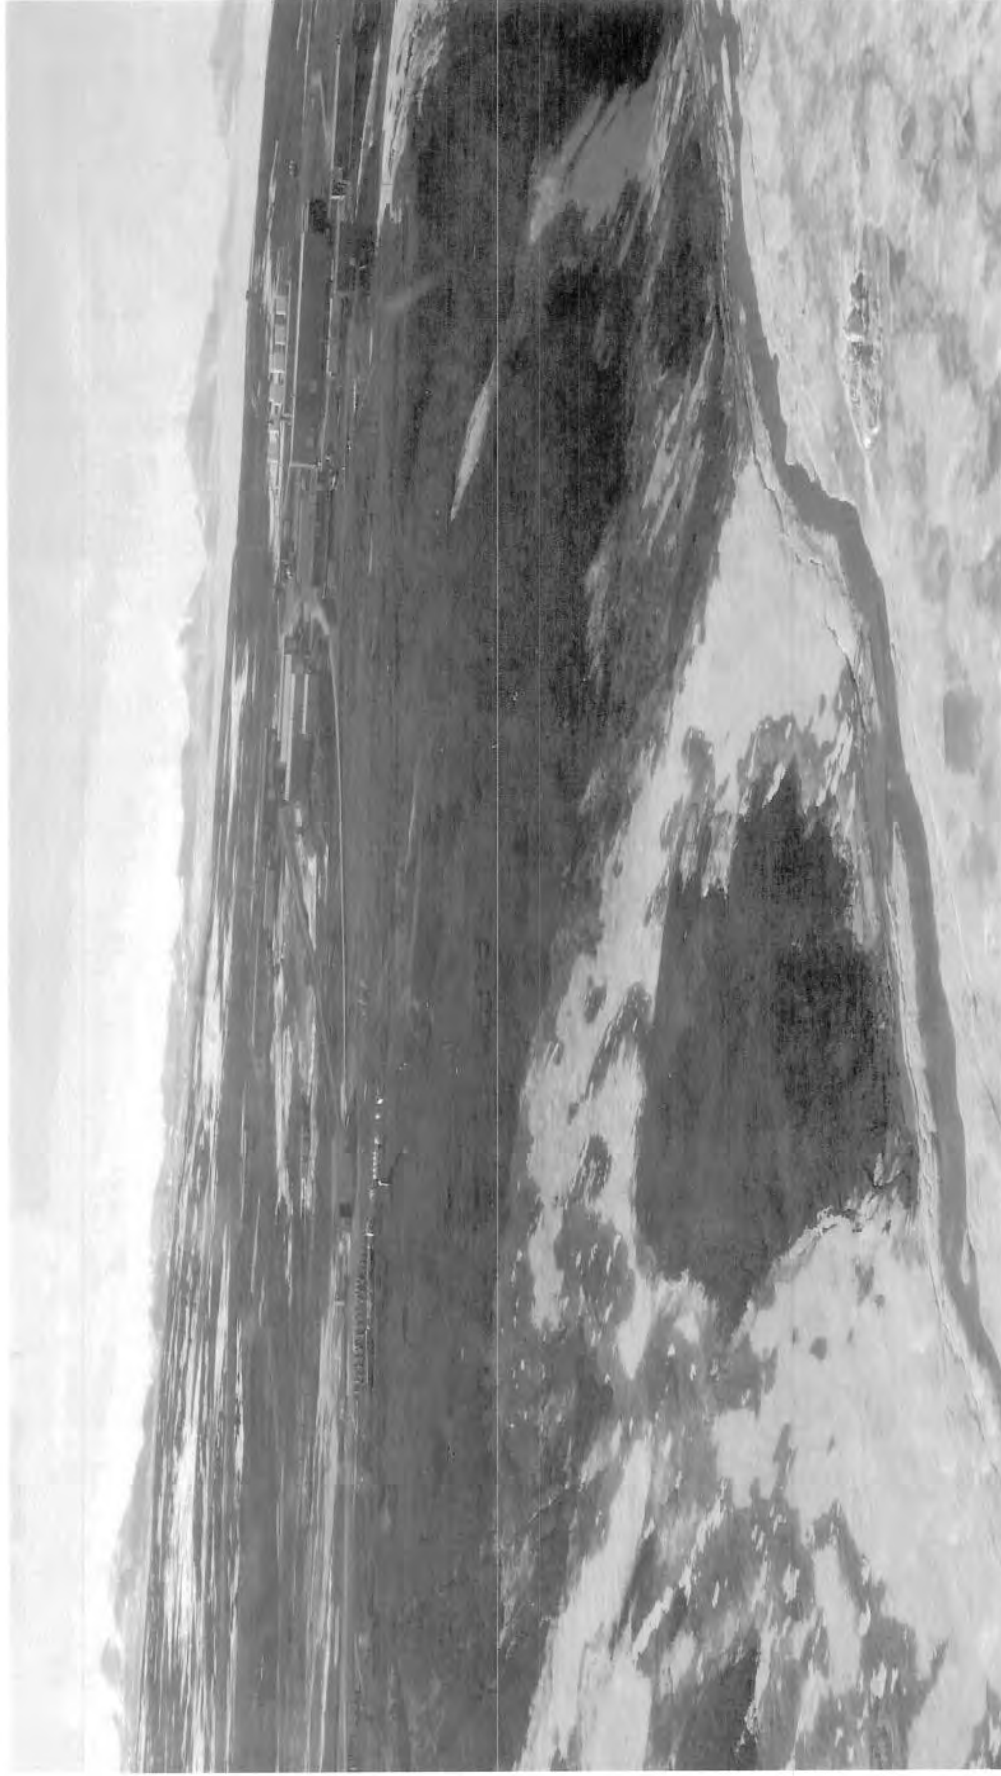
Figure 3. Aerial view of CFS-Alert with Dumbell Bay in the foreground (BRI, 2006).
