WATER LICENCE INSPECTION FORM

Licensee		Licensee Representative	
Department of National Defense - CFS Alert		Andrew Tam	
Licence No. / Expiry		Representative's Title	
3BC-ALT1015		Environmental Supervisor	
Date of Inspection		Inspector	
July 10 2019		Jeremy FRASER	
Activities Inspected			
<input checked="" type="checkbox"/> Camp	<input type="checkbox"/> Drilling	<input type="checkbox"/> Mining	<input type="checkbox"/> Construction
<input type="checkbox"/> Roads/Hauling	<input type="checkbox"/> Other:	<input type="checkbox"/> Other:	<input checked="" type="checkbox"/> Reclamation
<input checked="" type="checkbox"/> Fuel Storage

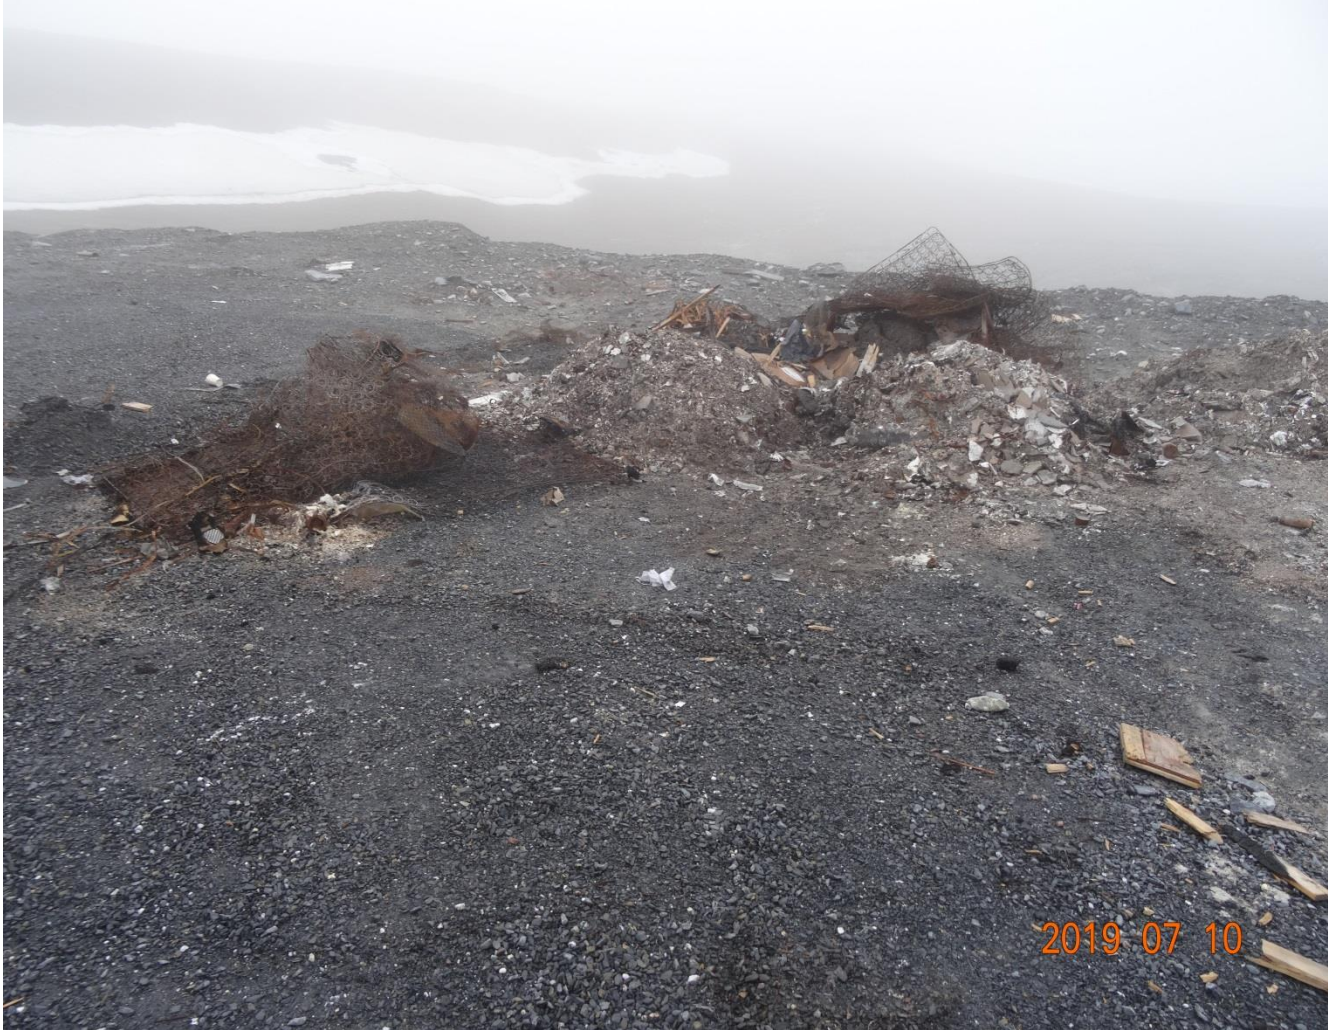
Photo #3

The ALT-4 Main Station Landfill is captured under the 3BC-ALT1015 Water Licence (*see photo 3*). This authorizes the deposit of waste including ash from the burn pan (*see photo 4*) located within this facility. CFS Alert is authorized to burn all untreated wood, cardboard and acceptable food waste in the incinerator including (*see photo 5*) burning waste oil in a waste oil burner onsite. DND CFS Alert actively monitors water runoff from this site as a requirement of the Water Licence *Part J Item 6* at the sampling station ALT-4 (*see photo 6*). During inspection of this facility there were no concerns noted regarding the deposit of waste or management of the Landfill.

Description: Main Station Landfill waste deposit

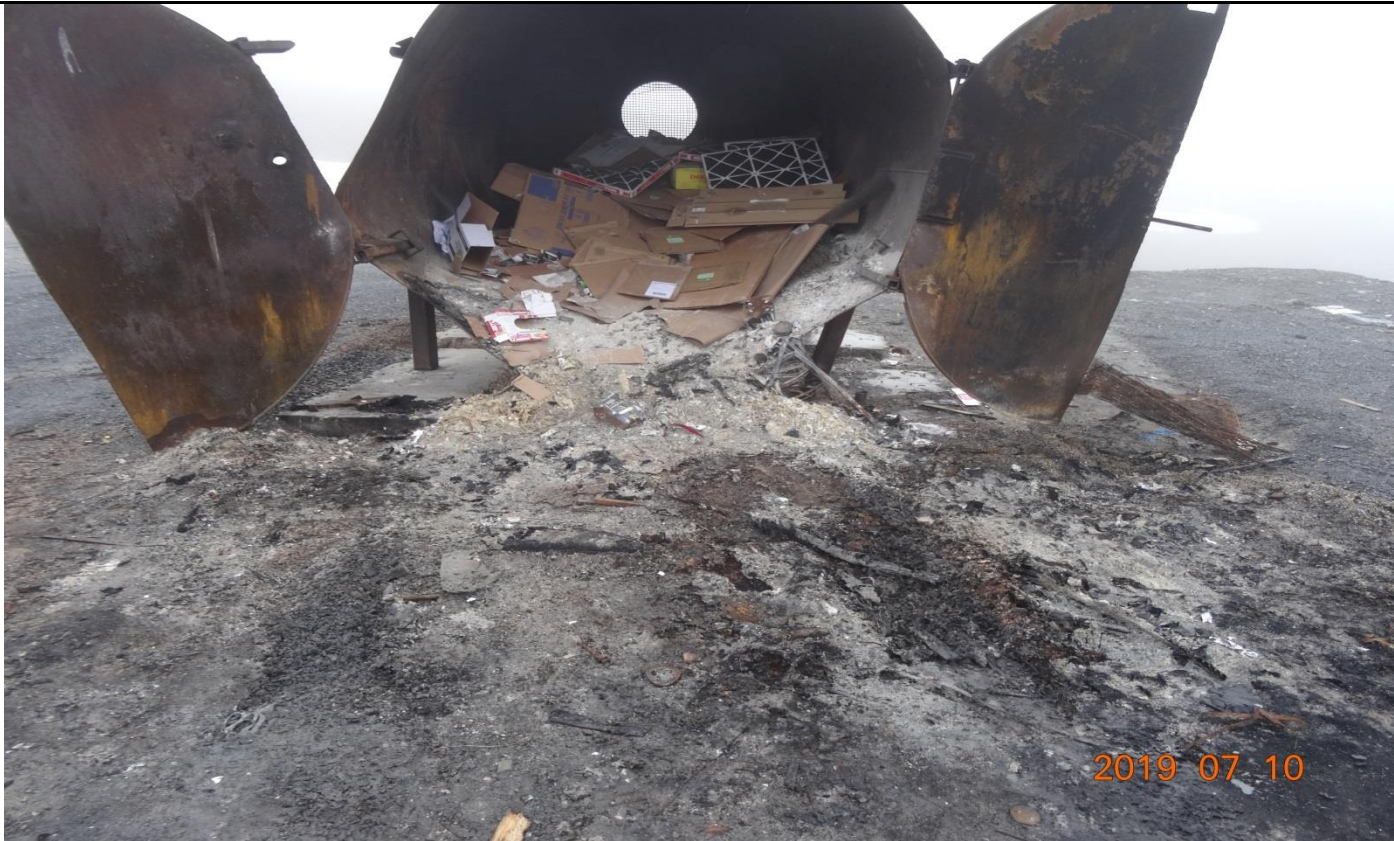
Photo #4

Description: Main Station Burn Pan located within the Main Station Landfill facility

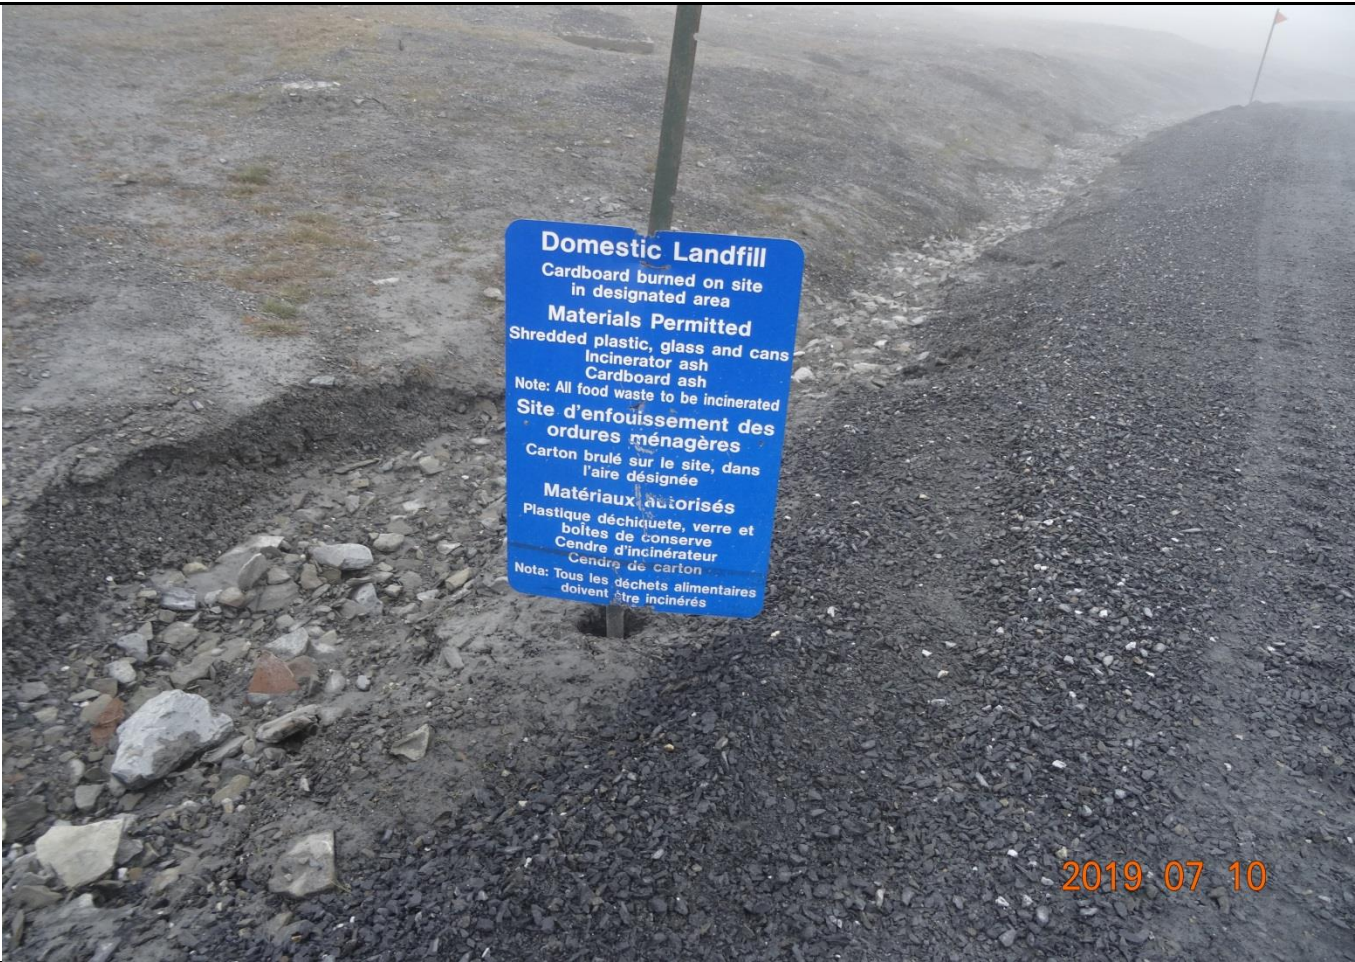
Photo #5

Description: Signage indicates acceptable material to be deposited within the Landfill ALT-4

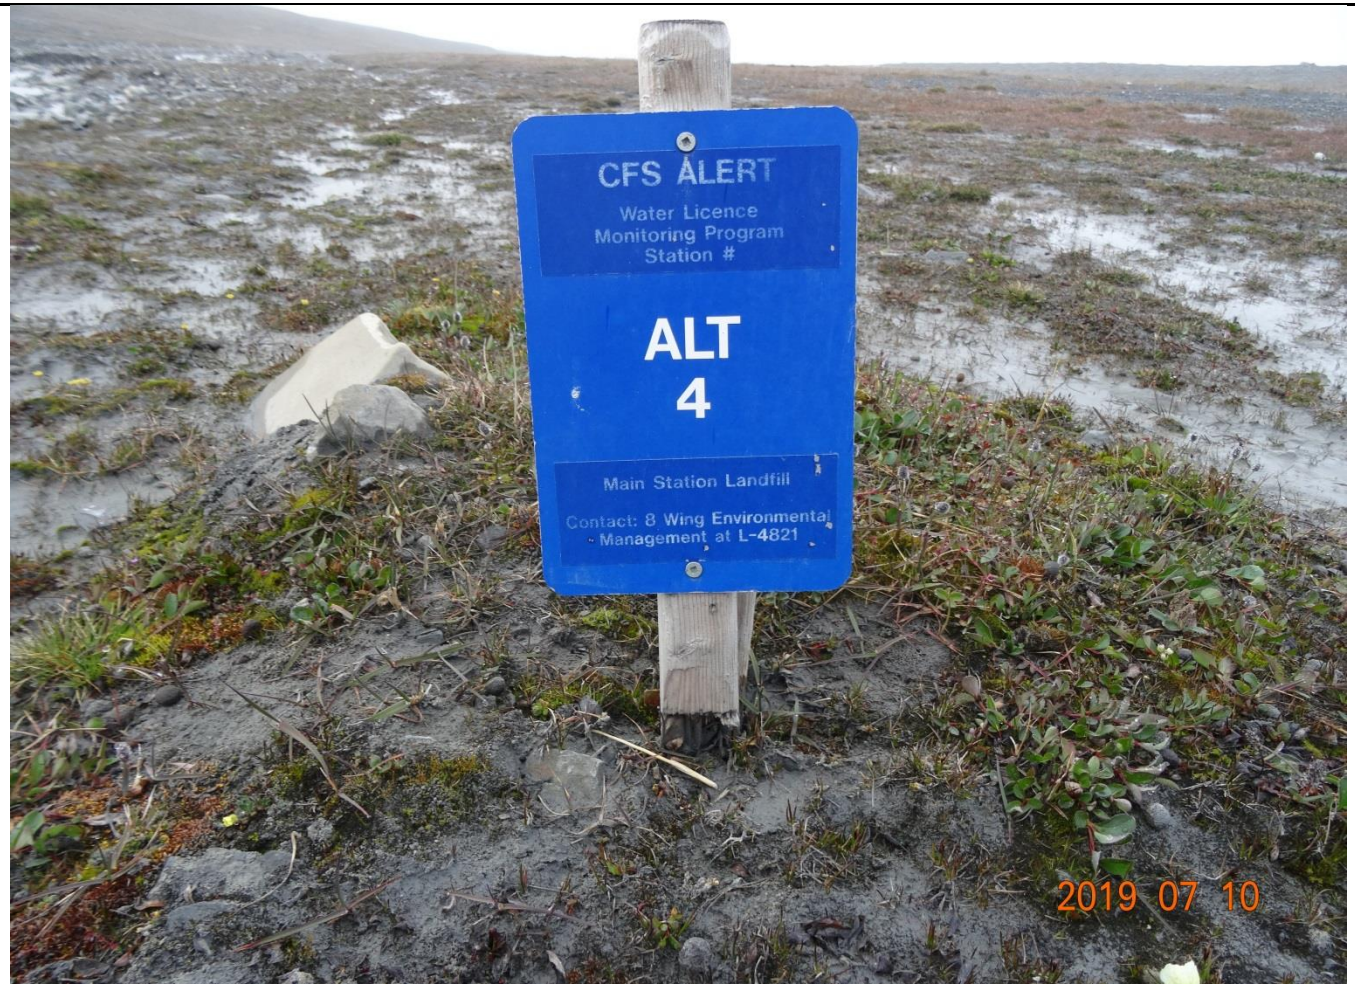
Photo #6

Description: Main Station Landfill water runoff sample location

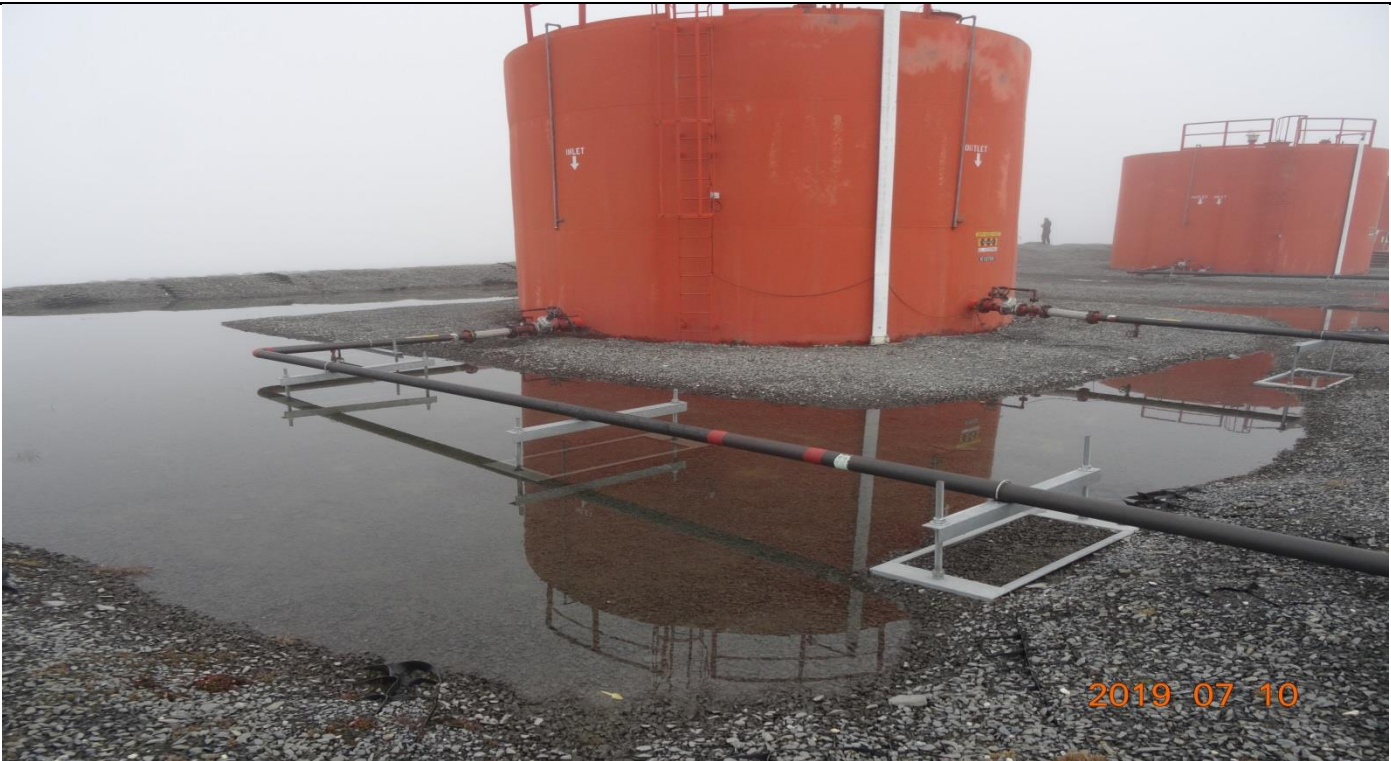
Photo #7

This authorization permits DND to hold fuel onsite for various uses. DND holds, on this site ALT-8, 6 fuel tanks within an unlined berm. 2 white fuel storage tanks approximately 455,000L each and 4 orange fuel storage tanks approximately 236,000L each. During the inspection of this facility it was noted that water is contained within the berms (*see photo 7*). During the inspection of this facility it was noted that signs of historic overflows are apparent with slumping throughout the berm walls. CFS Alert staff informed the inspector that in years past and in previous reports water from this facility has vanished. This leads to the inspector to believe that this facility is not operating as intended and potential unauthorized discharges have occurred with no quality control of potentially contaminated water. This is in contravention of the Act (*Nunavut Waters and Nunavut Surface Rights Tribunal Act*) NWNSRTA Section 12(1), (2) & (3). The inspector believes that water from this facility percolated through the berm wall to the east of the fuel storage facility downhill towards the contaminated soil facility and through to the far east side of the facility filling it beyond capacity and breaching the northeast corner of the contaminated soil facility and releasing into the environment (*see photos 8, 9, 10, 11*). The inspector noted a drum style spill kit located in the vicinity of the fuel tank farm that has been damaged and its contents appear to be removed. (*see photo 12*) It is important to keep emergency response equipment up to date in the event of an emergency. The inspector is requesting a new spill response kit to be replaced along with its appropriate contents to ensure proper mitigation measures are in place in the event of an emergency.

Description: lower airfield fuel tank farm - Water contained within the unlined berm housing fuel tanks

**Airfield Fuel Tank Farm, Landfarm parallel to the Airfield Tank Farm and Sewage Terrace System** – prior to discharge Water with in the facilities DND must sample to verify compliance with the criteria within the Water Licence. The release of the water weather or not this was intentional, is in contravention of the *Act NWNSRTA Section 12*.

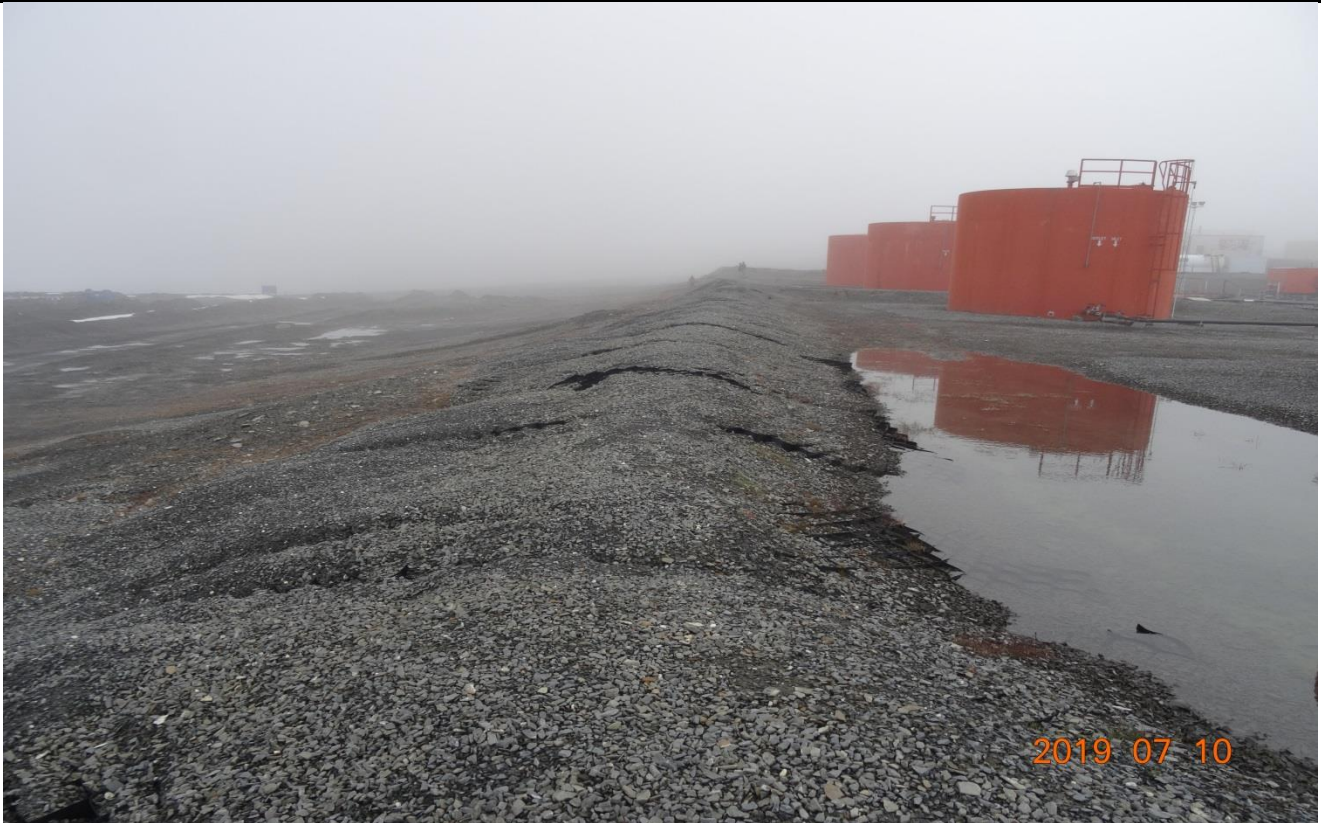
Photo #8

Description: Fuel Tank Farm on the right side of the photo and the contaminated soil landfarm on the left downhill from the fuel storage facility.

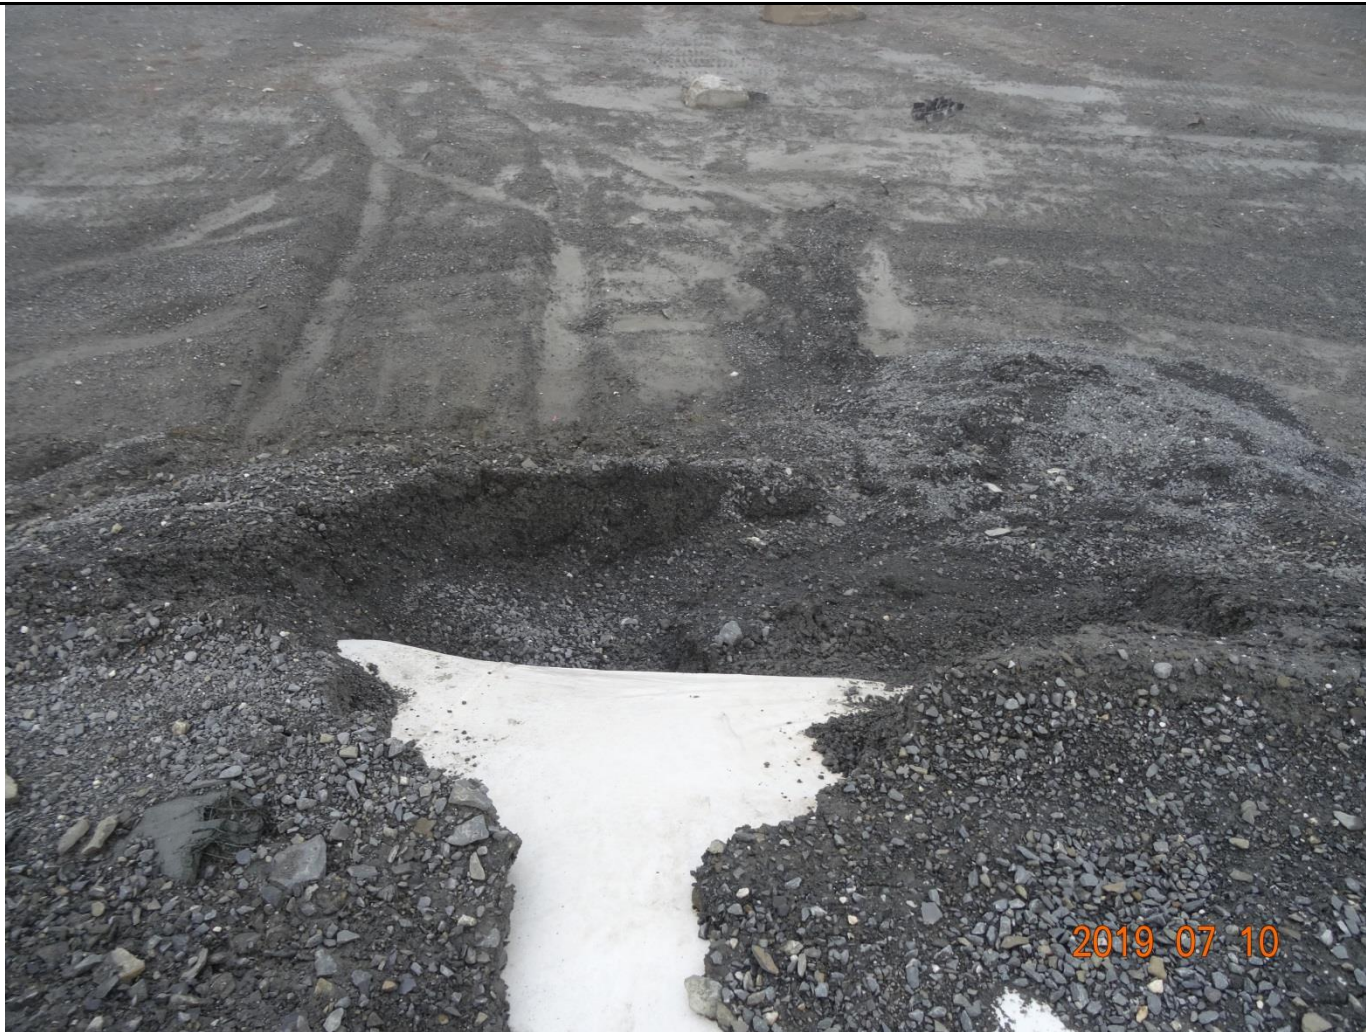
Photo #11

During inspection of this facility it was noted that the facility appeared to be at full capacity. It was also noted that the northeast corner of the berm containing the contaminated soil has washed out due to water levels being too high for the berm wall to contain (*see photo 10, 11*). This is an unauthorized discharge of contaminated water and in contravention of the Act NWNSRTA Section 12(1), (2) & (3) The inspector is request CFS Alert to repair the damaged berm prior to further deposition of contaminated soil into this facility. This event also fails to satisfy *Part D Item 11* of the licence which states “*Effluent discharged from the Fuel Storage Facilities and the Landfarm at monitoring program stations ALT-8, 9, 10 and 11 shall not exceed the following Effluent quality limits*”. With the release of material from this facility a contaminated soil farm the inspector believes that the substance fails to meet criteria in *Part D Item 11* of the licence. The substance can be classified as a hazardous substance and must be disposed of off-site. Failure to adhere to this request will result in further enforcement action by CIRNAC to ensure compliance.

**Description:** contaminated soil Landfarm facility Northeast corner of the berm breached – outside wall of the breached area washed out

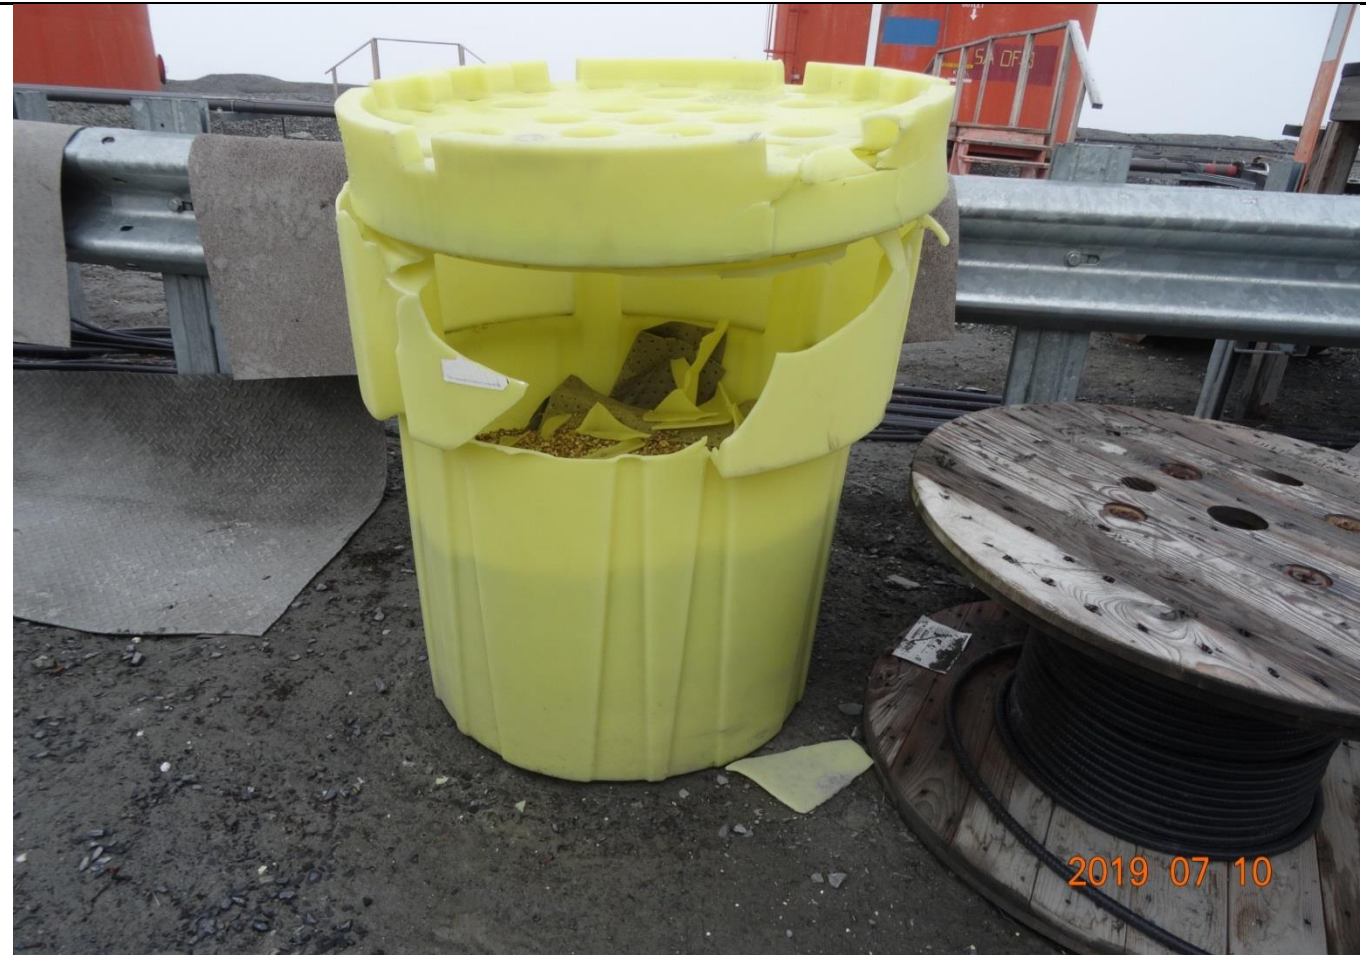
Photo #12

**Description:** Damaged Spill Response Kit – contents removed. Located between the tank farm and the parking area.

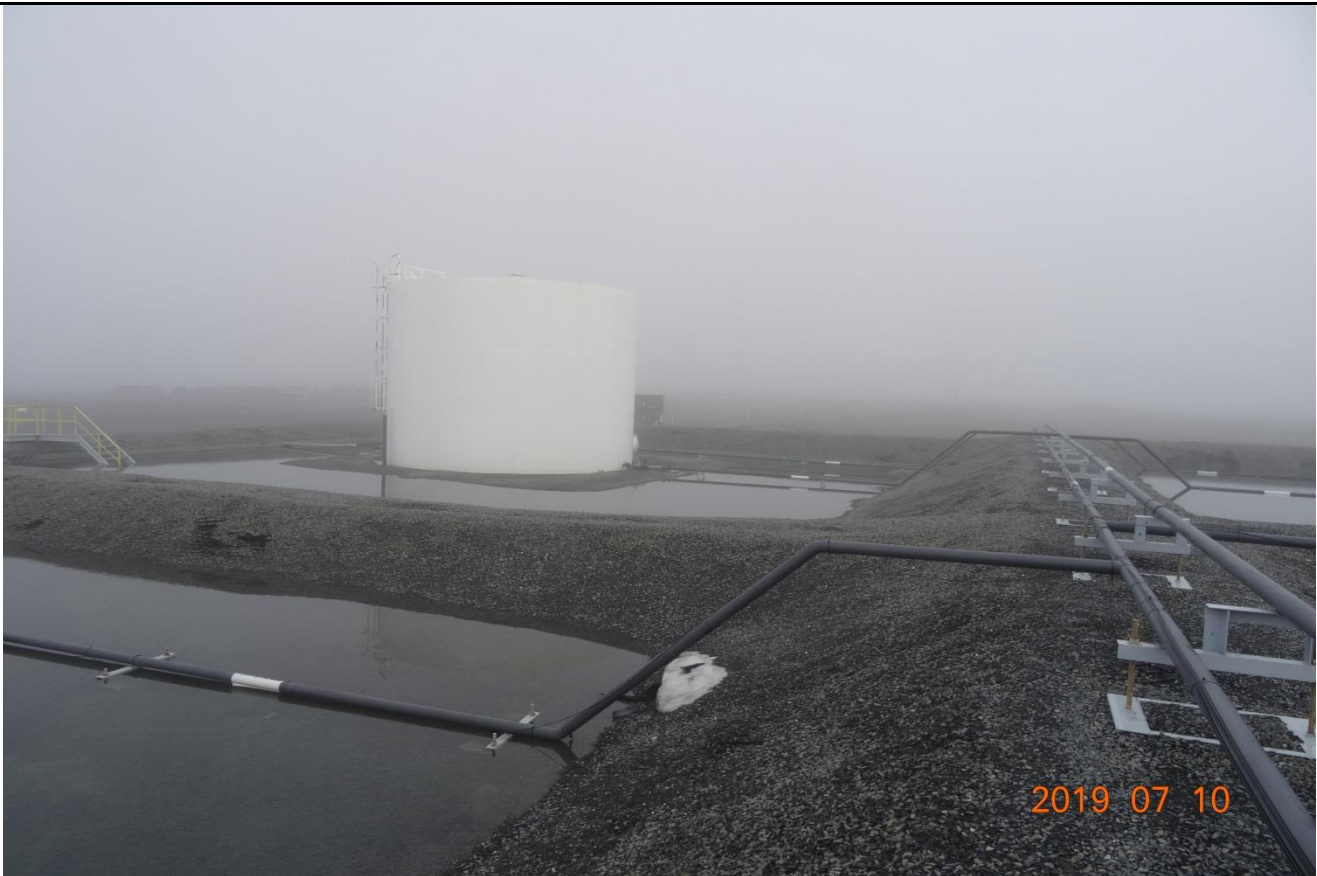
Photo #13

When the inspector arrived at this facility it appeared to be operating as intended. The grade and material used appear to be in stable condition with no slumping or apparent signs of seepage or leaks (*see photo 13*). No concerns were identified regarding this facility.

Description: Upper Fuel Tank Farm appears to be operating as intended

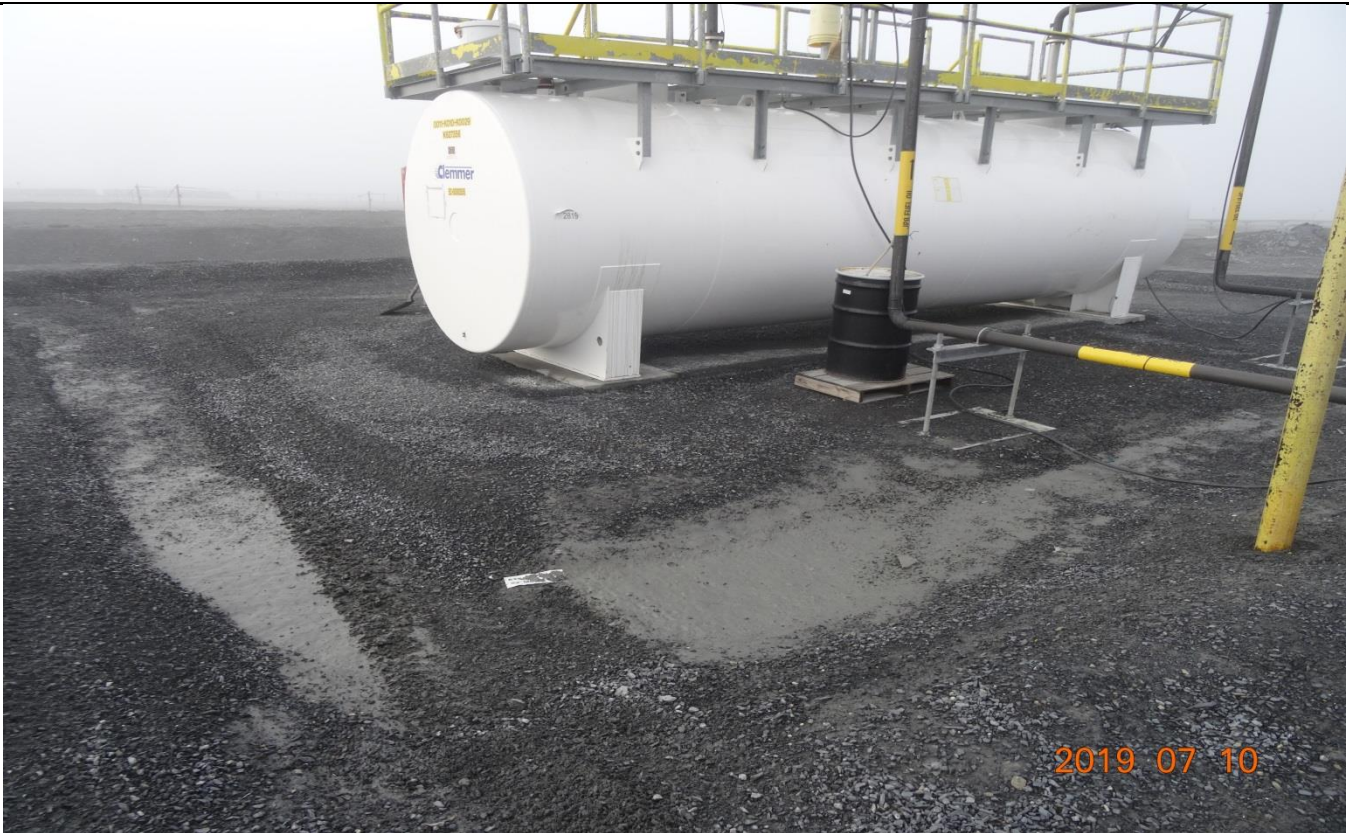
Photo #14

The day tank farm is located adjacent to the contaminated soil ALT-10.1 along the road to the CFS Alert airport runway. This facility appears to be in good order with no signs of leaks. The inspector noted tracks leading up onto and through the berm surrounding the Day Tank (*see photo 14*). DND is reminded that this activity compromises the structural integrity of the berm walls and could lead to an unauthorized release of fluid from this facility. No concerns other concerns regarding this facility.

Description: CFS Alert Day Tank Fuel Storage Berm. Vehicle tracks can be seen going through the facility

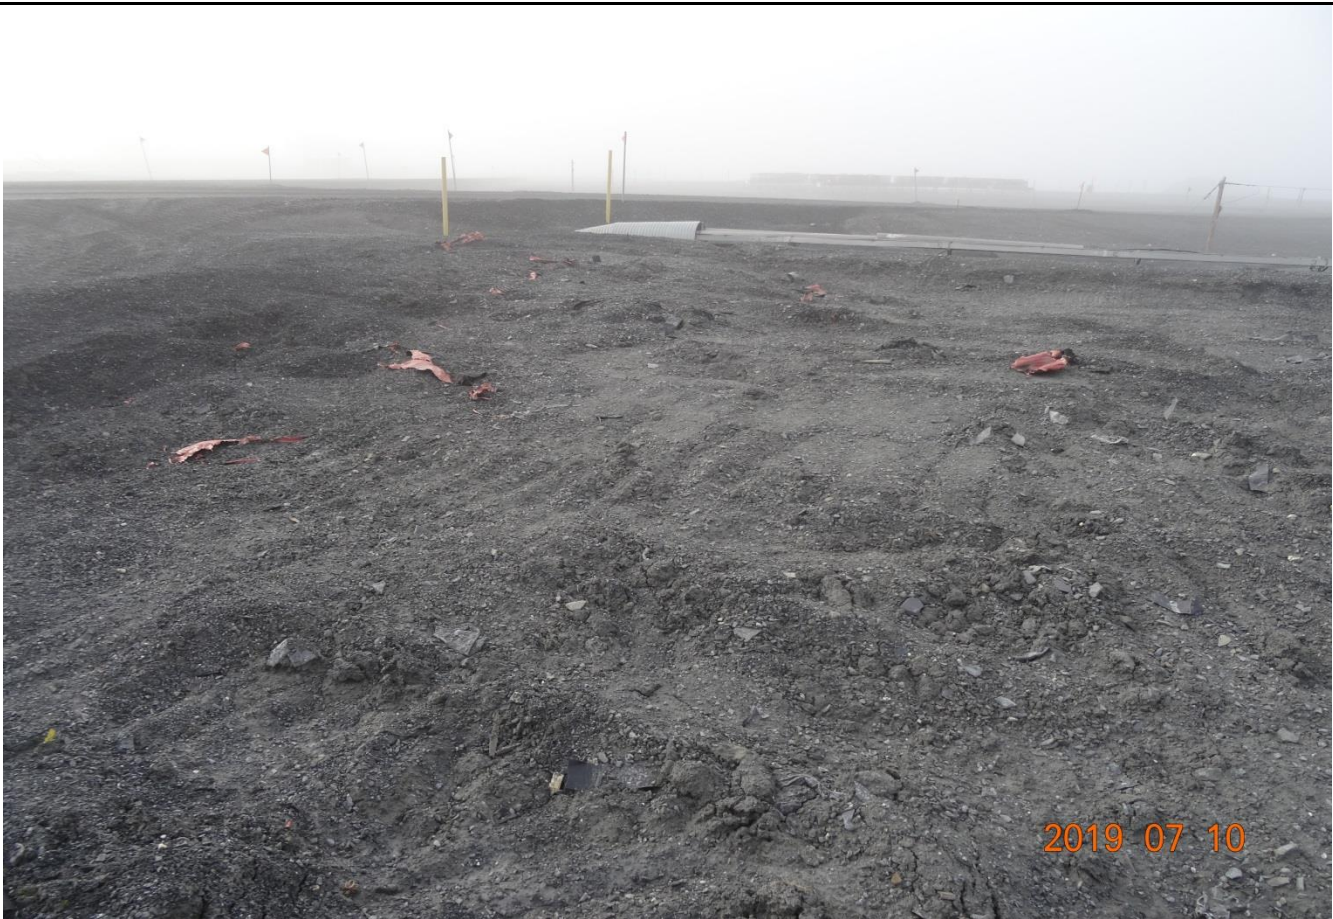
Photo #15

This facility appears to be in an unusable condition. The liner beneath the berm intended for contaminated soil is no longer an impermeable layer separating the contaminated soils from the environment (*see photo 15*). The Inspector was notified that contractors unknowingly damaged this facility. The inspector was also notified that the facility was not in commission during this time. DND was advised not to use this facility as a contaminated soil facility until such time as a new liner be installed to prevent contamination. No other concerns noted regarding this facility.

Description: ALT-10.1 Contaminated soil adjacent to the Day Tank Farm. Pieces of liner can be seen in this photo.

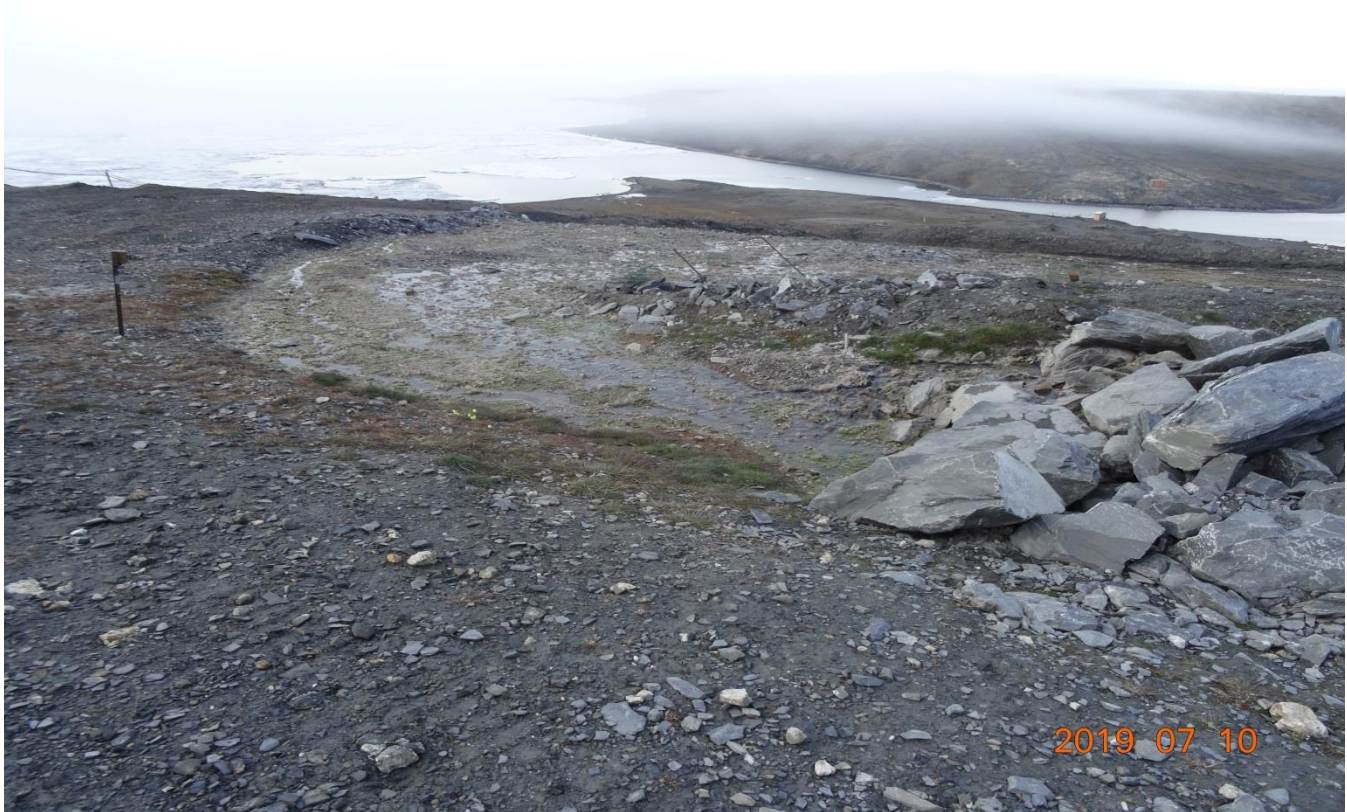
Photo #16

As a result of below freezing temperatures for long periods of time DND is continually running water to ensure the piping on site does not freeze. The outfall to the sewage terrace system is unsatisfactory to the Inspector. Sewage is freely flowing around the terrace system with little to no obstacles in its path (*see photo 16*). This is not an acceptable form of waste disposal as the facility is not operating as designed. DND is required by the licence to ensure controlled deposition is in order in *Part D Item 8*. DND shall mitigate this deposition to ensure controlled release of sewage is in place. The Licensee reports that all criteria set regarding the release of the sewage are met with the exception of TSS due to the nature of the building material used during construction. All criteria from the licence must be met. DND is to seek approval from the Nunavut Water Board granting the deposition of the high TSS into Parr Inlet. Any request to modify discharge criteria, including TSS, shall be done through the NWB

Description: Sewage flowing past the terrace system and freely flowing towards Parr Inlet

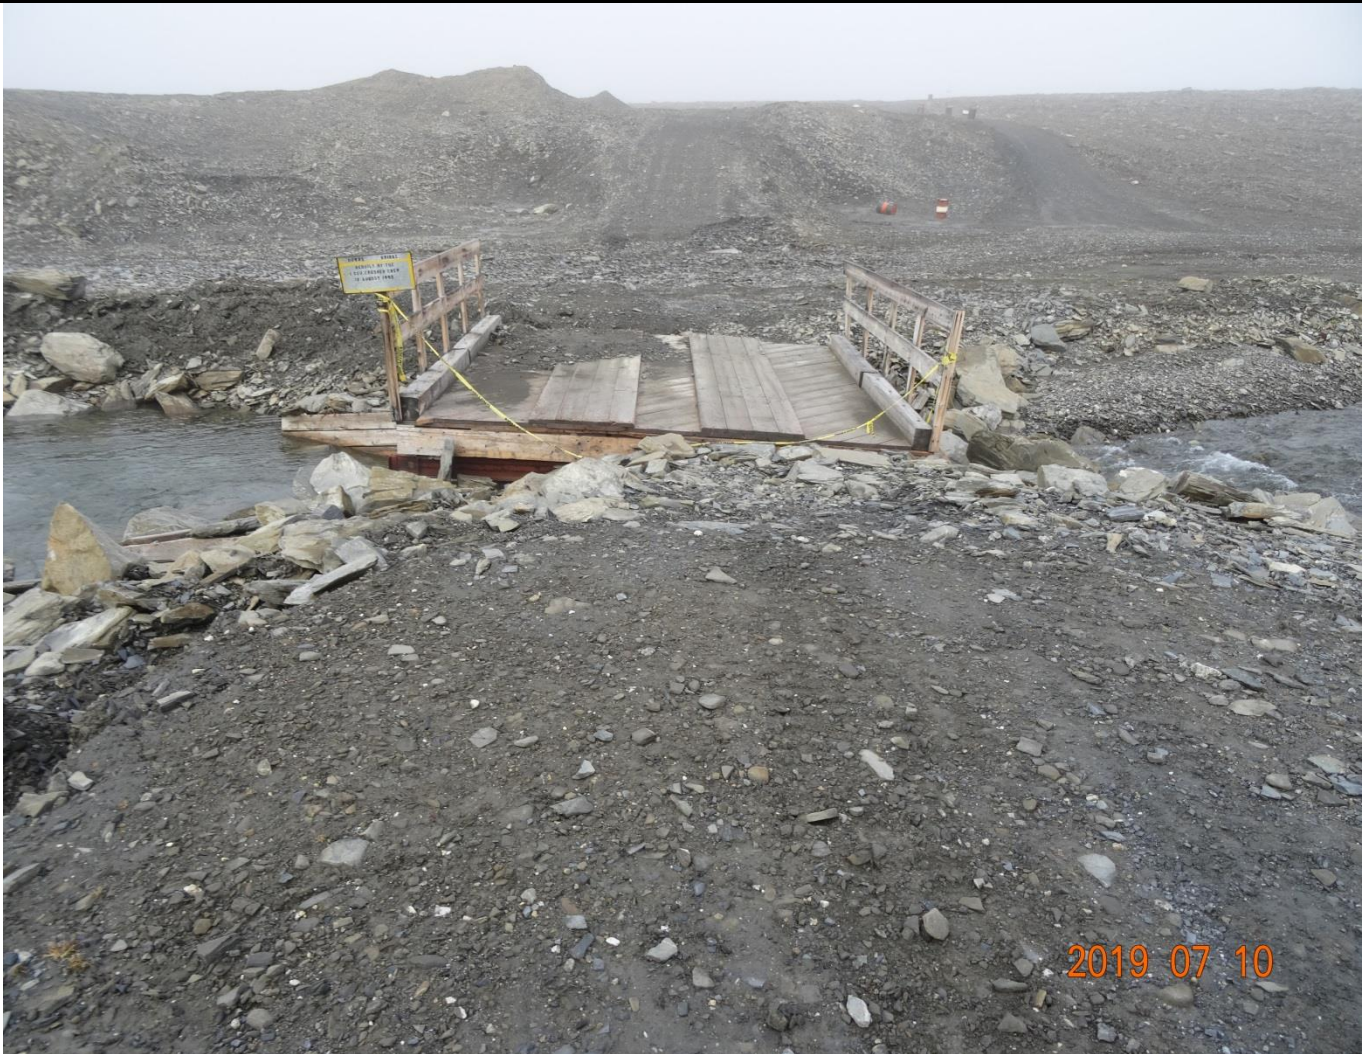
Location (NAD 83 DD MM SS.SS)

Description: Bridge to construction site in disrepair and tapped off

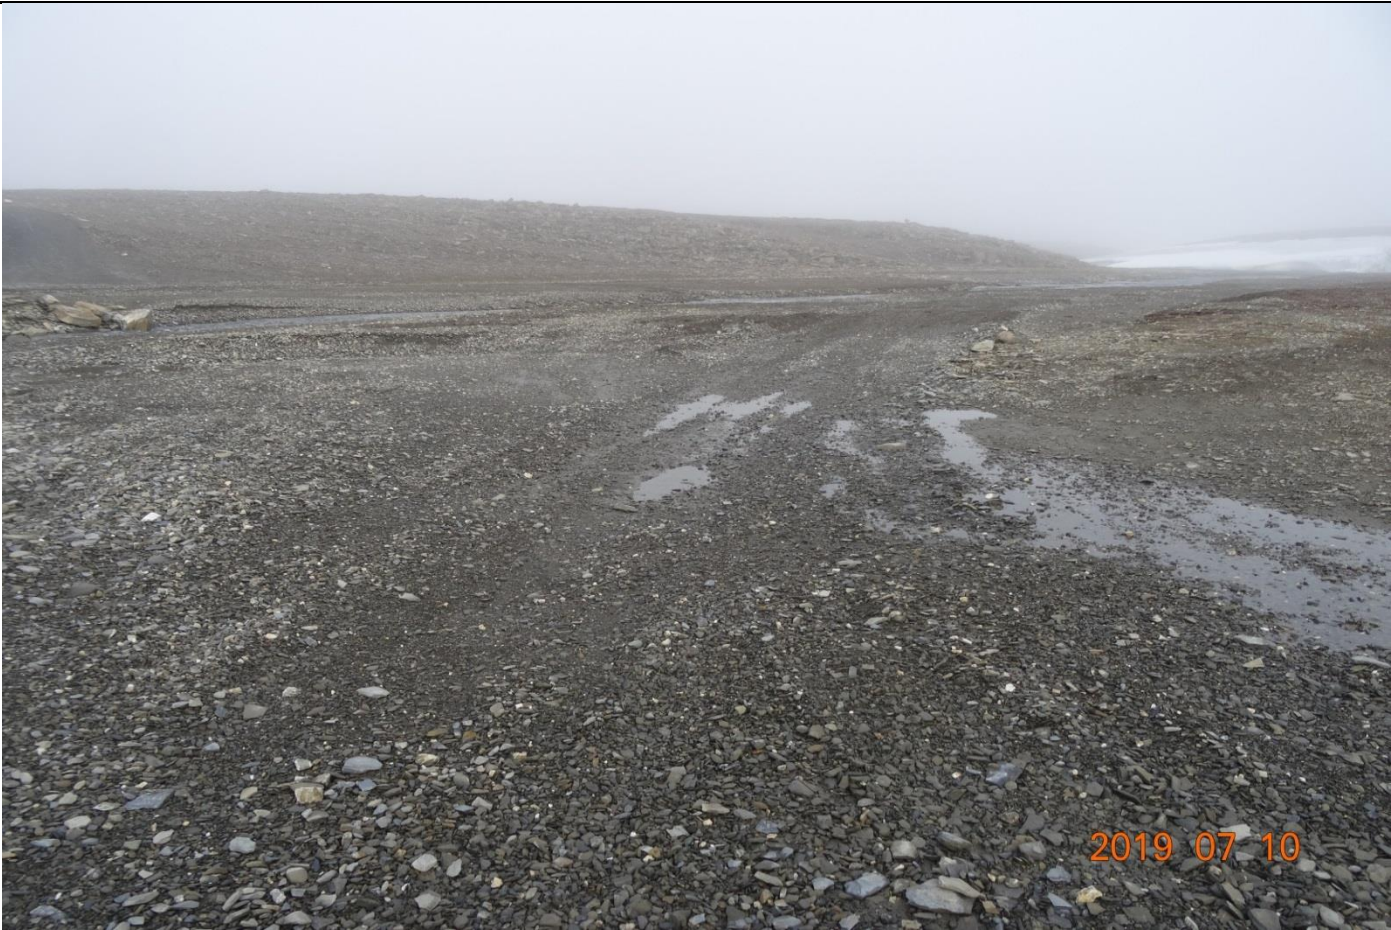
Photo #18

It is evident that DND is fording water and in doing so multiple times daily is altering the bed and the banks of the water body. This is in contravention of the Water Licence *Part C Item 6 & 7*

Description: Vehicle tracks can be seen in this photo leading to the water crossing.

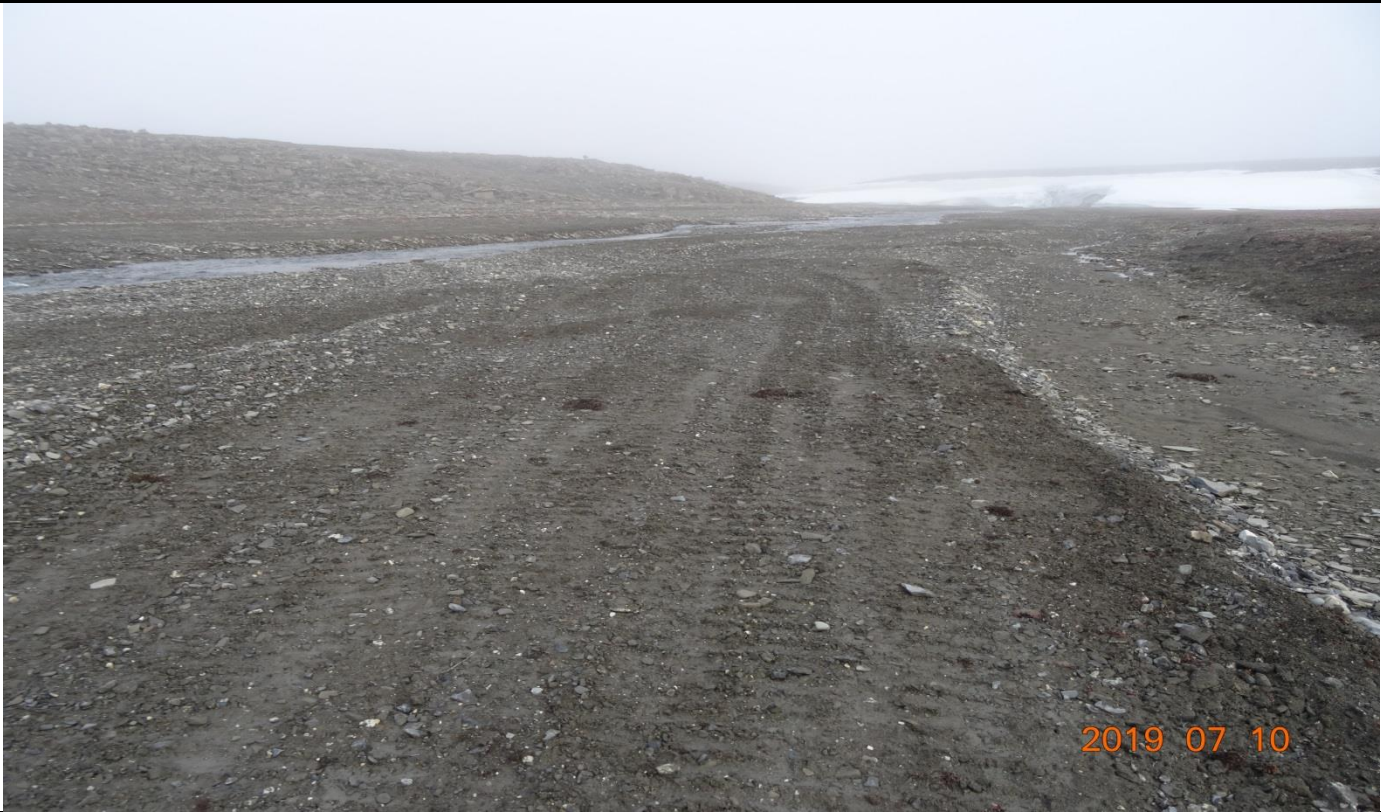
Photo #19

Description: Tracked Vehicle tracks can be seen in this photo leading in to the water in the background.

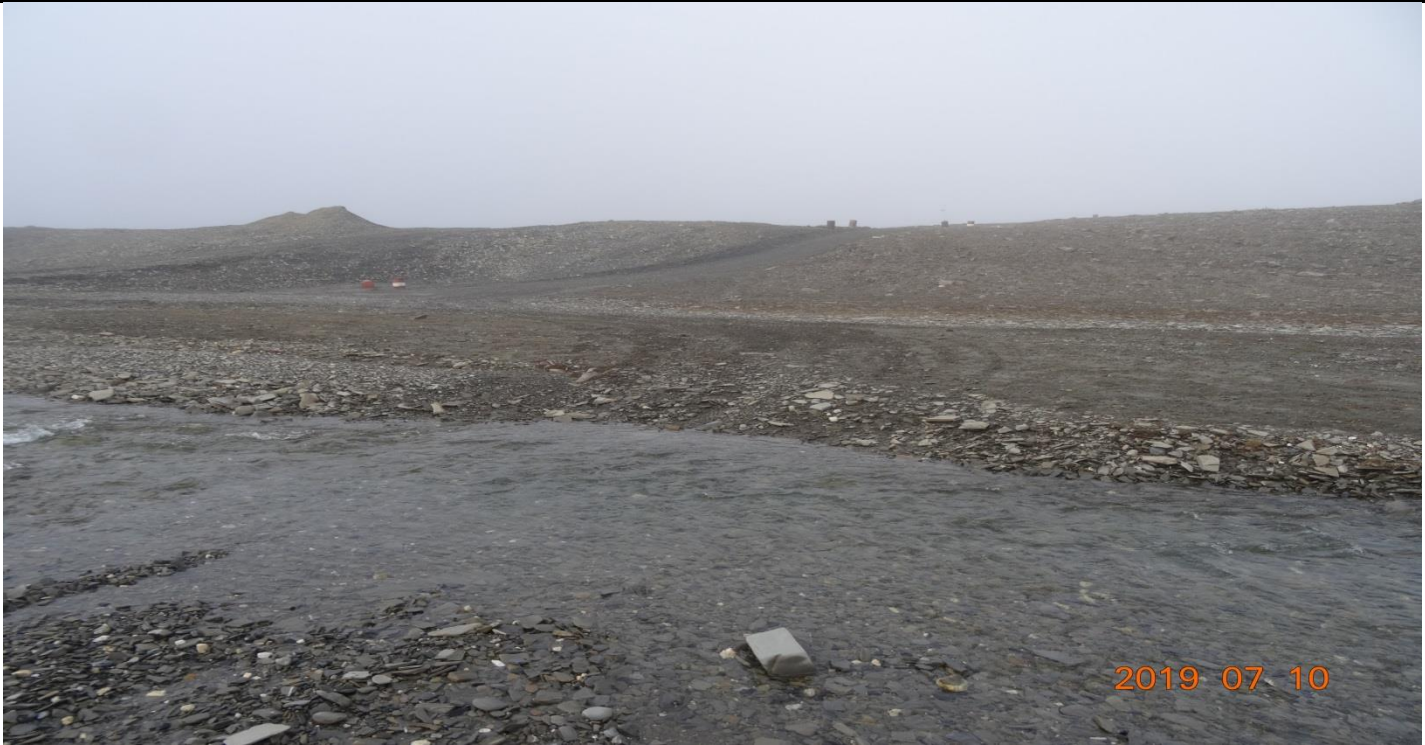
N

Description: Vehicle tracks can be seen coming out of the other side of the stream in this photo.
