8 Wing Environmental Management
Canadian Forces Base Trenton
74 Polaris Avenue, Room 305
PO Box 1000 Stn Main
Astrá ON K0K 3W0

16 May 2012

DETAILED REPORT: FUEL SPILL-CFS ALERT, 24 APRIL, 2012

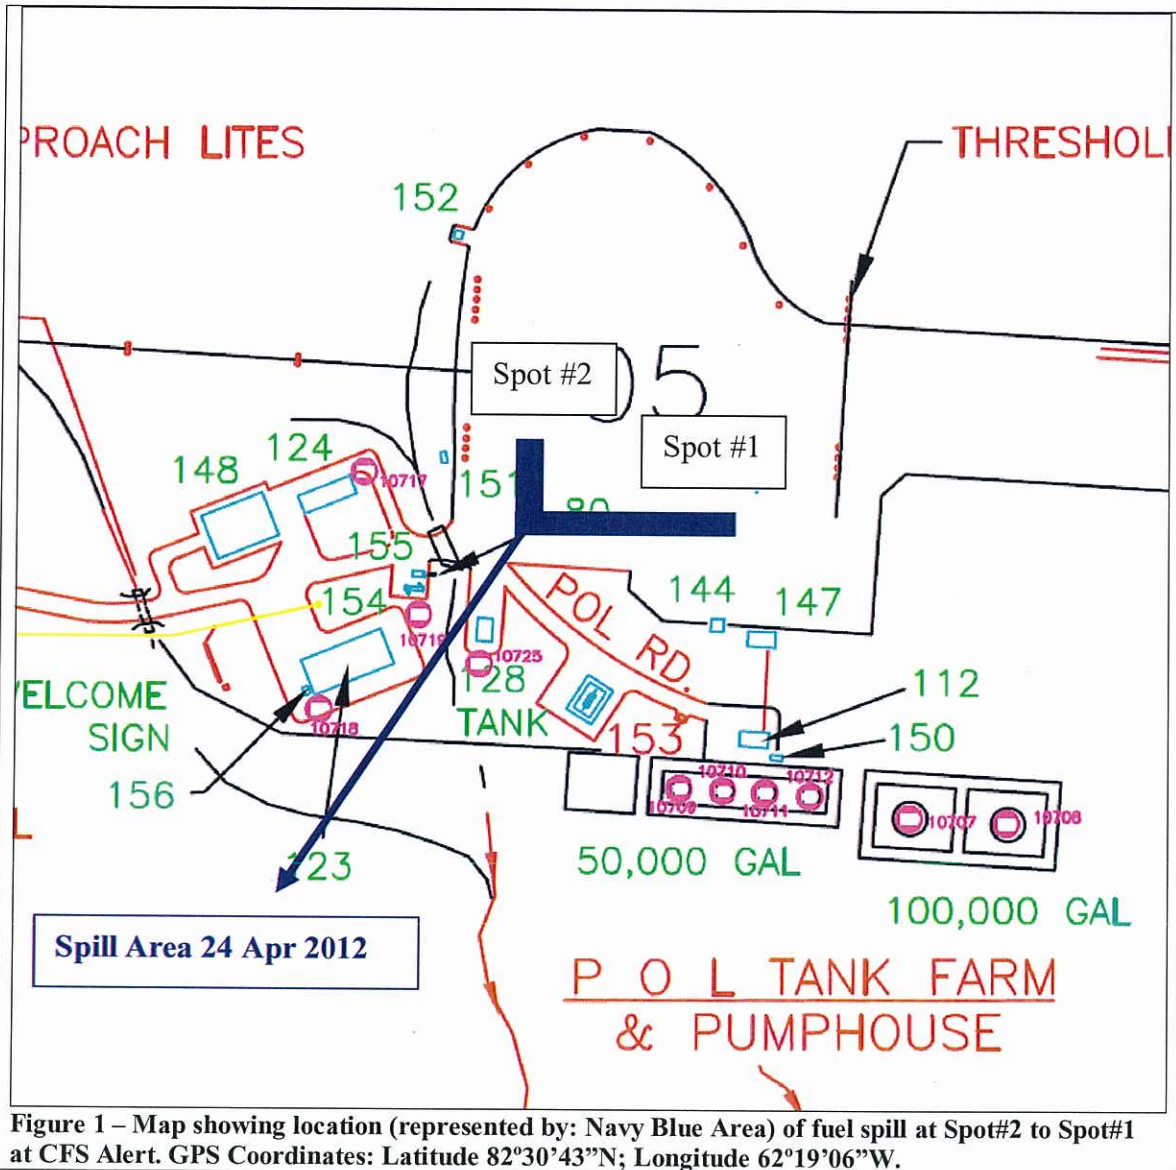
ANNEX A

1. Time, date and location of the spill occurrence.
 - a. The spill was discovered at 0230 EST on 24 April 2012 upon landing as the Aircraft was taxiing and turning from Spot#2 to Spot#1 on the ramp area at CFS Alert, Nunavut. The location of the Spot#2 to Spot#1 is at the southern end of the main runway and west of the Airfield Fuel Tank Farm pump house. GPS location of the spill: Latitude 82°30'43"N; Longitude 62°19'06"W. A map of the location of the spill is included in Annex A (Figure 1).
2. Amount and type of spilled product.
 - a. The source of the Aviation JP8 is from the aircraft fuel tank; the tail call sign of the aircraft is AC609. The spill amount is: 300 Litres.
