8 Wing Environmental Management  
Canadian Forces Base Trenton  
74 Polaris Avenue, Room 305  
PO Box 1000 Stn Main  
Astra ON K0K 3W0

09 April 2013

## DETAILED REPORT: FUEL SPILL-CFS ALERT, 20 MARCH, 2013

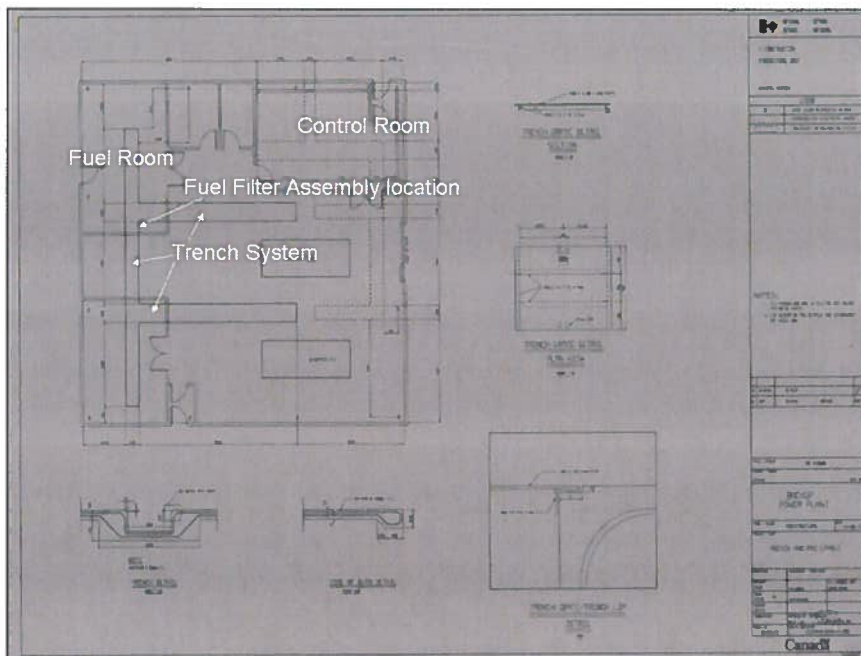
- b. Approximately 851 L of JP8 was released and entirely contained within the Building's interior concrete secondary-containment system of trenches (capacity of 17,000L). 849 L of JP8 were recovered from the containment system and pumped into barrels for future use. The residual 2 L were collected using spill absorbent materials and later disposed of by incineration. The entire building was aerated to promote evaporation of fuel residuals. It should be noted that there was no release of product to the outside environment.

**Figure 2 – Interior floor plan of the Stand By Power Plant (B-146) at CFS Alert showing the locations of the fuel room, fuel filter assembly location, and interior trench system.**

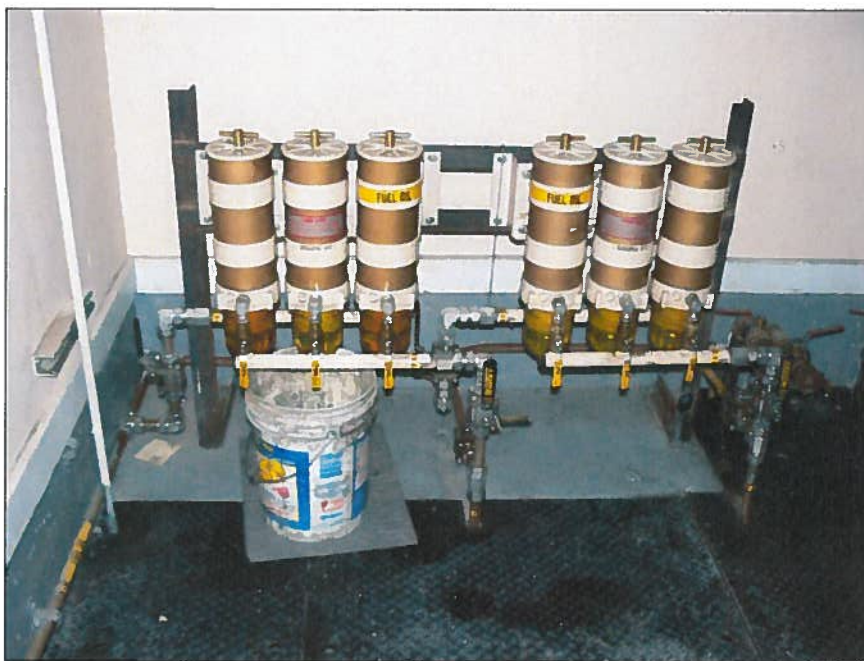
2. Amount and type of spilled product.
  - a. 851 Litres of JP8 (Aviation Fuel) was spilled.
3. Root cause(s) of the spill.
  - a. A cracked plastic sight bowl was discovered on the bottom portion of the fuel filter assembly (Figures 3 & 4).

**Figure 3 –Fuel Filter Assembly located in the Fuel Room at the Stand-By Power Plant (B-146).**

5. Recurrence prevention.
  - a. This spill occurrence is considered to be an isolated event. Station Staff have replaced the broken plastic sight bowl on the fuel filter assembly.

- b. The Station has ordered eighteen (18) new replacement plastic sight bowls to proactively replace all plastic sight bowls within the Main and Stand-By Power Plants.

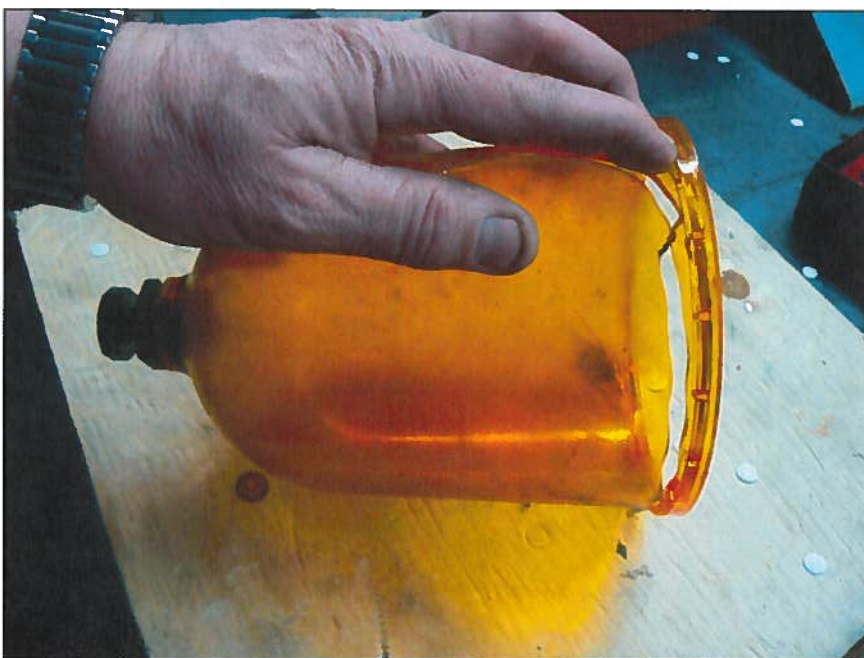
1. This report is intended to detail the discovery and follow-up actions taken in response to the 20 March 2013 indoor spill of JP8 (Aviation Fuel) at Canadian Forces Station (CFS) Alert – Stand-By Power Plant Fuel Room. This spill was a result of a cracked plastic sight bowl on the fuel filter assembly located between the fuel storage tank ID# K10701 (EC# 00002535) and the generators.

**Figure 4 – Cracked plastic sight bowl from the Fuel Filter Assembly (Brand: Racor).**
