8 Wing Environmental Management
Canadian Forces Base Trenton
74 Polaris Avenue, Room 305
PO Box 1000 Stn Main
Astra ON K0K 3W0

27 June 2013

DETAILED REPORT: HYDRAULIC FLUID SPILL-CFS ALERT, 17 JUNE, 2013

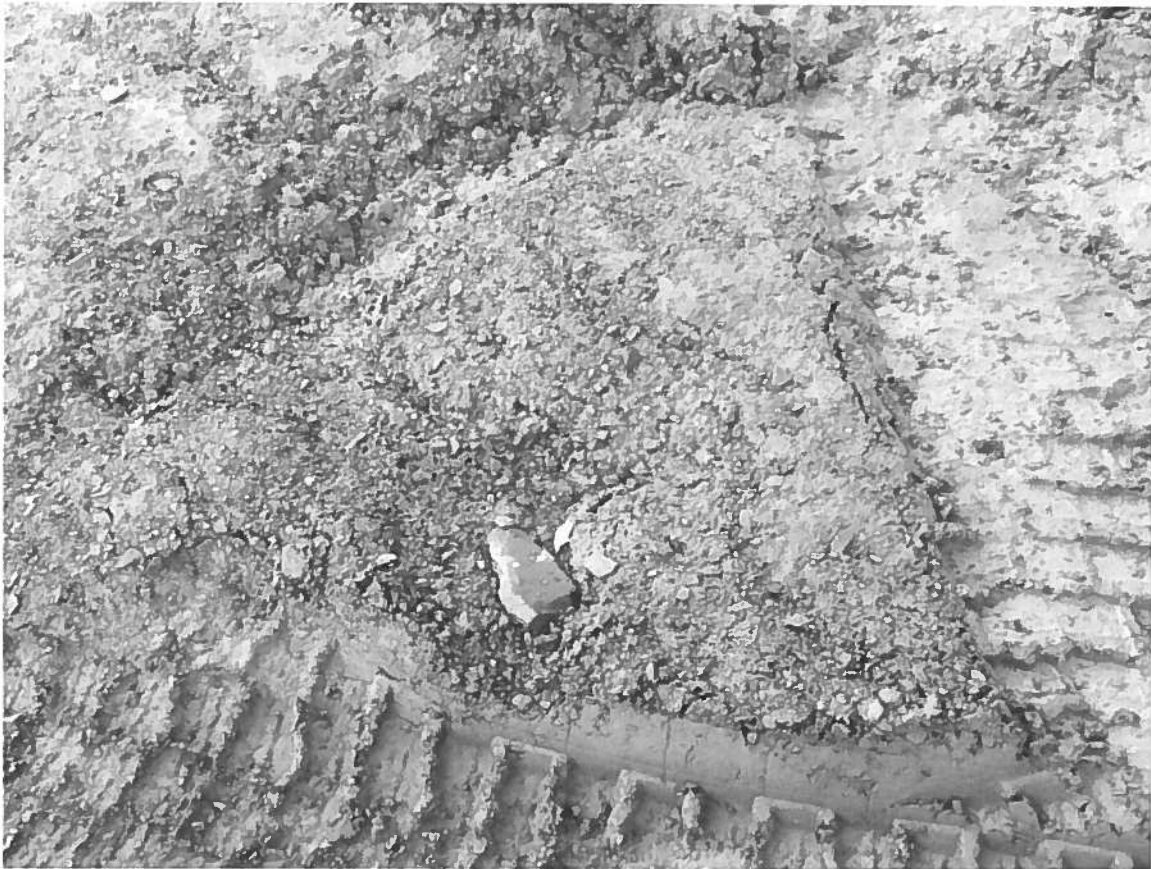
- a. A hydraulic hose had broken from the machinery while in operation.
4. Measures taken to contain and clean up the spill site.
 - a. Upon discovery of the spill, operations with the Loader was ceased. The Spill Contingency Plan was implemented by the night shift crew and hazardous materials responders. The affected gravel area was about 1 m², and this area was isolated (Figure 2).

Figure 2 – Photo of the affected gravel spill area (approx. 1 m²).

- b. Approximately 4 L of hydraulic fluid was recovered by manually excavating the affected gravel into a drum.
5. Recurrence prevention.
 - a. This spill occurrence is considered to be an isolated event. Station Staff returned the Loader to Transportation/Maintenance for repairs.
