8 Wing Environmental Management
Canadian Forces Base Trenton
74 Polaris Avenue, Room 305
PO Box 1000 Stn Main
Astra ON K0K 3W0

19 September 2013

DETAILED REPORT: FUEL SPILL-CFS ALERT, 27 AUGUST, 2013

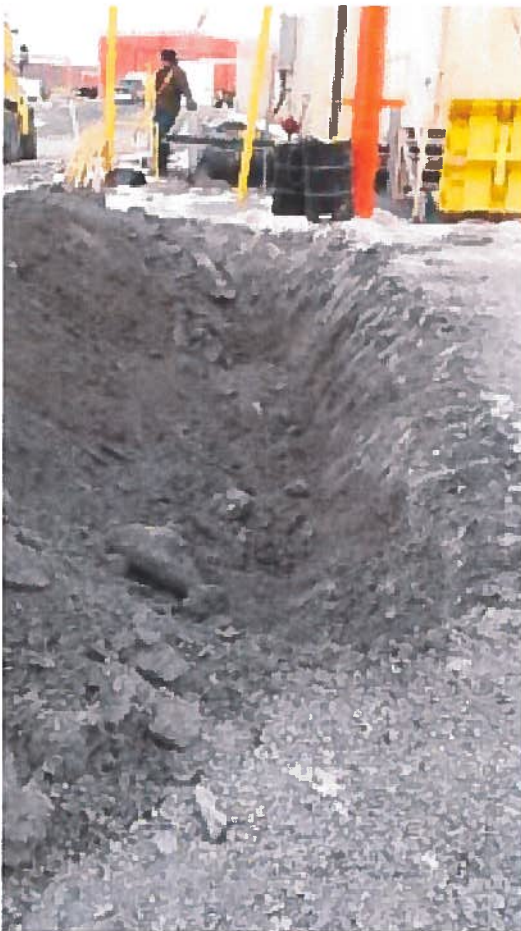
- c. 21 cubic metres of fuel contaminated soil was excavated by heavy equipment (Figure 2) and placed into the newly constructed Day Tank Landfarm Facility for remediation treatment. Two soil samples were collected for analytical testing.

Figure 2 – Excavation of fuel contaminated soils at CFS Alert.

e. The 205 L of DF8 collected in the containment barrel was recovered for future use. The excavated open trench was fertilized with Monoammonium Phosphate (MAP) fertilizer to promote *in-situ* bioremediation of any residual hydrocarbon; the trench was then backfilled with clean gravel material.
