8 Wing Environmental Management
Canadian Forces Base Trenton
74 Polaris Avenue, Room 305
PO Box 1000 Stn Main
Astra ON K0K 3W0

09 January 2015

DETAILED REPORT: HEATING GLYCOL SPILL-CFS ALERT, 14 DECEMBER 2014

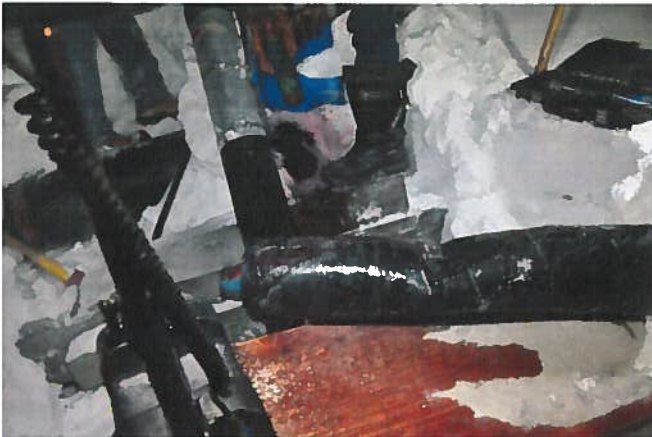
- a. Corrosion over time on the copper heat recovery pipeline was the cause of the spill.
4. Measures taken to contain and clean up the spill site.
 - a. Upon discovery of the spill, glycol contaminated snow (red discolouration, Figure 2) was removed to access the pipeline and placed into barrels as hazardous waste. The corroded section of heat recovery pipeline (Figure 3) was isolated, removed, and replaced with new piping. Spill absorbing materials were deployed by the HazMat Team to collect the glycol. Clean up materials were collected for proper incineration.

Figure 2 – Photo of the repair effort and glycol contaminated snow at the utility area in CFS Alert (14 December 2014).

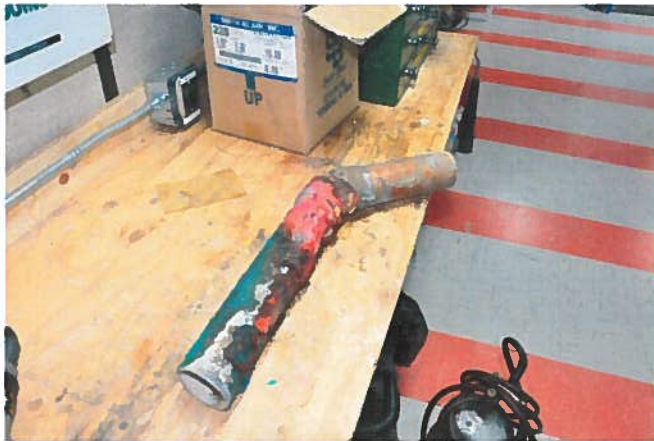
5. Recurrence prevention.
 - a. This spill occurrence was due to corrosion by moisture entering the insulation around the copper piping.
 - b. For prevention, DND has raised a project file to have the entire glycol heat recovery pipeline inspected during summer 2015.

Figure 3 – Cause of the glycol spill was due to corrosion of the heat recovery pipeline.

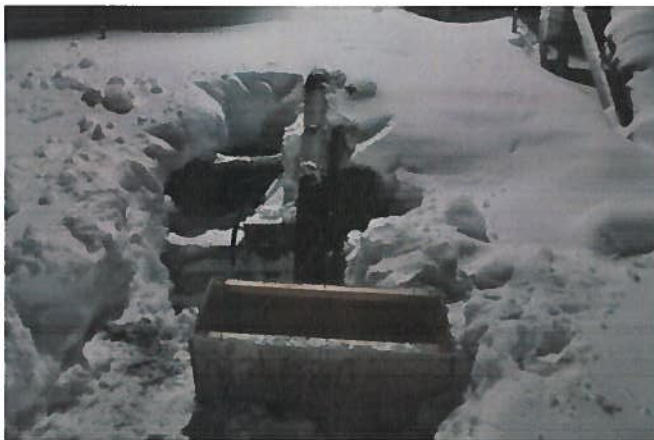
- b. The spill area was 6 square metres (Figure 4).
 - c. 400L of glycol contaminated snow was collected into two (2) barrels. The spill area will be monitored by Station Staff during spring melt (June) and inspected by DND in the summer months (June-August).

Figure 4 – Photo of the spill area and the glycol heat recovery pipeline (14 December 2014).

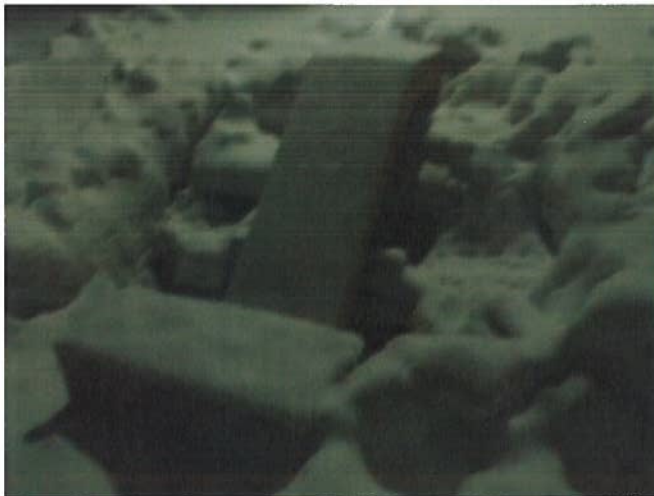
- d. During the spill event, the outdoor air temperature was -29°C, with the wind chill factor nearing -40°C, providing challenges to conducting outdoor work. The site has since been re-covered by drifting snow (Figure 5).

Figure 5 – Photo of the spill site as of 30 December 2014.
