WATER LICENCE INSPECTION FORM

Licensee		Licensee Representative	
James S. Kennedy Deputy Director General Northern Watch Technology Demonstration Project Defence Research and Development Canada – Atlantic 9 Grove Street, PO Box 1012 Dartmouth, Nova Scotia, B2Y 3Z7 Email: Jim.Kennedy@forces.gc.ca		None at time of Inspection	
Licence No. / Expiry		Representative's Title	
3BC-NWT1113 Exp. Sept 30, 2013		NA	
Land / Other Authorizations		Land / Other Authorizations	
058E12001			
Date of Inspection		Inspector	
09/07/2014		A.Keim	
Activities Inspected			
<input checked="" type="checkbox"/> Camp <input type="checkbox"/> Drilling <input type="checkbox"/> Mining <input type="checkbox"/> Construction <input type="checkbox"/> Reclamation <input checked="" type="checkbox"/> Fuel Storage <input type="checkbox"/> Roads/Hauling <input type="checkbox"/> Other: Water Discharge <input type="checkbox"/> Other:

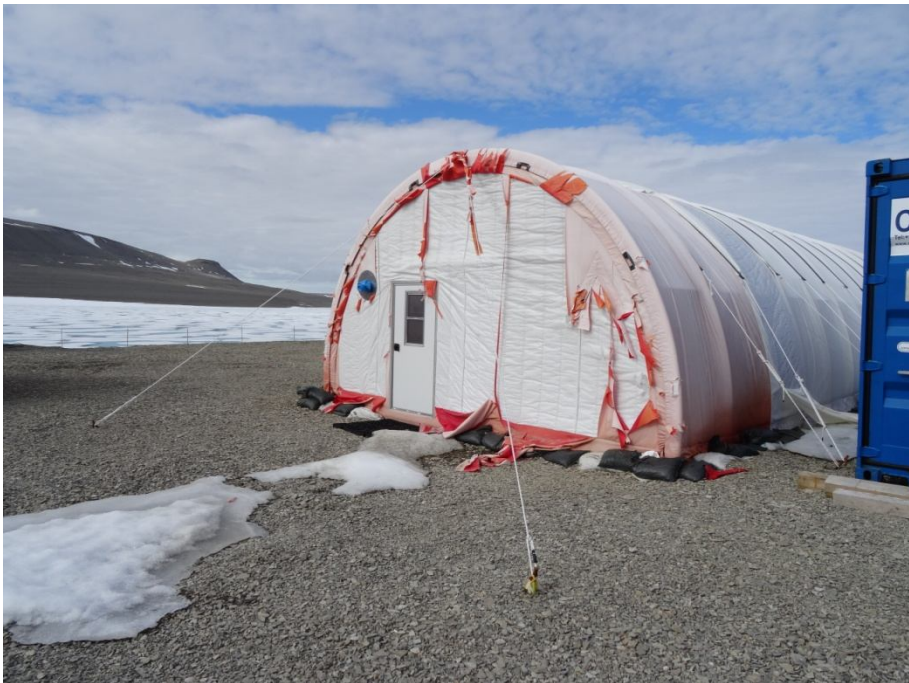
Figure 3 Weather-haven type structure -storage

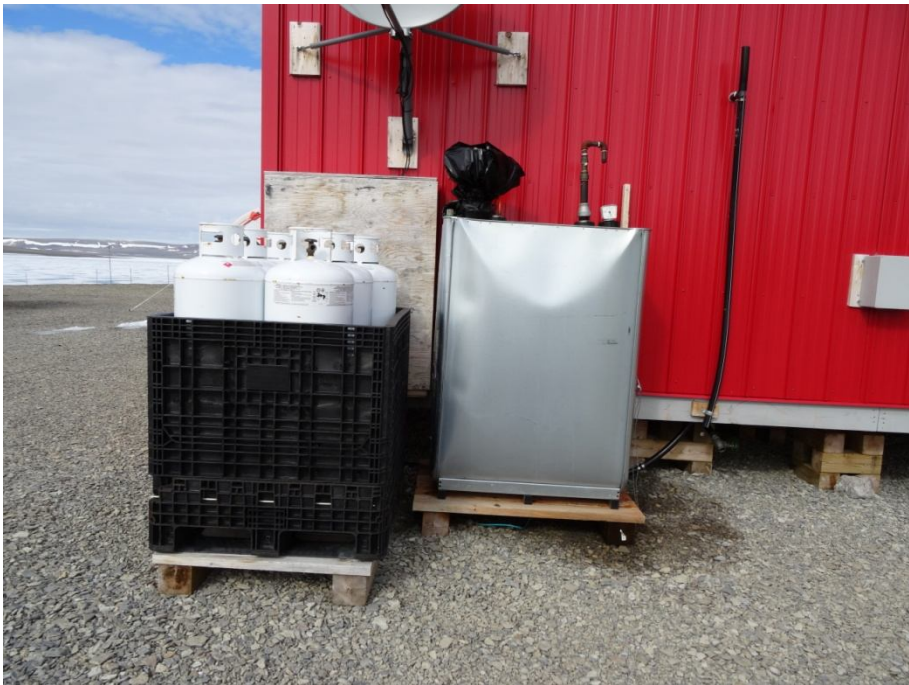
Figure 4 Fuel tank behind main building

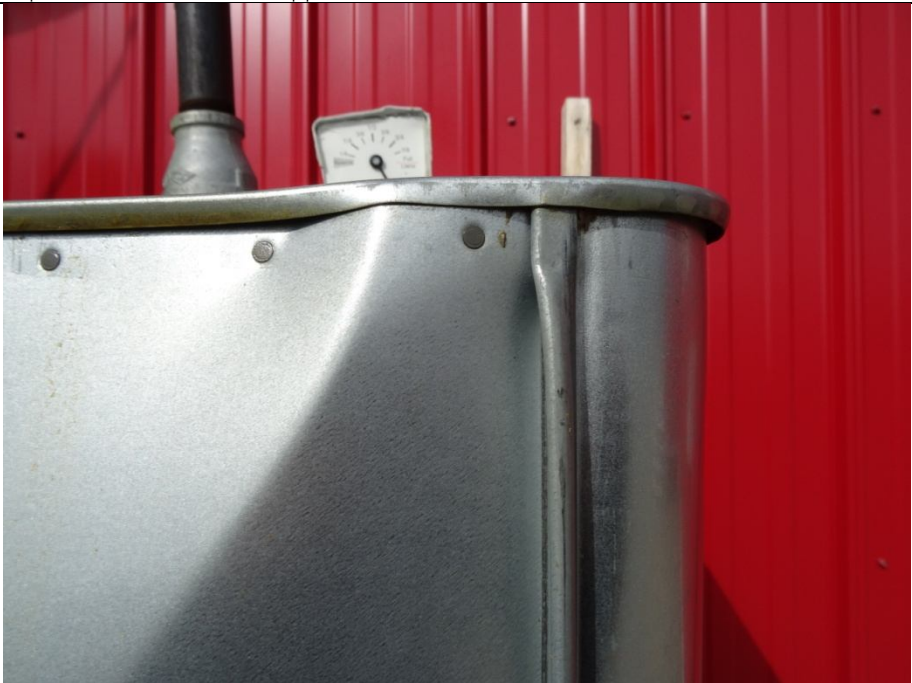
During the period of inspection each of the buildings was checked for security and to determine if any damage or fuel leaks had occurred since the last inspection. Upon going to the North (island Facing) side of the large main building the Inspector found that a large tank containing fuel had (it appears) buckled under the weight of the fuel and had leaked 10-30 l of heating fuel onto the ground below the tank and possibly under the building. This was reported to the contact listed in the annual report on July 17th, 2014 at the first opportunity of the Inspector. It is unclear when the last inspection of the site by the operator/owner was. Given that fuel is to be kept on site a system of monitoring of this fuel should be put in place to prevent and detect leaks.

Figure 5 Fuel tank note buckled top Note rivets not welds

The Licensee shall ensure compliance with the issued Water License by employing the conditions set out in Part G Conditions applying to Spill Contingency Planning and implementation of Item 4 of that Part. Specifically;

1. Implement the Spill Contingency Plan, dated March 1st , 2011 as per Part G item 2 of the Water License.

2. Report the Spill as detailed in the Plan

3. Within 30 days provide the Inspector;

a. a detailed report that will include the amount and type of spilled product,

b. the GPS location of the spill,

c. and detail the measures taken to contain and clean up the spill site.

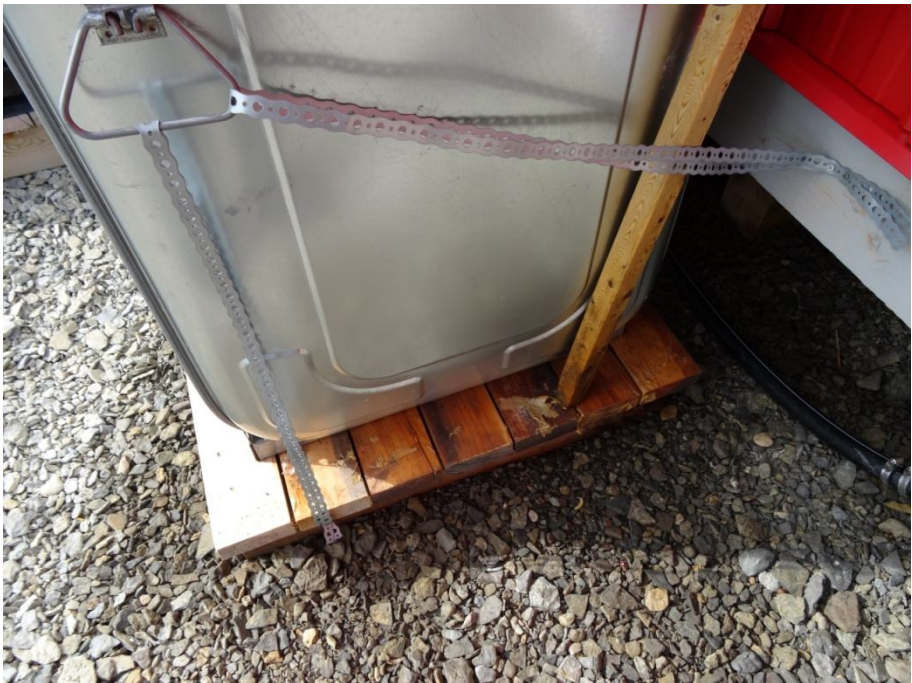
Contrary to Section 12 (1b) of the Nunavut Water and Nunavut Surface Rights Tribunal Act, the Licensee did deposit waste (fuel oil) in any other place in Nunavut under conditions in which the waste, or any other waste that results from the deposit of that waste, may enter waters in Nunavut.

Figure 6 Tank secured to building using metal round ,, note fuel staining

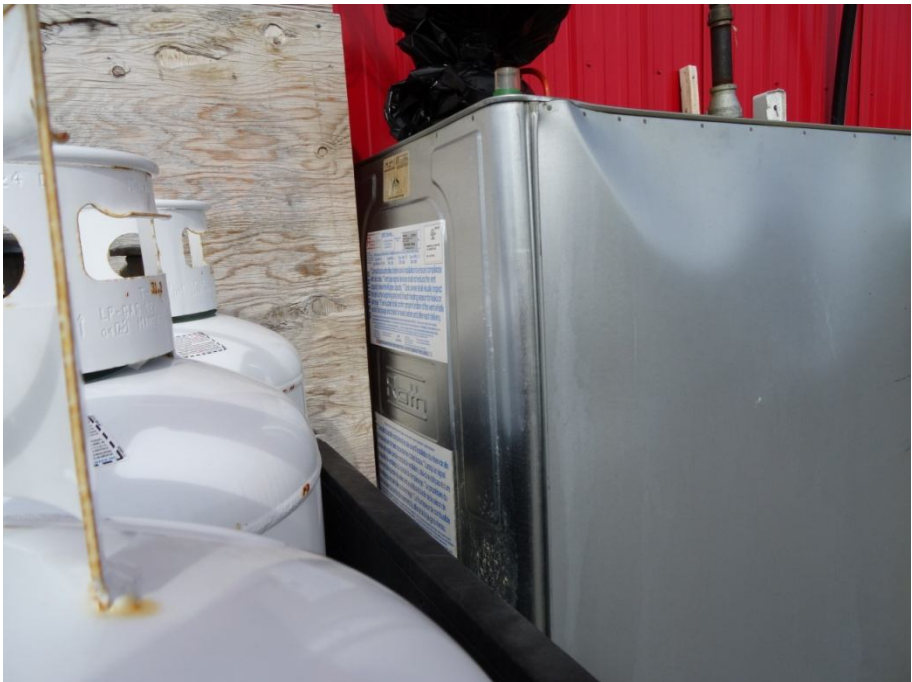
Figure 7 Buckling at opposite end

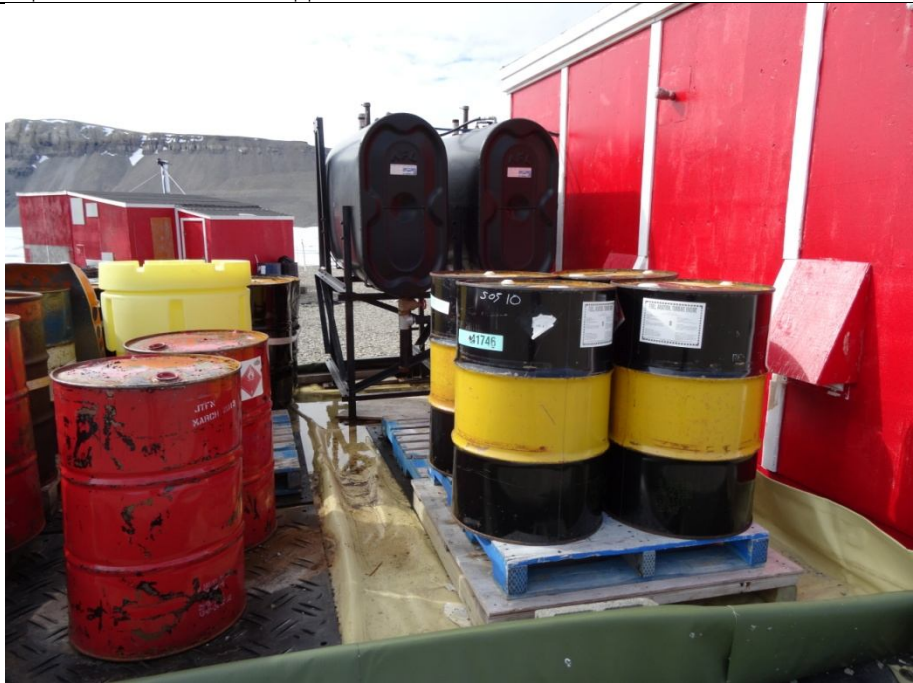
Figure 8 Fuel storage in secondary containment

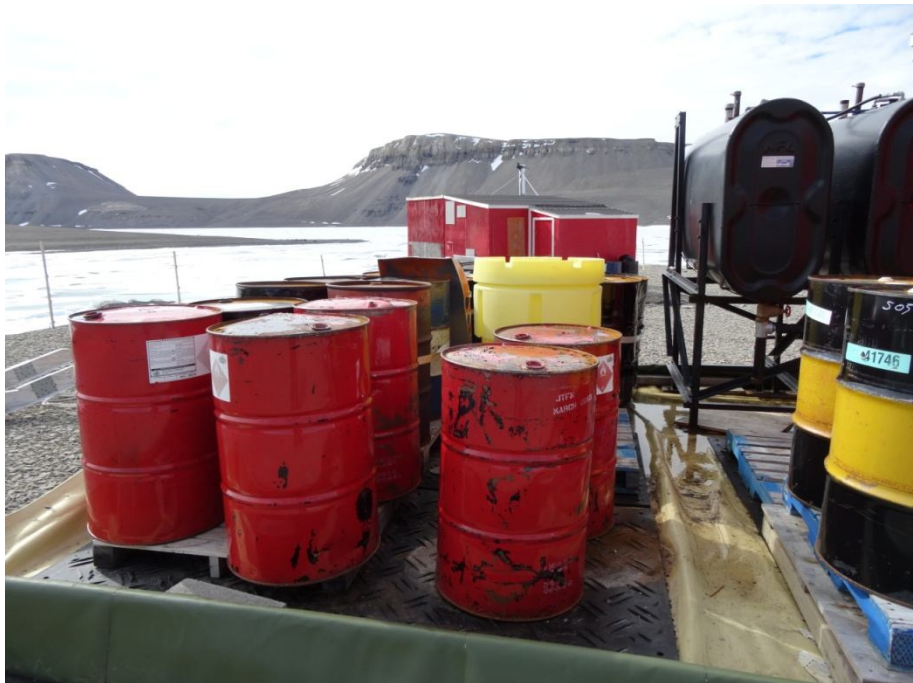
Figure 9 Secondary containment

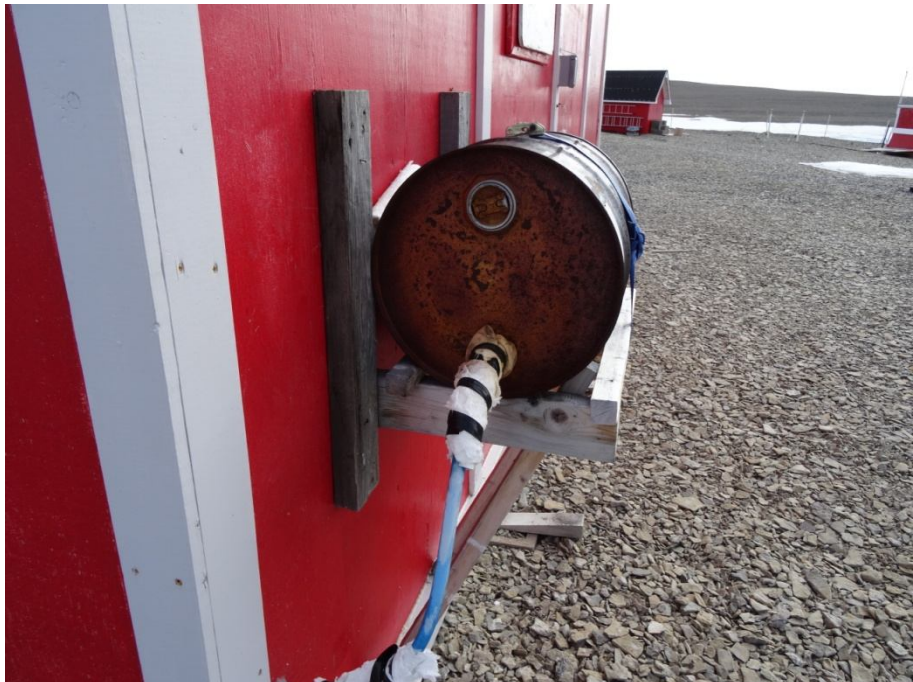
Figure 10 Fuel tank outside one of the buildings. Joints are wrapped

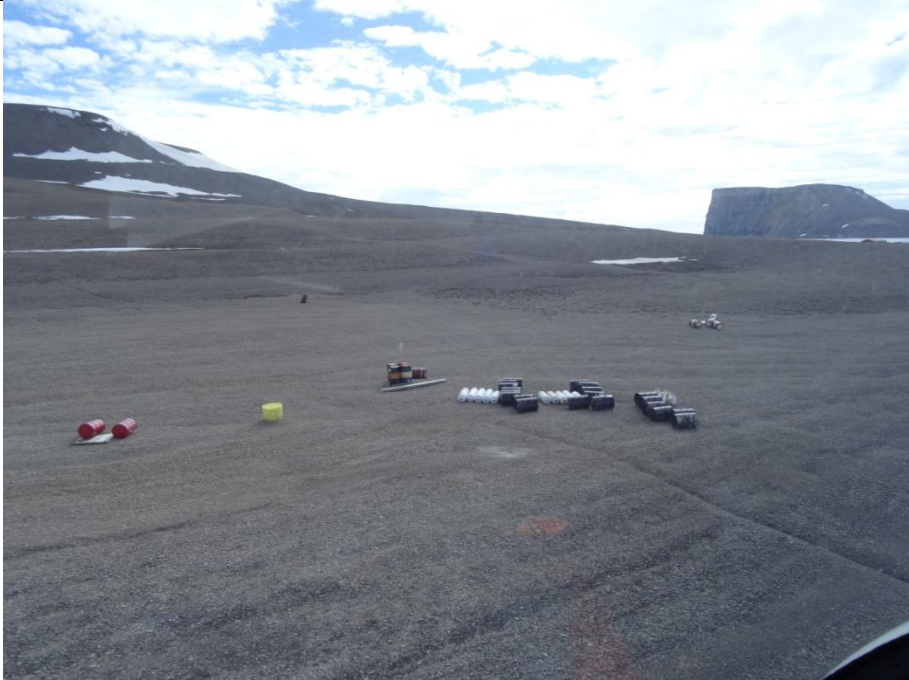
Figure 11Fuel found at airstrip without secondary containment. No spills noted at the time of Inspection.
