**11 September 2014**

**Report of Fuel Spill Assessment and Corrective/Remediation Work**

Photographs – DRDC Arctic Deployment to Gascoyne Inlet Camp 2014

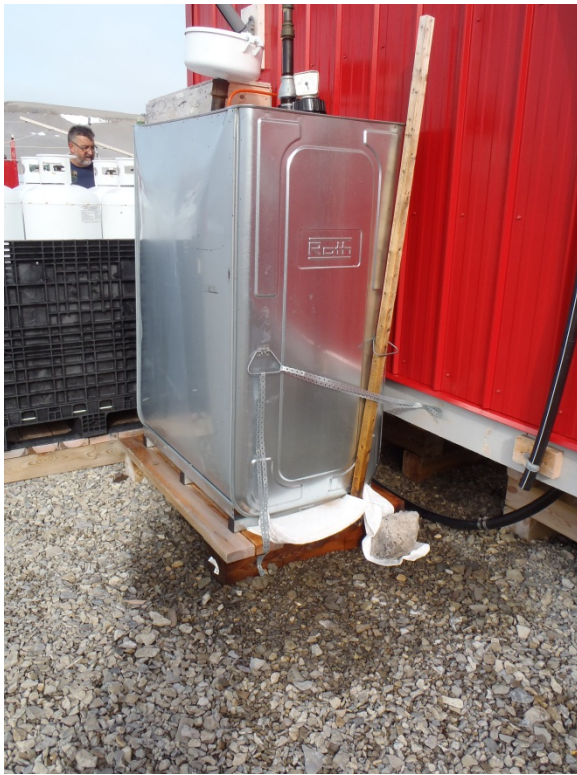
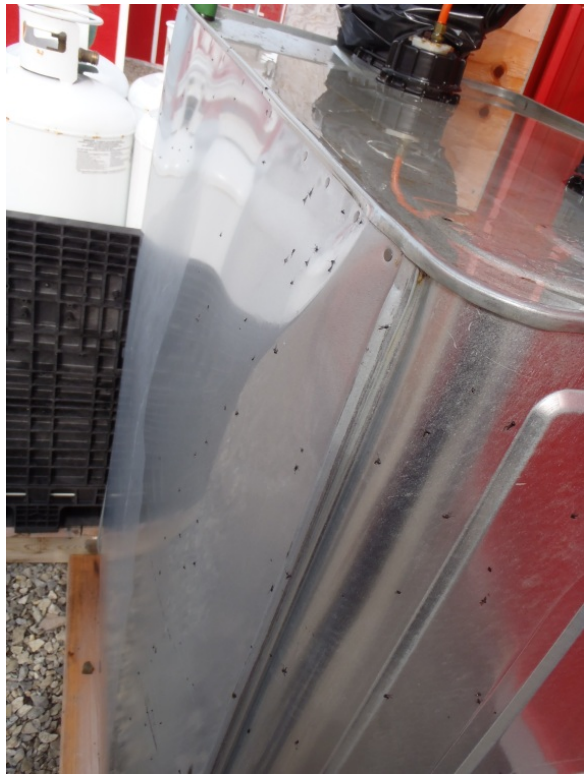
bulged the outer tank skin and compressed the inner tank. The upper seam of the tank had one small rupture, otherwise the inner and outer tanks were intact and without leaks.

Roth tank showing bowing to outer skin

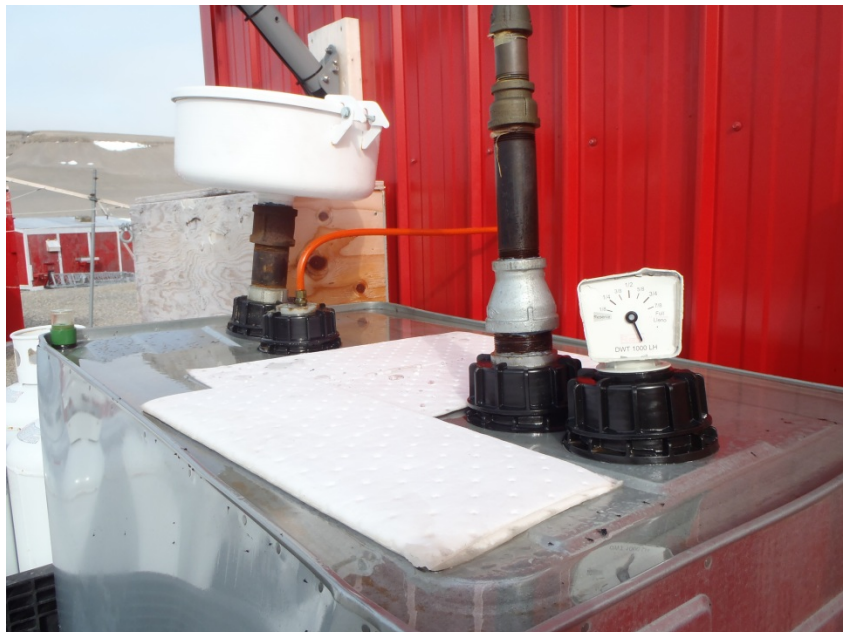
Diesel fuel is pink. Note very low quantity of fuel in water

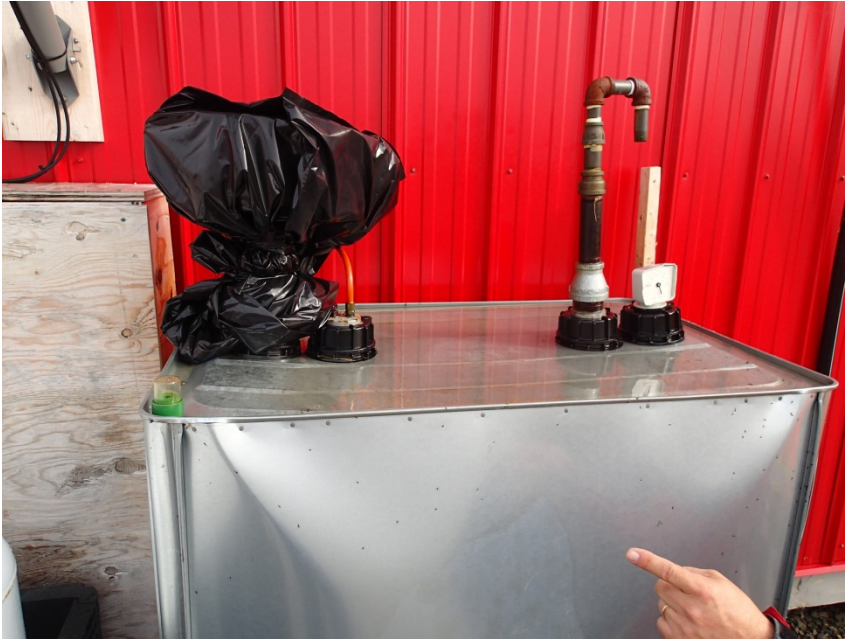
Review of the reference identified that this type of tank requires a roof (Ref pages 11 and 33) for outside installations to ensure that there is no buildup of snow or water on the top of the tank. There is no seal between the outer and inner tanks and water can seep into the outer tank easily. When this freezes in the winter, it can create enough pressure in the inner tank that, if the tank is full; it will force

Connections to Inner tank. Note lack of gaskets

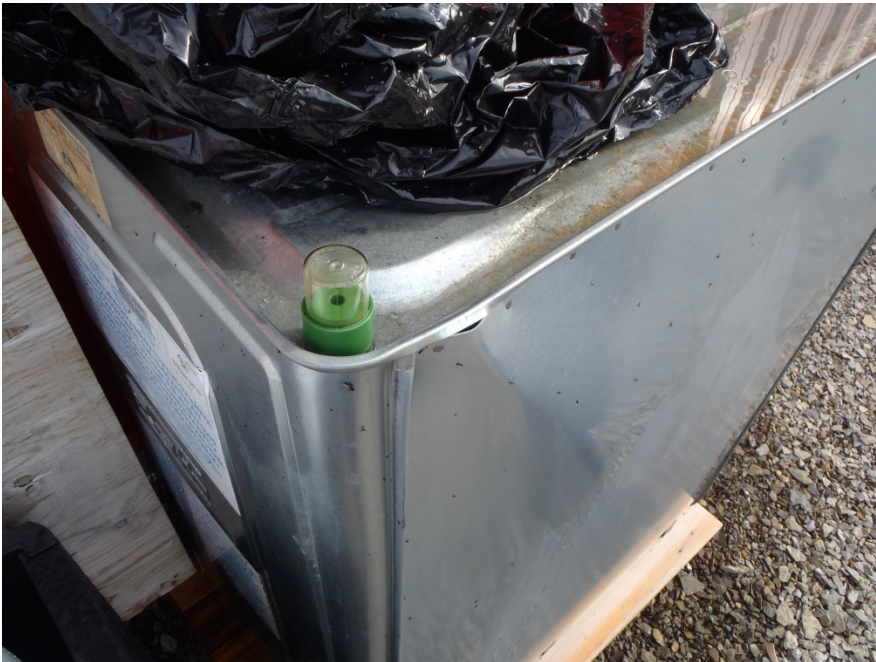
Outer tank sight glass

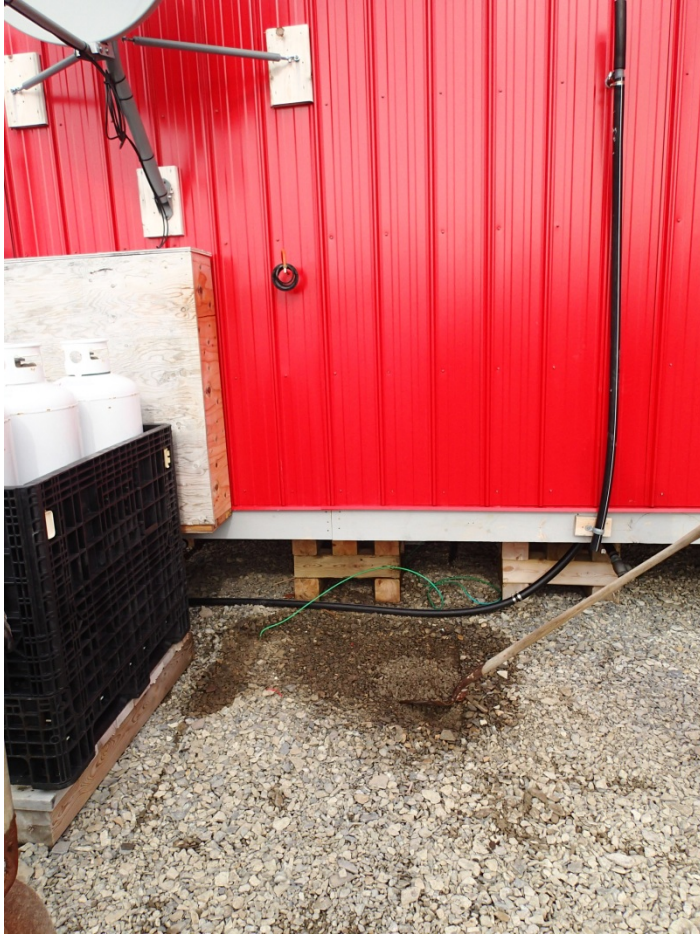
Based upon the size of the ground stain and concentration of fuel in the stain, the amount of fuel spilled was less than nine liters (two imperial gallons) and perhaps as low as 4.5 Liters.

Extent of spill impact with tank removed.

The ground around the tank was hand shoveled into a Bobcat bucket. The area to be removed was determined by the ground stain present when the stand and tank were removed. Soil (gravel) removed was a minimum of 12 inches around the stain and down as deep as the frost line. This depth varied from 12 to 16 inches. The bucket was then poured onto a two inch galvanized stainless steel pan and left to evaporate. As we did not have a method of determining how much fuel was in the ground, the only method of determination was odor. There was no smell of fuel emanating from the soil removed and although it is not common practice, it was decided to attempt to light the ground in the pan. Numerous attempts revealed that if there was any fuel, the concentration of it was so small that it would not ignite. As the soil dried, it was apparent that there was no need to keep it in the pan and after two days we put the soil at a marked location to be tested next year. The hole was then filled with soil from an area we have been using for fill.

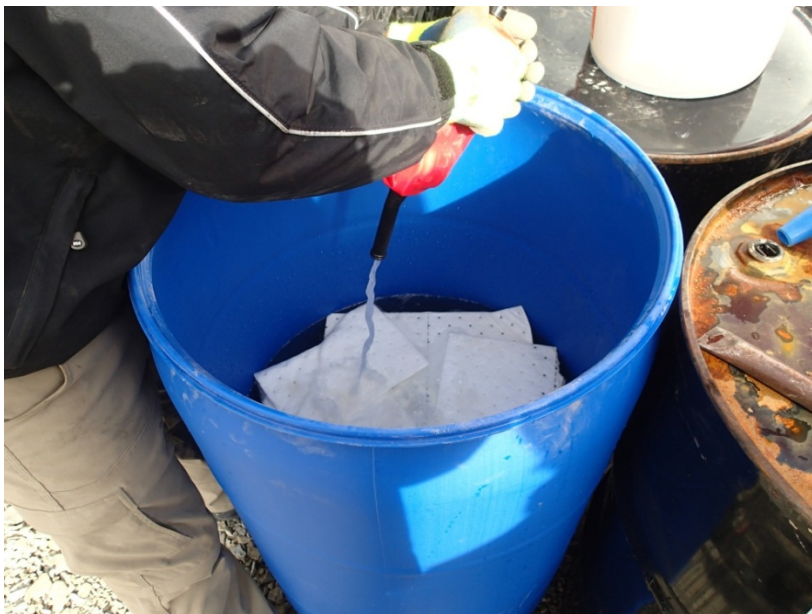
Draining last water out of the outer tank

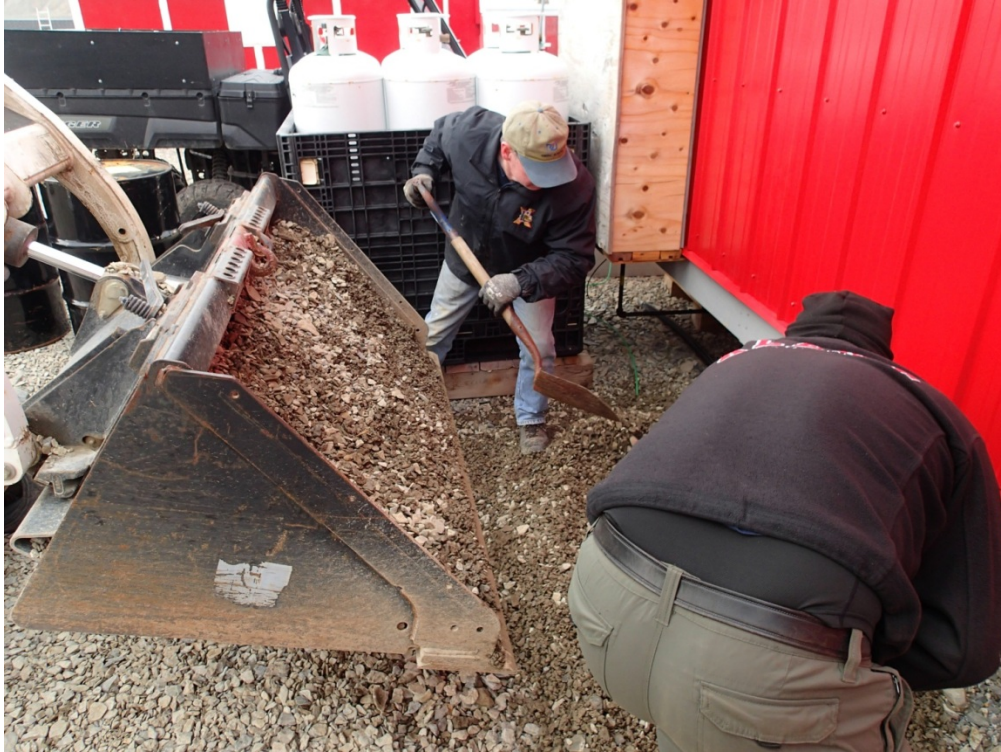
Replacing gravel at spill site

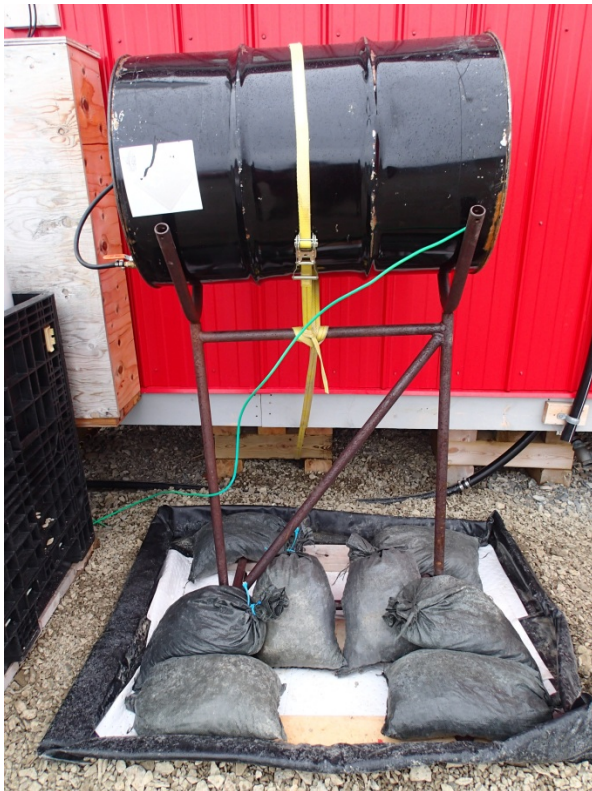
Temporary fuel tank and berm

A temporary fuel tank for the furnace was set up in a berm using a 45 gallon drum and stand. It was tied in place and the berm was lined with fuel absorbent pads weighted down with sandbags. It was left in place for use in April during OP Nunaliut in the upcoming spring.
