Technical Memorandum

Date: 19 June 2007
To: Louise Grondin, Agnico-Eagle Mines Ltd.
Cc: Roy Lindsay (AE), Laurier Roy (AE), Paul-Henri Girard (AE), Stéphane Robert (AE), Harvey Blouin (Nuna), Wes Danielson (Nuna), Len McHale (Nuna)
From: Gary Mann and Duane Hudd (North/South)
RE: AWPAR Mitigation Update 19 June 2007

AWPAR Mitigation Update – 19 June 2007 - Photos

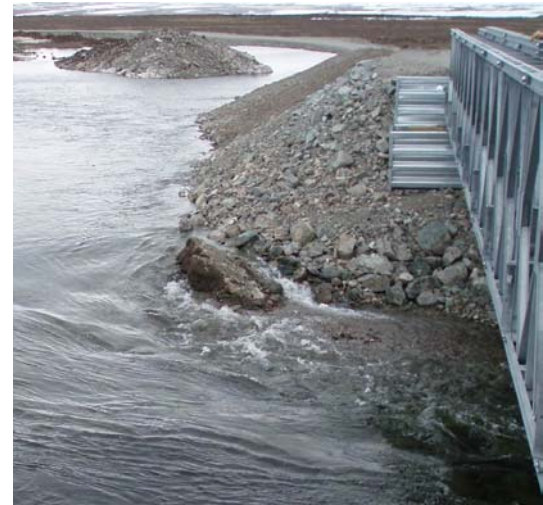
high to safely access the U/S N stockpile (comprised of primarily of gravel-sized or larger material); this pile was washed downstream by strong flows on June 18.

Photo 2. R02 –U/S N side stockpile unreachable due to high water (18Jun07).

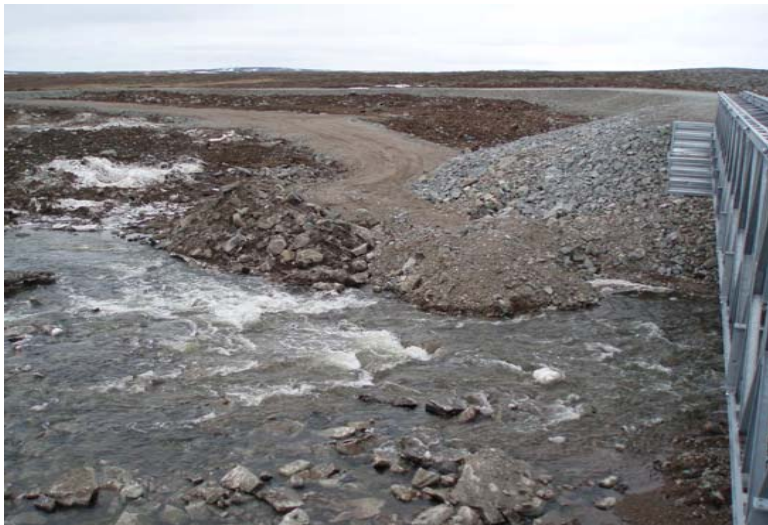
- **R02** – The issues:
 - Stockpiled materials in or immediately adjacent to the currently wetted channel (one U/S N side¹; two D/S S side) – The two D/S S side stockpiles were excavated with a backhoe on June 16 (see photos). Detailed monitoring was conducted downstream as these stockpiles were right in the channel; water quality findings as described above. Water levels were too

Photo 3. R02 – Stockpiles in channel (D/S S side)

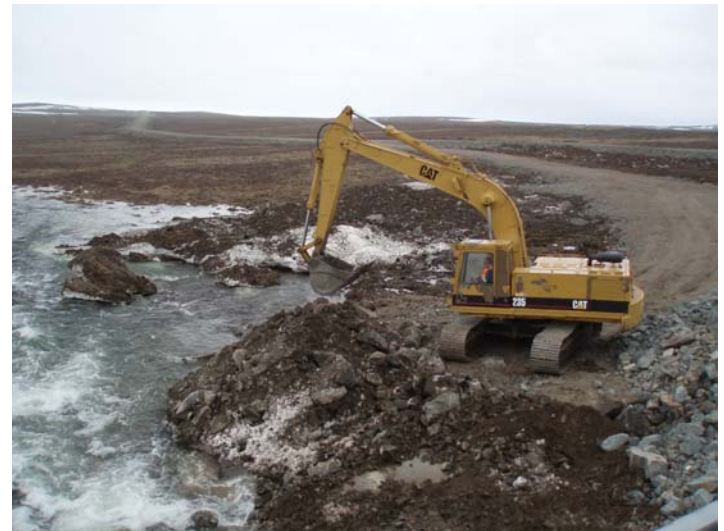
Photo 4. R02 – Stockpiles being removed (D/S S side) (16Jun07)

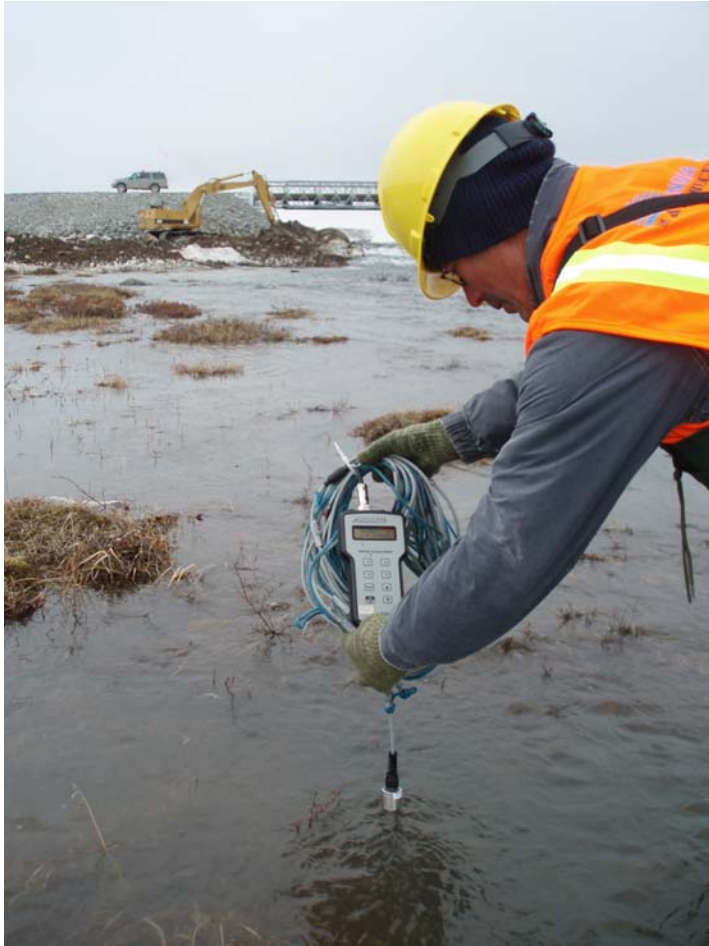
Water quality remains generally good based on continued turbidity monitoring. Downstream conditions have been assessed in detail, with turbid water being found primarily in localized pockets (if present at all) along the channel margins and immediately adjacent to the bridge approaches; these collectively comprise a negligible proportion of the channel and discharge as a whole.

Photo 5. R02 – Turbidity monitoring downstream during stockpile removal (D/S S side) (16Jun07)

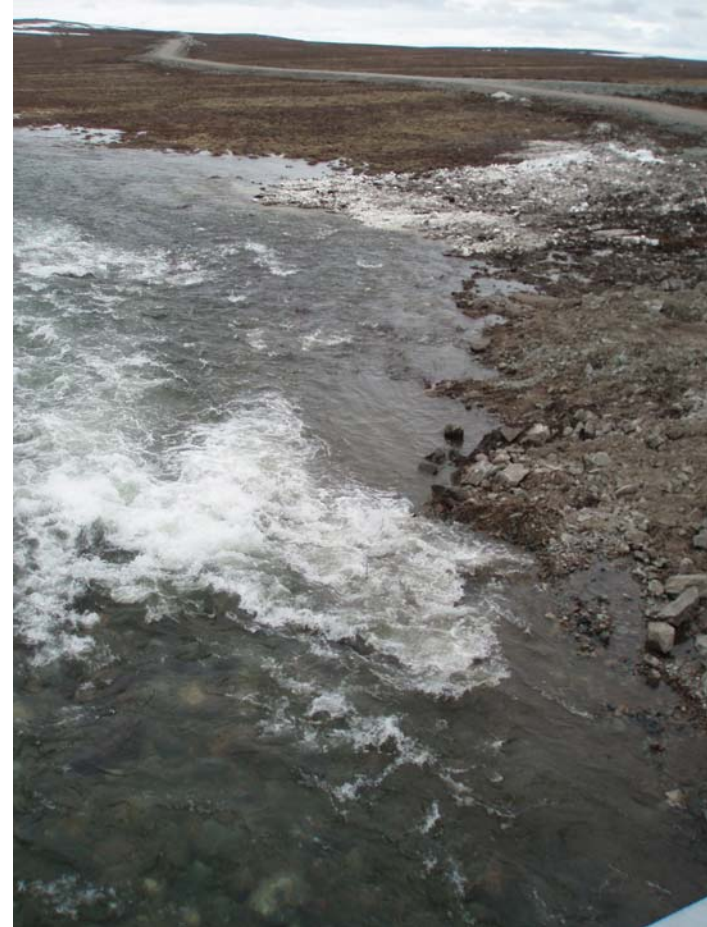
Photo 6. R02 – Shoreline after stockpile and debris removal (D/S S side) (17Jun07)

- Construction-related materials on snow/ice present within the overall confines of the channel (U/S N side; D/S N and S sides) – The D/S S side debris was removed on June 17. Planned removal of the U/S N side (comprised primarily of angular cobbles) was abandoned due to safety concerns with high water. This material was and the D/S N side (comprised of coarse sand, cobble and boulders) was also called off. The snowbridge from the N side had melted away, which would have meant entry of the dozer into the channel for about 50 to 70 m. It was determined that this action would pose greater disturbance to the channel than the debris remaining on the snow/ice.

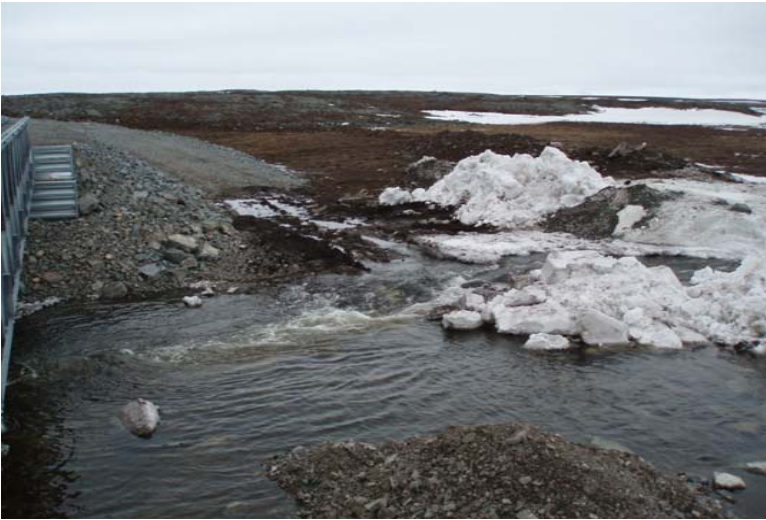
Photo 7. R02 – Unstable bank/riparian area (U/S S side) (15Jun07)

- Unstable bank/riparian area associated with ice bridge approach (U/S S side) – This area was partially addressed on June 17, with larger materials collected from the D/S stockpiles. Coverage by the larger material was not adequate and placement of large gravel/small cobble material was recommended to fill in the gaps and provide further stabilization. This work was scheduled for completion by June 20.

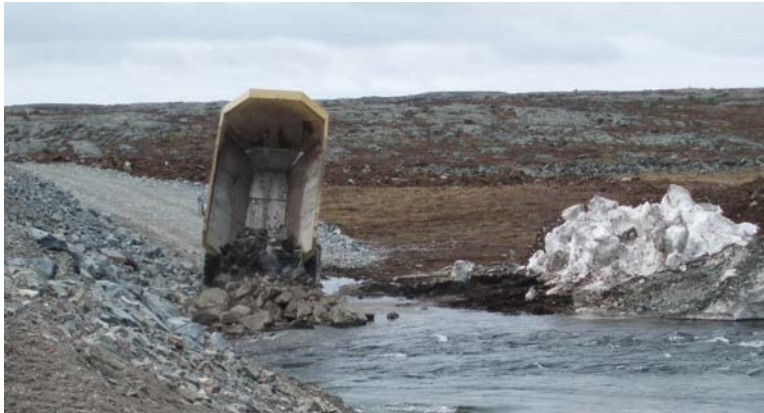
Photo 8. R02 – Adding boulders to stabilize unstable bank area (U/S S side) (17Jun07)

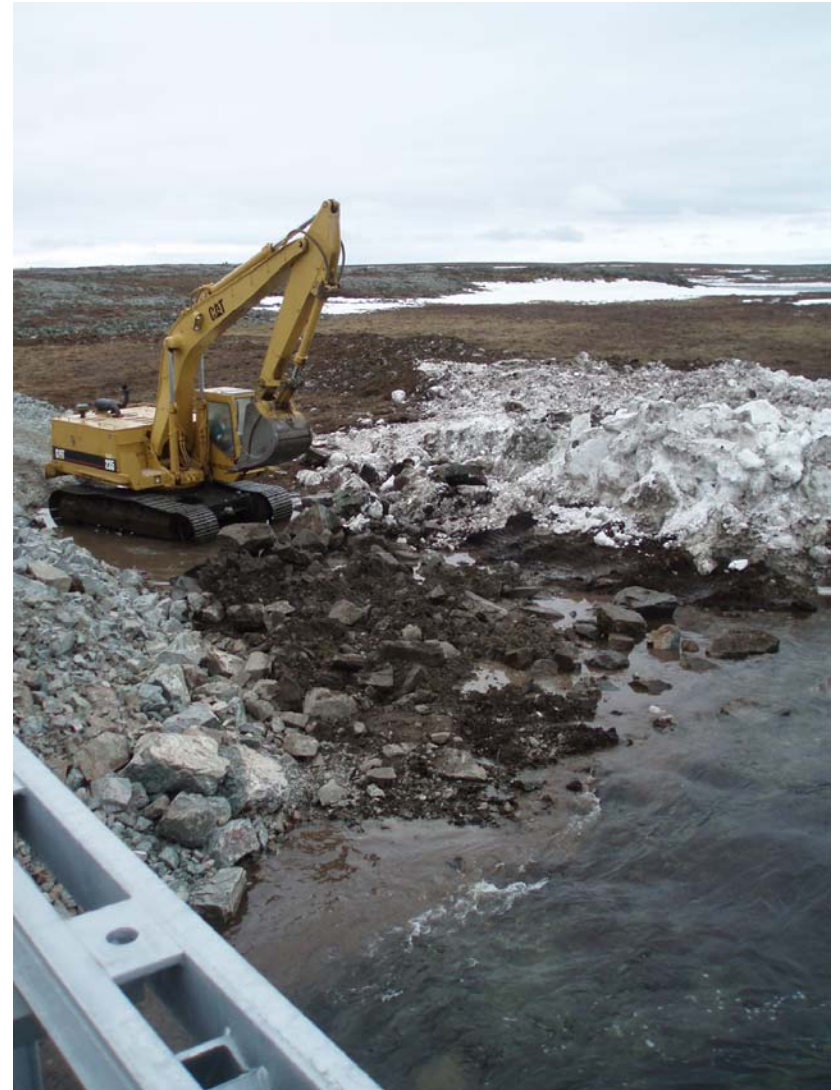
Photo 9. R02 – Adding boulders to stabilize unstable bank area (U/S S side) (17Jun07)

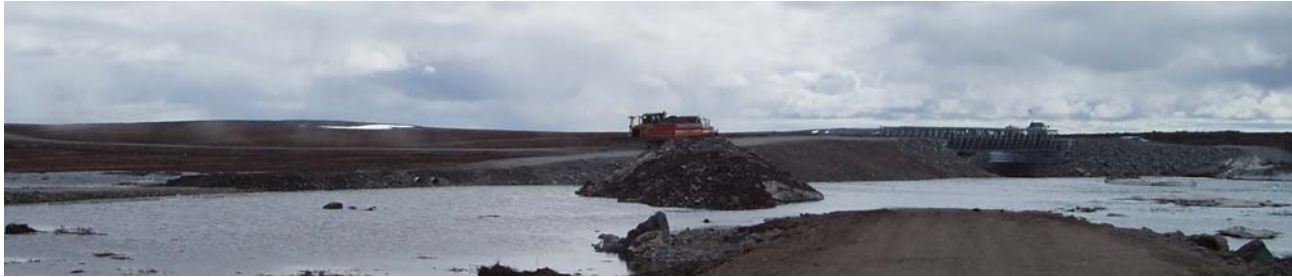
Photo 10. R02 – Road height increase and culvert spillway installation to prevent major instability and erosion on N approach (19Jun07).

- **Seepage through approach on N side of channel** – This new task was made **high priority** on June 18, when rising water levels were approaching road height. It is clear that this long approach (approximately 80 meters of encroachment into the stream channel) will likely require several culverts to mitigate through-road seepage and associated road stability problems. Several options were considered (raise road level, cut temporary spillway, install culvert), but a combination of all three was selected to maximize road stability and hence provide the greatest control of potential sedimentation. A culvert was installed at slightly below former road height to act as a spillway and the road was built up approximately 0.75 m over the previous height. This work was completed on June 19 and will be monitored for success.

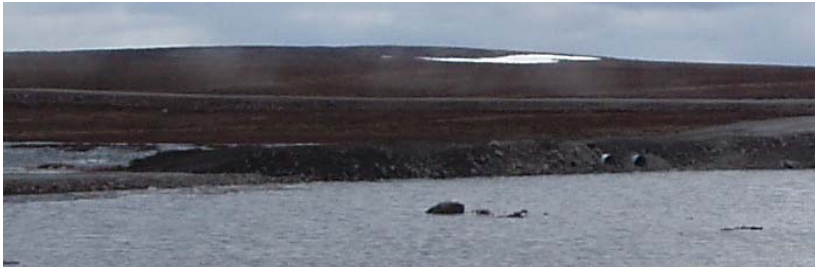
Photo 11. R02 – Close up of Photo XX.

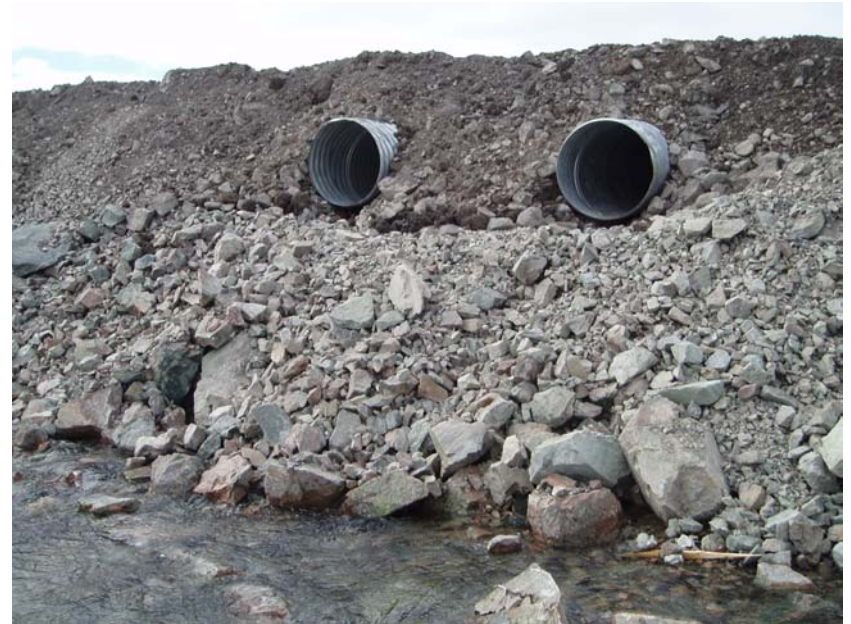
Photo 12. R02 – D/S side showing newly added culverts and road material (19Jun07).

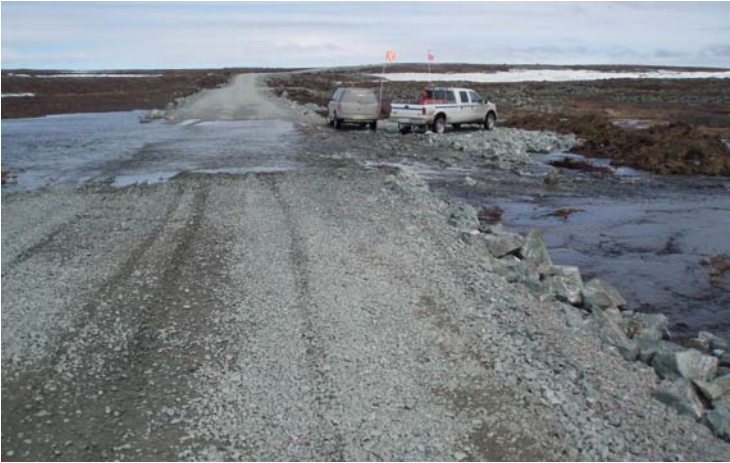
- **Through-road Seepage** – Downstream water continues to flow relatively clear, without significantly increased turbidity. No specific actions are needed unless conditions change and road stability is threatened.
- **Over-road Flows** – R07 was the area with the most significant flows over the road. Road height in this spot is in the process of being raised well above the U/S pooled water; this should be completed by June 20. Water flows appear to have reduced at the other locations, so continued monitoring is all that is recommended at this time.

Photo 13. R07 – Flow over-topping road. D/S flow clear, except when vehicles pass (15Jun07)

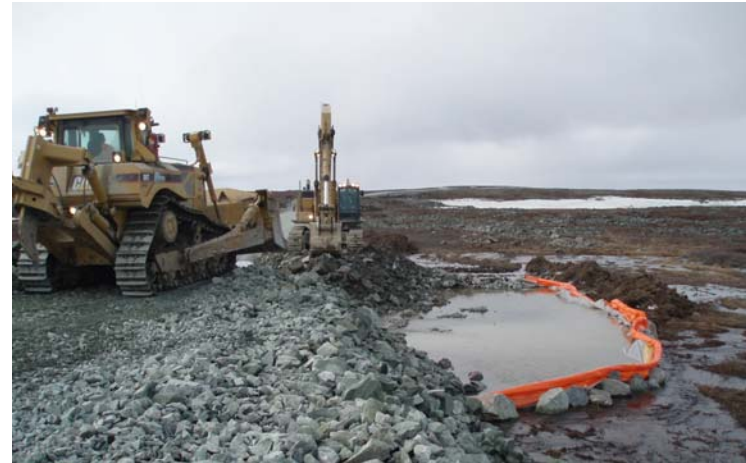
Photo 14. R07 – Sediment settling pond with silt curtain while road is being raised (18Jun07)

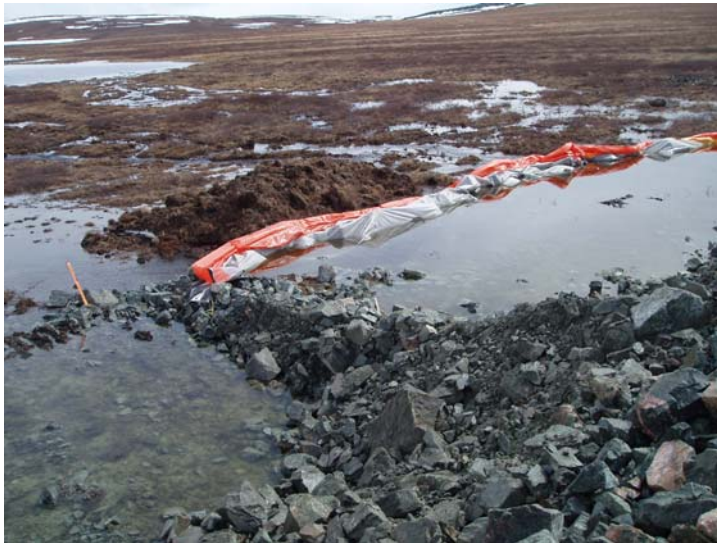
Photo 15. R07 – Settling pond showing clear water (19Jun07)

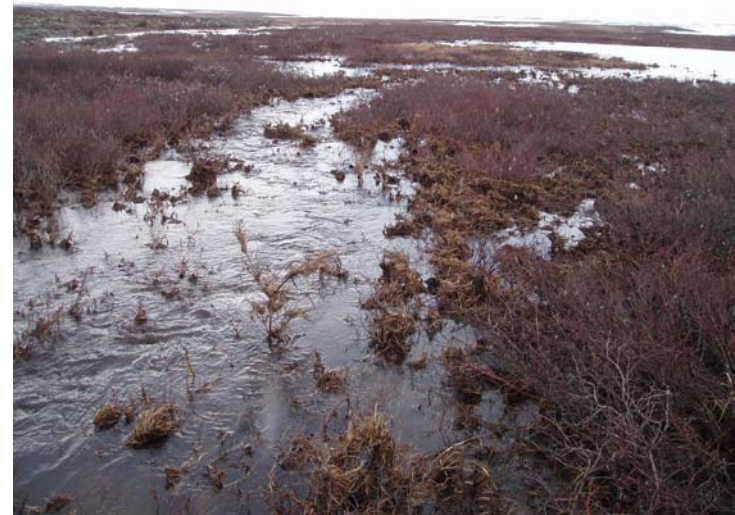
Photo 16. R07 – D/S water running pretty clear (19Jun07)
