Technical Memorandum

Date: 16 June 2007

RE: AWPAR Stream Crossing Monitoring Reconnaissance, 15 June 2007

AWPAR Reconnaissance Survey (15 June 2007) Photos

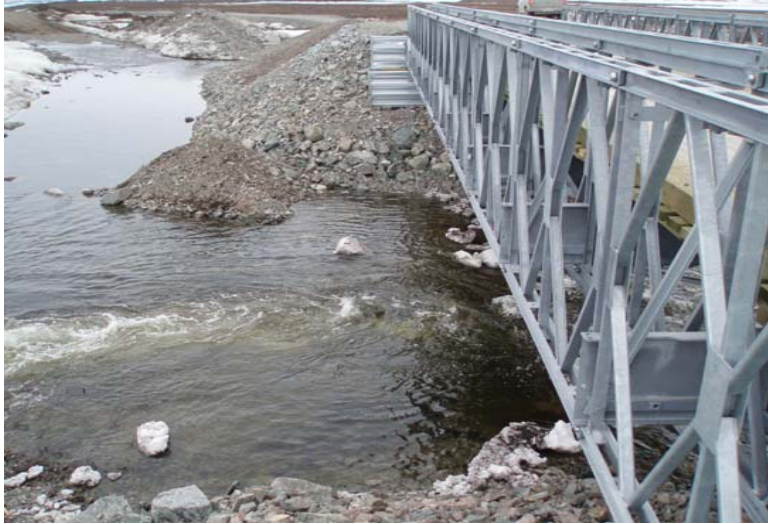
- Stockpiled materials in or immediately adjacent to the currently wetted channel (one U/S N side¹; two D/S S side) (**Photos 1 and 2**) – these materials consist of a range of size classes including relatively fine grains. The piles should be removed with a backhoe and moved well away from the stream channel. Larger material (e.g., boulders) from the stockpiles should be retained and used for increased stabilization of abutment on the U/S S side. Work from the N side will require entering the stream for access, however the substrate in the access zone consists primarily of boulders and the activity poses much less risk than the inevitable consequences of inaction².

Photo 1. R02 – Stockpiled materials at stream margin (U/S N side).

Conducting this work is considered **high priority**.

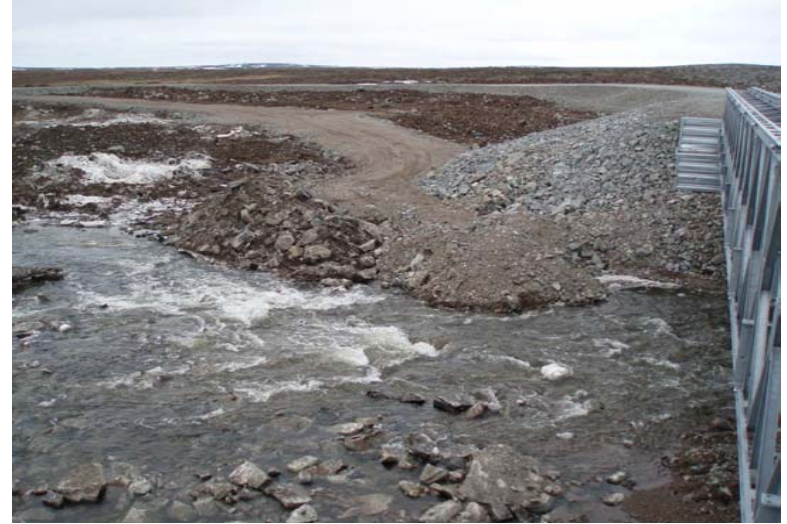
Photo 2. R02 – Stockpiled materials at stream margin (D/S S side).

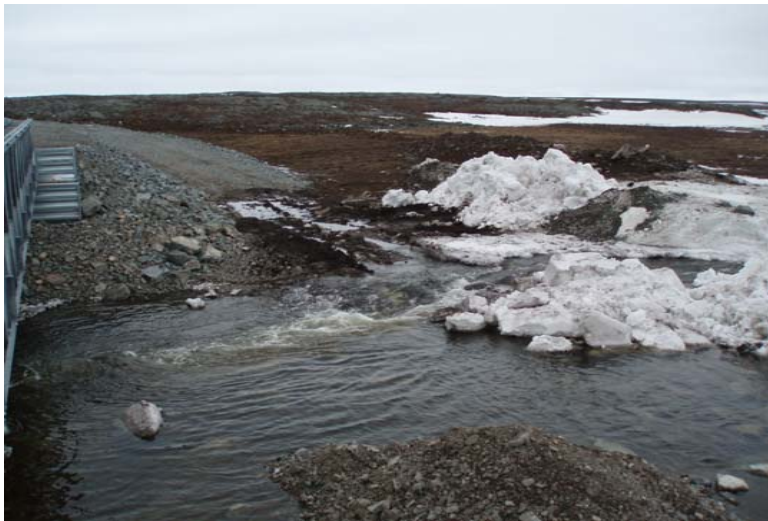
- Unstable bank/riparian area associated with ice bridge approach (U/S S side) (**Photos 3 and 4**) – machinery crossing this area has resulted in localized soil instability which would likely become a significant source of fines to the stream and possibly even a zone of severe erosion. Given the proximity to the S abutment, this area should be stabilized with larger material free of fines.

Photo 3. R02 – Unstable bank/riparian area (U/S S side)

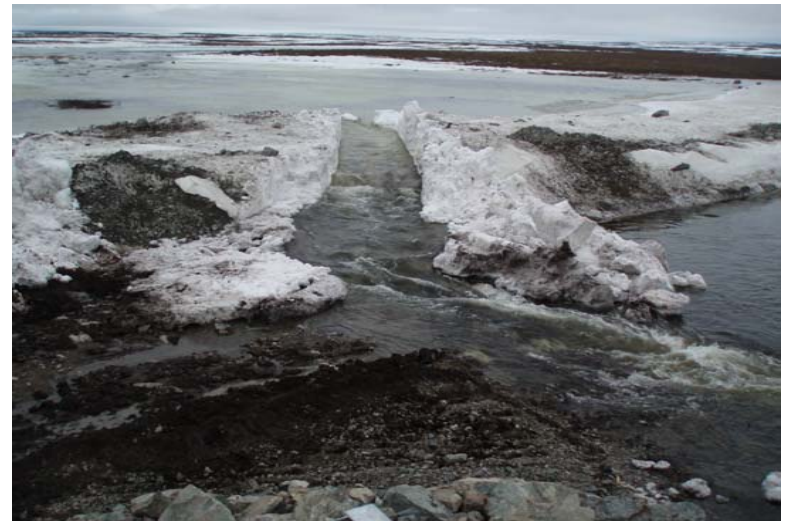
Photo 4. R02 – Unstable bank/riparian area (U/S S side)

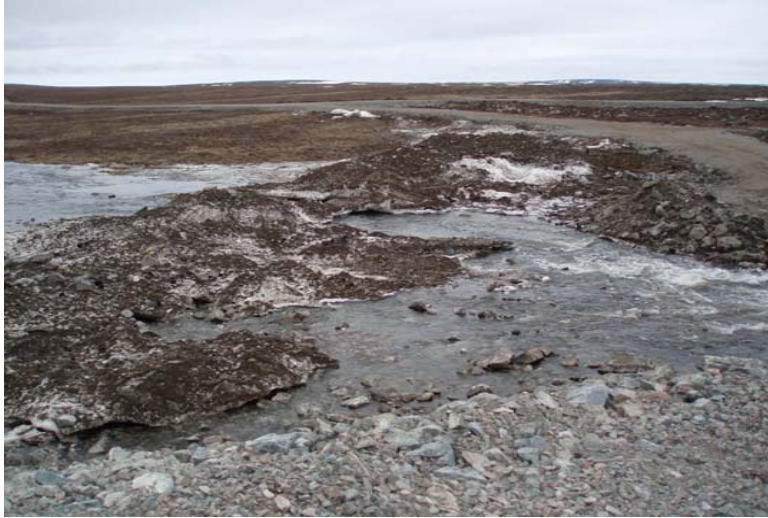
- Construction-related materials on snow/ice present within the overall confines of the channel (U/S N side; D/S N and S sides) (**Photos 5 and 6**) - without action, this material will eventually be deposited in the stream channel with continued melting of in-stream snow/ice. As much material as possible should be removed, but balanced against causing damage to the stream bank. Where possible, access may be improved working off the existing snow covering the bank (i.e., to reach further into the channel). Some material will remain out of reach and should not be attempted.

Photo 5. R02 – Construction-related debris on snow/ice within channel (D/S N and S sides).

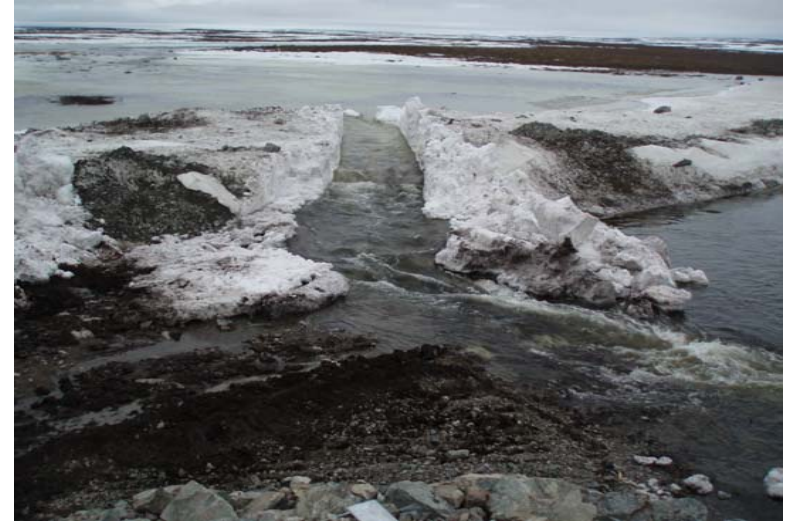
Photo 6. R02 – Construction-related debris on snow/ice within channel (U/S N and S sides).

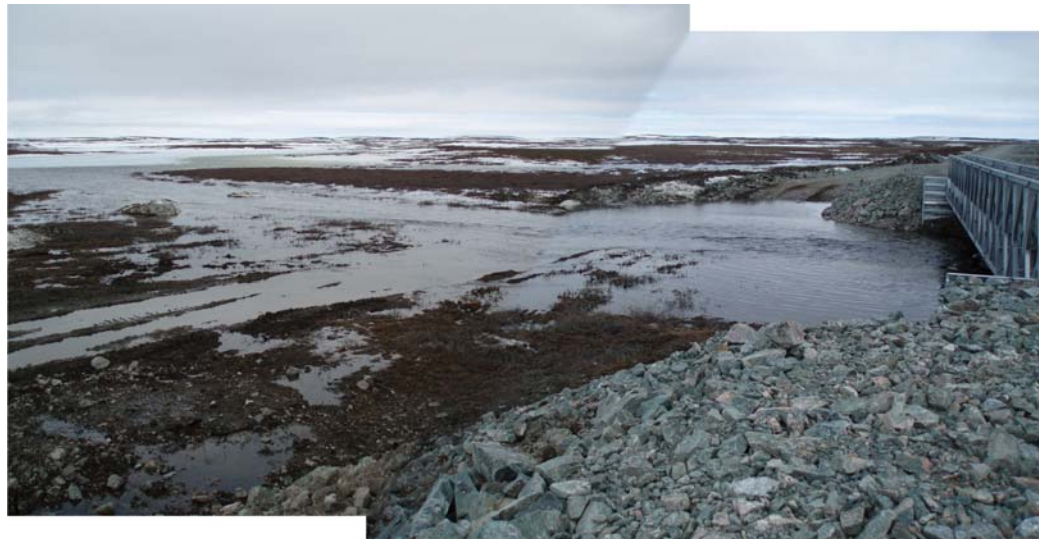
- **R05** – Water was clear downstream of the bridge, with no obvious ongoing significant sediment sources. The only issue observed was the unstable bank/riparian area (similar to

R02) associated with the ice bridge approach (U/S S side) (**Photo 7**). Mitigation as per R02. **High priority**.

Photo 7. R05 – Unstable bank/riparian area (U/S S side)

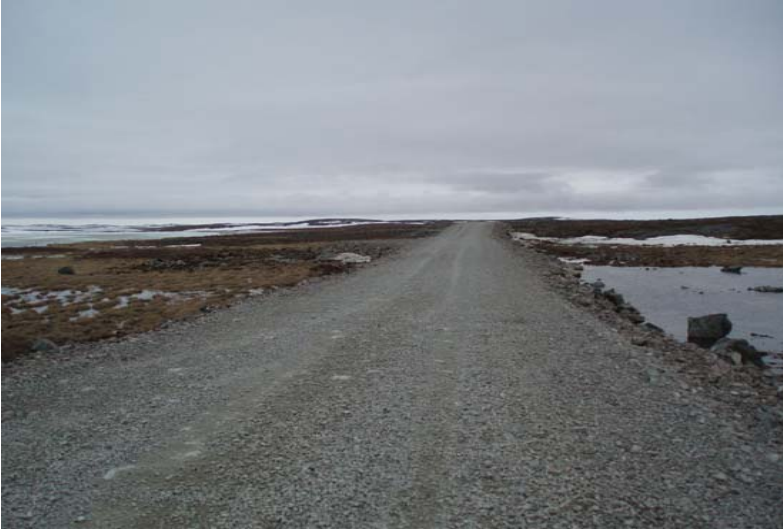
Culverts – No culverts have been installed yet. Water is predictably pooling up-gradient of the road (not only in planned locations, but also in many other areas³), with two outcomes: (1) percolation through the coarse road bed material is allowing flow without introduction of fines in most locations (**Photos 8 and 9**); (2) water moving over the road (km 12, R07, near Quarry 7) is also resulting in generally clear flows (**Photos 10 and 11**), with the exception of brief spikes of turbidity associated with road traffic. While both situations may pose certain localized permafrost-related stability problems (which is outside our area of expertise), neither appears to be resulting in increased suspended sediment loading to fish bearing waters as there are long pathways (i.e., hundreds of meters) through braided grassy channels in the few areas where sediment-laden water is leaving the road (i.e., the areas with water over-topping the road). Furthermore, seeing exactly where water is running now will ensure that culverts are both adequately located.

Photo 8. R04 – Typical situation for most culvert locations (water pooling slightly U/S).

Management of these areas should strongly consider not installing culverts until water levels drop, unless road stability is an issue or if road traffic is increasing sedimentation (e.g., R07). In the interim, silt fences should be installed where possible (and it may not be possible in areas with higher flows depending on the porosity of the material) to facilitate settling well away from fish bearing waters; this is **moderate priority** presently.

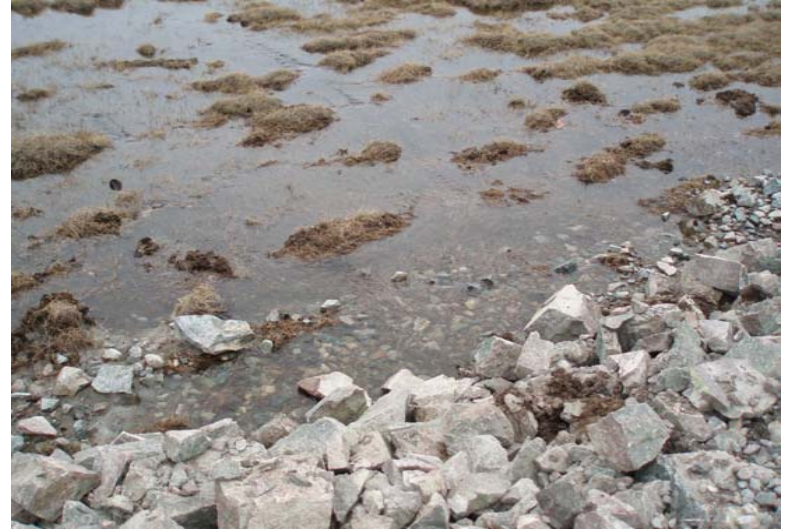
Photo 9. R04 – Water is flowing and generally free of sediment (D/S S side). This is typical of most locations.

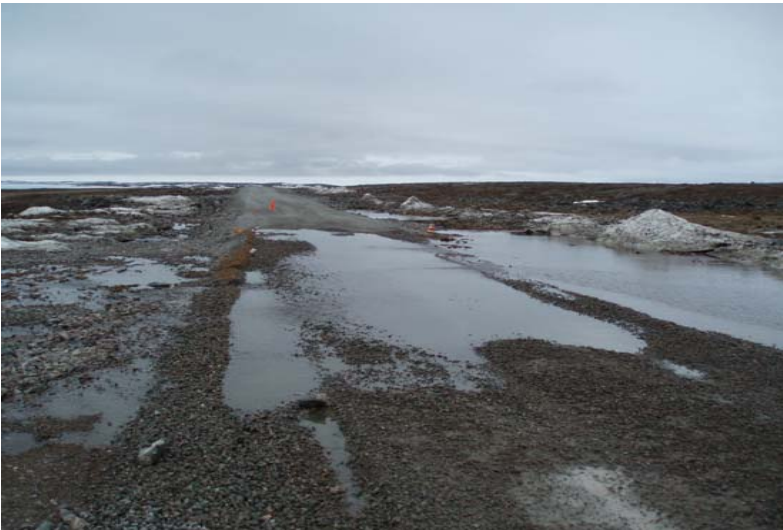
Photo 10. Km 12 – Water flowing over road and turnout area.

Further inspection of over-topping areas could be conducted to assess risks to fish bearing water from road-related sediment introductions. Our observations suggest that present risks are negligible, but further inspection and direct monitoring should be conducted for verification (**moderate priority**). It should be noted that risk levels and potential instability issues could substantially increase if melting rates accelerate in certain locations; continued monitoring will identify these areas. Should culvert installation be deemed necessary, measures should be taken to block flows from the upstream side (e.g., coffer dam) and entrain any sediments downstream (e.g., stacked silt fences); this should be conducted with the utmost care to avoid catastrophic road erosion.

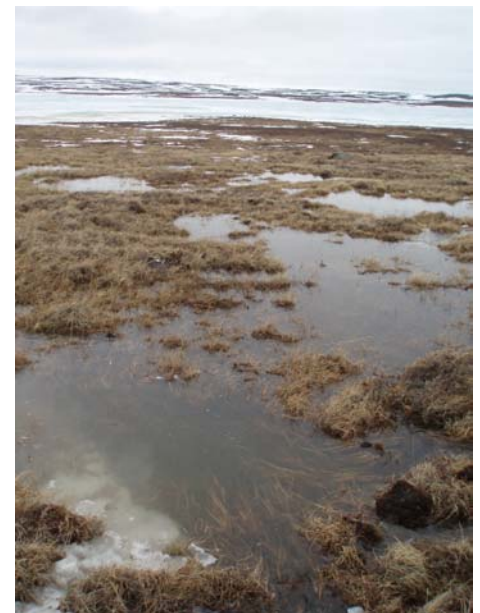
Photo 11. Km 12 – D/S water generally clear with lots of travel distance to fish-bearing water.
