Deposit of Waste and Failure to make a Spill Report In Contravention of Water Licence NWB3ARC0207 Inspectors Direction-

Constantine Bodykevich; duly designated Inspector pursuant to subsection 85 (1) Nunavut Waters and Nunavut Surface Rights Tribunal Act, conducted, on May 23, 2003 an Inspection in regards to Spill (03-332), a prolonged discharge of untreated Sewage Lagoon effluent to Arctic Bay.

## **Arctic Bay Spill Inspection 2003**

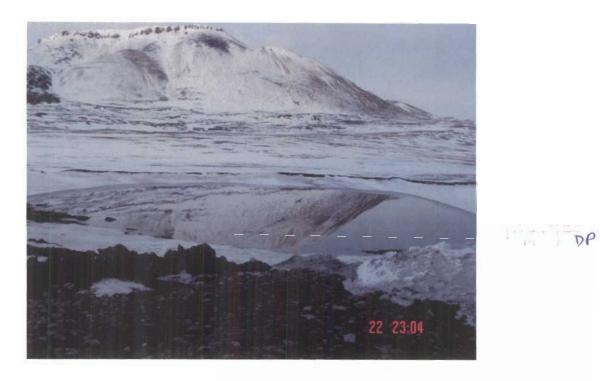
Photo 1. New Sewage Lagoon at full capacity.

Immediately enlarge the dump road north ditch to stop the melt water from accumulating in the new lagoon.

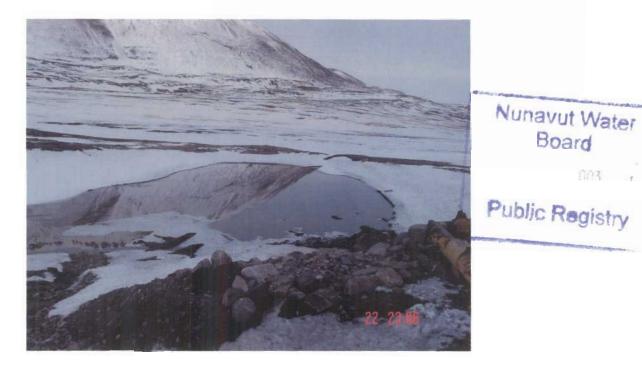
Photo 2. Old Sewage Lagoon.

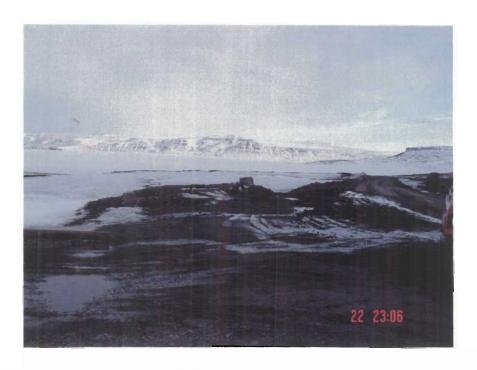
Photo 3. New Sewage Lagoon truck discharge, seepage from north side of road getting into new sewage lagoon.

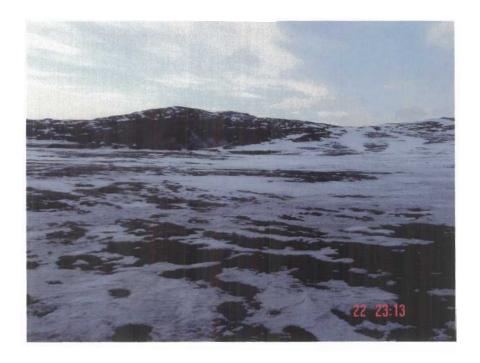
Photo 4. Area that had been flooded by breach in New Sewage Lagoon about 1000 square metres.

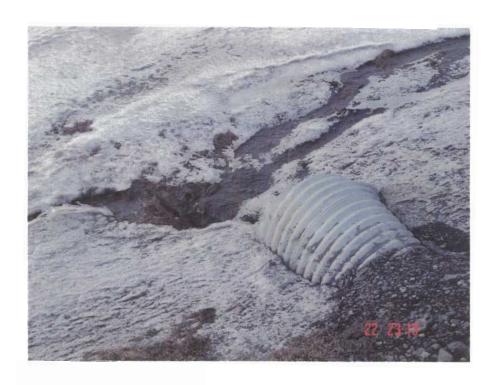
Photo 5. Culvert that drains Lagoon effluent to Arctic Bay.

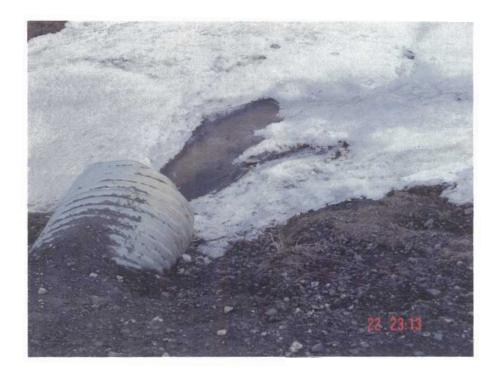
Photo 6. Discharge side of Arctic Bay road culvert.

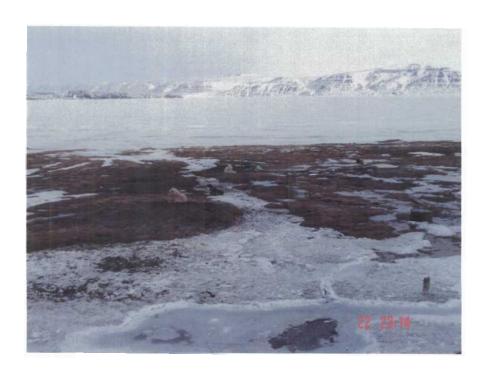
Photo 7. Flow path of Arctic Bay Sewage Lagoon effluent.

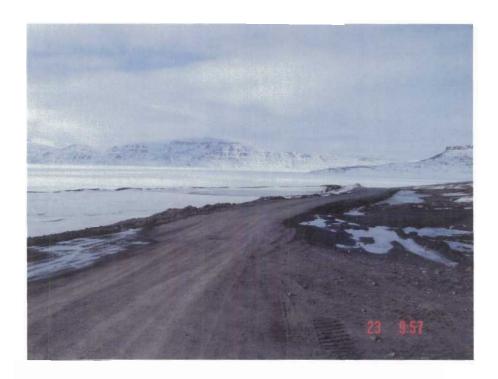
Photo 8. New Sewage Lagoon showing minimal freeboard in lagoon.

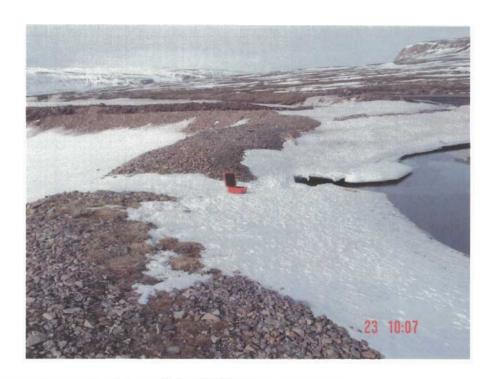
Photo 9. Location of breach in Old Sewage Lagoon.

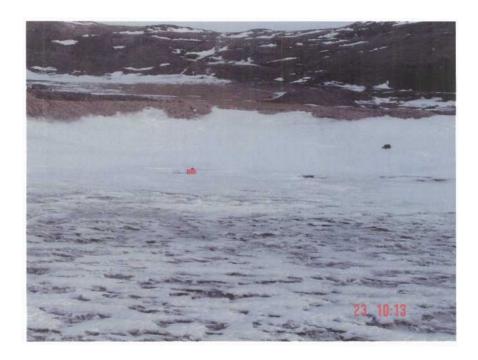
Photo 10. Location of effluent seepage from Old Sewage Lagoon. Sample ARC-3-1 N730203.9 W0850458.9

Immediately place aggregate material at the toe of the old sewage lagoon to eliminate the present seepage problem.

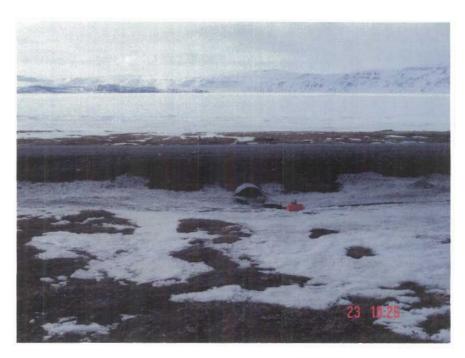
Photo 11. Culvert at Arctic Bay road sample ARC-3-2 N730153.6 W0850515.9.

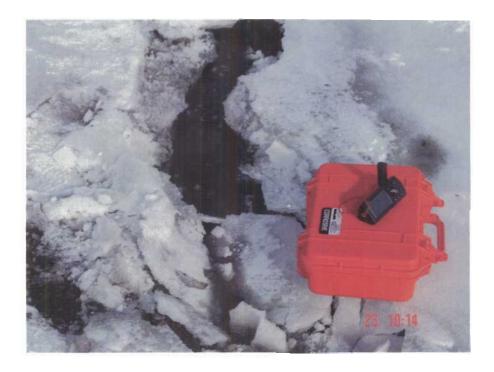
Photo 12. Chanel of flowing Sewage effluent from Old Sewage Lagoon.

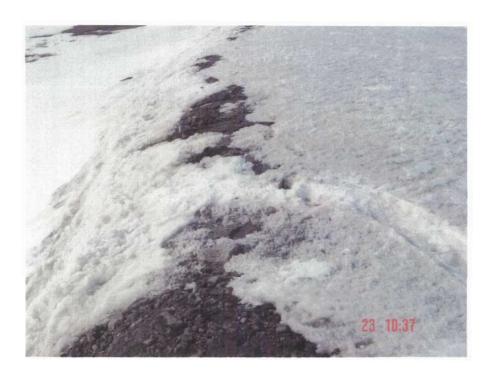
Photo 13. Breach in New Sewage Lagoon berm.

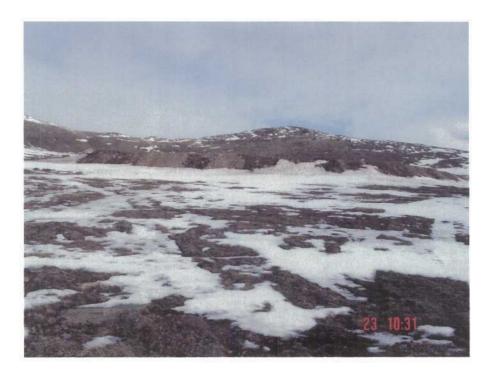
Photo 14. Southern side of New Sewage Lagoon shows no signs of seepage.

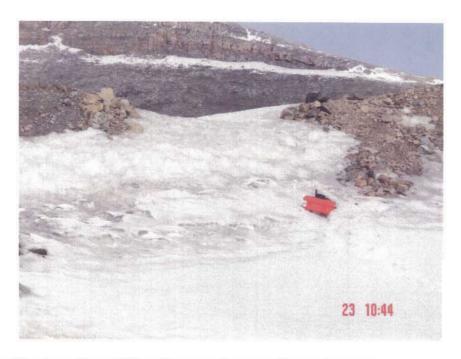
Photo 15. Location of New Sewage Lagoon berm breach.

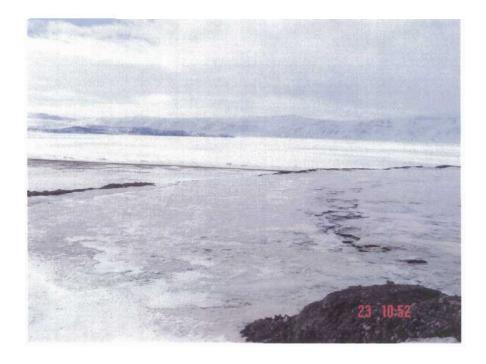
Photo 16. New Sewage Lagoon with breached section in the centre of the photo.

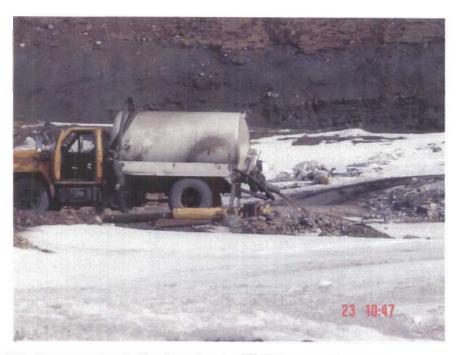
Photo 17. Sewage truck discharging in Old Sewage Lagoon.

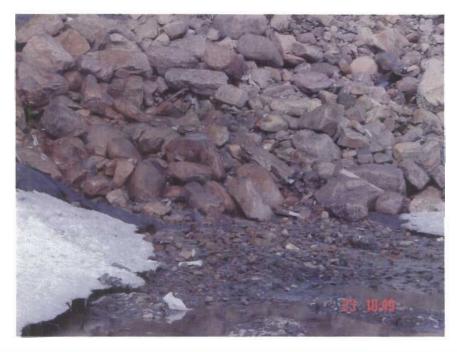
Photo 18. Bottom of Old Sewage Lagoon within 15 minuets of truck discharge.

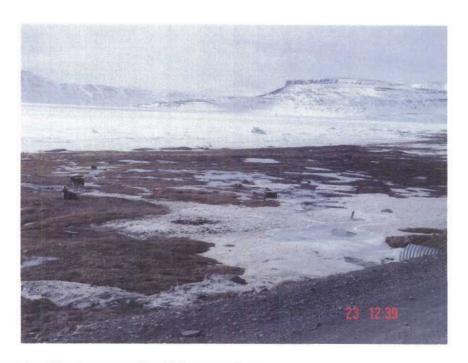
Photo 19. Discharge path of Sewage Lagoon effluent.

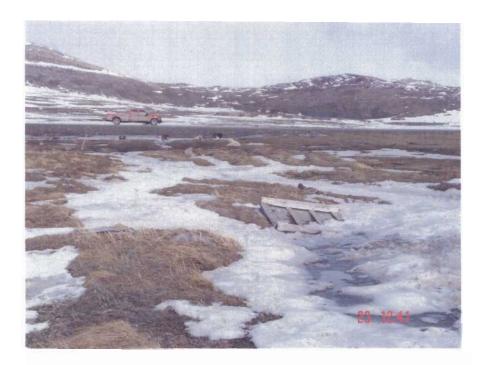
Photo 20. Discharge path of Sewage Lagoon effluent and location of Sample ARC-3-3
