RE: August 3, 2003 Municipal Water Licence Report

The Water Resources Officer (WRO) appreciates the assistance provided during the tour of the Hamlet's Water use and Waste Disposal Facilities. Enclosed for your records is a copy of the Municipal Water Use Inspection Report performed on August 4, 2003. During the inspection the following observations were noted.

Arctic Bay Inspection 2003

MUNICIPAL WATER USE INSPECTION REPORT

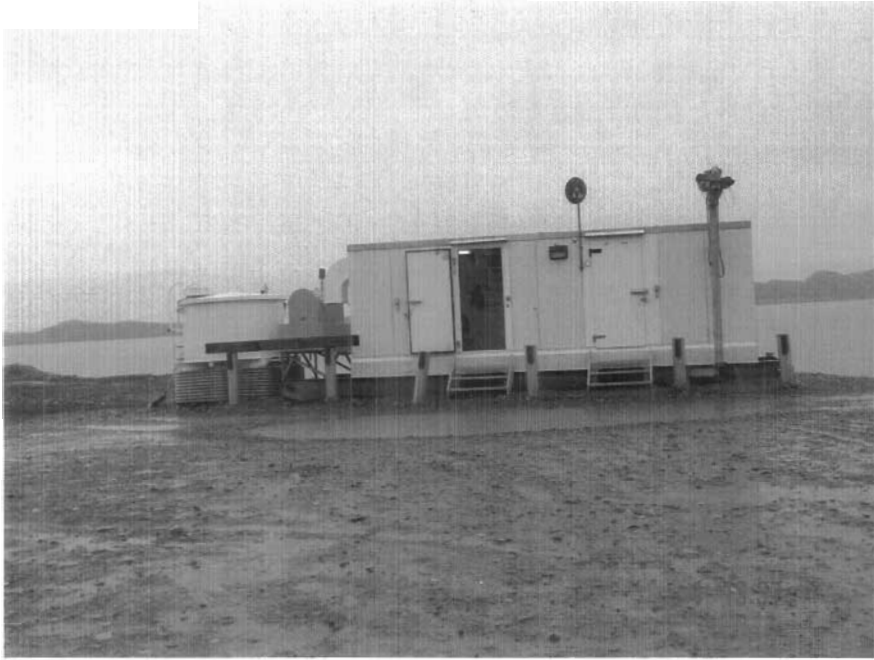
for the Water Intake Facility fuel oil supply (photo 1). The NWB shall be contacted for authorization prior to the removal and remediation (land farming) of the contaminated soil.

Photo 1. Water Supply Intake Facility, water sample N 72.5931.7 W 85.0048.5.

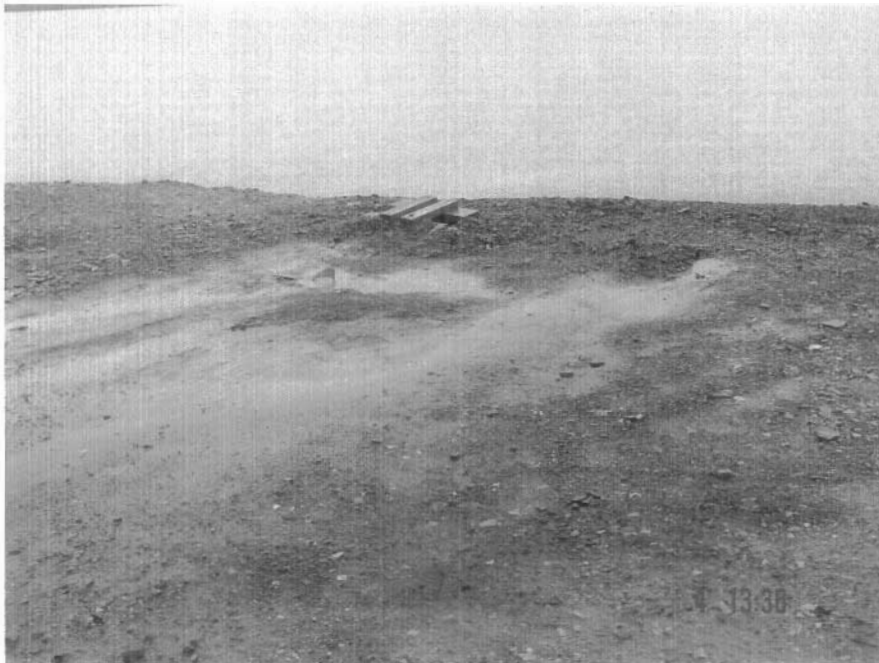
Photo 2. Contaminated ground at truck fill station at Water Intake Facility.

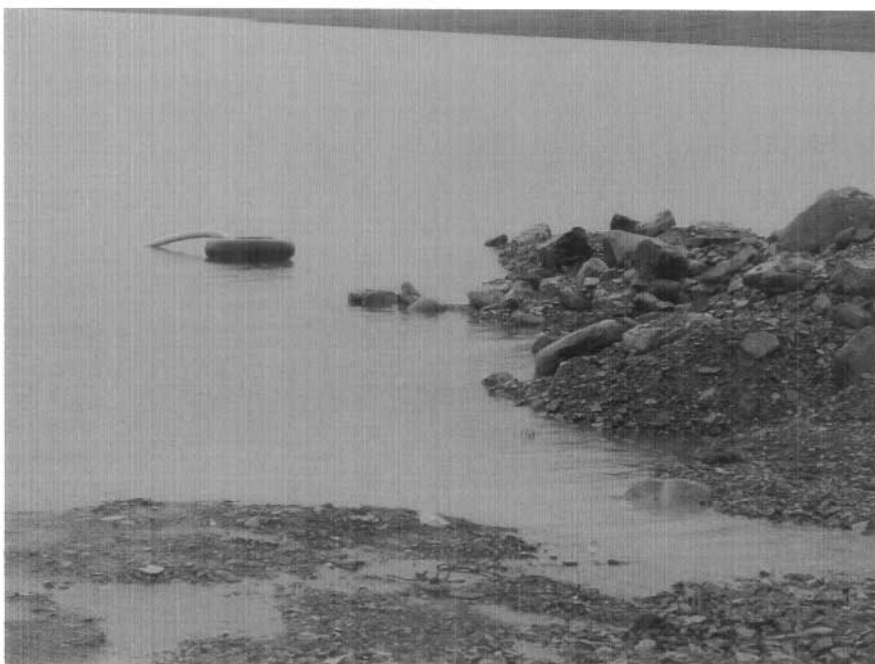
The Water Intake Facility is fairly well maintained however there is garbage around the Water Intake Facility (photo 3-5). Signs are required at the Water Intake Facility to alert the public that no boating or fishing are allowed on Marcil Lake. The Inspector noted oil staining at the Water Intake Facility ruck fill station (photo 2). This stained soil shall be removed and a Spill Kit shall be placed at the Water Intake Facility to reduce the potential of contaminating the water supply. Secondary containment shall be provided

Photo 3. Auxiliary truck fill intake at Water Intake Facility

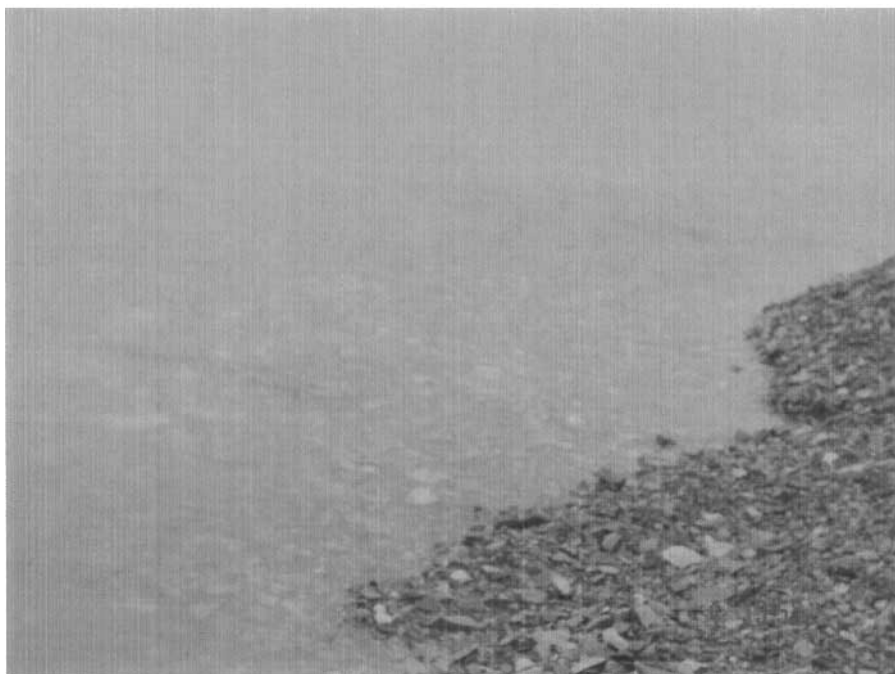
Photo 4. Abandon mooring line adjacent to Water Intake Facility.

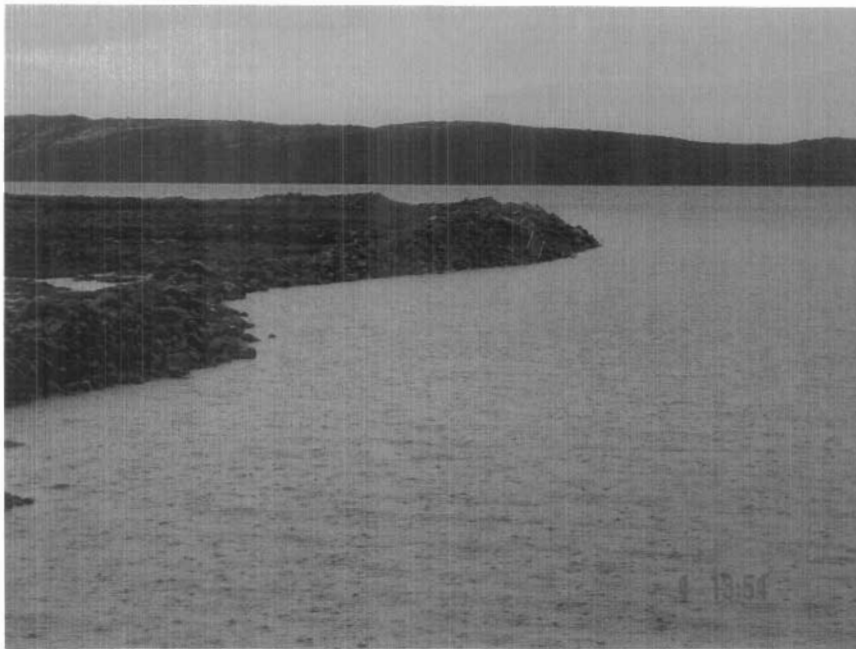
Photo 5. Abandon ladder found by Water Intake Facility.

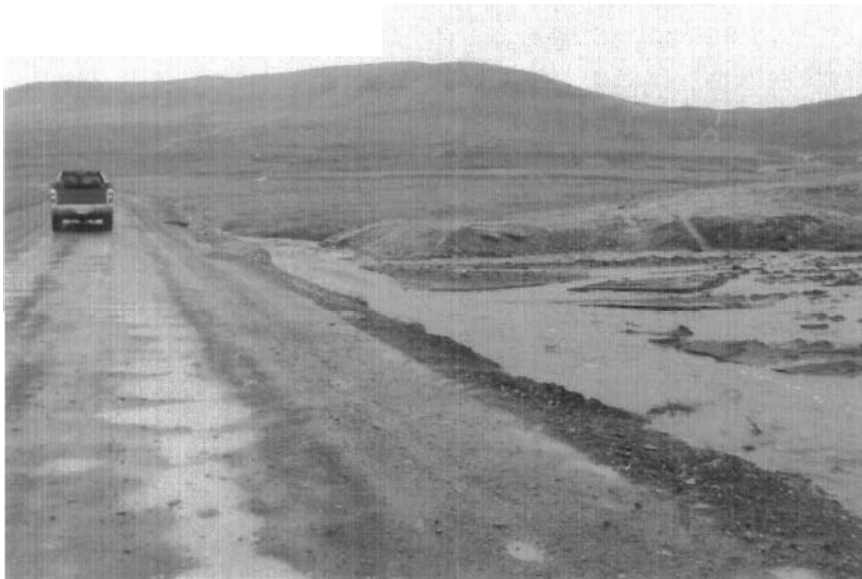
Photo 10. Runoff and Sewage Lagoon effluent at Arctic Bay Road.

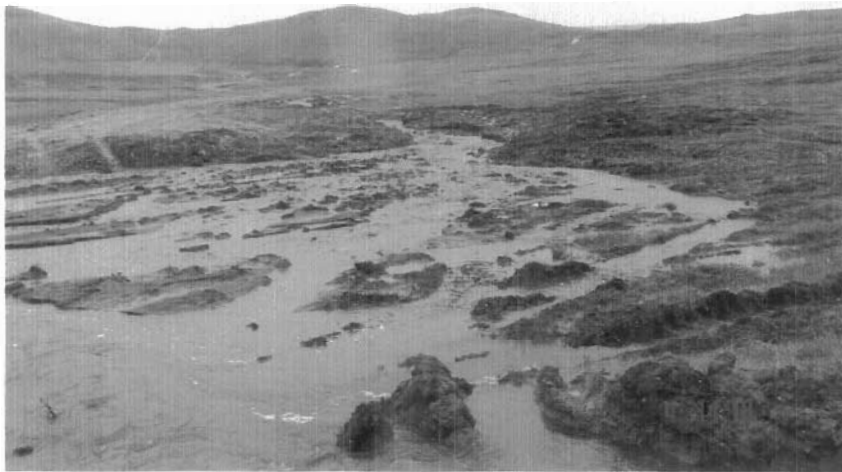
Photo 11. Runoff diversion berm, and Runoff observed during high rain event.

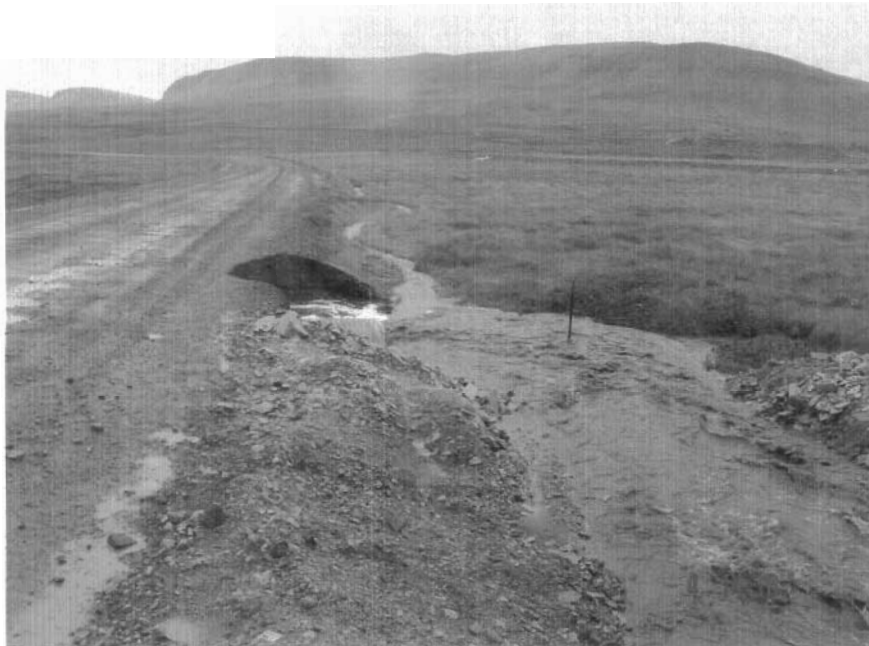
Photo 12. Erosion to Arctic Bay road caused by Runoff and sewage effluent.
Sewage sample N 73.0153.6 W 85.0511.5.

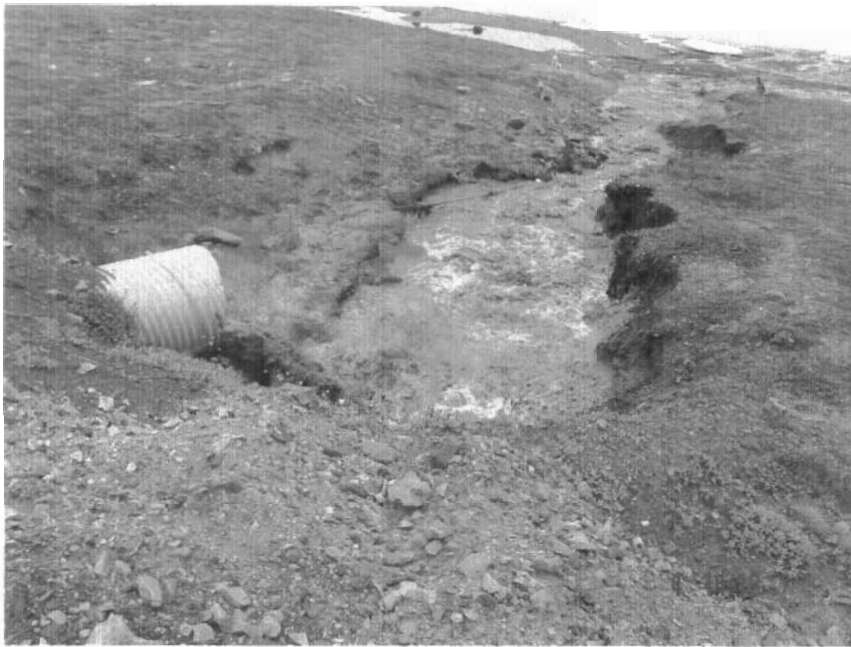
Photo 13. Erosion on discharge side of Arctic Bay Road, Erosion caused by runoff and sewage effluent.

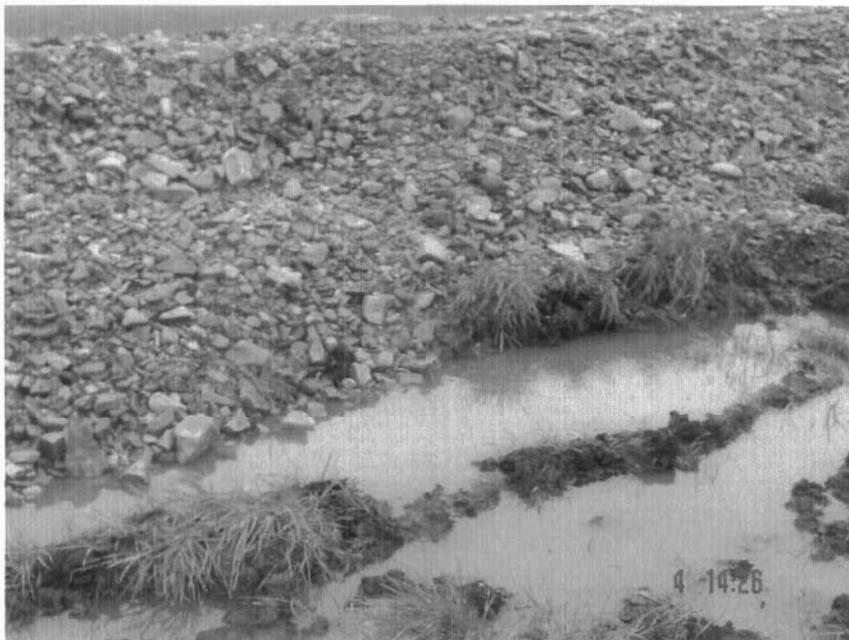
Photo 14. Sewage effluent shown at dispersion berm # 3.

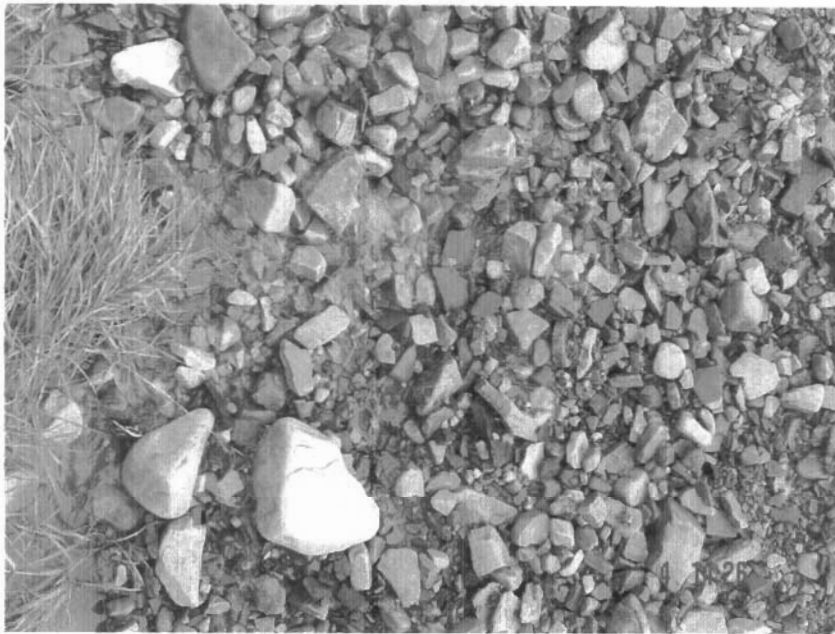
Photo 15. Sewage seepage shown percolating through berm #2.

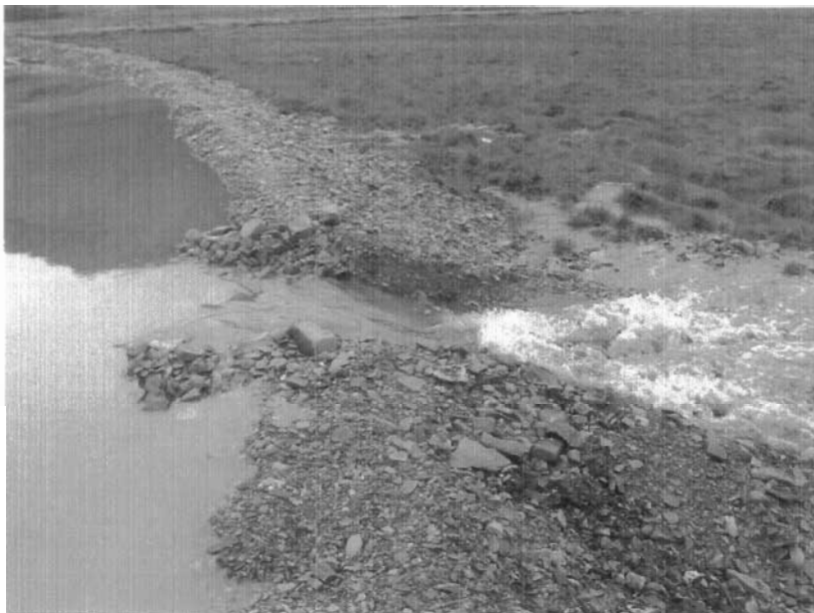
Photo # 16. Excessive sewage effluent shown at berm #2 spillway.

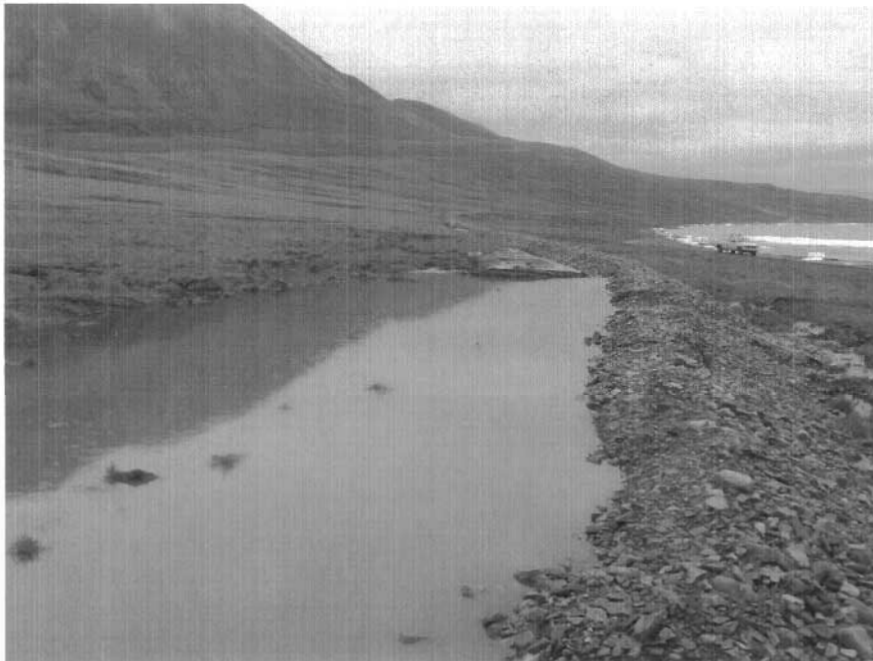
Photo 18. Berm # 3 shown operating as designed.

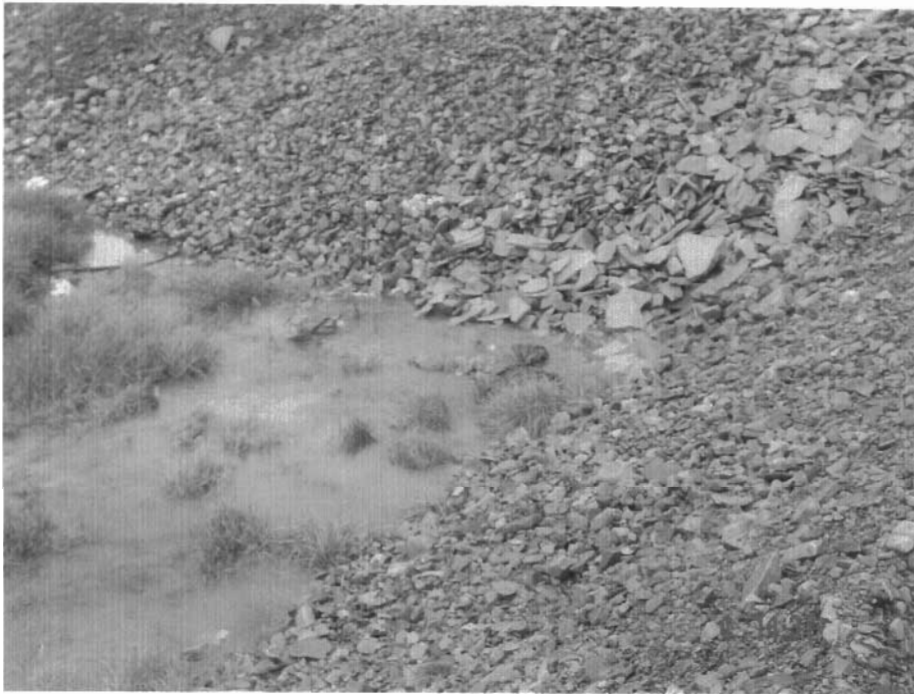
Photo 19. Excessive seepage at (Old-summer Sewage Lagoon).

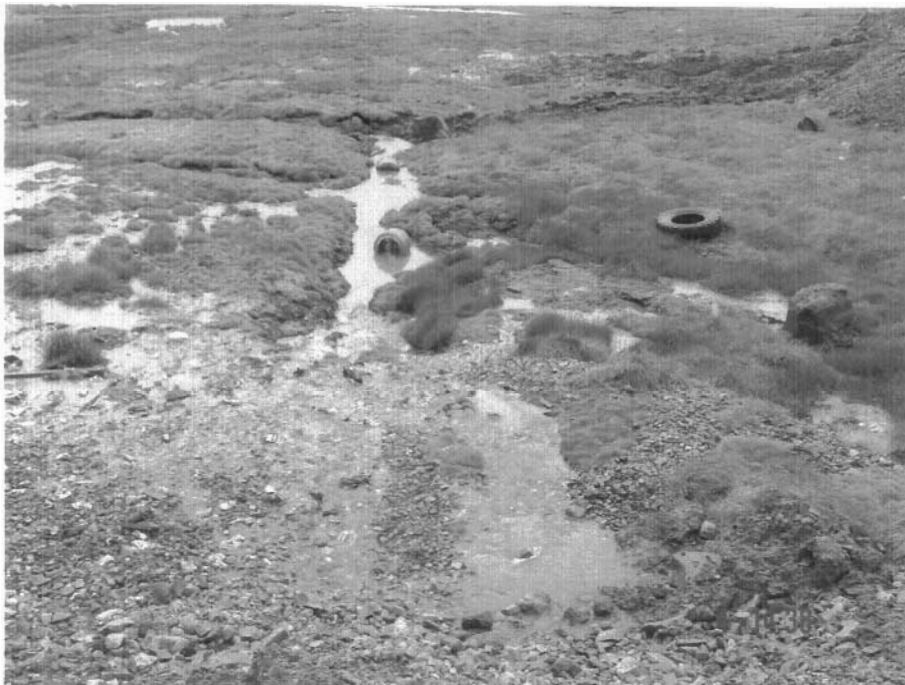
Photo 20. Old - Summer Sewage Lagoon seepage chanal.

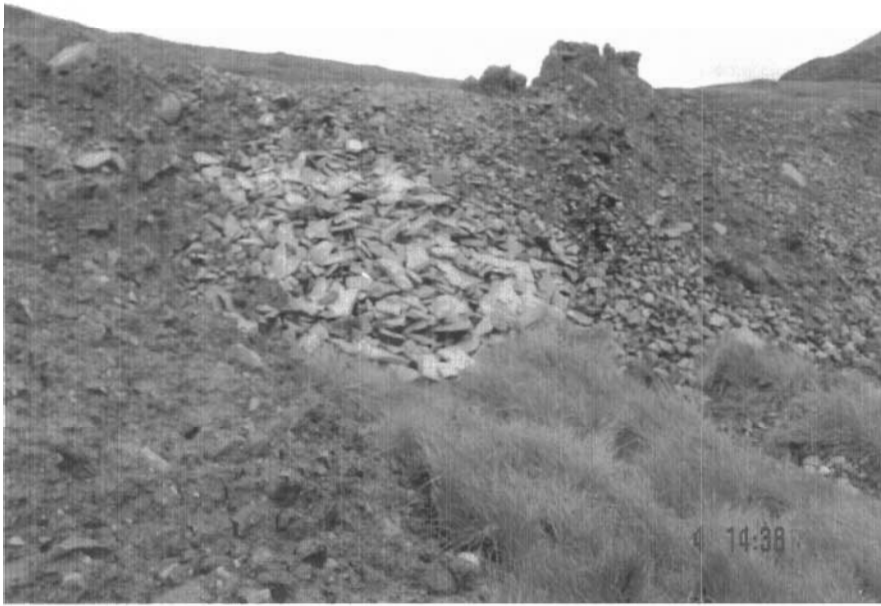
Photo 21. Size of aggregate material in side of Old Sewage Lagoon.

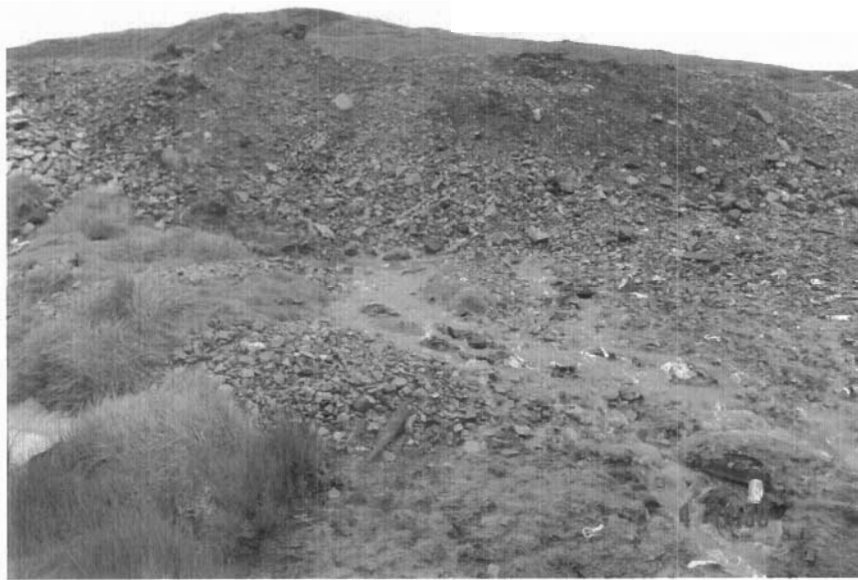
Photo 22. Seepage from Old-Summer Sewage Lagoon.

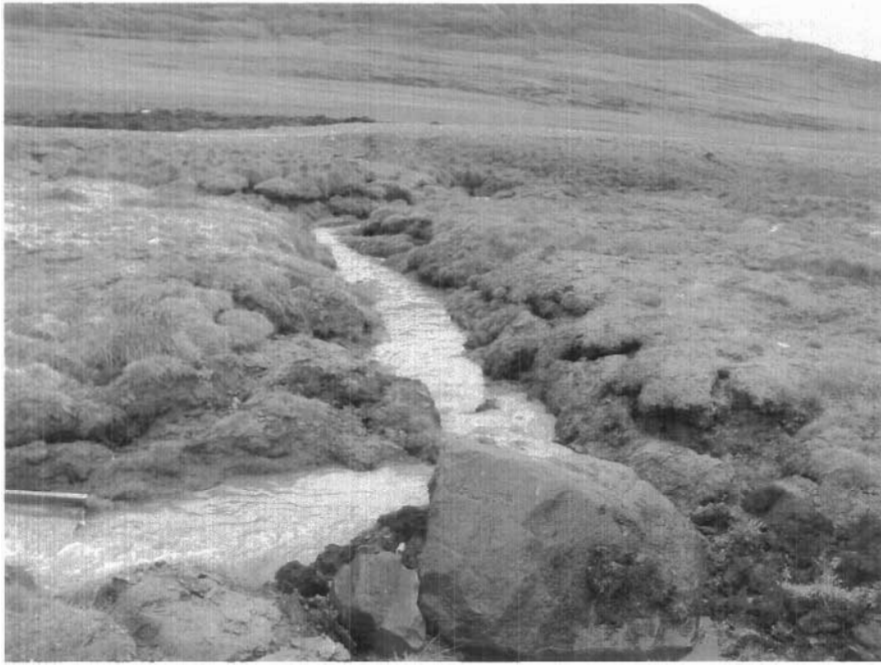
Photo 23. Chanel cut by excessive seepage from Old-Summer Lagoon.

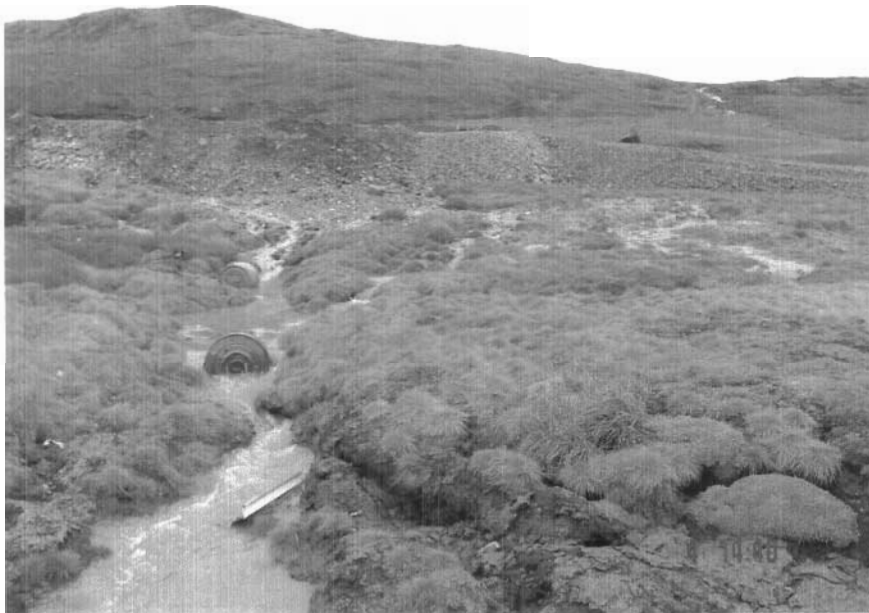
Photo 24. Seepage channel from Old-Summer Sewage Lagoon.

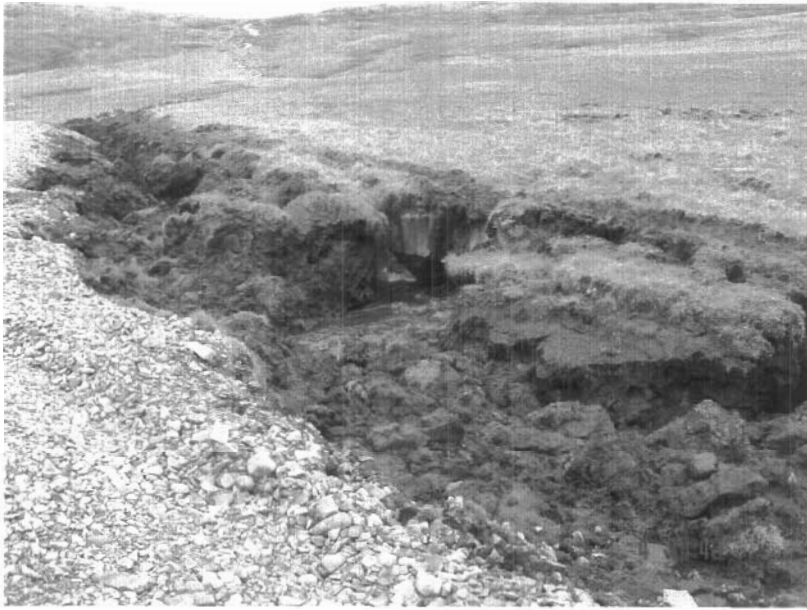
Photo 25. Erosion caused by Runoff around sewage treatment area.

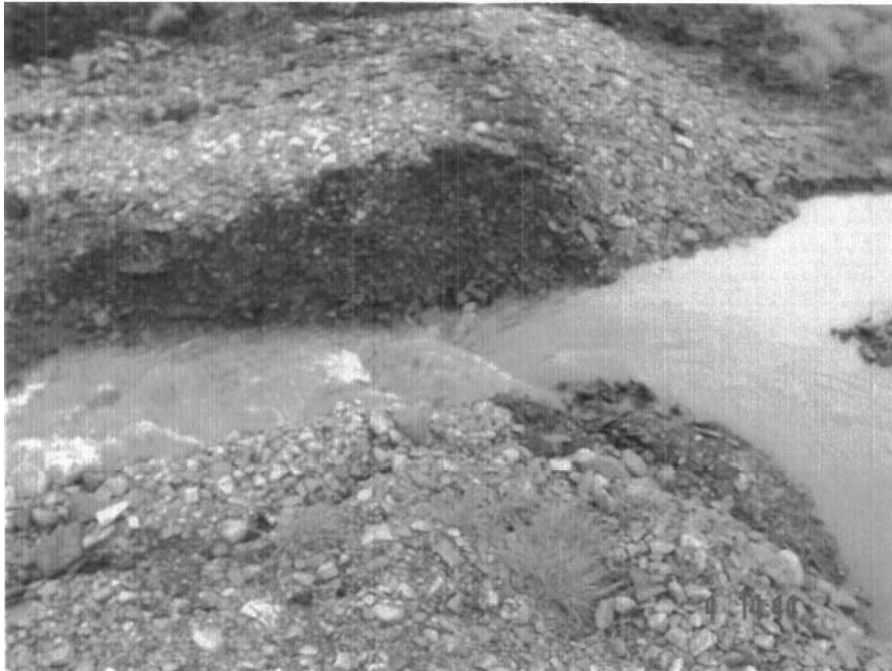
Photo 27. Shale and coarse aggregate material shown in wetlands dispersion berm. Excessive flow in spillway.

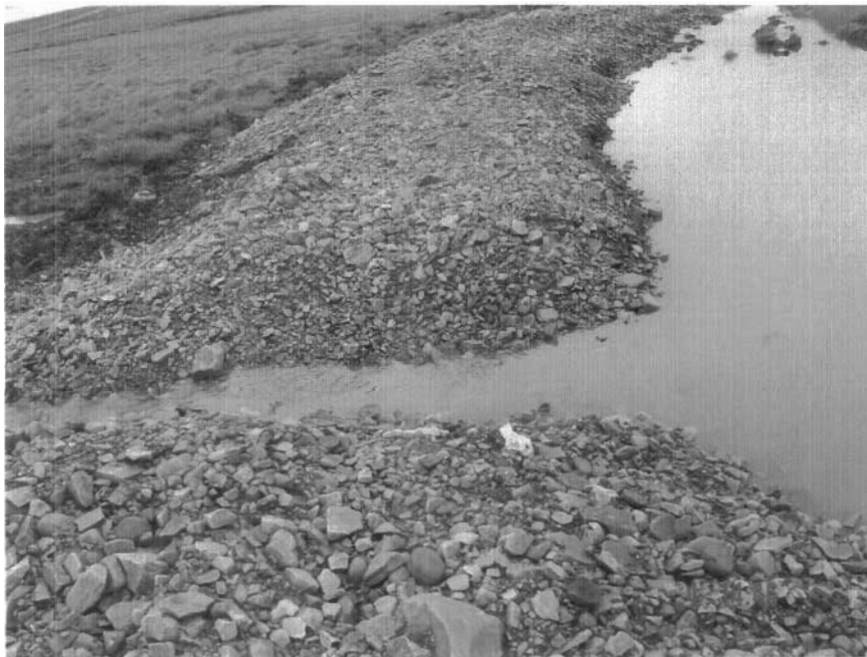
Photo 28. Spillway shown in berm #2, shown operating due to improper material in berm.

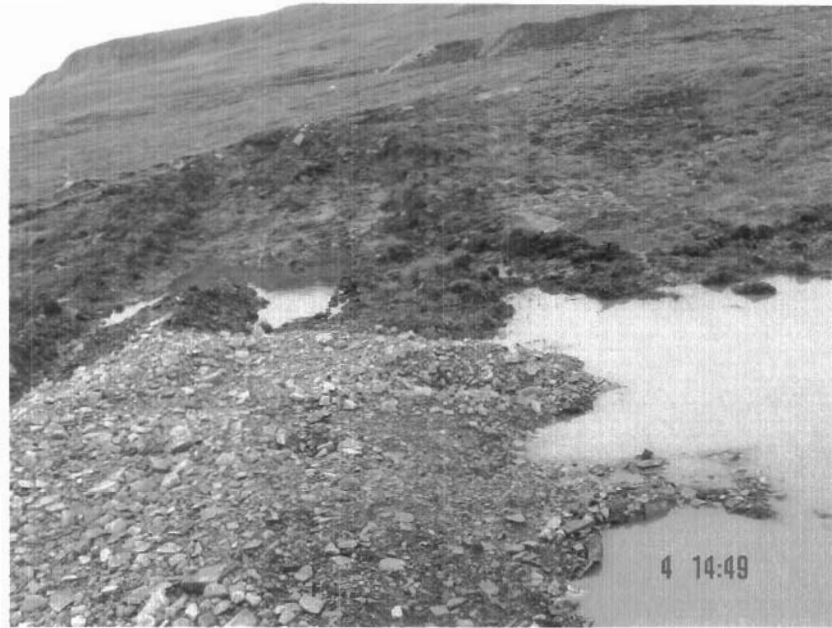
Photo 29. Seepage shown circumventing dispersion berm # 1.

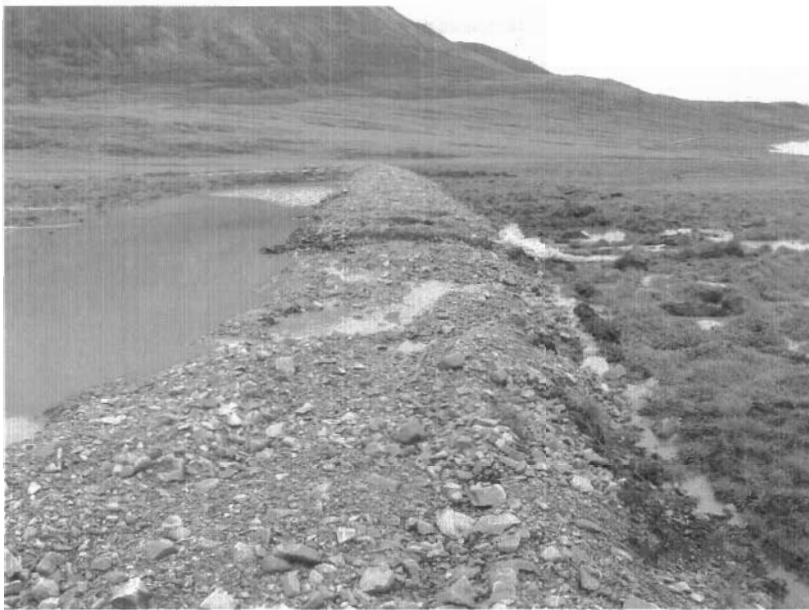
Photo 30. Dispersion berm shown with insufficient coarse aggregate material above shale core.

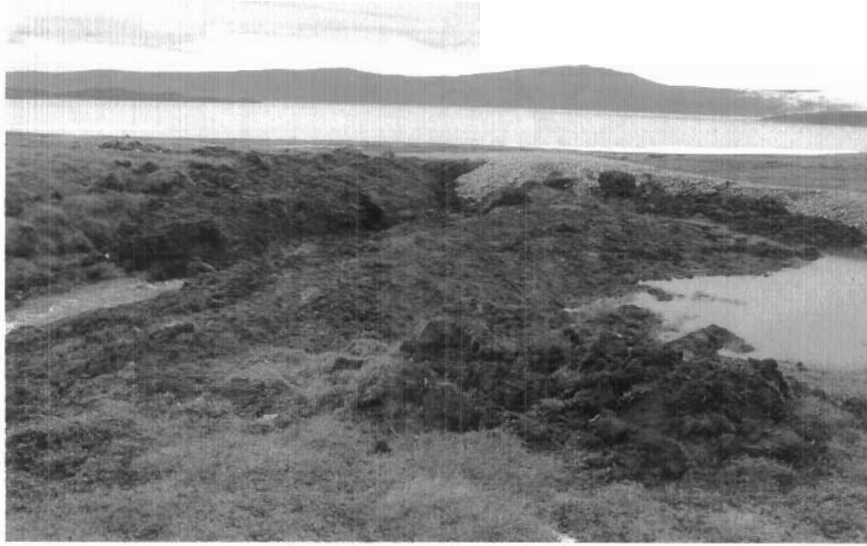
Photo 31. Erosion trench produced by diversion of runoff.

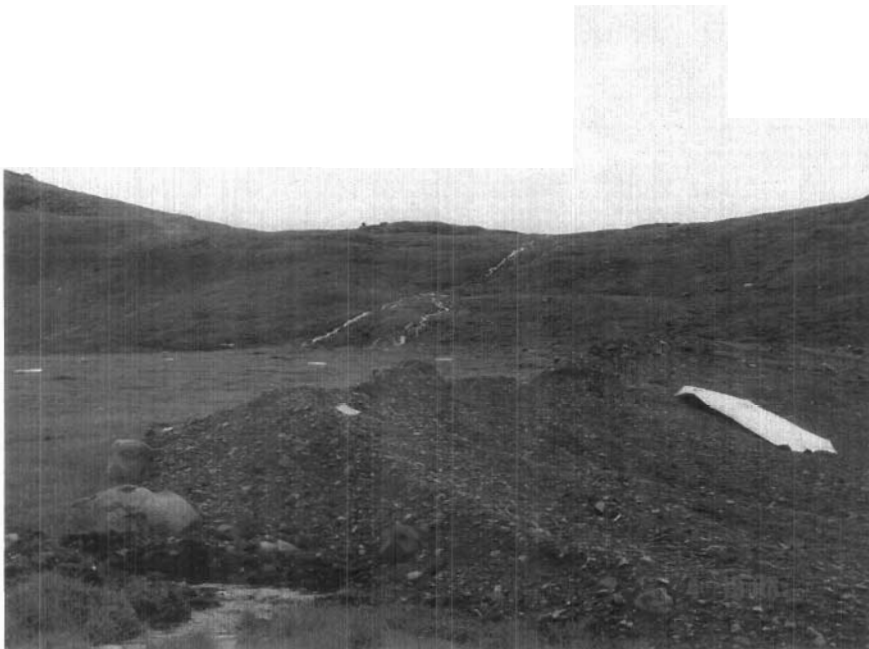
Photo 32. Runoff from hill at back of dump.

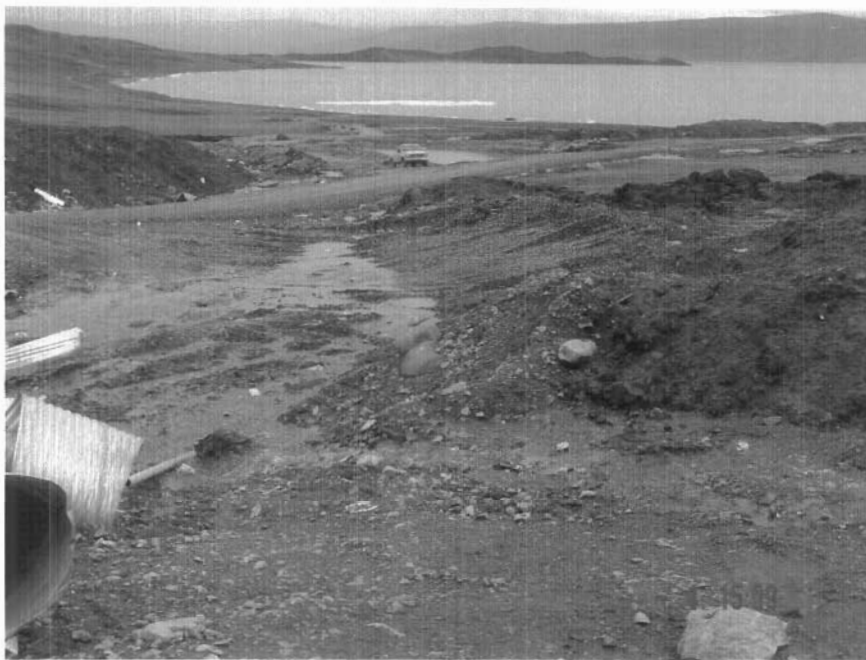
Photo 33. Runoff through buried metal dump area.
Dump seepage sample N 73.0208.4 W 85.0459.9.

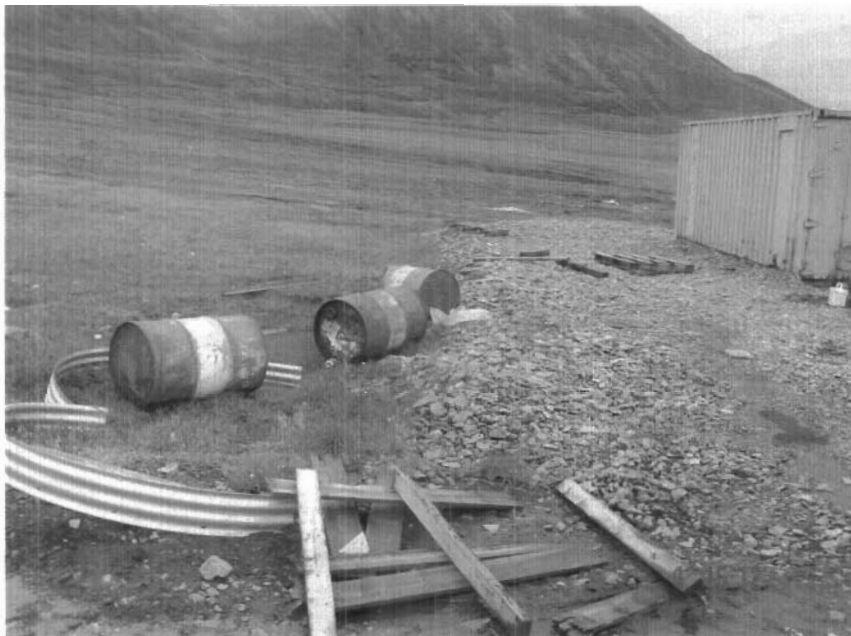
Photo 34. Staining of soil shown by improperly stored waste drums.

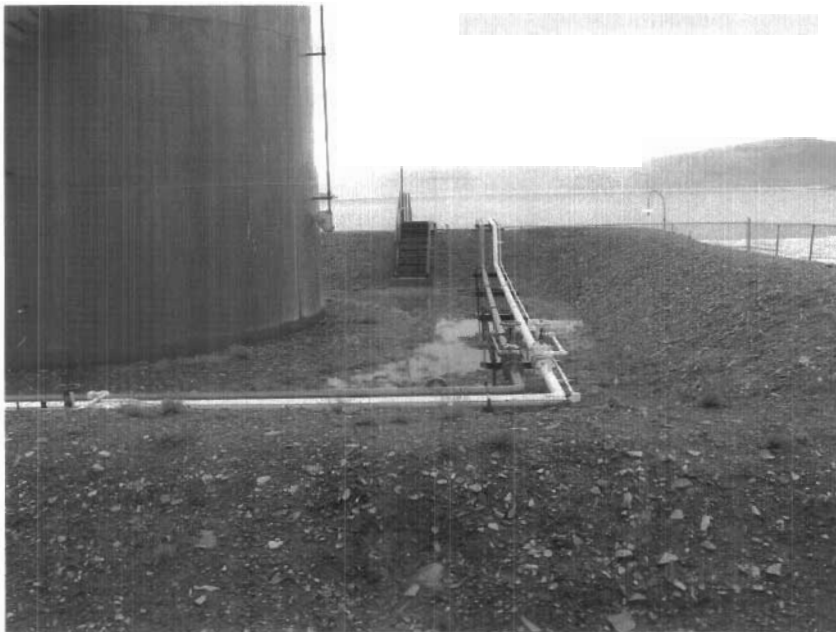
Photo 36. Tank Farm berm in good condition with minimal contained water.
