WATER LICENCE INSPECTION FORM

Licensee	Licensee Representative
Hamlet of Arctic Bay	Bhabesh Roy
Licence No. / Expiry	Representative's Title
3BM-ARC1419/Renewal expires August 28, 2019	Municipal Engineer
Land / Other Authorizations	Land / Other Authorizations
Date of Inspection	Inspector
July 26, 2018	Joseph Monteith
Activities Inspected	
<input type="checkbox"/> Camp	<input type="checkbox"/> Drilling
<input type="checkbox"/> Roads/Hauling	<input type="checkbox"/> Mining
	<input type="checkbox"/> Construction
	<input type="checkbox"/> Reclamation
	<input type="checkbox"/> Fuel Storage
	<input checked="" type="checkbox"/> Other: Potable water, Sewage, and Solid Waste
	<input type="checkbox"/> Other:

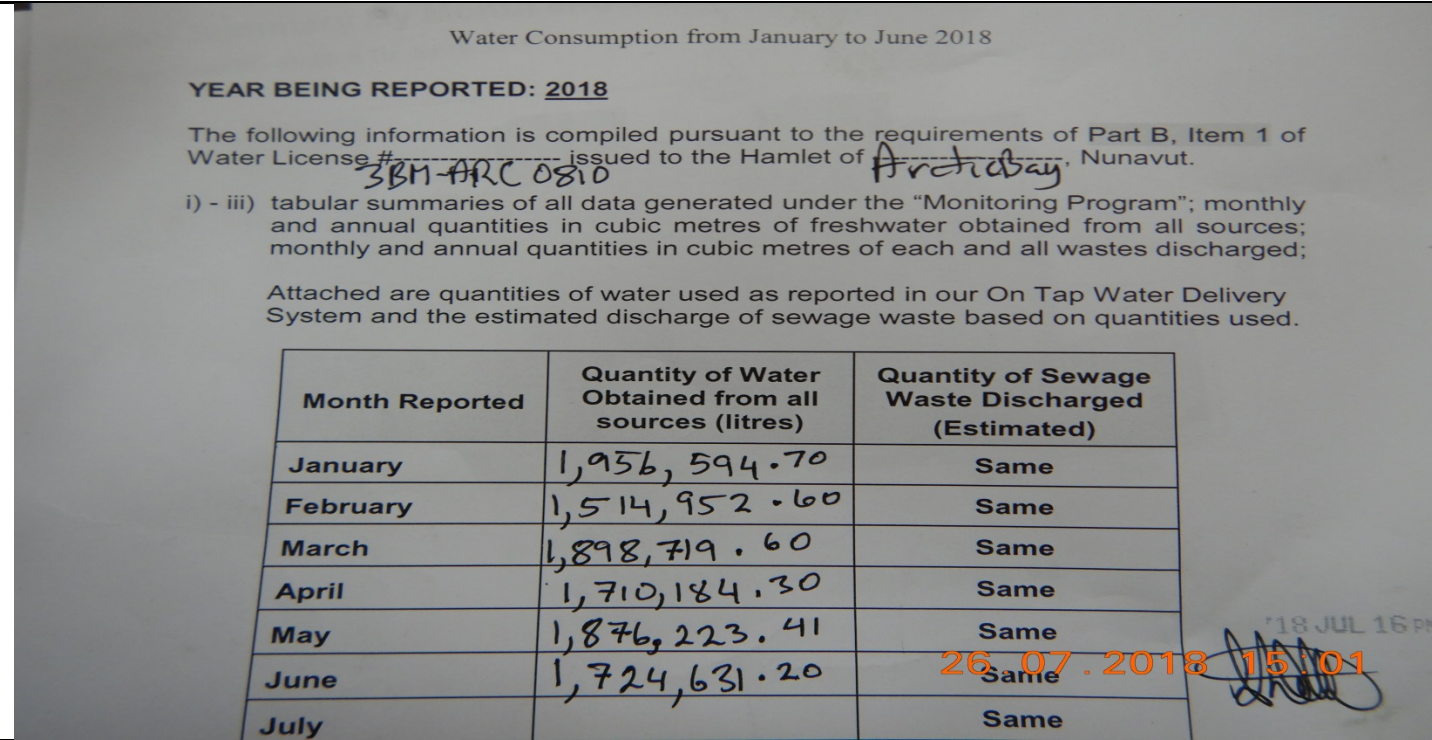
Photo 1

Description: Water consumption from January to June 2018

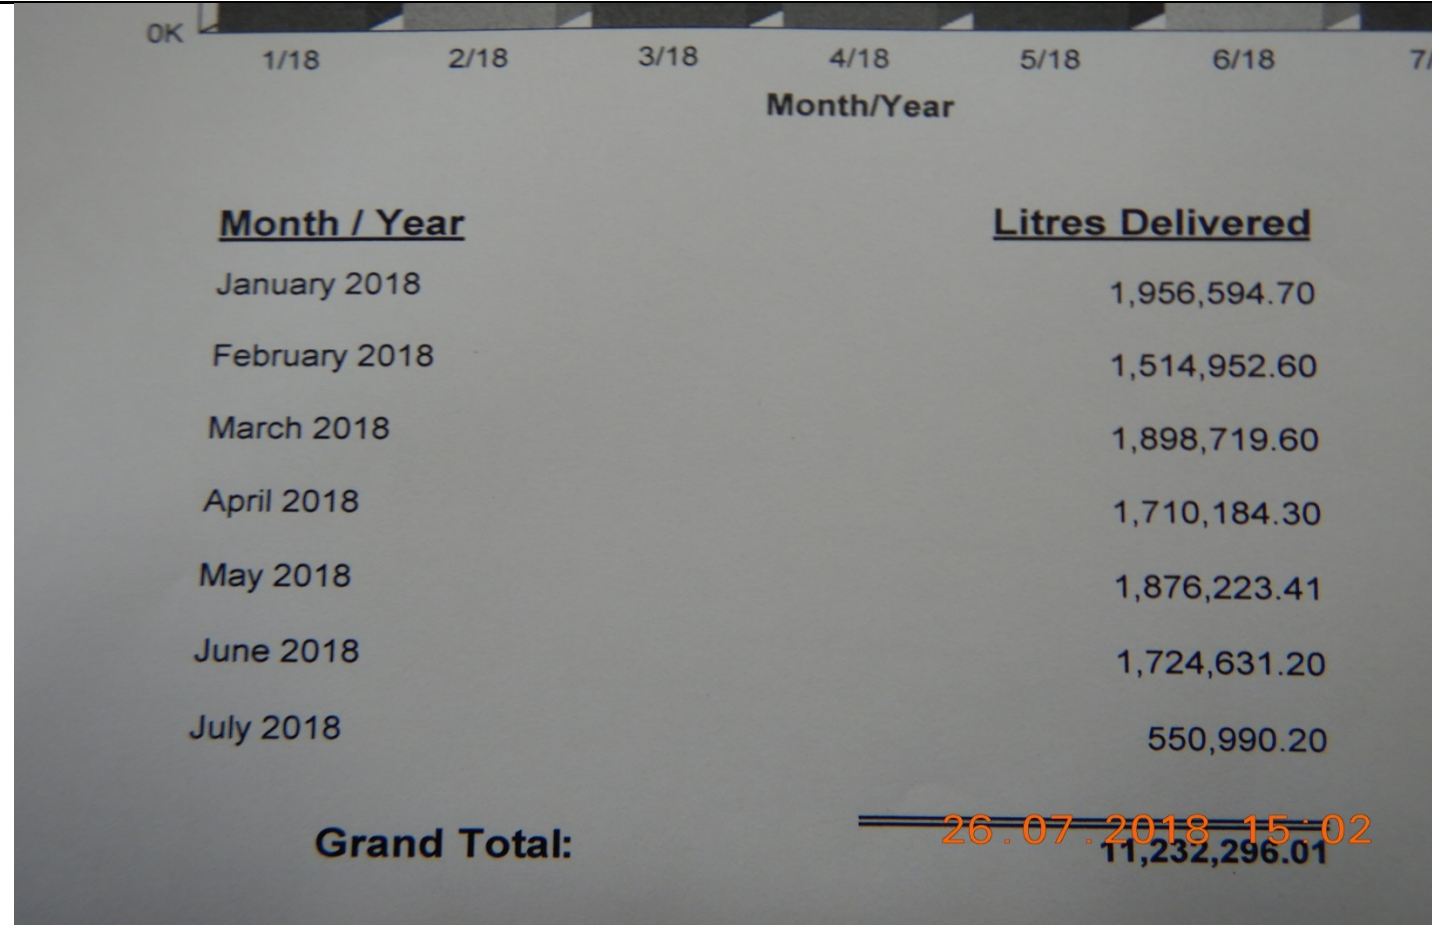
Photo 2

Description: Water Delivered from January to July 2018

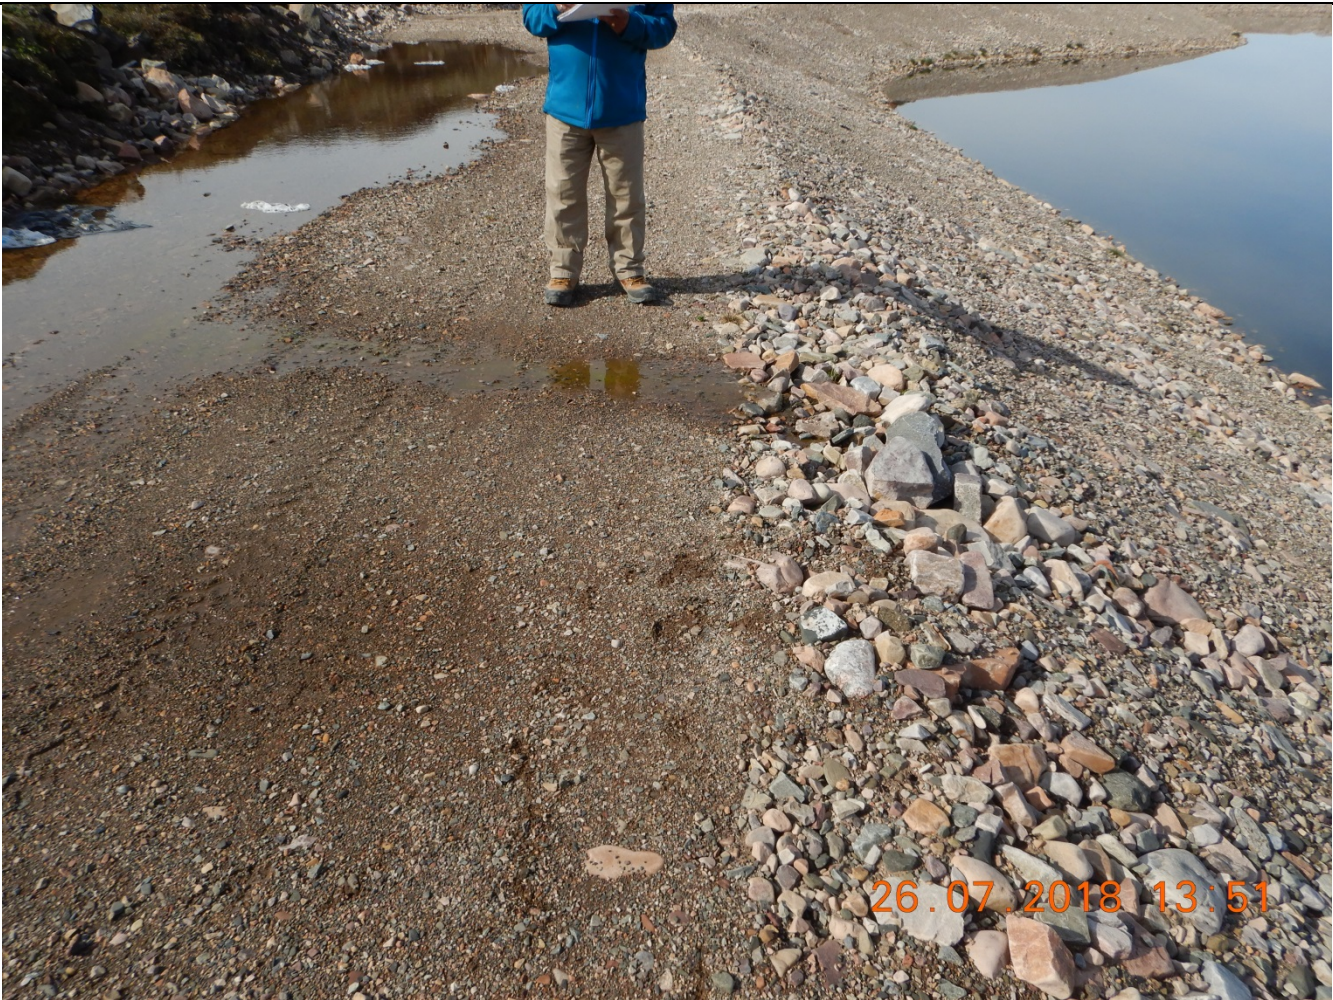
Photo 3

The berm walls surrounding the lagoon did have a pool of water on the west side of the lagoon, with minor migration of raw water from the pool into the lagoon. This could create erosion on the walls, Bhabesh Roy actioned for some soil to be placed down to mitigate the potential for erosion.
6.

The concerns of this site would be the pooling of water on the west side of the lagoon wall, and the damage to the access box for the thermistors, which were noted by Bhabesh Roy at the time of the inspection.
10.

Description: pool of water ontop of lagoon wall

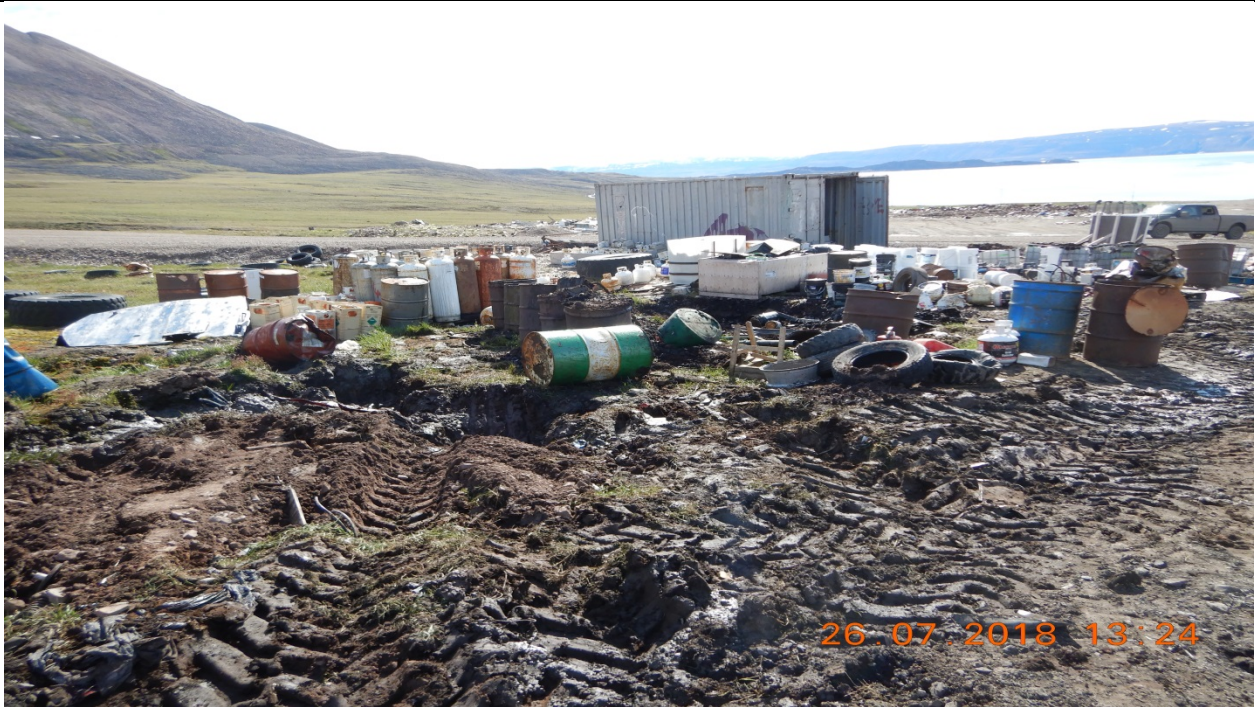
Photo 5

At the time of the inspection it was observed that a lot of the hazardous waste found throughout the solid waste facility was not in secondary containment, and not encapsulated, which runs contrary to Part D: Subsection 7 which is to prevent the deposit of deleterious substances into any water. Hazardous waste exposed to the elements poses a significant risk of migration of the hazardous waste into water.

Description: Hazardous Waste exposed to the elements

Send out Hazardous Waste to an approved Hazardous Waste Disposal Facility, to make room for any future deposits of hazardous waste.

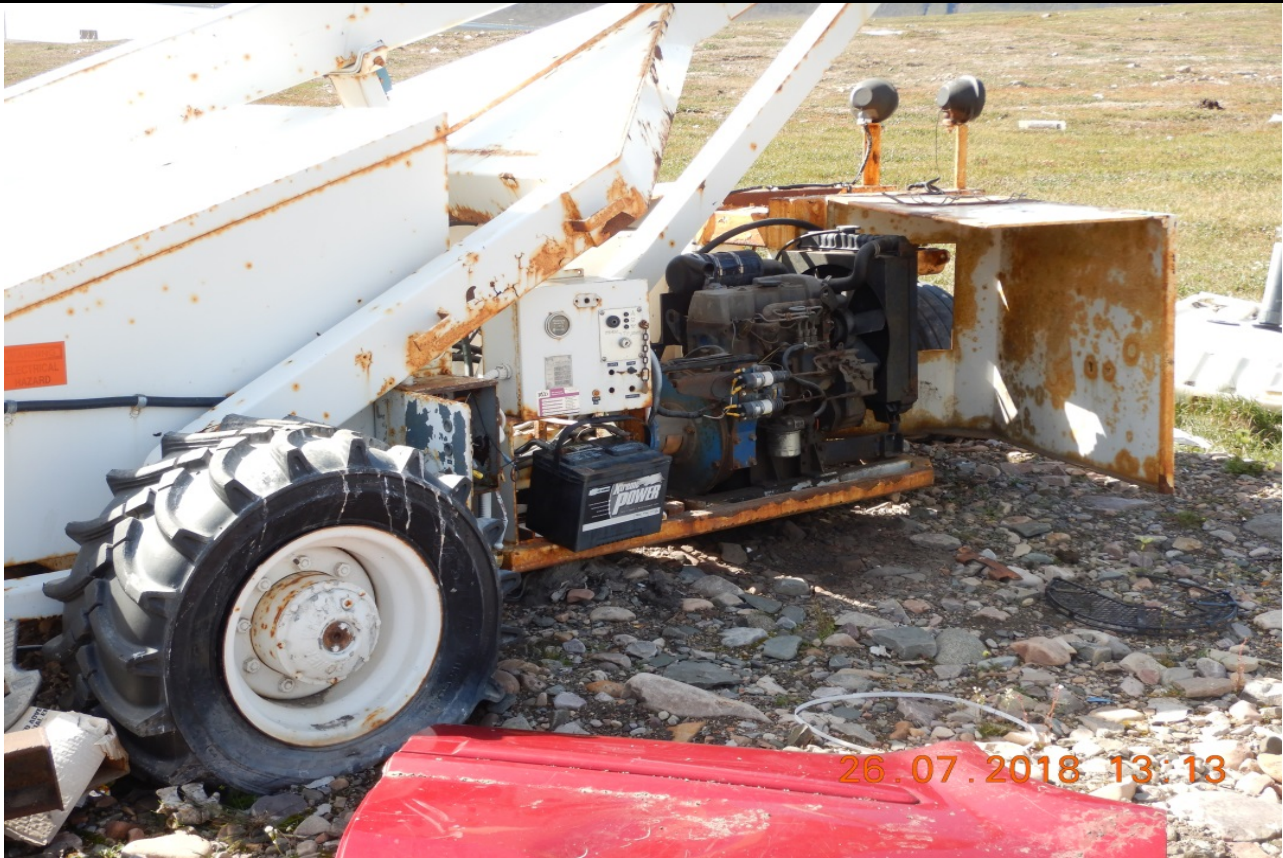
Photo 6

Hazardous Waste batteries were observed throughout the metals section of the land fill. Any rain that gets in contact with the batteries has the potential to carry with it the hazardous waste into water.
15.

Description: Battery exposed to the elements in the bulk metal section of the Solid Waste Facility

It was encourage at the time of the inspection to consolidate all the hazardous waste such as batteries found throughout the bulk metal section of the Solid Waste section to segregate them to the hazardous waste sea can.

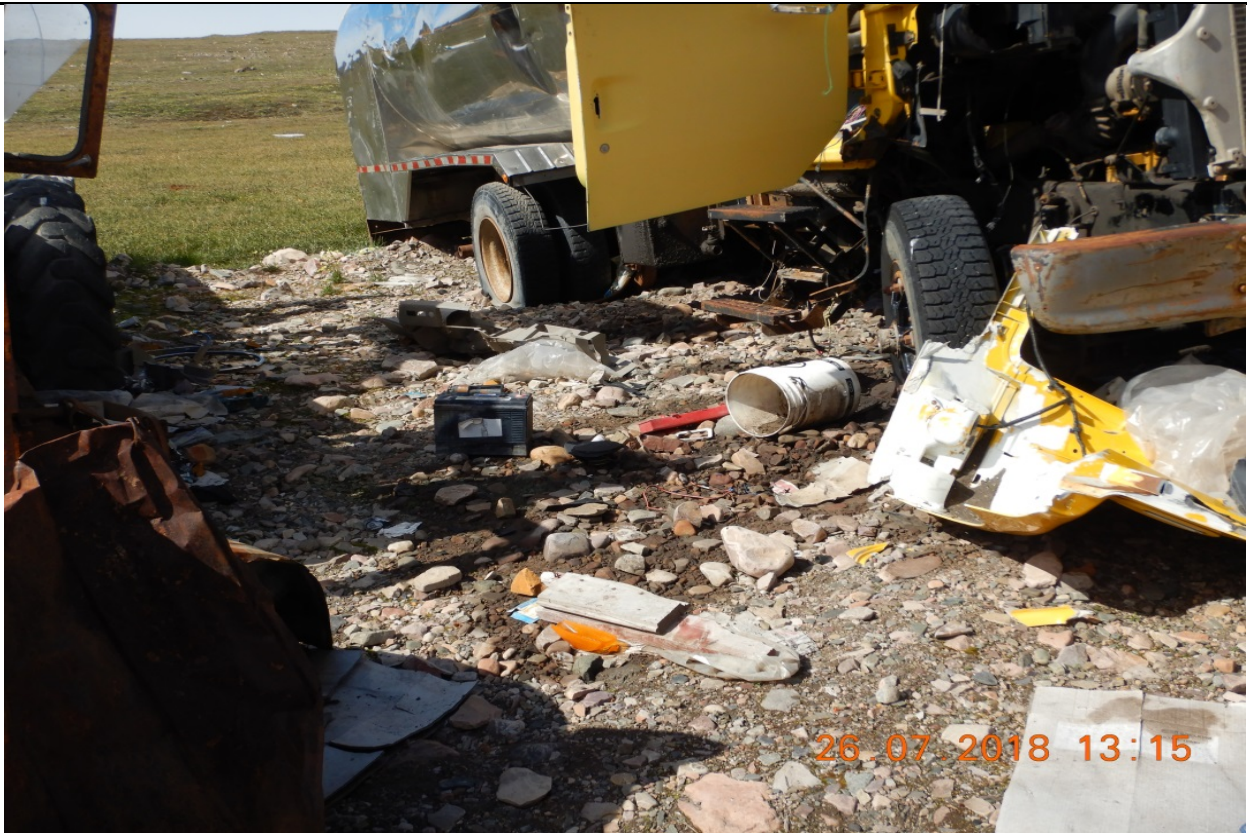
Photo 7

Description: Battery exposed to the elements in the bulk metal section of the Solid Waste Facility

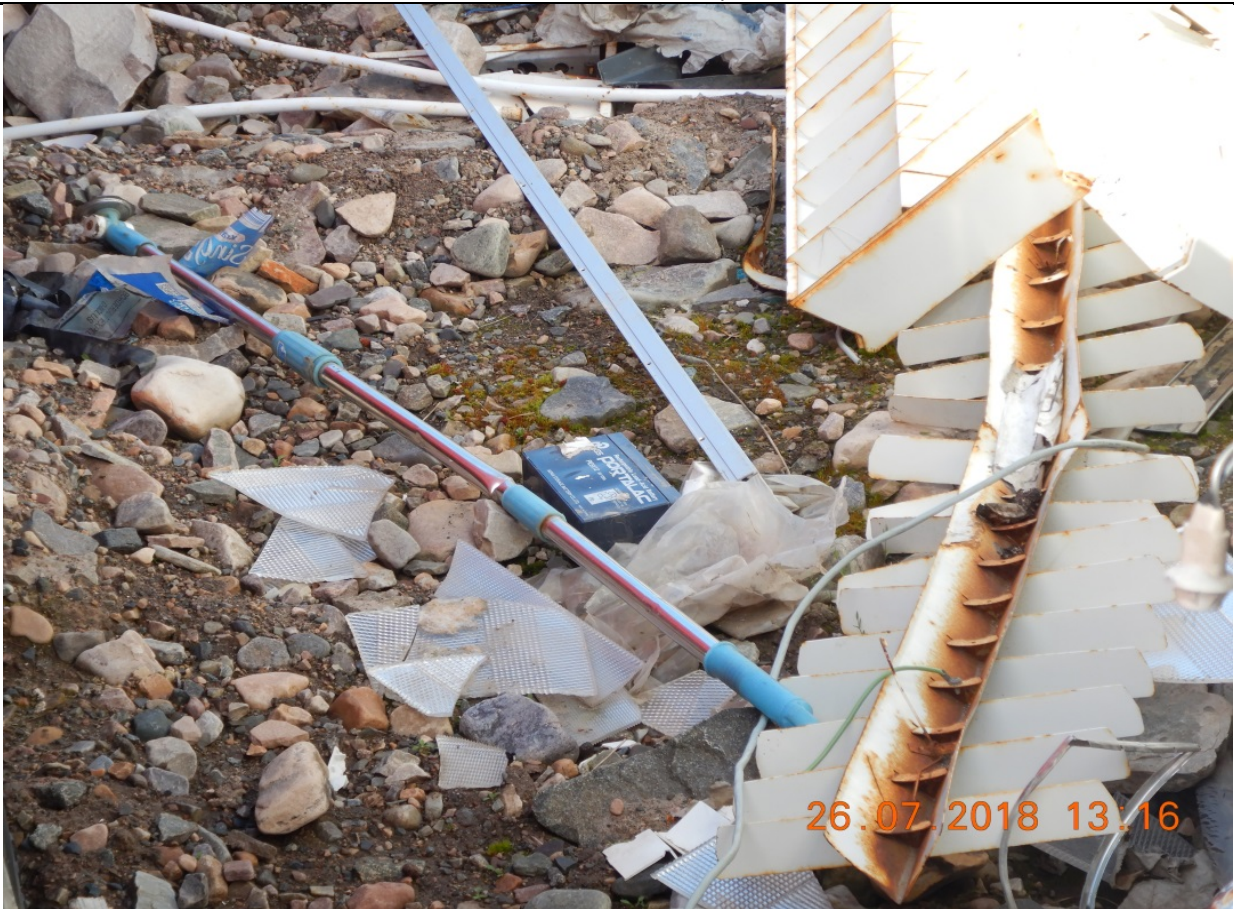
Photo 7

Description: Battery exposed to the elements in the bulk metal section of the Solid Waste Facility
