WATER LICENCE INSPECTION FORM

Licensee	Licensee Representative
Hamlet of Arctic Bay	Bhabesh Roy
Licence No. / Expiry	Representative's Title
3BM-ARC1924	Municipal Engineer
Land / Other Authorizations	Land / Other Authorizations
Date of Inspection	Inspector
July 21, 2021	Joseph Monteith
Activities Inspected

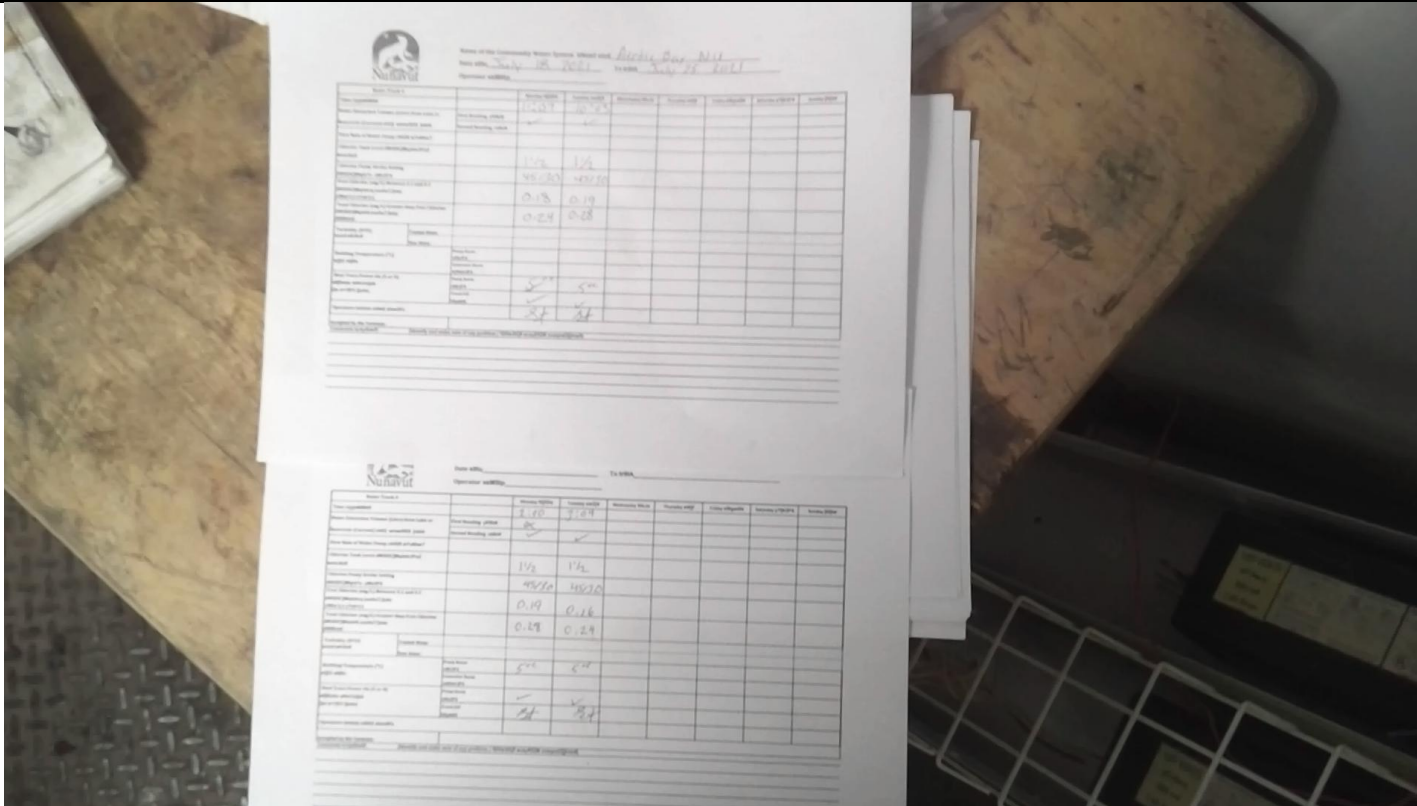
Photo 3

2. The flow meter in the pump house isn't working(photo 2). The municipality records the amount withdrawn from trucks, and that information is recorded in a log book (photo 3).

Description: Water logs being kept. But, photo is ineligible. Bottom sheet starting reads 45130. Doesn't indicated whether in litres or m³.

- It was encouraged at the time of the inspection to consolidate all the hazardous waste such as batteries found throughout the bulk metal section of the Solid Waste section to segregate them to the hazardous waste sea can.
- Articulate how you calculate water usage.
- The Licensee is reminded to remain diligent to prevent wastes from entering water, and the environment.
- Stop all the water from interacting with the hazardous waste facility, and the burn and cap from migrating off site.
- Submit spill reports for all spills regardless of size and quantity, from all hamlet facilities.
- Submit a spill report for the observed spills at the Sewage Lagoon, and clean it up as per the license.
