WATER LICENCE INSPECTION FORM

Licensee	Licensee Representative
Hamlet of Arctic Bay	Gord Marinic
Licence No. / Expiry	Representative's Title
3BM-ARC1924	Regional Engineer
Land / Other Authorizations	Land / Other Authorizations
Date of Inspection	Inspector
July 9, 2022	Joseph Monteith
Activities Inspected	
<div><div><input type="checkbox"/> Camp</div><div><input type="checkbox"/> Drilling</div><div><input type="checkbox"/> Mining</div><div><input type="checkbox"/> Construction</div><div><input type="checkbox"/> Reclamation</div><div><input type="checkbox"/> Fuel Storage</div></div> <div><div><input type="checkbox"/> Roads/Hauling</div><div><input checked="" type="checkbox"/> Other: Potable water, Sewage, and Solid Waste</div><div><input type="checkbox"/> Other:</div></div>

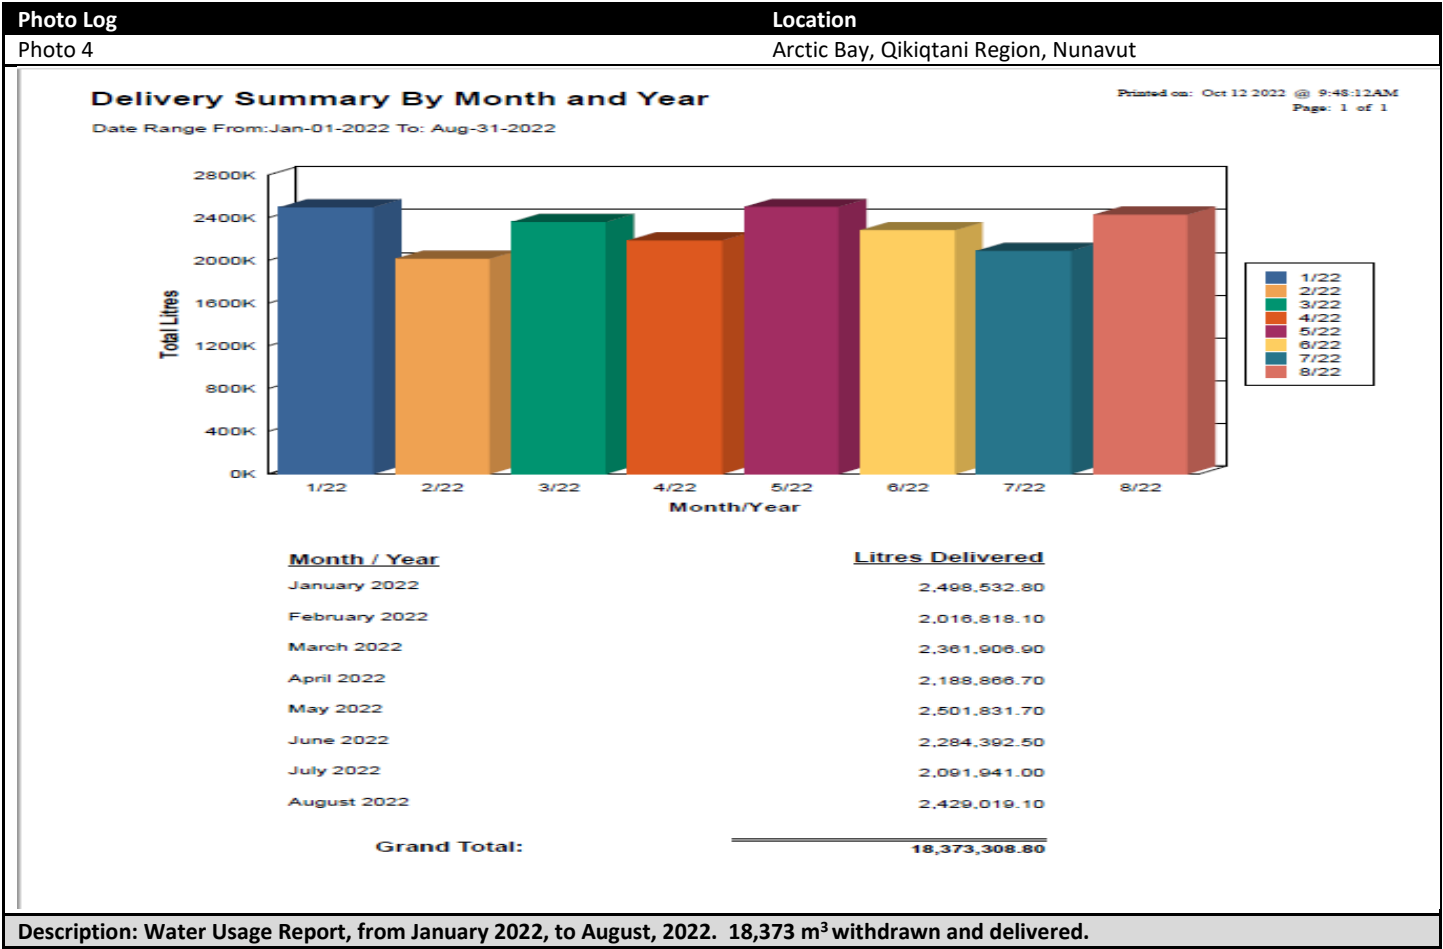
Description: Water logs being kept. But, records of water withdrawal volumes not recorded.

• Articulate how you calculate water usage.

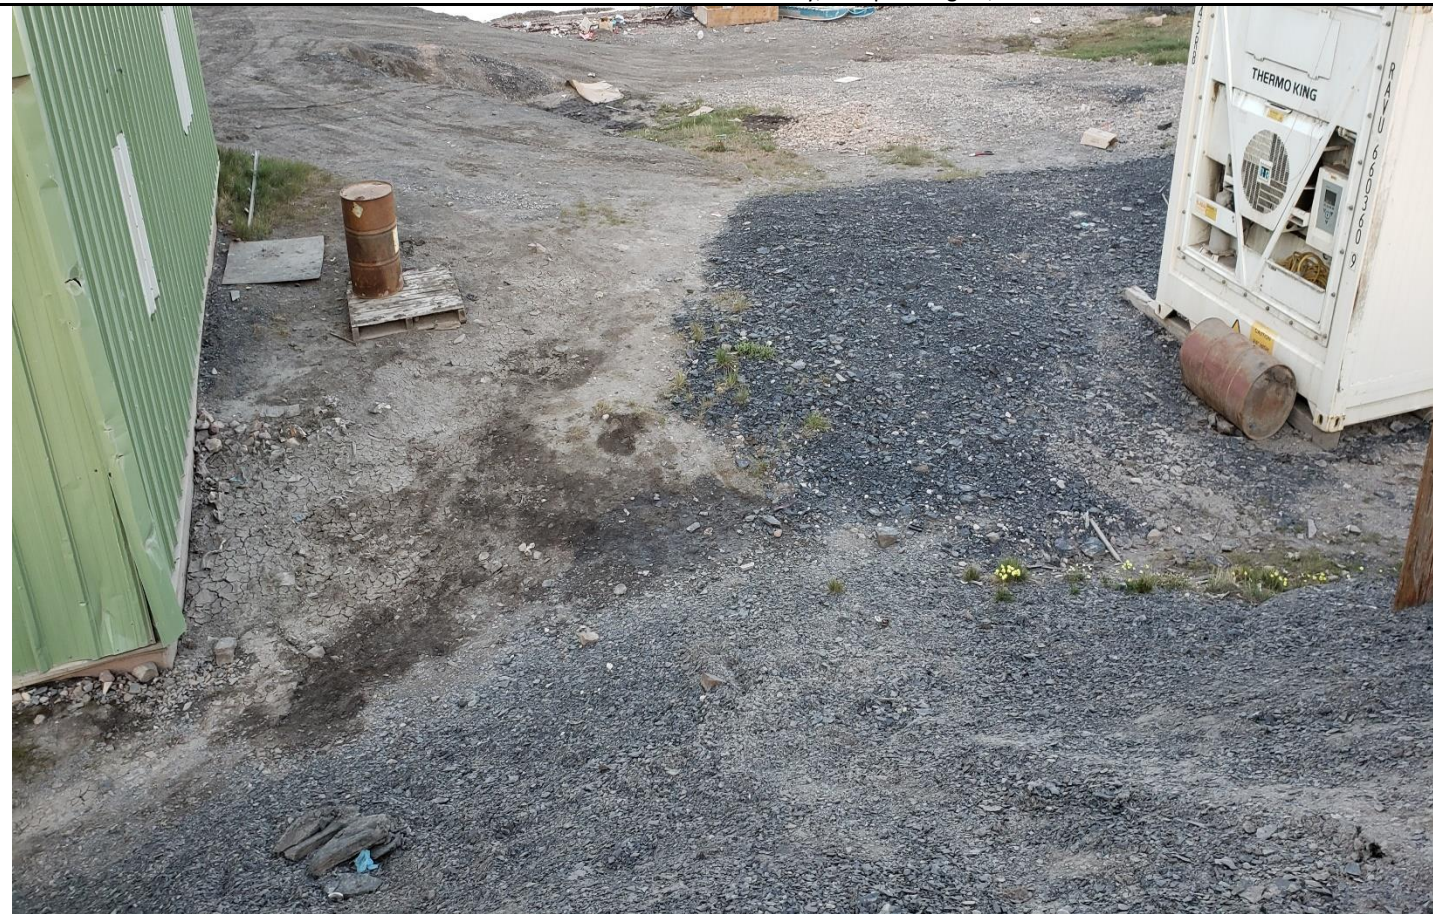
Photo Log #	Location
Photo 12	Arctic Bay, Qikiqtani Region, Nunavut

17. Hazardous Waste Drums were observed at the Municipal Garage within municipal boundaries. Numerous signs of spills were observed behind the garage (photo 10, 11, 12).

Description: Hazardous Waste Drums observed behind 2 nd Municipal garage. Spills observed.

• Submit a spill report for the observed spills at the municipal garage. Move the Hazardous Waste Drums to the Solid Waste Facility as per the terms and conditions of your water license Part D: Item 7, and clean the spills.
