# Water Licence Inspection Report

<b>Authorization</b>	<b>Representative</b>
<b>Arctic Bay</b>	<b>Debbie Johnson</b>
<b>Authorization No. / Expiry</b>	<b>Representative's Title</b>
<b>3BM-ARC1924/AUGUST 28, 2024</b>	<b>sao_ab@qiniq.com</b>
<b>Other Authorization/s</b>	
<b>Activities Inspected</b>	
<input checked="" type="checkbox"/> Camp <input type="checkbox"/> Drilling <input type="checkbox"/> Mining <input type="checkbox"/> Construction <input type="checkbox"/> Reclamation <input type="checkbox"/> Fuel Storage <input type="checkbox"/> Roads/Hauling <input type="checkbox"/> Winter Hauling <input type="checkbox"/> Camp, Private <input checked="" type="checkbox"/> Other (Drill site, unmanned)

On June 17, 2023 I, Isaiah James Bolt, Inspector with the Crown Indigenous Relations and Northern Affairs Canada (CIRNAC), Along with Fellow Inspector Joseph Monteith of CIRNAC, conducted an on site inspection of Arctic Bay's license **3BM-ARC1924** to verify compliance of the conditions of their water license.

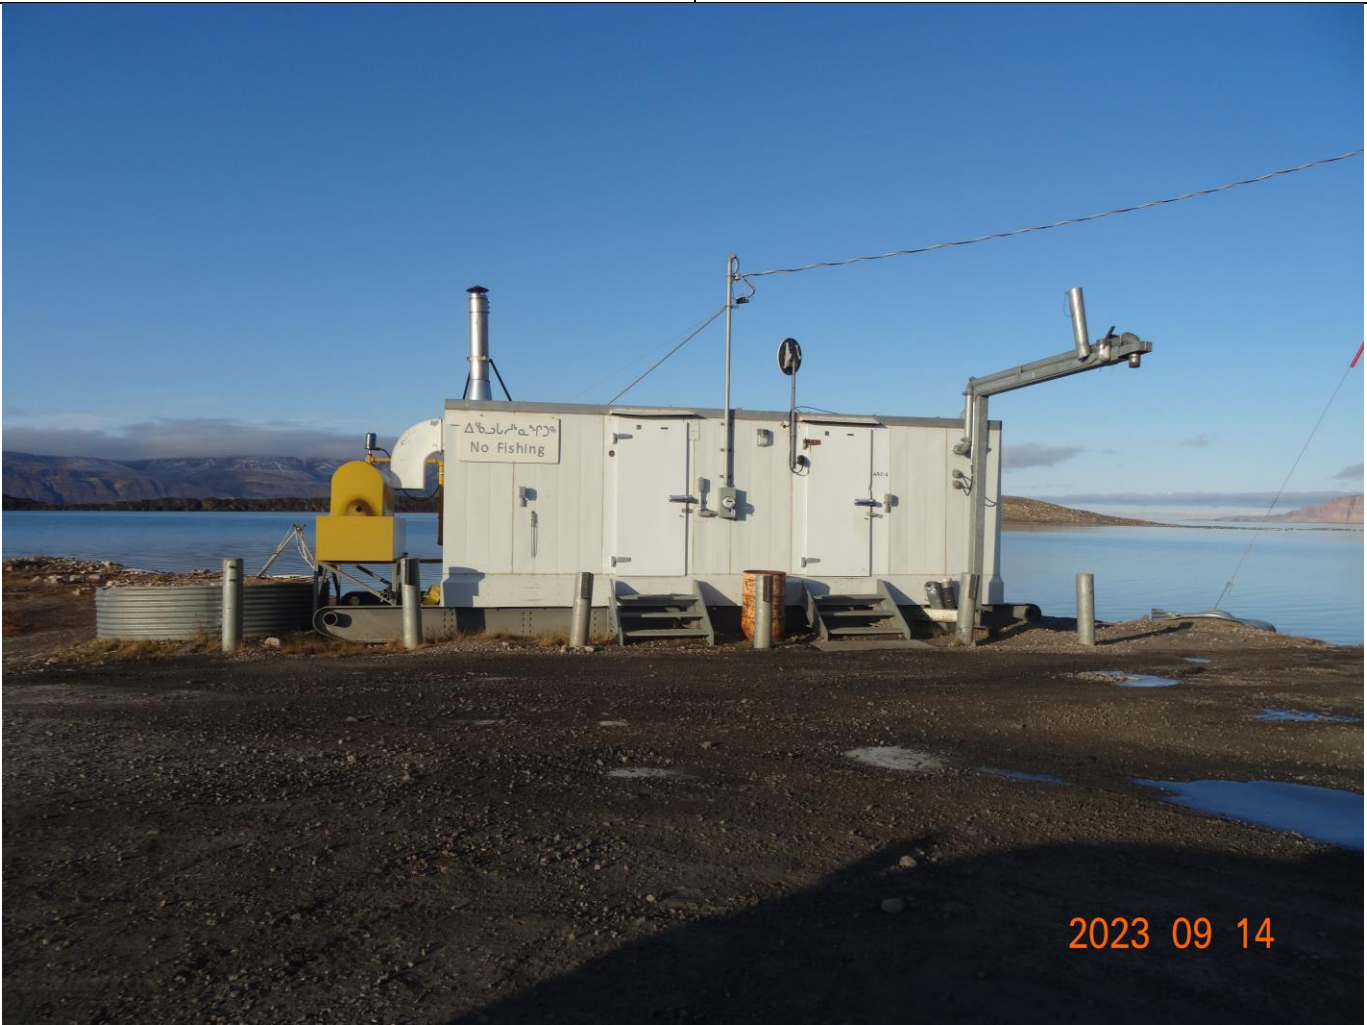
Photo No.	Location
Photo #1	Click or tap here to enter text.

1. Water is being withdrawn from pump house at Marcil Lake(photo 1), as approved by the Water Licence. They were withdrawing water from Marcil Lake using trucks when the water pump from the pump house was broken.
2. The flow meter in the pump house reads 40937779m at the time of inspection. (Photo #2)
3. Water logs are being kept, but no water extraction volumes or flow rates recorded on the log. (Photo #3)
4. A photo of the totalizer in one of the water trucks was taken (Photo #4).

Description:
Pump house where water is withdrawn.

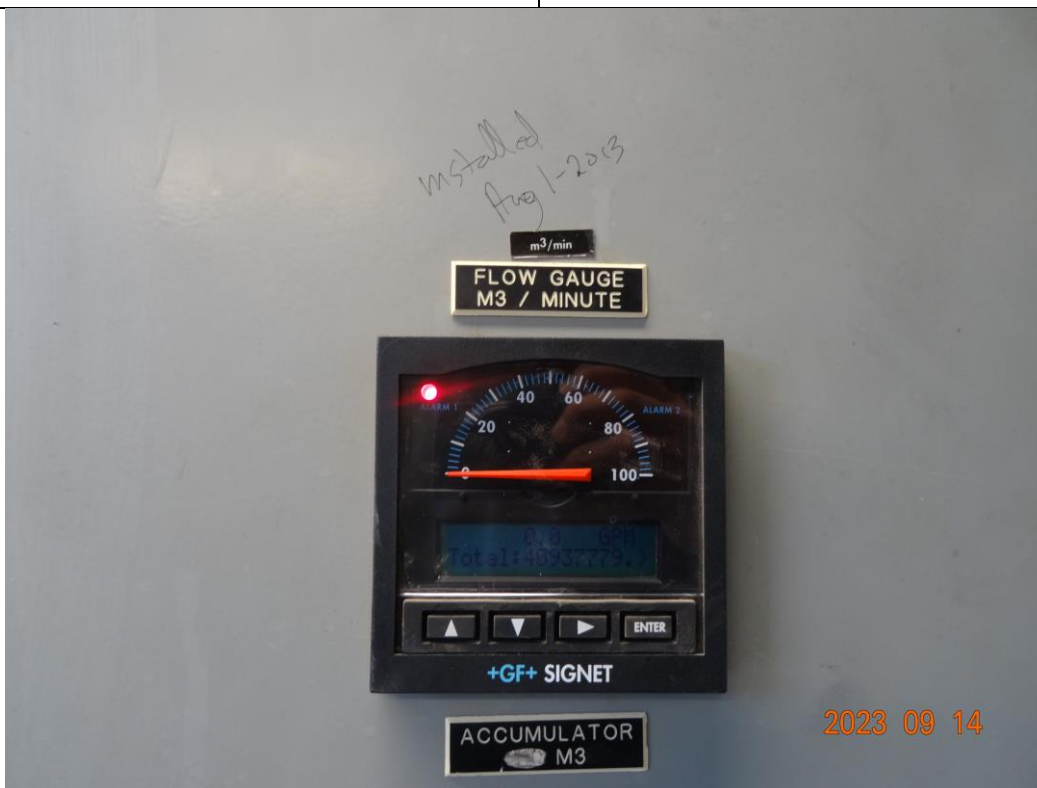
Photo #2

Water treatment plant totalizer. Flow gauge meter: 40937779.0

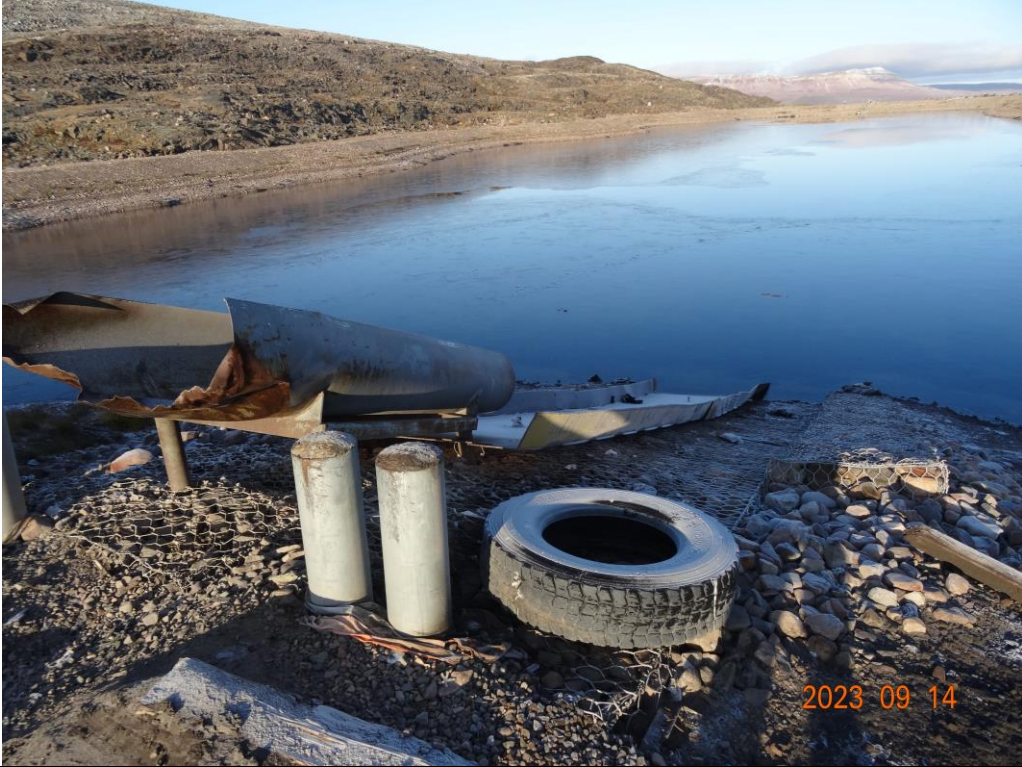
Photo No.	Location
Photo #6

<b>Description:</b> Sewage truck deposit location.

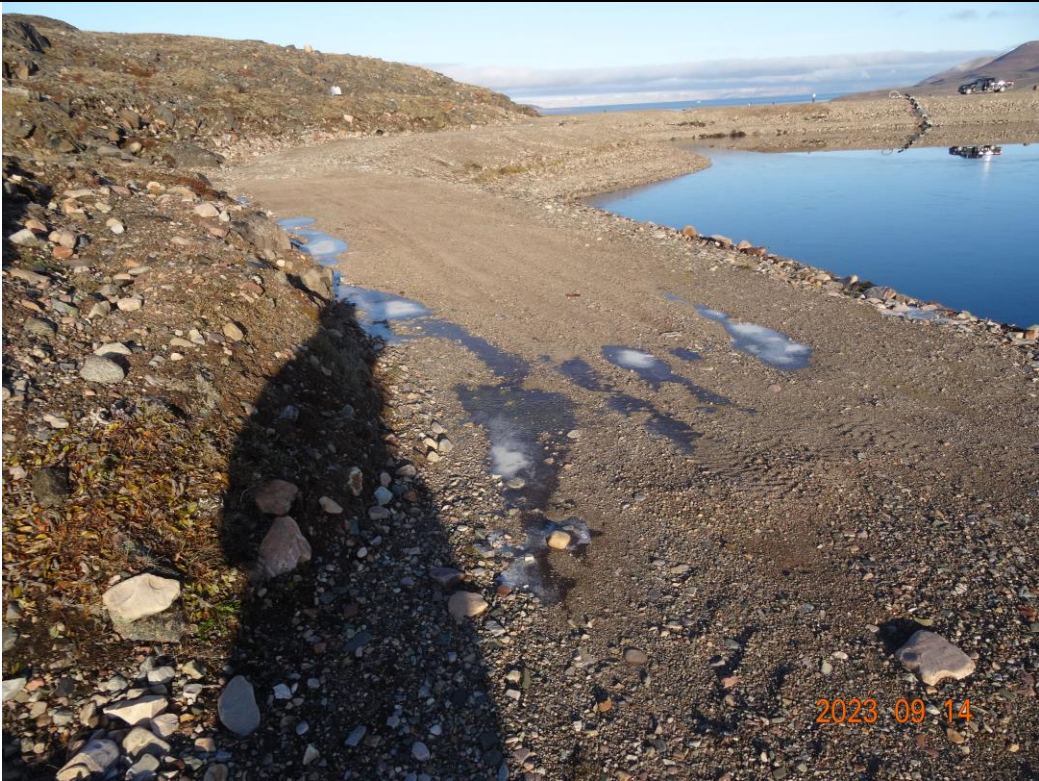
Photo No.	Location
Photo #7

5. Some debris observed in the lagoon (plywood).
6. Surface water runoff from the mountain is migrating into the lagoon instead of around it. (Photo #7)
7. The freeboard at the time of inspection was estimated at around 4 metres.
8. Spill way and decanting pipe observed, no concerns. (Photo#8)
9. Decanting pipe is directed into a half culvert to help spread the effluent. (Photo #9)

<b>Description:</b> Ice shows migration of water from uphill into the lagoon. (No diversion ditch)

1. In regards to section 2, #1: Ensure water use logs are being taken at the assigned withdrawal site (ARC-1)
2. In regards to section 2, #2: Ensure surface water run off is being diverted away from the solid waste and hazardous waste facility.
3. Consolidate all waste oils/hazardous waste into a Hazardous waste berm/secondary containment.
4. Clean up oil stains, leaks, spills that are found outside of both Garage #1 and Garage #2.
5. Ensure burn and cap facility has proper wind blown litter mitigations (fencing).
6. Store contaminated soil in a proper berm or contaminated soil drums to ensure soil isn't exposed to the elements, and water run off isn't flowing through the piles of dirt.
7. Please respond to the actions required by September 25, 2024.

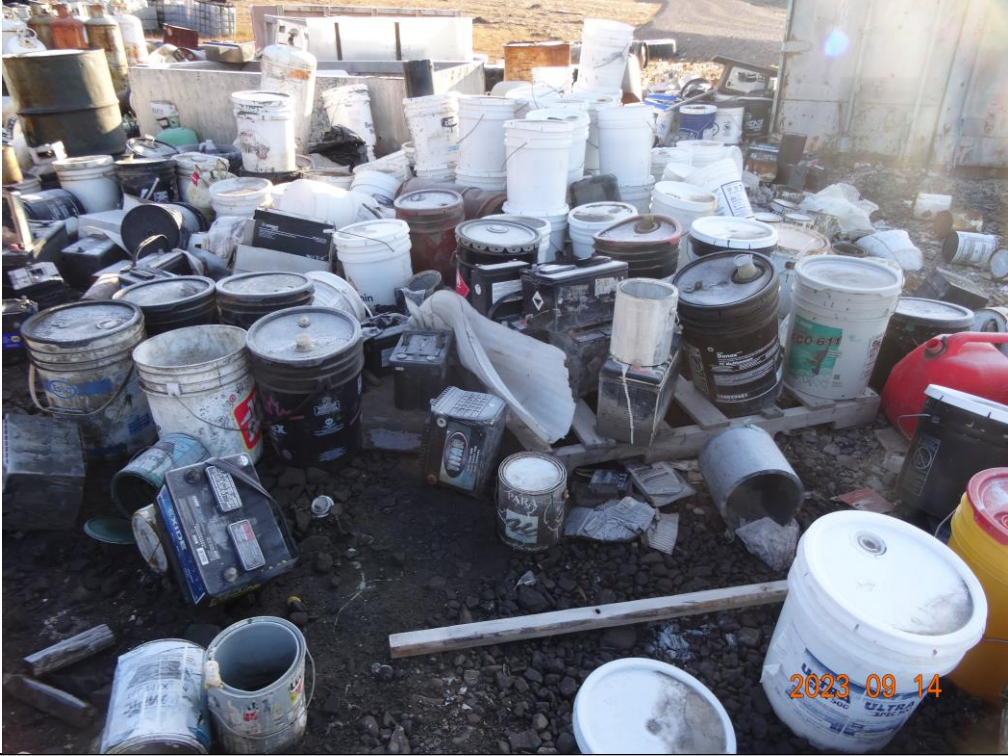
Photo No.	Location
Photo #14

10. Surface water run-off from the mountain above the bulk metal facility flows through metals, and hazardous waste area.
11. Inspectors observed many propane tanks, fuel drums, batteries and buckets of waste product out of containment and mixed together. Product is not in any way contained or sorted (Photo #13,14,15)
12. Around Garage 1 and Garage 2 there are many waste oil drums stored out of secondary containment. Many spills have been observed outside of both garages (Photos #24-#30). Some seem new and active, others seem older.
13. Buckets of waste oils are also stored outside of garage #1. (Photo#23)

3. Waste oil drums, waste oils buckets, propane tanks and various items not stored in a proper hazardous waste facility.
4. Many waste oil drums leaking outside of the garages. All not in secondary containment.

<b>Description:</b> Another rimage of the hazardous waste area, broek batteries have lead/acid exposed to the elements, buckets with various materials inside, open paint cans and old jerry cans.

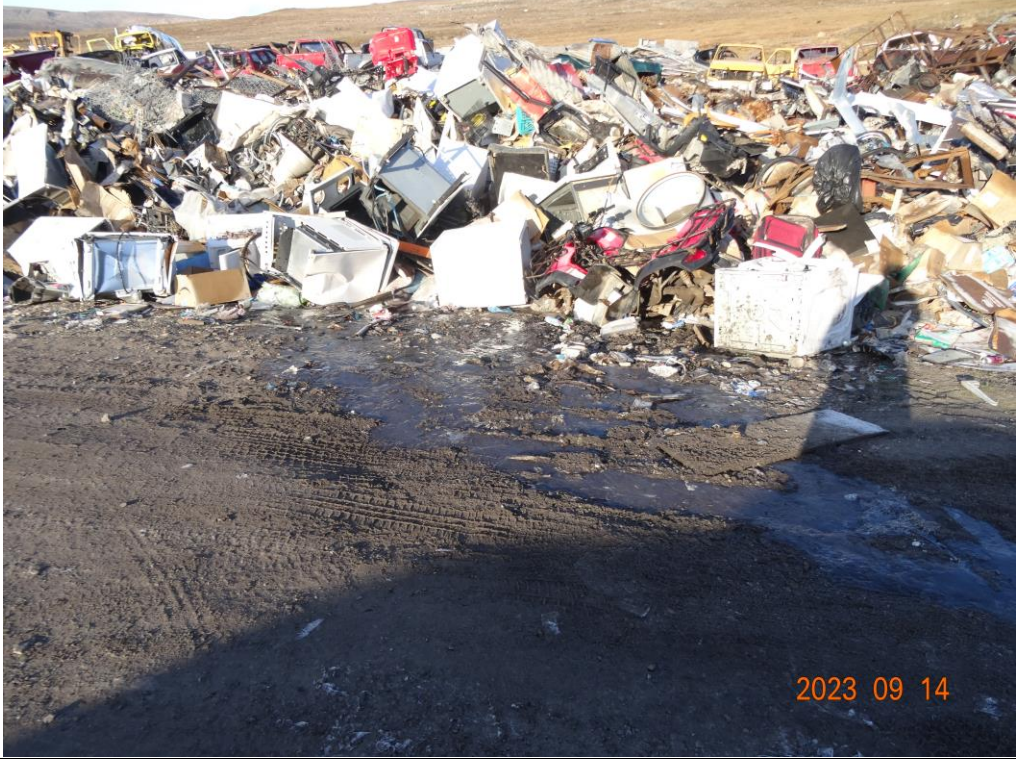
Photo No.	Location
Photo #18

2. Surface water runoff is migrating into the metal facility/hazardous waste facility. Part D Item 7of the issued water license: *"The Licensee shall segregate and securely store all hazardous materials and/or hazardous Waste, including Waste oil, within the Solid Waste Disposal Facility in such a manner as to prevent the deposit of deleterious substances into any Water and until such time that proper disposal arrangements are made."*

<b>Description:</b> Water flowing into bulk metal facility from the hazardous waste section.

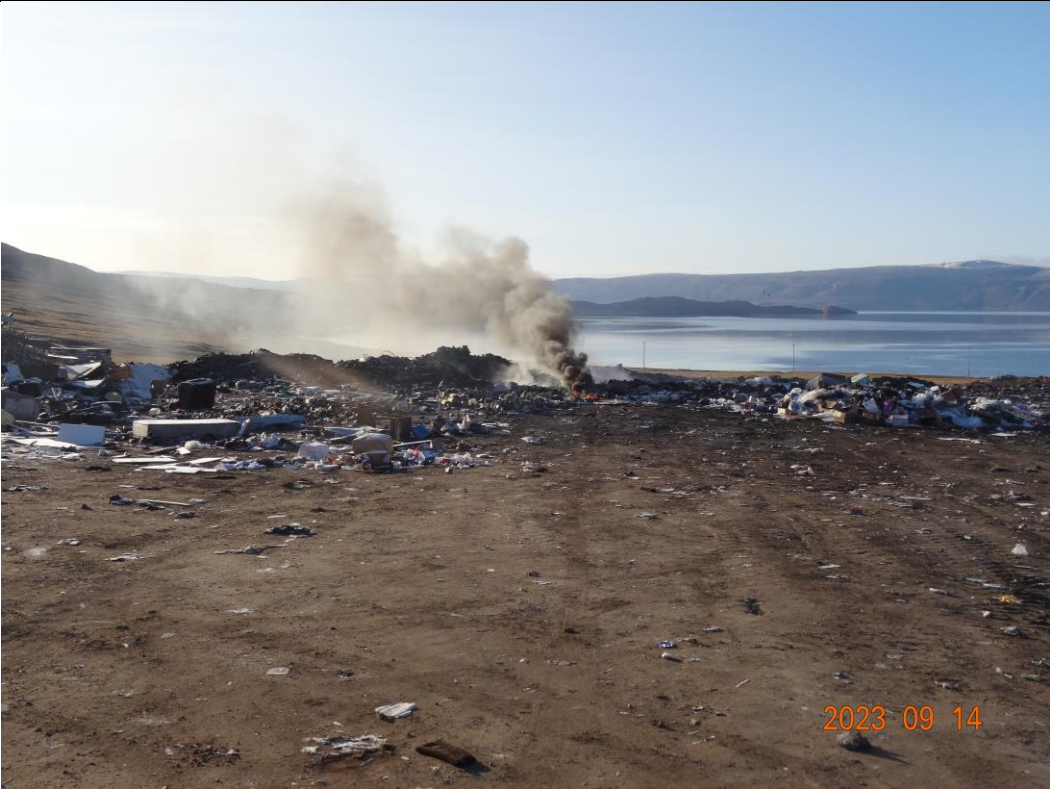
Photo No.	Location
Photo #19

14. There is no fencing around the Burn and cap facility. (Photo #19 and #20)
15. Some propane tanks observed in burn and cap facility. (Photo #20)
16. Contaminated soil stored near the entrance to the burn and cap is exposed to the elements (Photo#21). The plastic covering the piles of contaminated soil has blown off and isn't doing anything. Rain and melt water can easily come in contact with the contaminated soil and migrate downhill.

5. No proper fencing at burn and cap facility. Part D, Item 8 of the issued water license: *"The Licensee shall implement measures to control wind-blown litter at the Solid Waste Disposal Facility."*

<b>Description:</b> Burn and cap area active burning.
