Water Licence Inspection Report

Authorization	Representative
Municipality of Arctic Bay	Andre Larabie
Authorization No. / Expiry	Representative's Title
3BM-ARC1924	Senior Administrative Officer
Activities Inspected	
<input type="checkbox"/> Camp, Commercial <input type="checkbox"/> Drilling <input type="checkbox"/> Mining <input type="checkbox"/> Construction <input type="checkbox"/> Reclamation <input type="checkbox"/> Fuel Storage <input type="checkbox"/> Roads/Hauling <input type="checkbox"/> Winter Hauling <input type="checkbox"/> Camp, Private <input checked="" type="checkbox"/> Other

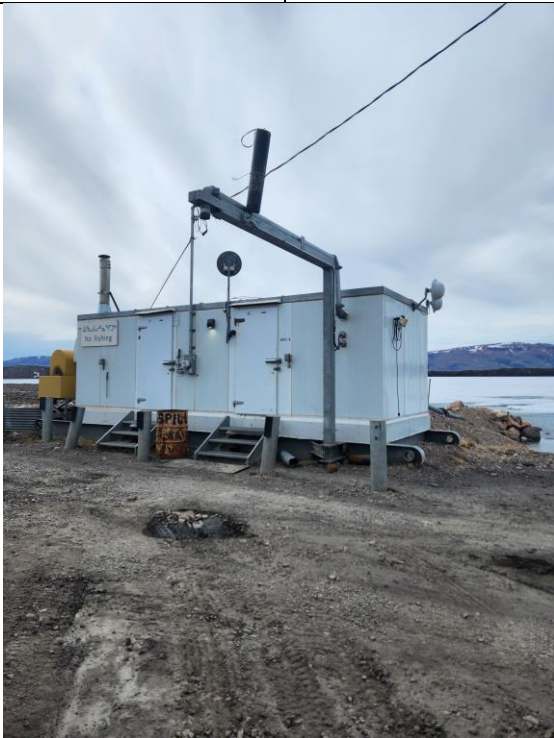
Photo No. 1	Lat/Long (DD.MM.SS.SS, NAD83)
Photo

Description:
Arctic Bay Water Pump Station.

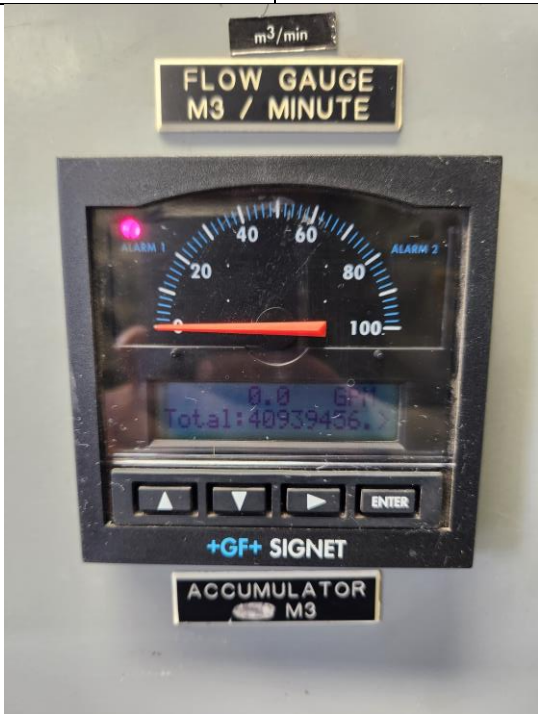
Photo No. 2	Lat/Long (DD.MM.SS.SS, NAD83)
Photo

Description:
Flow instake meter located inside the pump station.

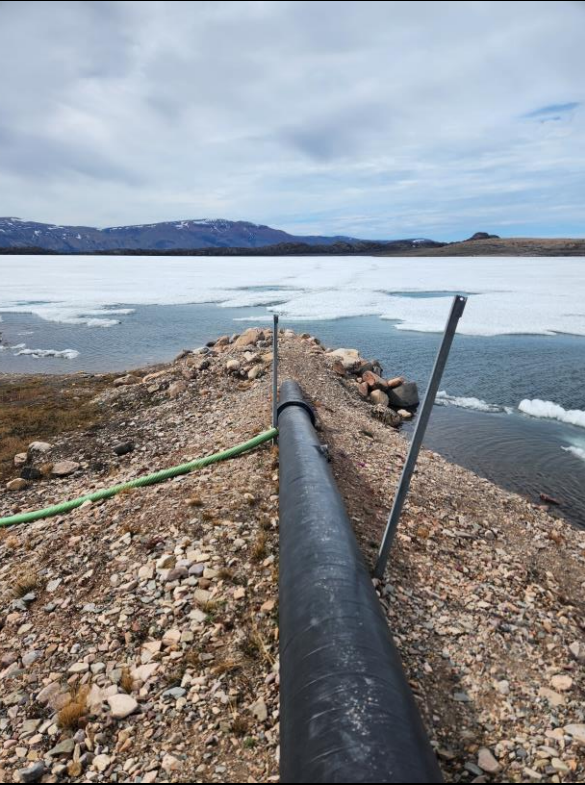
Photo No. 3	Lat/Long (DD.MM.SS.SS, NAD83)
Photo

Description: View of pump station intake hose leading to the water reservoir.

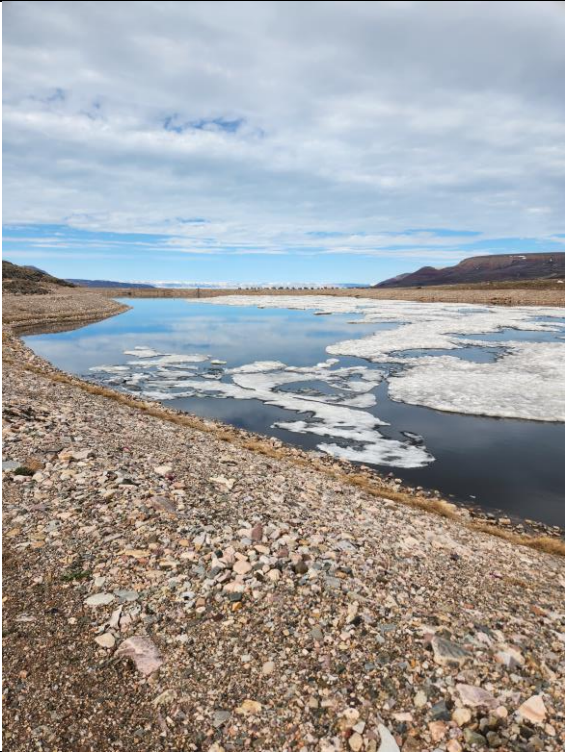
Photo No. 6		Lat/Long (DD.MM.SS.SS, NAD83)
Photo		Click or tap here to enter text.

Description:		
Photo of Arctic Bay's sewage lagoon.

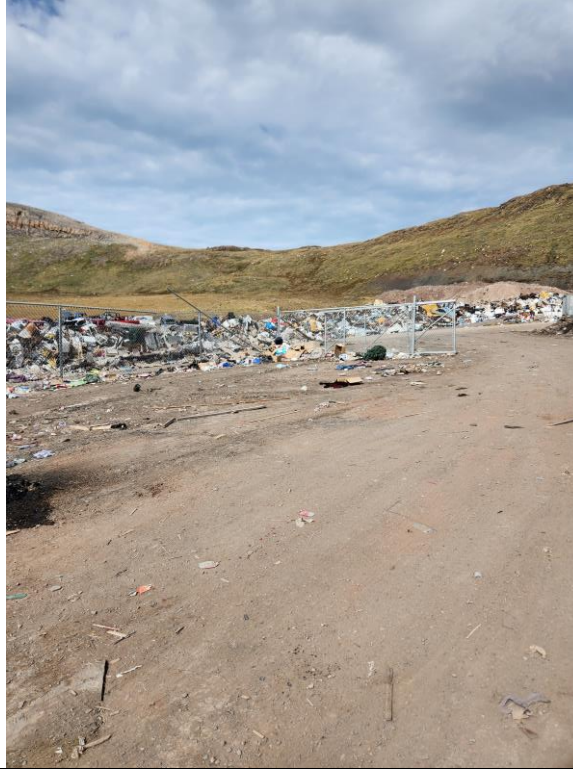
Photo No. 9

1. A waste oil spill was observed at the Sewage Treatment Facility.
2. The monitoring station signs at the sewage treatment facility were damaged and must be replaced.
3. Fencing at the Solid Waste Facility is not installed surrounding the facility.
4. Hazardous waste is actively migrating away from the hazardous waste facility and entering the Bulk Metal Facility.
5. Waste oil drums were observed on pallets outside of the hazardous waste facility.

Photo of solid waste facility/dump. Note that the fencing does not surround the entire facility.

1. The waste oil spill must be reported to the NT-NU Spill Report line. The spill must be remediated to its natural condition.
2. The monitoring station signs must be repaired or replaced and be legible to the public and employees.
3. Fencing must be installed at the Solid Waste Facility/Dump to prevent wind-blown debris from escaping the facility.
4. Hazardous waste must be contained to prevent further contamination within the waste sites. Hazardous wastes must be secured and stored within secondary containment.
5. *These items must be addressed and back in compliance within 30 days of receiving this report. If the Hamlet is unable to address these concerns due to staffing or financial issues, then a formal plan must be in place to have these non-compliant issues addressed*

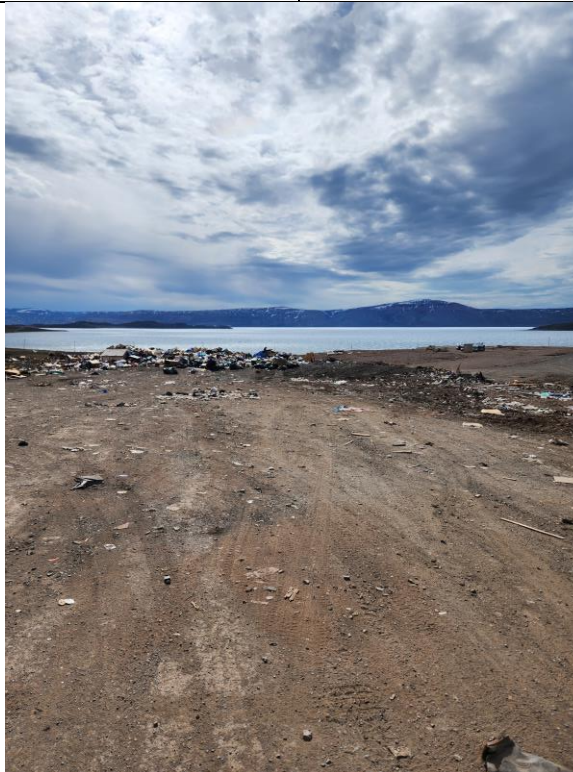
Photo No. 10

Another view of the solid waste facility, facing West.

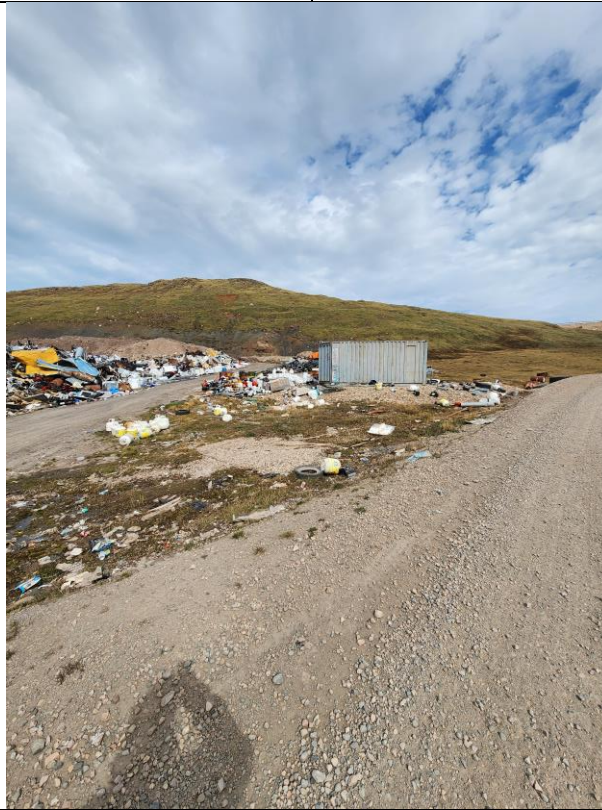
Photo No. 11

Photo of the hazardous waste facility. This area also does not have any fencing or any form of containment for hazardous waste.

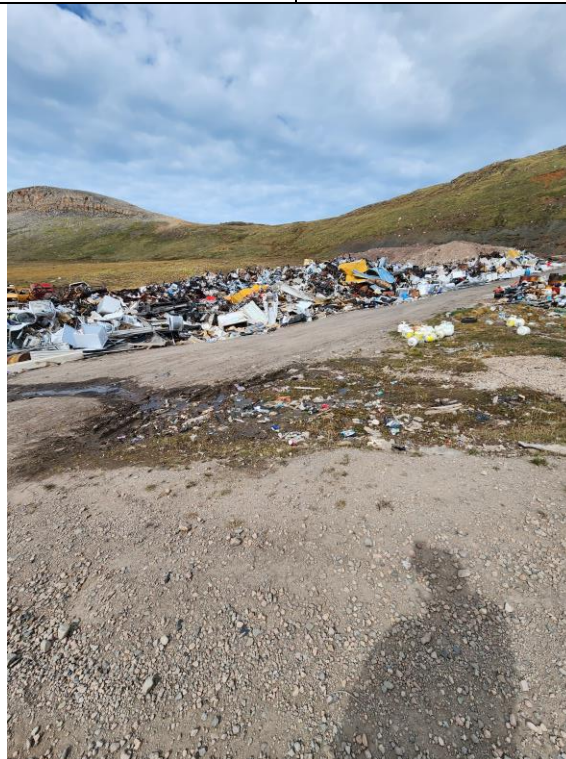
Photo No. 12

Photo showing hazardous waste migrating to the other side of the road.

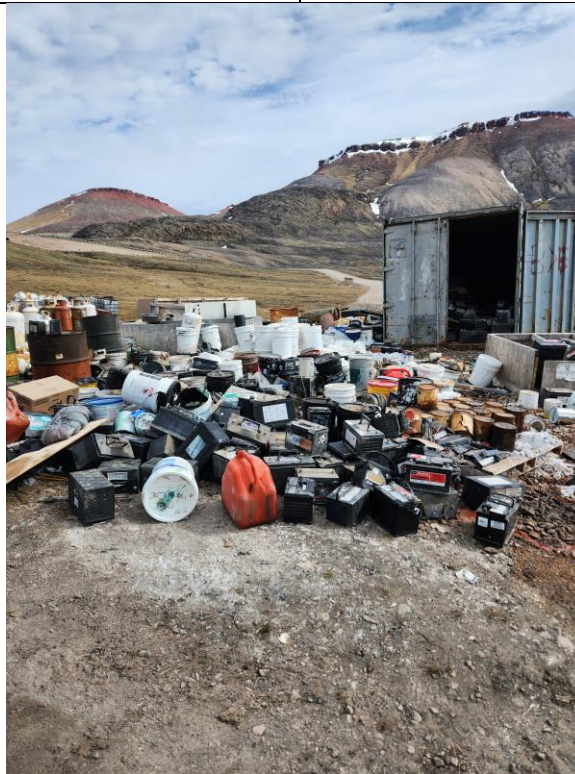
Photo No. 13

Hazardous waste is piled in this general area, which slopes down to the main access road.

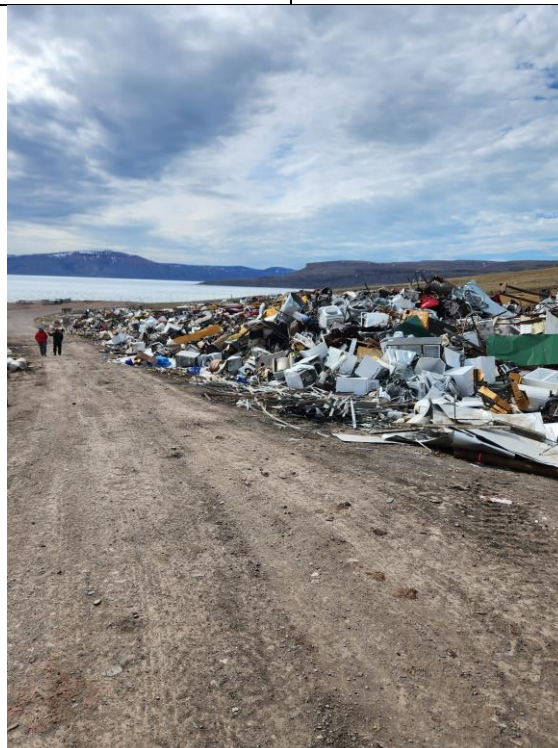
Photo No. 14

Photo showing the bulk metal facility. Hazardous waste such as car/ATV batteries were observed along the side of the road.
