**Site Investigation Report for the Water & Sewage System
In the Hamlet of Baker Lake, NU**

Department of Community & Government Services

September, 2005

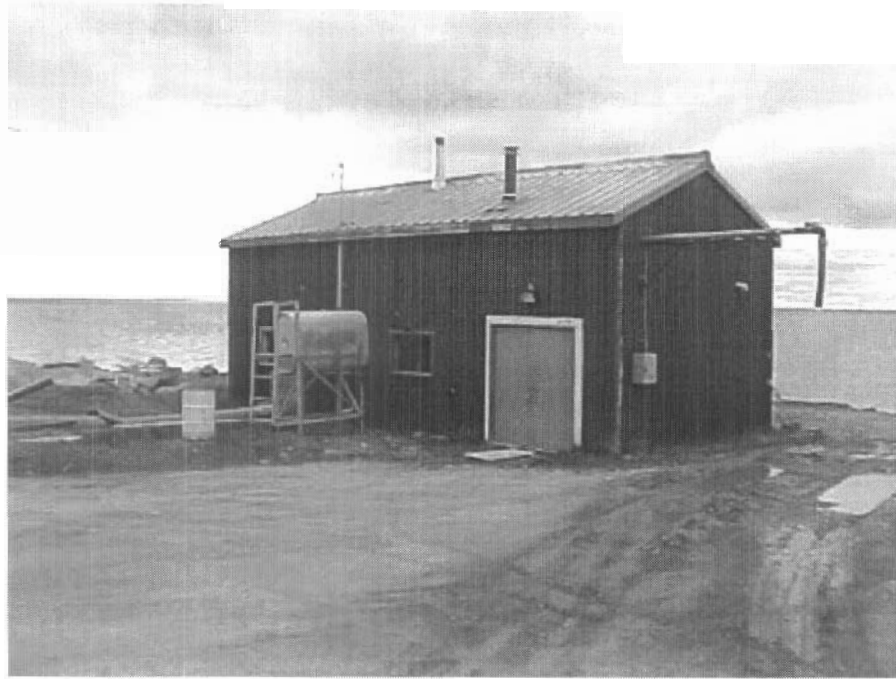
Water is supplied to the water trucks by means of an overhead truck-fill arm with flexible downspout, with thaw capability afforded by a manually activated heat trace (Figure-1).

Figure-1 Water intake /treatment facilities

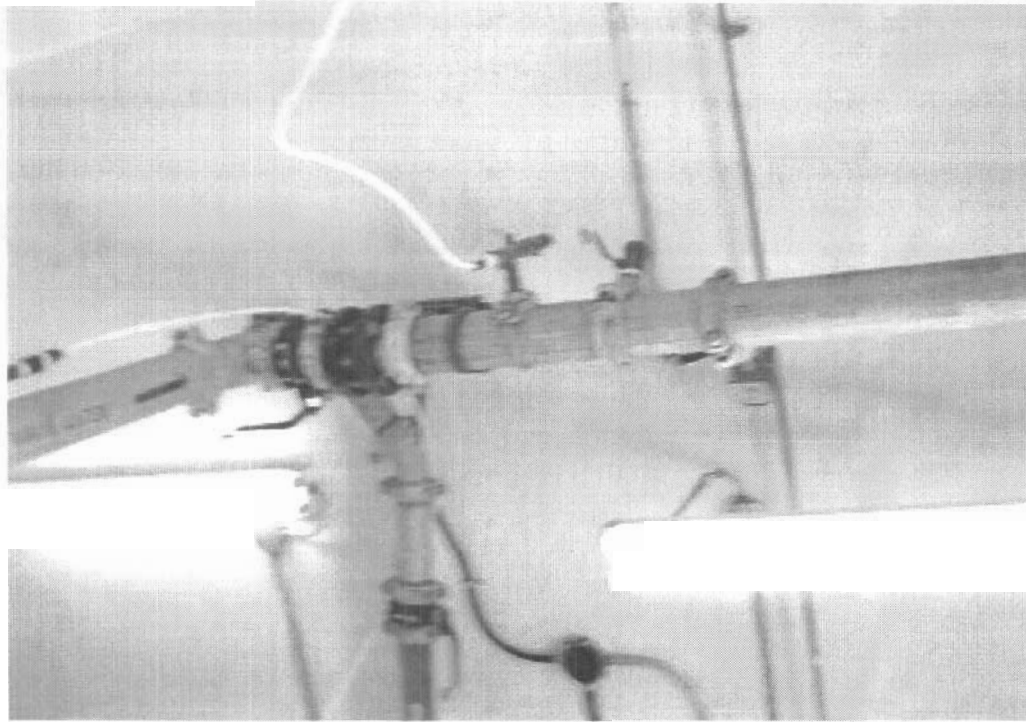
Water for the hypochlorite mixing tank is supplied from the discharge line. The hypochlorite feed pump is controlled by the rate of water supplied to the water trucks by means of a flow-sensing meter mounted on the discharge line. The chlorine is supplied to the main line by a tube and chlorine injector (Figure-2).

Figure-2 Addition point of chlorine at the discharge pipe

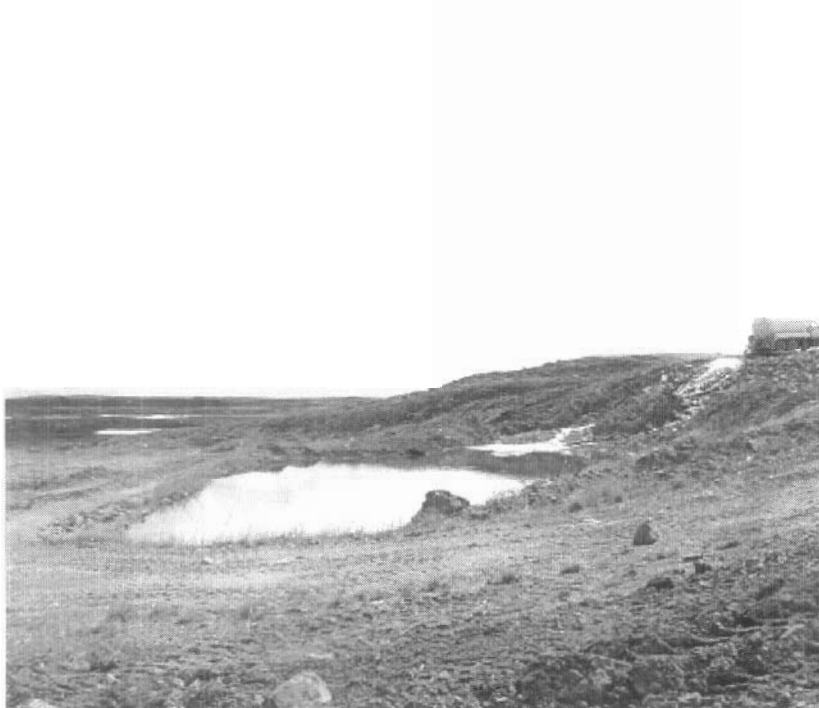
The truck-collected sewage was dumped to the bermed pond on the road side (Figure-3). The sewage was found to seep from this bermed pond. This bermed pond may partially be regarded as a primary treatment, for large particles in the sewage may settle or be screened.

Figure-3 Sewage dumping pond

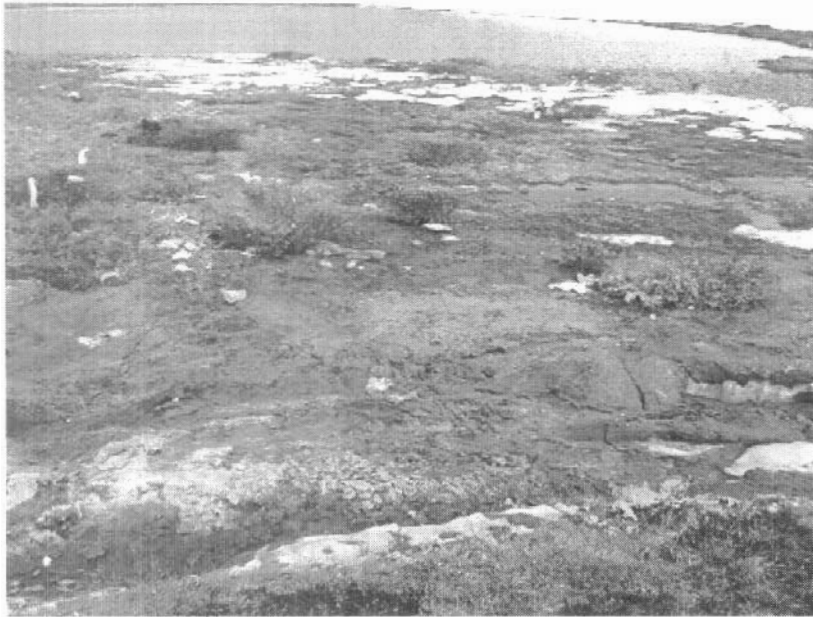
The effluent from the dumping pond flowed over the slope area and down to the first pond (P1). The slope area between the dumping pond and P1 was covered by a thick layer of slime (Figure-4).

Figure-4 Slime layers on the slope after the dumping pond

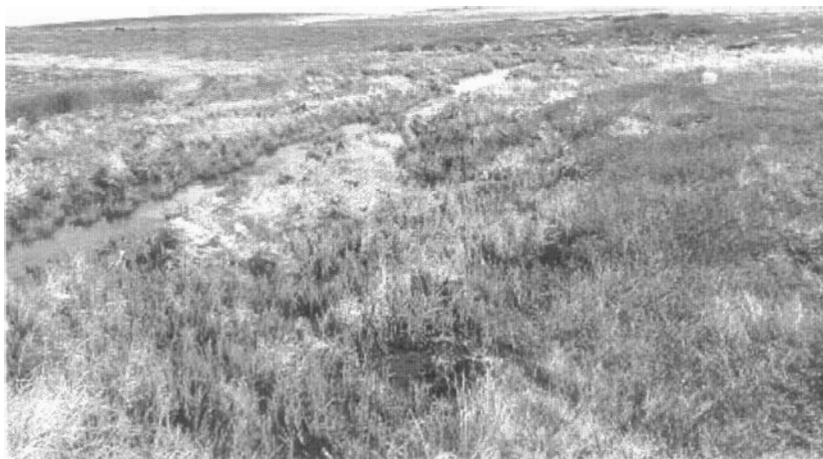
Effluent from the first pond flowed through a defined channel to the second pond while the effluent from the second pond proceeded over a large area of wetland with abundant vegetation plants to the third pond, P3 or Landing Lake, as was locally called (Figure-5, 6). The effluent from the P3 flowed by gravity through a defined sloping gravel ditch, and finally was discharged at Baker Lake (Figure-7, 8).

Figure-5 Defined channel from pond1 to pond 2

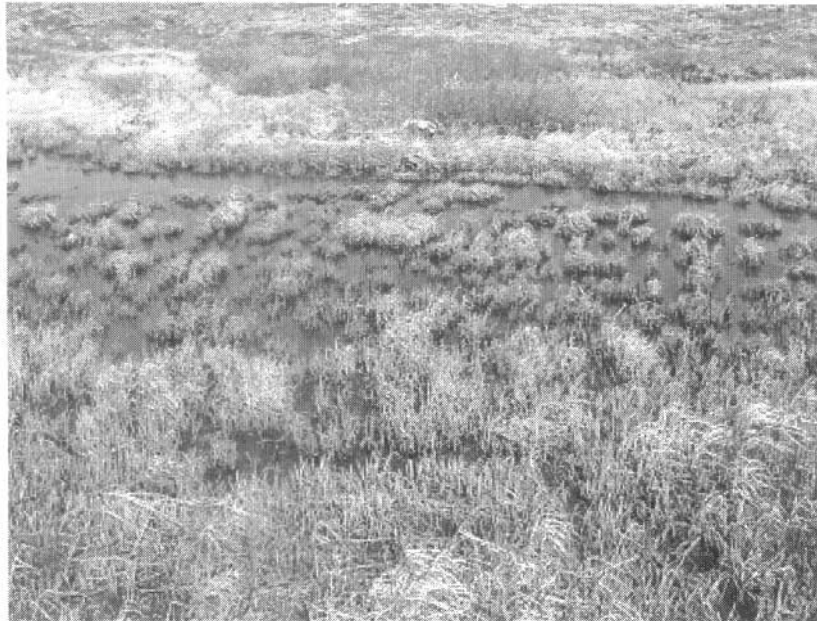
Figure-6 Shallow water area with species of sedges between pond 2 and pond 3

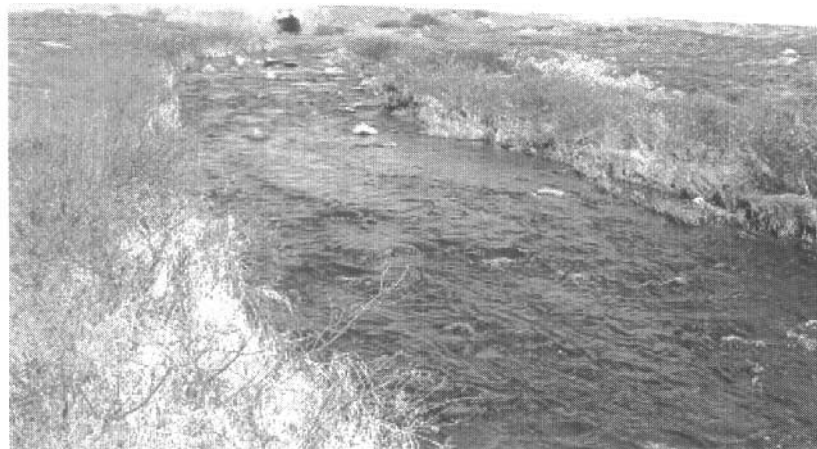
Figure-7 Confined gravel ditch for effluent to Bake Lake

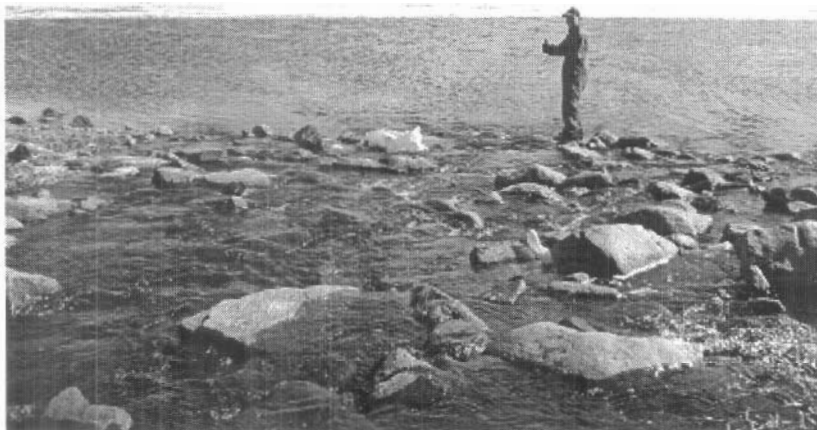
Figure-8 Final discharge point to Baker Lake

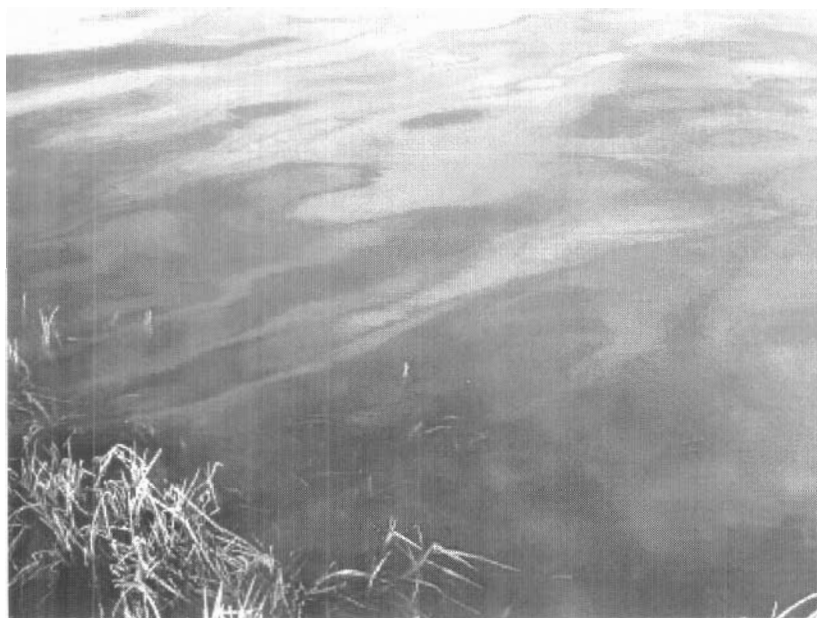
From visual inspection, the water in P1 and P2 appeared to be turbid and green in color due to algae boom (Figure-9). This was probably due to the combined functions of the rich organics and nutrients (nitrogen, phosphorous, etc.) in the water as well as the long daylight in the summer. However, the effluent from P2, after flowing over the area of wetland with abundant vegetation plants, became significantly clear when it entered the Landing Lake (P3). No smell could be smelted.

Figure-9 Algae boom in P2

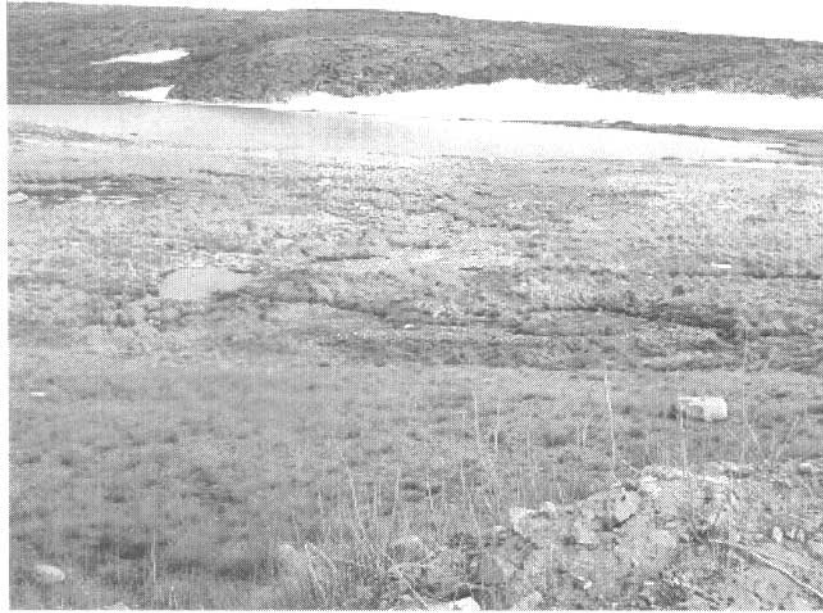
Figure-10a The vegetation plants around the P1

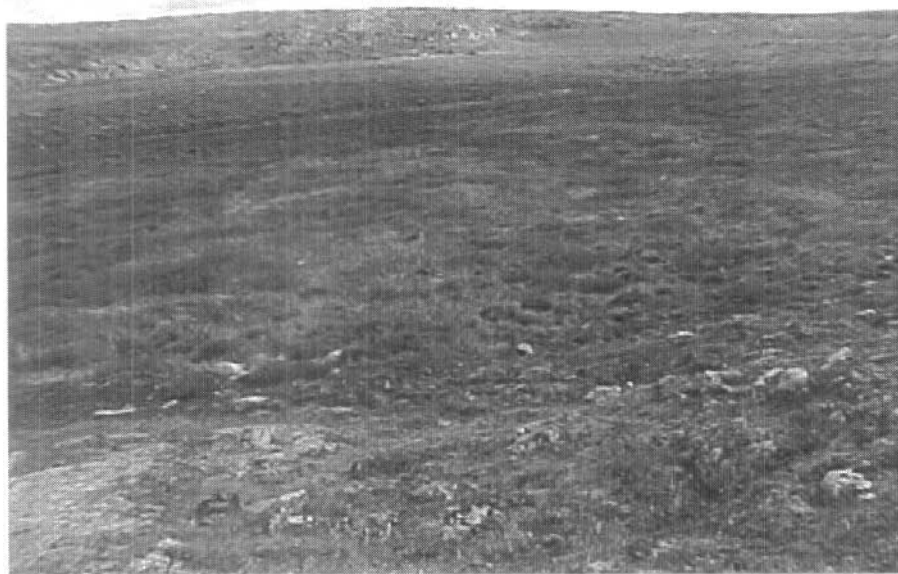
Figure-10b The vegetation plants wetland area before P3

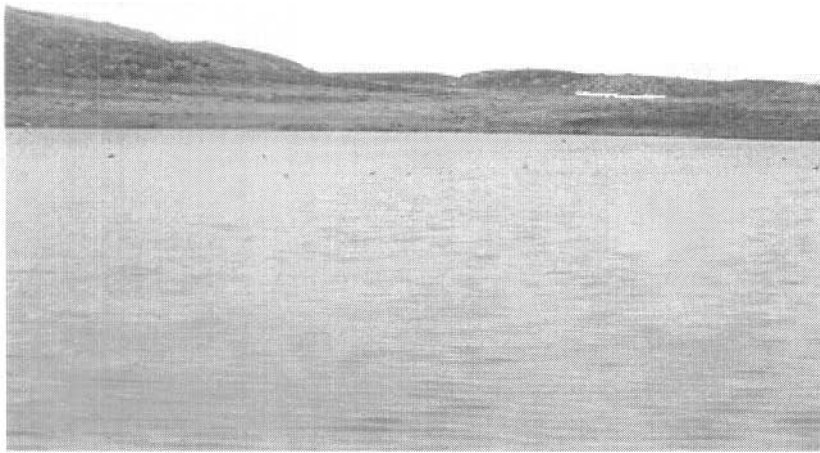
Wildlife observed in the upland areas included sparrows, plovers, geese, mouse, as well as bugs and mosquitoes. Some ducks were seen swimming on the surface of water in all three lagoons (Figure-11). Bones of dead animals (probably caribous) were also noted. Small fishes were found in the last pond (Landing Lake). By talking to a local resident, it was learned that there were lots of fishes in the Landing Lake (P3). No fish was found in the first two ponds.

Figure-11 Wild swimming ducks in pond 1

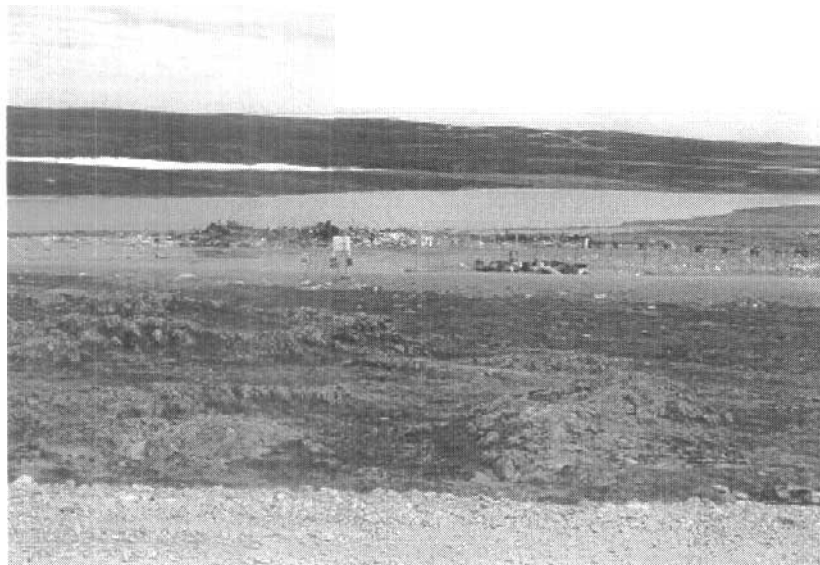
observed there. The landfill is about 20 meters away from the pond (Figure-11). On the east shore of the Landing Lake (P3), almost thirty discarded metal oil barrels were observed (Figure-12). This would potentially affect the quality of sewage effluent in the wetlands, especially in the melting and rainy seasons due to release of oil and grease, metals, etc. On the third site visit and sampling, it rained almost everyday. According to the third test results report, some of the metals, such as Zinc, exceeded the guidelines limit. There was close relations between these two.

Figure-13 Landfill area beside pond 2

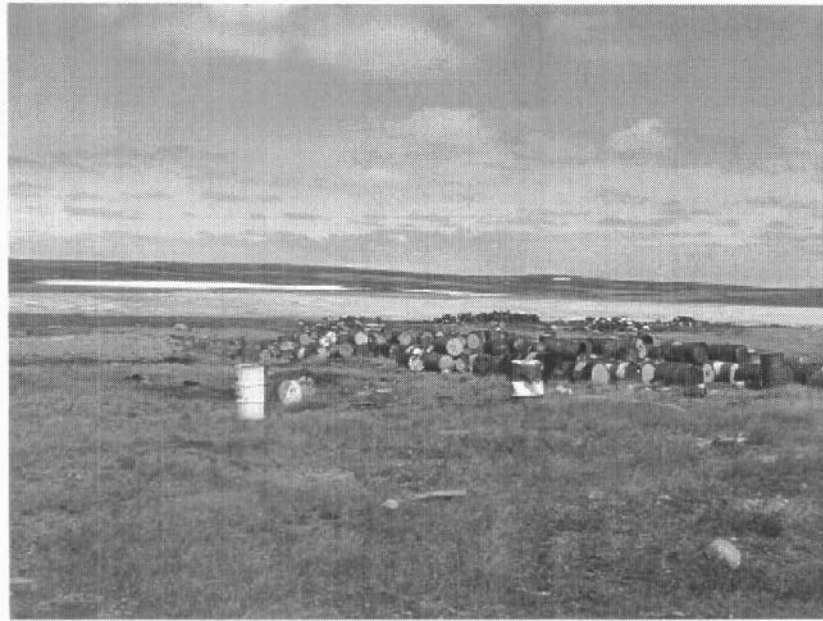
Figure-14 Garbage cans close to the pond 3

- The discarded metal oil barrels were advised to be removed from the sewage disposal area to avoid potential negative effect for the final discharged effluent quality;

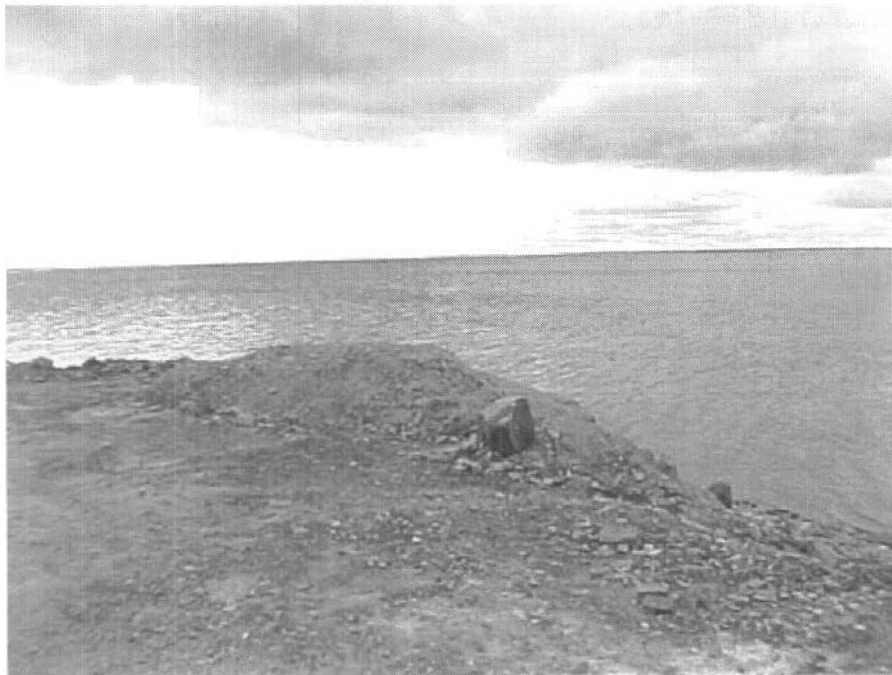
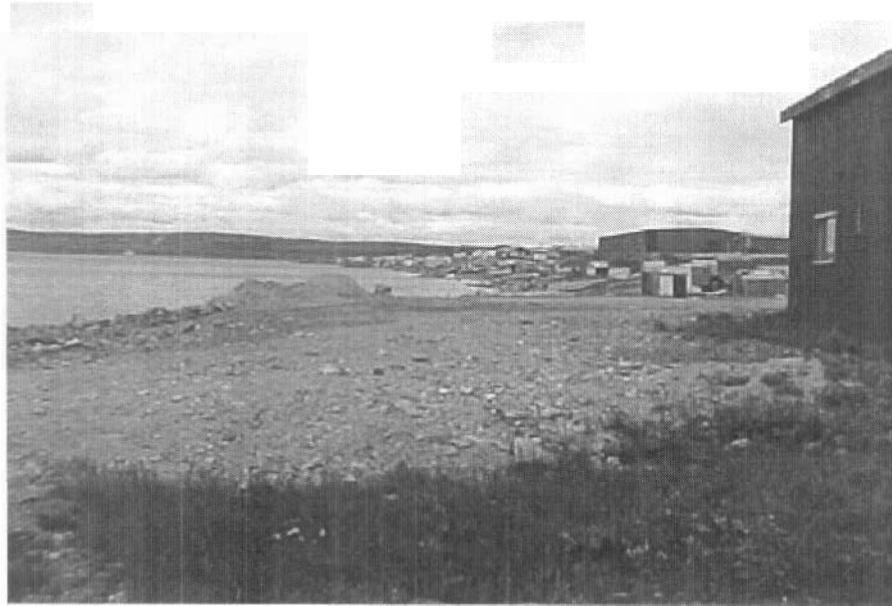
Water intake /treatment facilities It was observed that the ground area round the water intake /treatment facilities (pump house) was not constructed and was full of loose earth and sand (Figure-15). This may potentially result in the deterioration of the drinking water quality, especially in the snow-melting and rainy seasons. In the first and third test reports, the turbidity of the sample water collected beside the pump house was 3.4 and 1.4 NTU respectively, both exceeded the GCDWQ requirements. This may probably be resulted from this. It is recommended that some vegetation be transplanted around the pump house, which may help to fix the loose earth and sand. This is an effective and economic solution to this issue.

Figure-15 Loose earth and sand beside the pump house

Figure-15b Loose earth and sand beside the pump house

- On-site signage was suggested to set up in the areas such as water intake/ treatment facilities, solid waste and sewage disposal facilities;
- Appropriate vegetation plants were suggested to be transplanted around the pump house, which may help to fix the loose earth around to avoid potential deterioration of water quality;
