**Site Investigation Report for the Water Supply System  
In the Hamlet of Baker Lake, NU**

**Department of Community & Government Services**

**September, 2005**

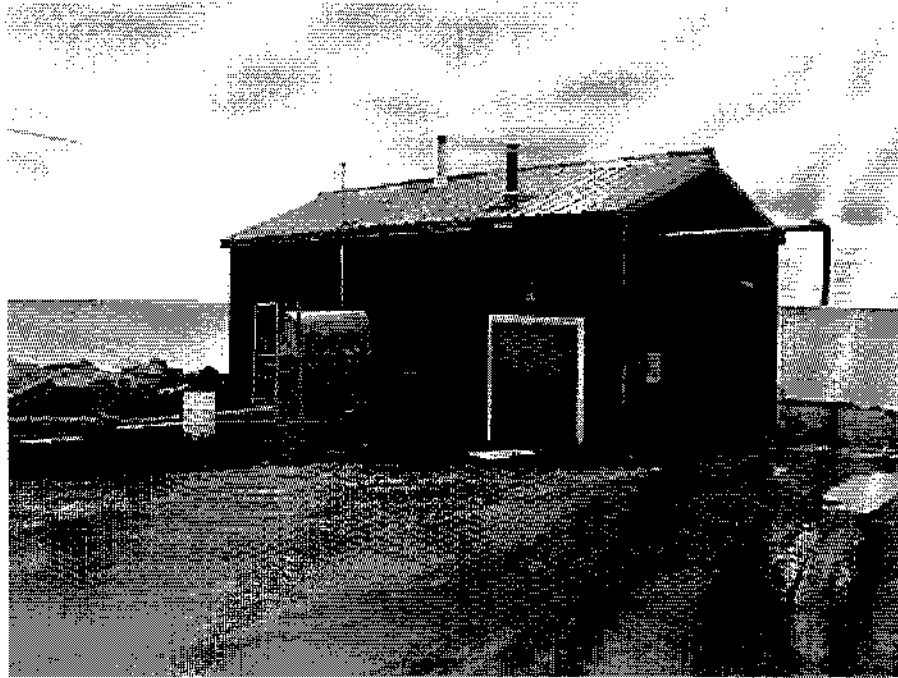
Water is supplied to the water trucks by means of an overhead truck-fill arm with flexible downspout, with thaw capability afforded by a manually activated heat trace (Figure-1).

Figure-1 Water intake /treatment facilities

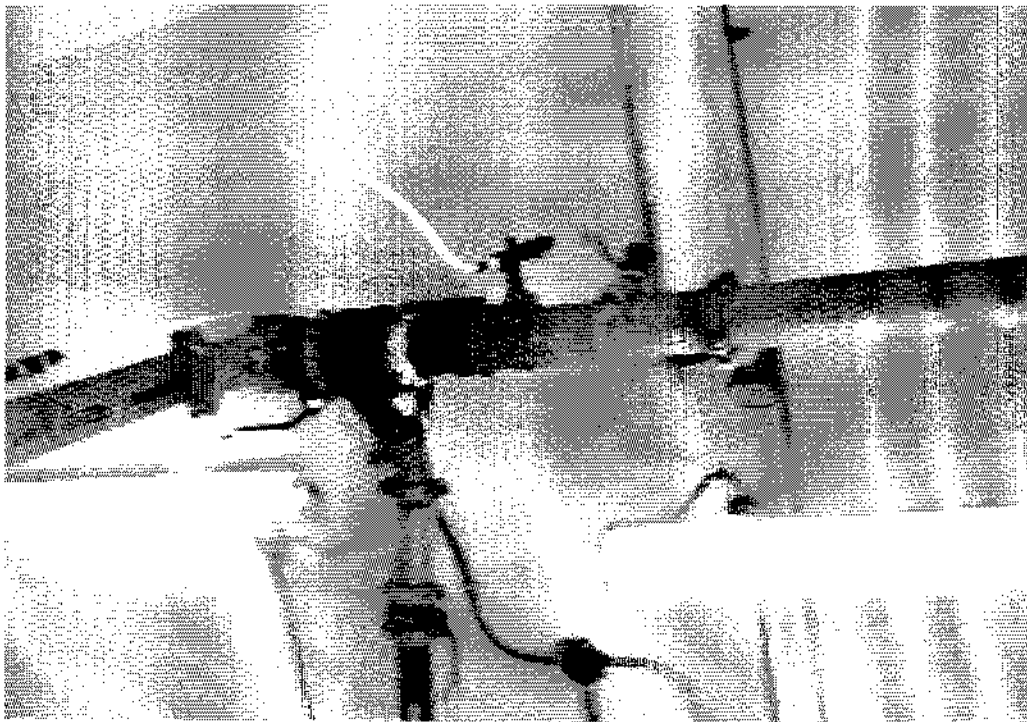
Water for the hypochlorite mixing tank is supplied from the discharge line. The hypochlorite feed pump is controlled by the rate of water supplied to the water trucks by means of a flow-sensing meter mounted on the discharge line. The chlorine is supplied to the main line by a tube and chlorine injector (Figure-2).

Figure-2 Addition point of chlorine at the discharge pipe

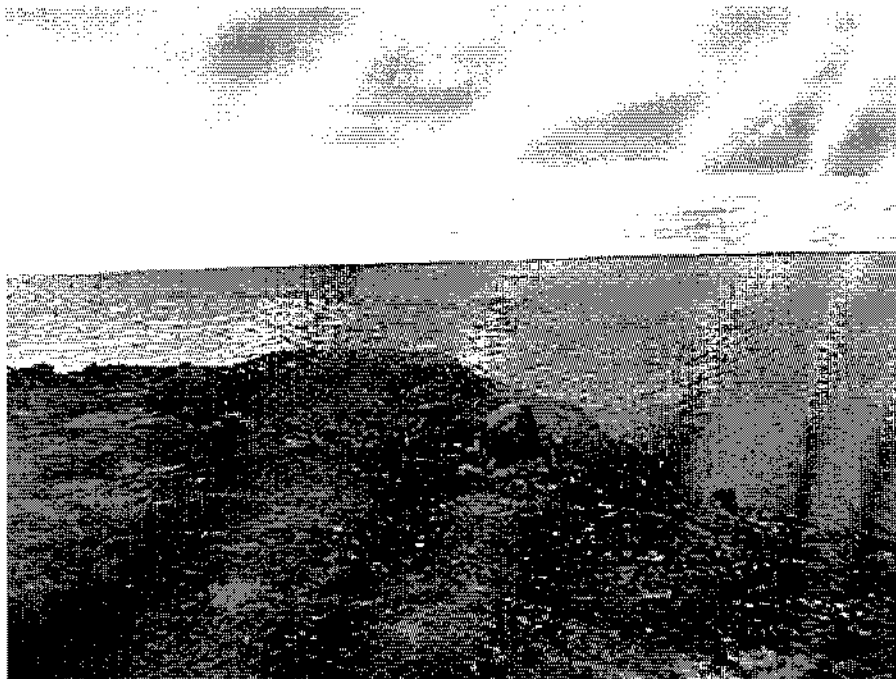
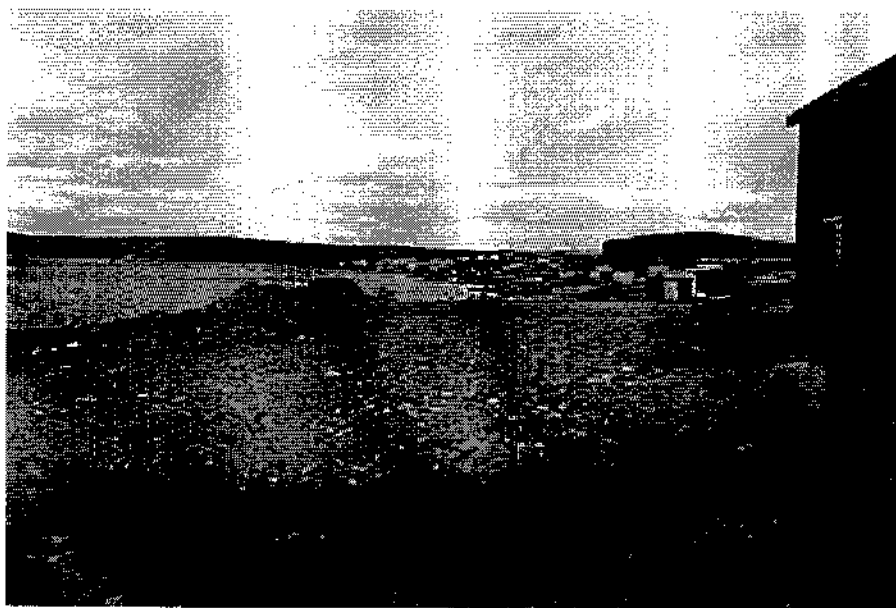
**Water intake /treatment facilities** It was observed that the ground area round the water intake /treatment facilities (pump house) was not constructed and was full of loose earth and sand (Figure-3). This may potentially result in the deterioration of the drinking water quality, especially in the snow-melting and rainy seasons. In the first and third test reports, the turbidity of the sample water collected beside the pump house was 3.4 and 1.4 NTU respectively, both exceeded the GCDWQ requirements. This may probably be resulted from this. It is recommended that some vegetation be transplanted around the pump house, which may help to fix the loose earth and sand. This is an effective and economic solution to this issue.

Figure-3a Loose earth and sand beside the pump house

Figure-3b Loose earth and sand beside the pump house

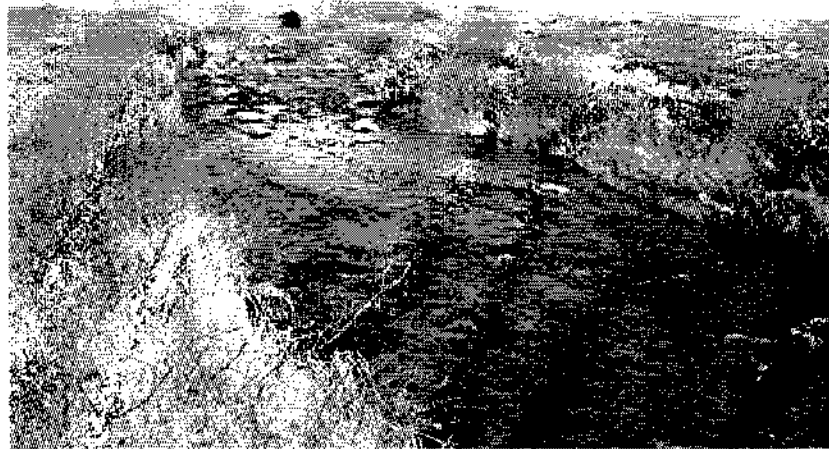
Figure-5 Confined gravel ditch for effluent to Bake Lake

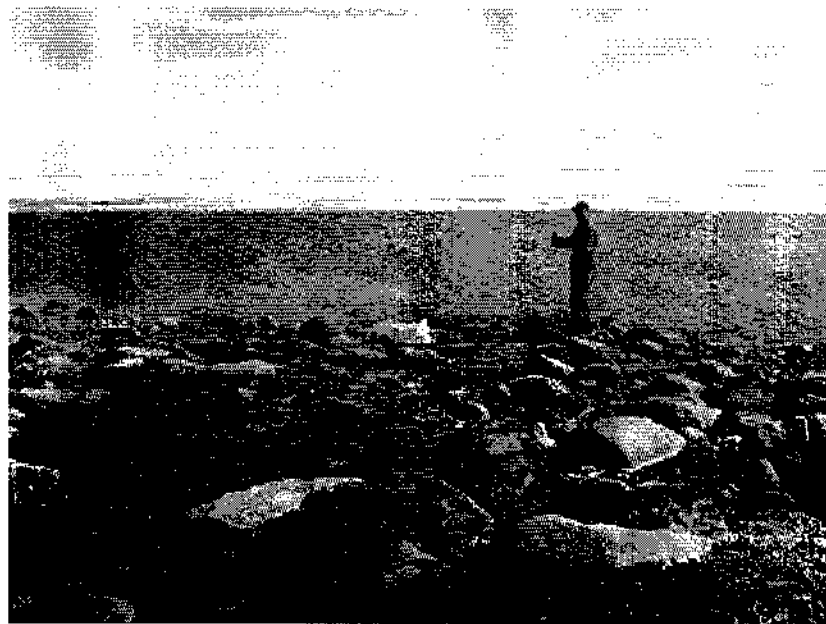
Figure-6 Final discharge point to Baker Lake

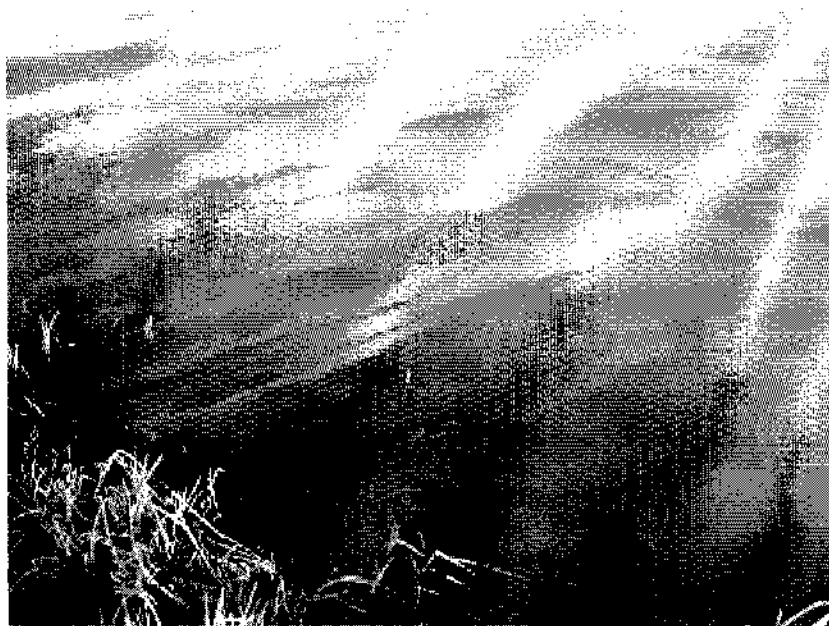
Figure-7 Algae boom in P2

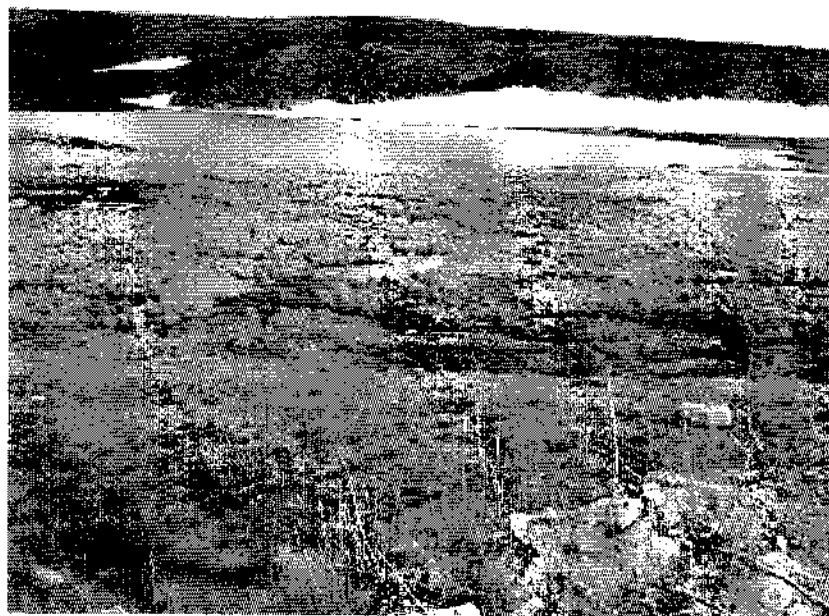
Figure-8a The vegetation plants around the P1

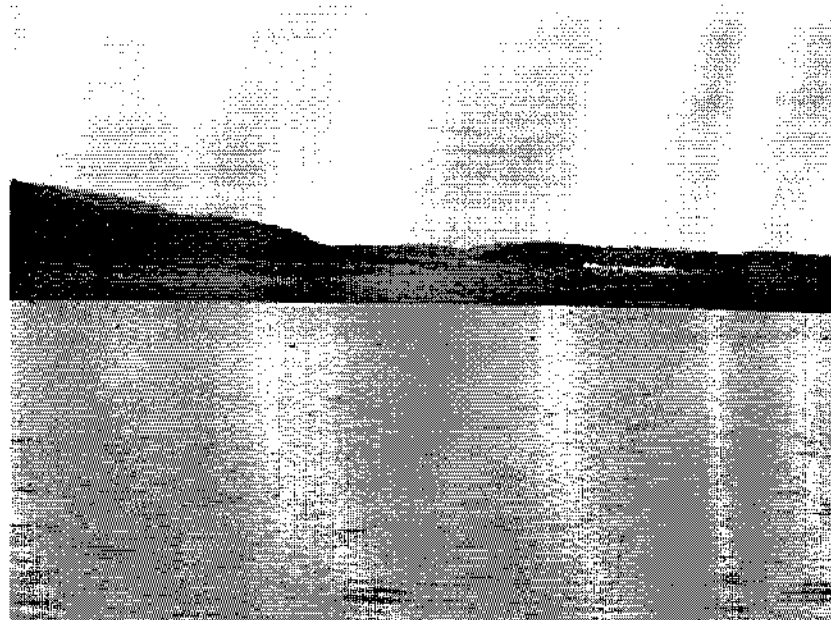
Figure-9 Wild swimming ducks in pond 1

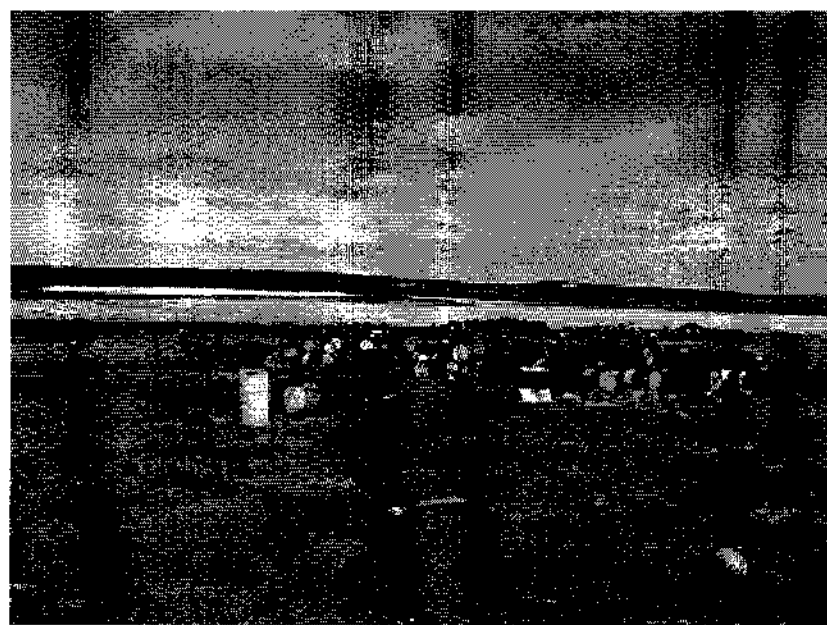
Figure-11 Garbage cans close to the pond 3
