WATER LICENCE INSPECTION FORM

Licensee Representative		
	Sheldon Dorey		
• •	Representative's Title		
3BM-BAK1526/ December 6 th , 2026 Senior Administrative Officer Date of Inspection Inspector

PHOTO LOG Date: **Authorization Number:** Camera/Model: Inspector July 28th 2021 3BM-BAK1526 Samsung S9 **RMO Shouldice** Lat/Long (DD.MM.SS.SS, NAD83) Photo No.

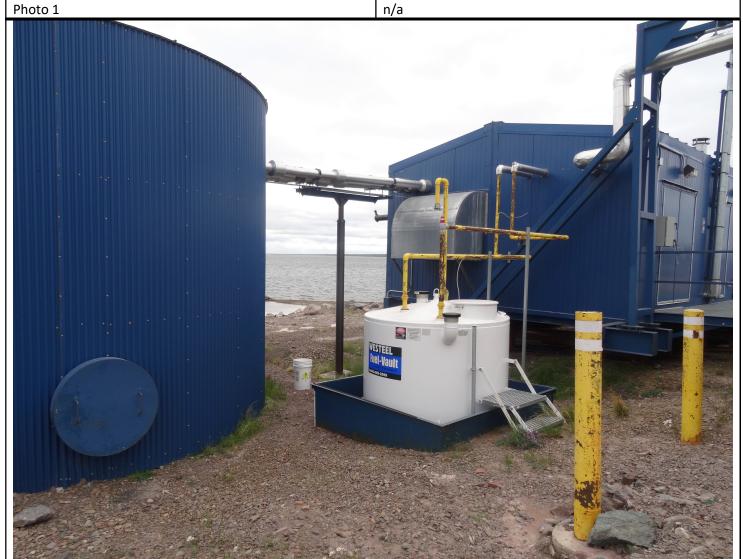
Water treatment plant

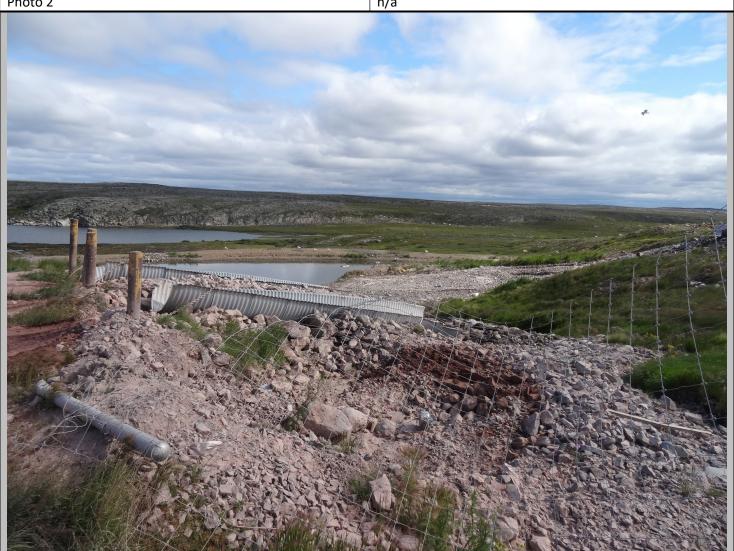
Lat/Long (DD.MM.SS.SS, NAD83) Photo No. Photo 2 n/a

Sewage discharge location in to holding cell

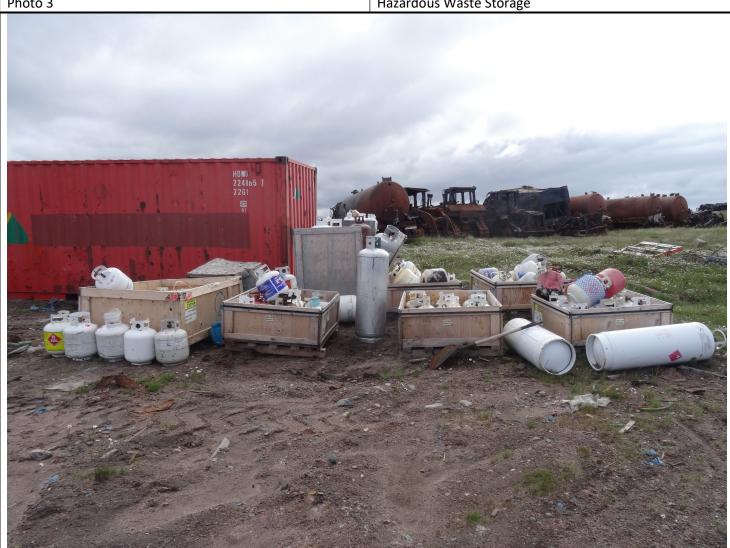
Lat/Long (DD.MM.SS.SS, NAD83) Photo No. Hazardous Waste Storage Photo 3

Hazardous waste storage area at bulk lay down

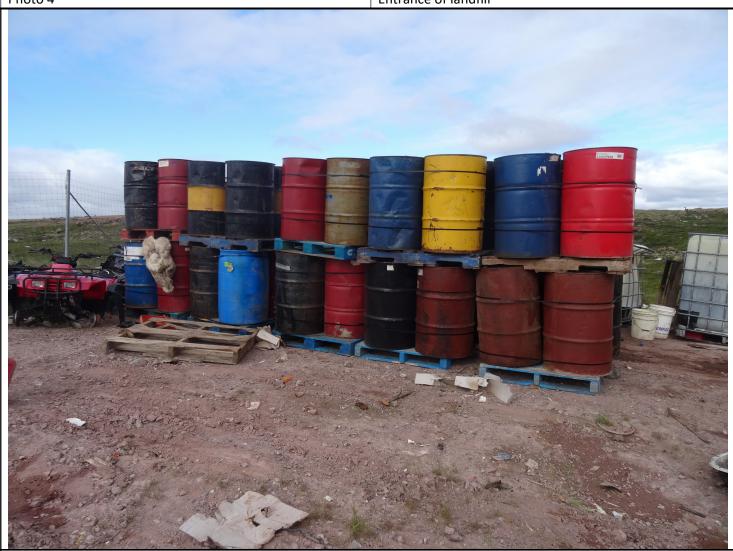
Lat/Long (DD.MM.SS.SS, NAD83) Photo No. Photo 4 Entrance of landfill

Waste oil storage
