**WATER LICENCE INSPECTION FORM**☒ Original
☐ Follow-Up Report

Licensee	Licensee Representative
Hamlet of Baker Lake	Sheldon Dorey
Licence No. / Expiry	Representative's Title
3BM-BAK1526/December 6, 2026	Senior Administrative Officer
Date of Inspection	Inspector
September 15, 2022	WRO. K AMSEL
Activities Inspected	
<input type="checkbox"/> Camp <input type="checkbox"/> Drilling <input type="checkbox"/> Mining <input type="checkbox"/> Construction <input type="checkbox"/> Reclamation <input type="checkbox"/> Fuel Storage <input type="checkbox"/> Roads/Hauling <input checked="" type="checkbox"/> Other: Municipal Undertaking <input type="checkbox"/> Other:

On September 15, 2022 Water Resource Officer Kyle Amsel (Inspector) of Crown-Indigenous Relations and Northern Affairs Canada (CIRNAC) conducted an Inspection of Water Licence 3BM-BAK1526 (Licence). The Licence is issued to the Hamlet of Baker Lake for the use of water and deposit of waste for a Municipal Undertaking.

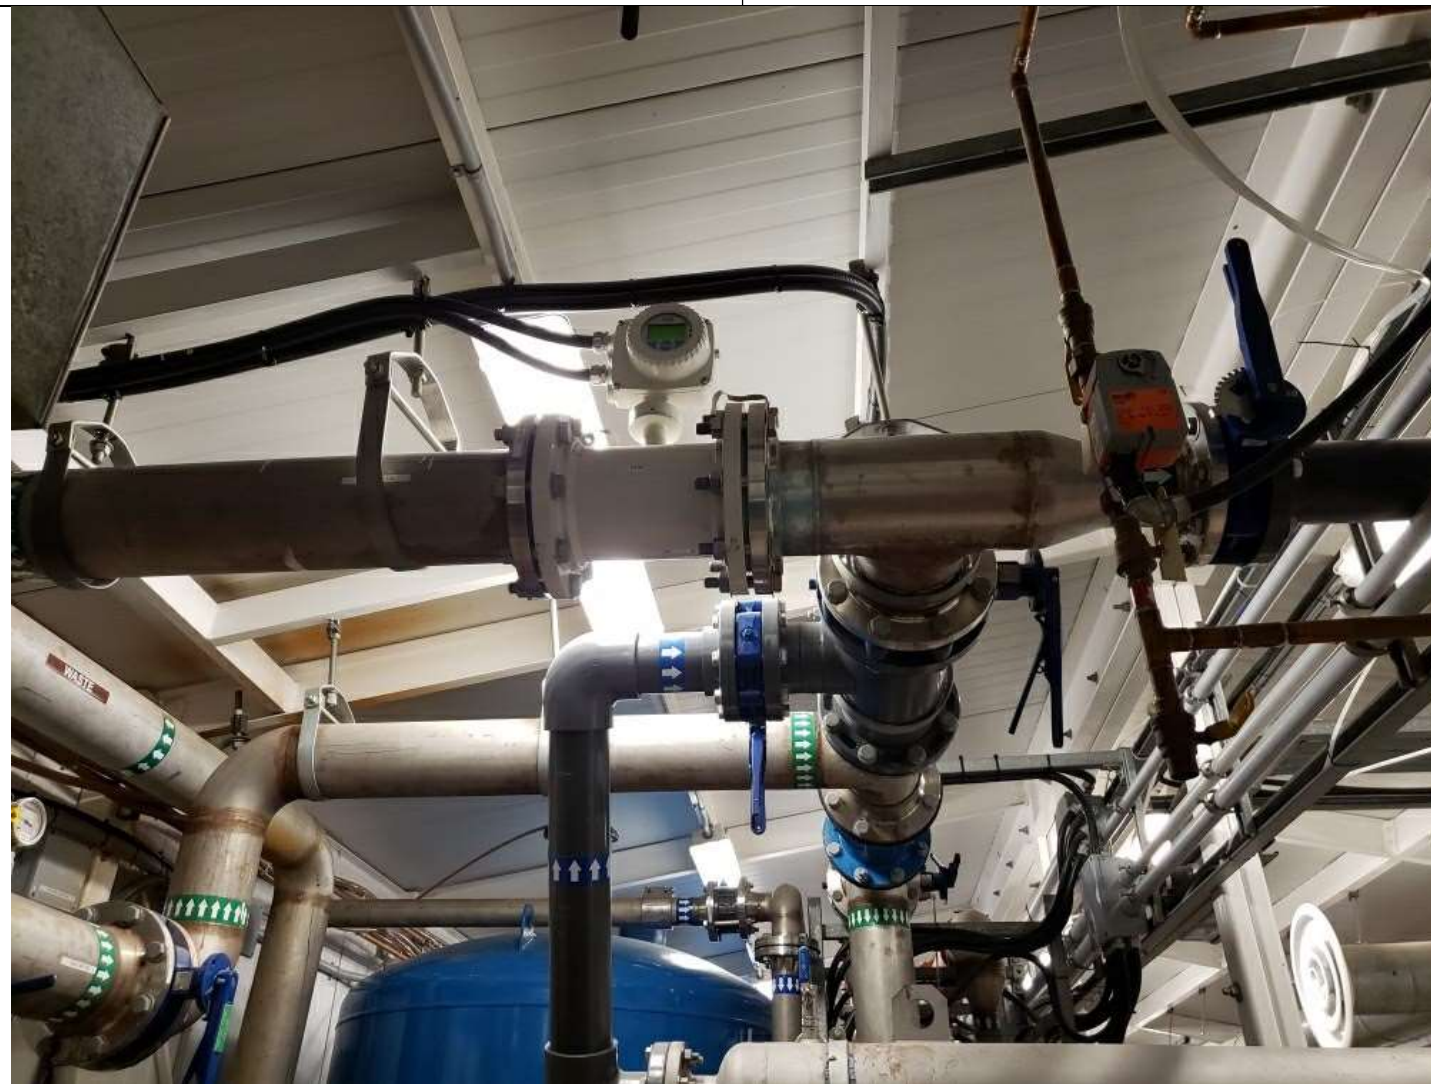
- A flow meter is installed on the raw water intake (photo 1). Representatives were not sure if the reader measured total volume. At 1523hrs a separate electronic system read 63,790.0, though no unit of volume was on the display and the pump operator indicated that the system resets during a power outage. This box was labelled "FT00"

- No sign was observed denoting "BAK-1" which is non-compliant with Part B Item 4 of the Licence.
 - As of September 23, 2022 water usage totalled 36,678m³.

Water flow meter installed at freshwater facilities BAK-1.

- Prepare and Install signage.
- Ensure a freeboard of 1m at all dams, dykes, or structures intended to withhold, divert or retain water or waste.

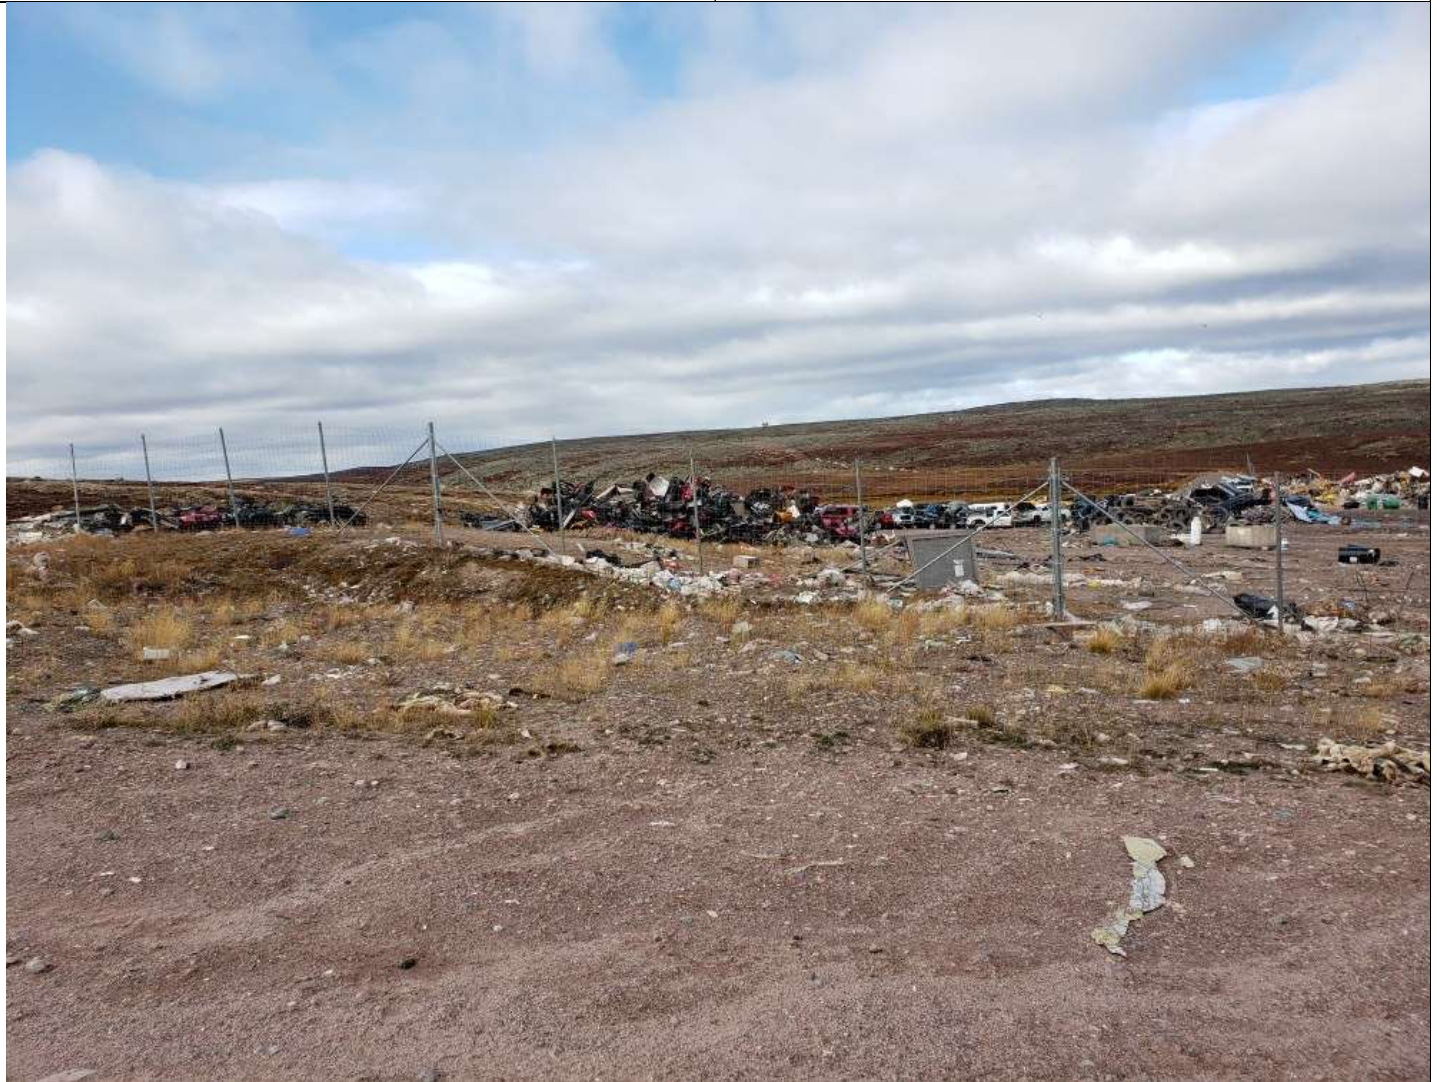
- Solid Waste Disposal Facility (SWDF)
 - The SWDF is well maintained and surrounded by fencing which contains the waste within (photo 2).
 - Representatives stated a full time dump monitor has been employed by the Hamlet.

Solid Waste Disposal Facilities sorrounded by fencing.

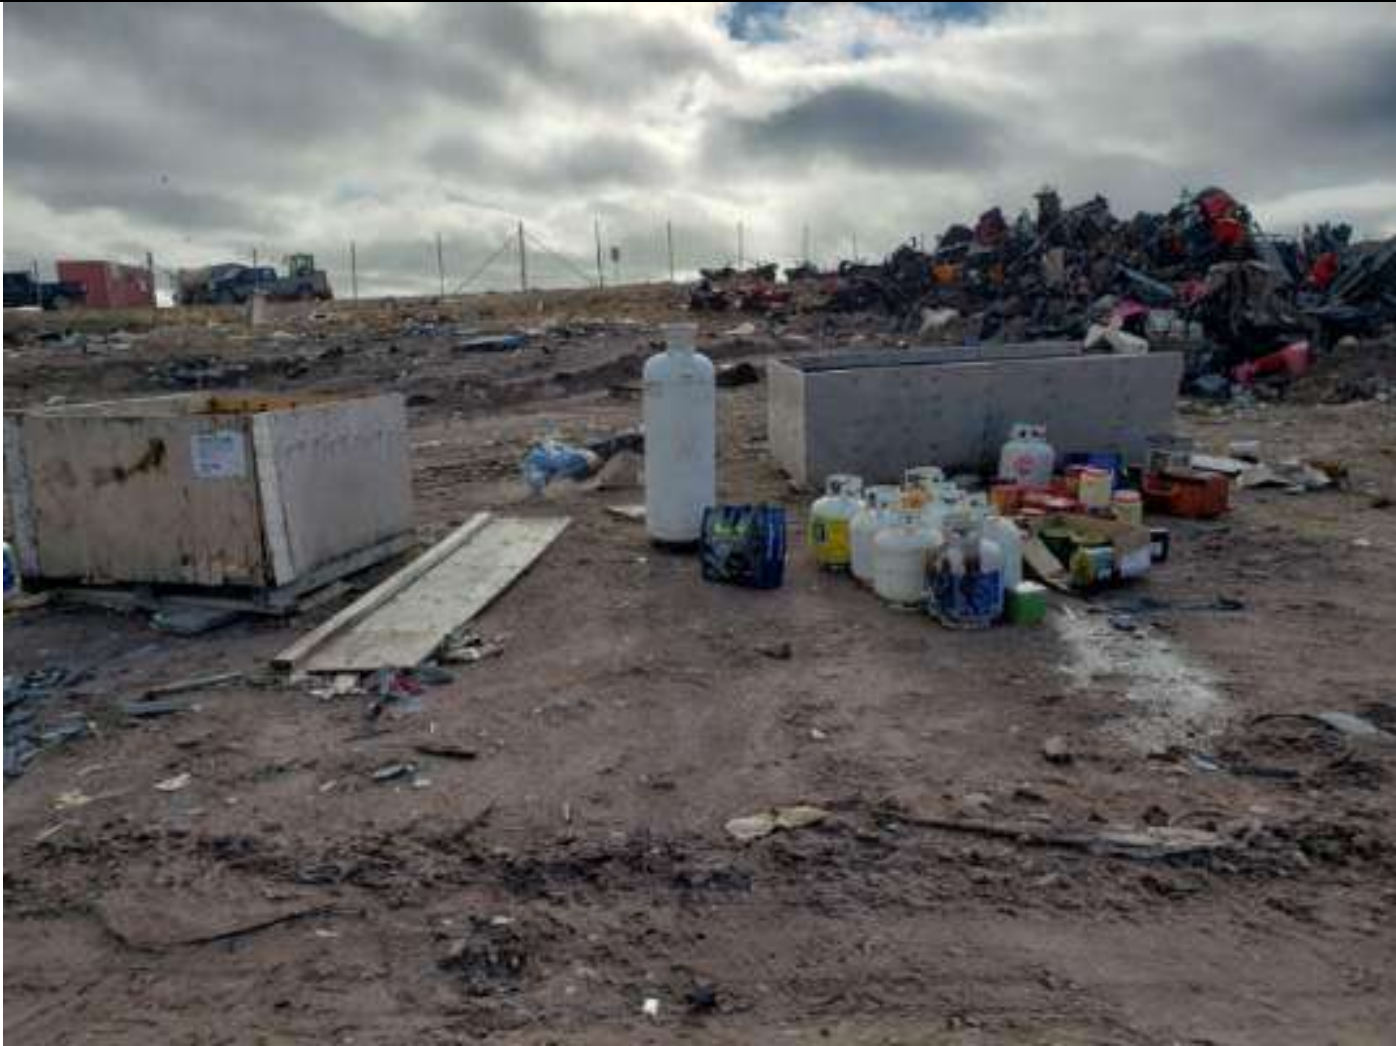
- Representatives are hoping to remove scrap steel from the SWDF next sealift season.
 - Household garbage is restricted to the East end of the SWDF.
 - Appliances, waste oil, batteries, etc are all segregated satisfying Part D Item 7 of the Licence. The volume of waste oil, batteries and propane tanks is negligible due to a good backhaul program. (photo 3)

Description:			
Extent of all hazardous materials at the Solid Waste Disposal Facilities.

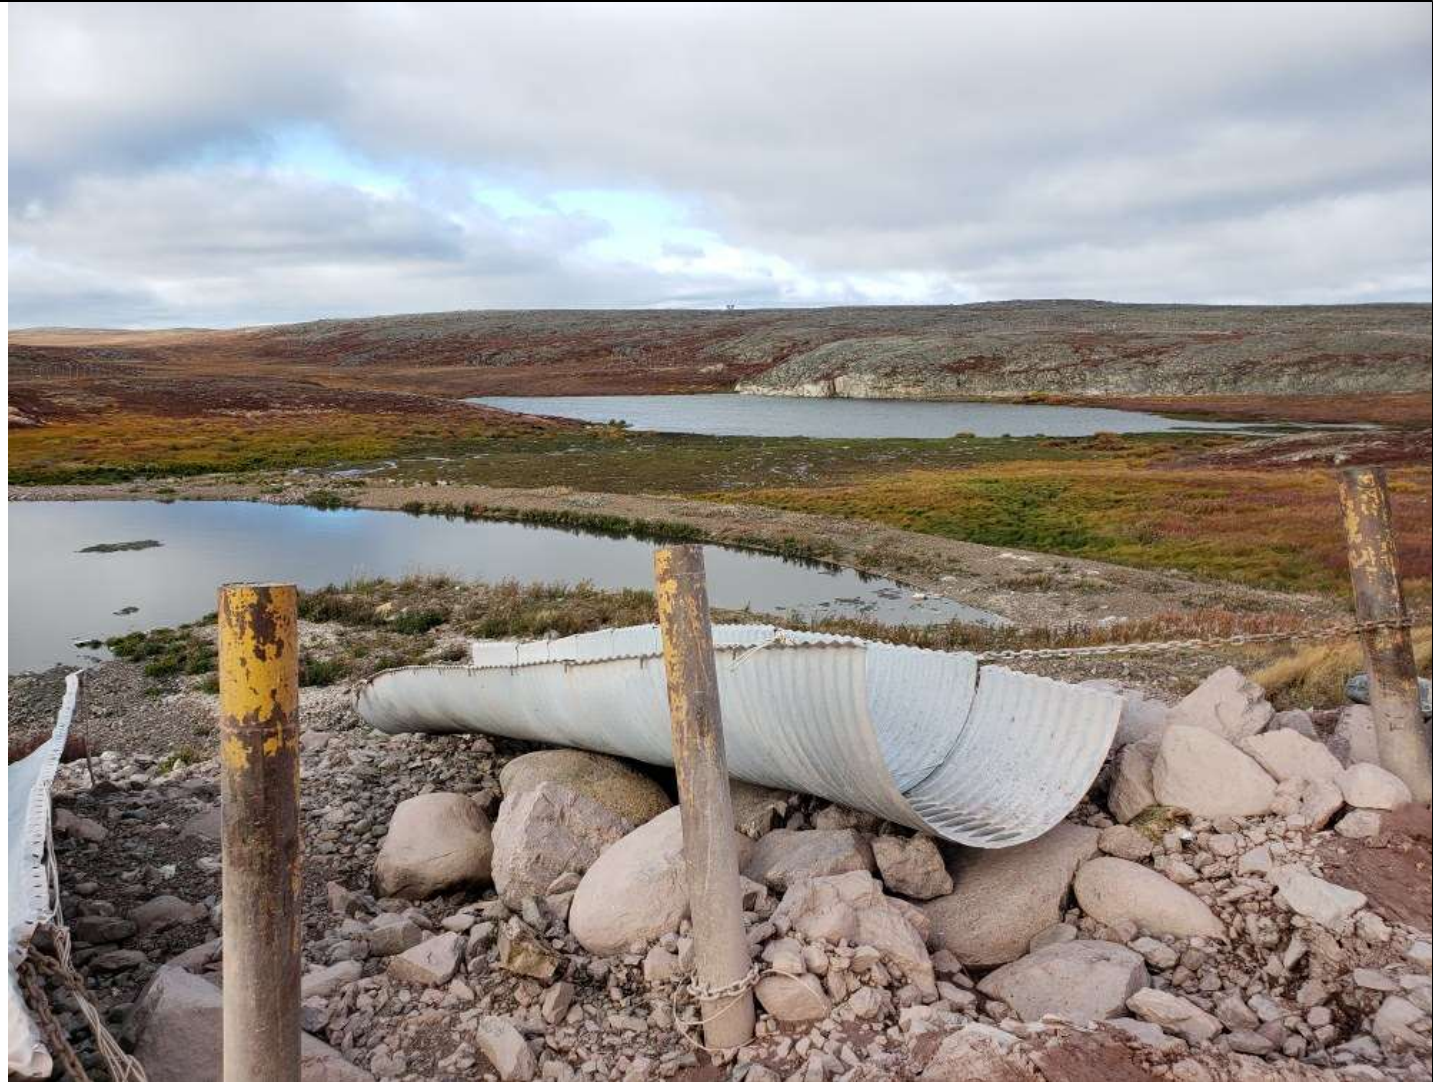
- The sewage facilities use a berm structure to capture sewage as it is deposited by pump truck. The freeboard of this structure was estimated at 15cm. This is non-compliant with Part D Item 3 of the licence. (photo 4)

- Part B Item 4, the Licensee shall post necessary signs to identify monitoring stations.
- Part D Item 3, the licensee shall maintain a freeboard of 1m at all dams, dykes, or structures intended to withhold, divert or retain water or waste.

Sewage outfall facilities. Bermed sewage lagoon in center/left of photo. Berm has minimal freeboard. Wetland sewage treatment area in background.

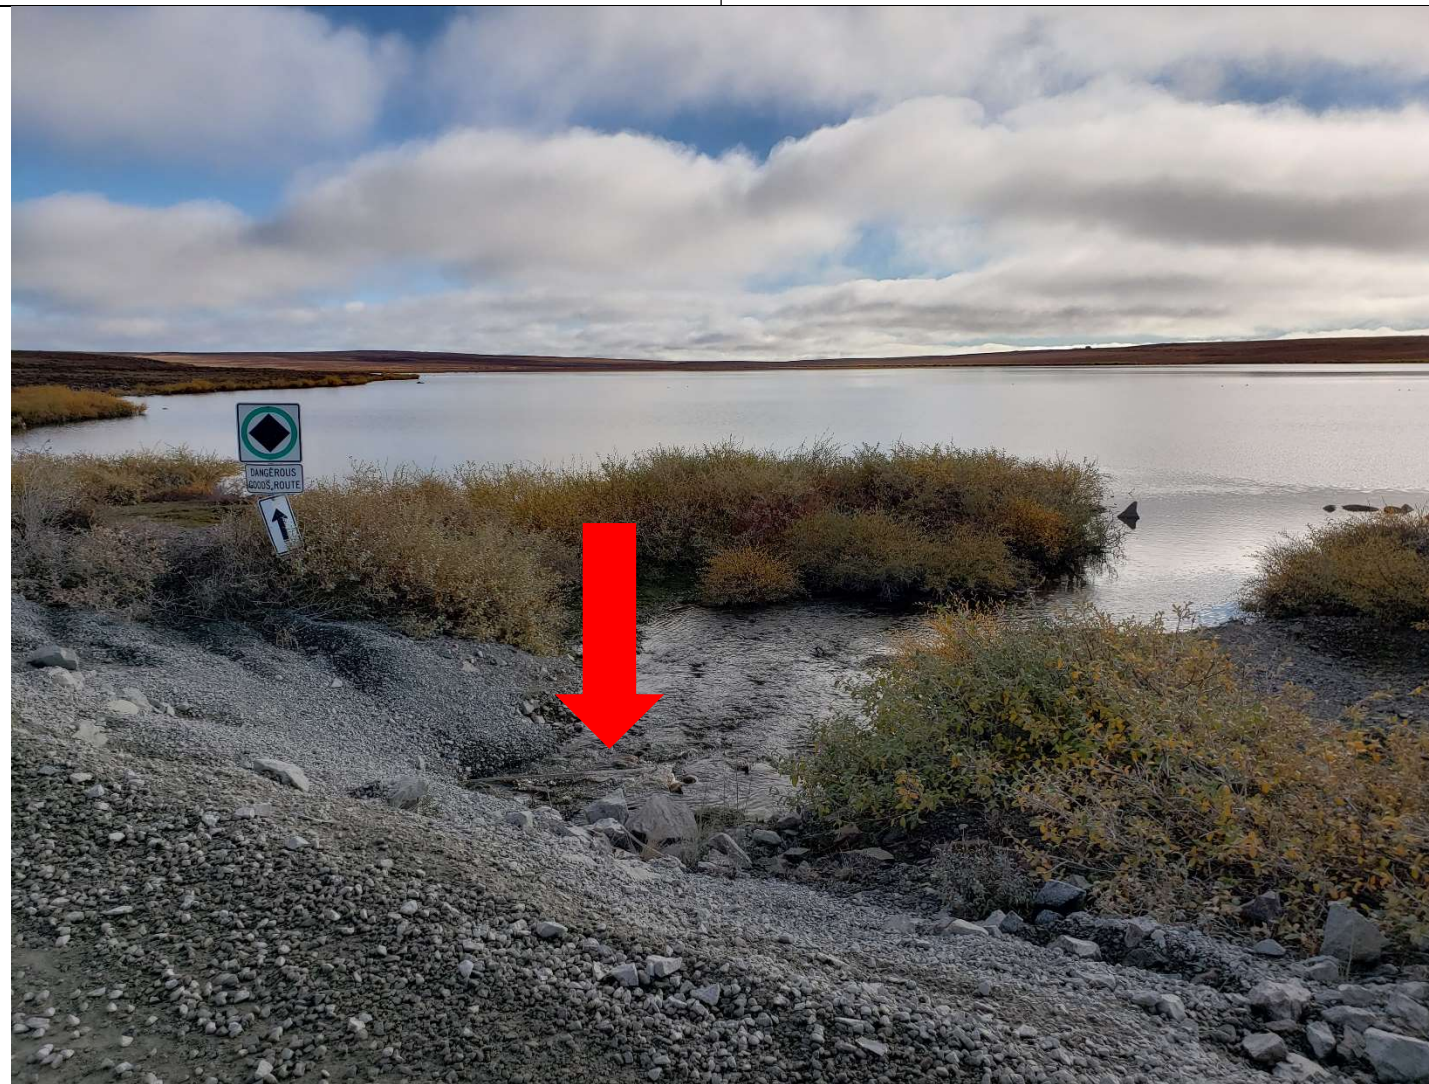
- a. BAK-2 N64° 19' 14.8" W95° 58' 29.6", this sample point is defined in Part H Item 1 of the Licence as "Runoff from the Sewage and Solid Waste Disposal Facilities just prior to the inlet to Airplane Lake, prior to the culvert". The point has been moved to the downstream end of the culvert to improve longevity of the signage and provide a safer location for sampling without affecting monitoring objectives. (photo 5).

Description:
New Location of BAK-2, arrow denotes sample location and area where signage is required.

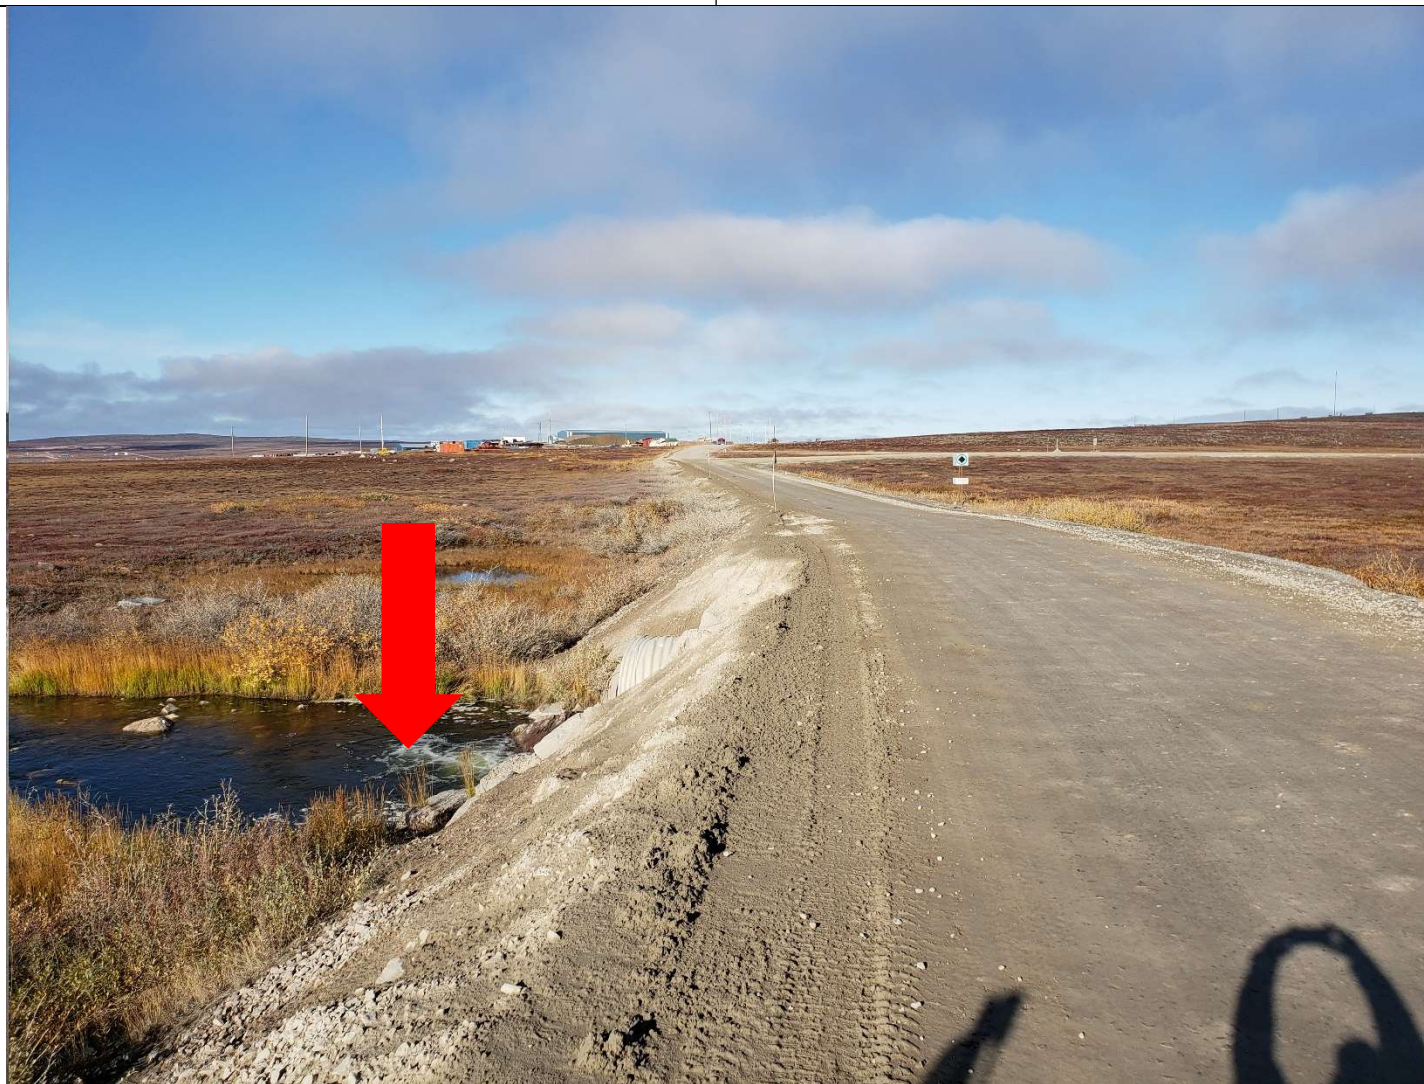
- b. BAK-3 N64° 18' 59.5' W95° 58' 30.7", (photo 6).
 - c. BAK-4 N64° 19' 42.8" W95° 59' 37.9" (photo 7&8) This location is at a small culvert at the lowest point in the SWDF.

Location of BAK-3, arrow denotes sample location and area where signage is required. Photo facing West towards Baker Lake (community) on road to Agnico Eagle Gold Mine sealift area.

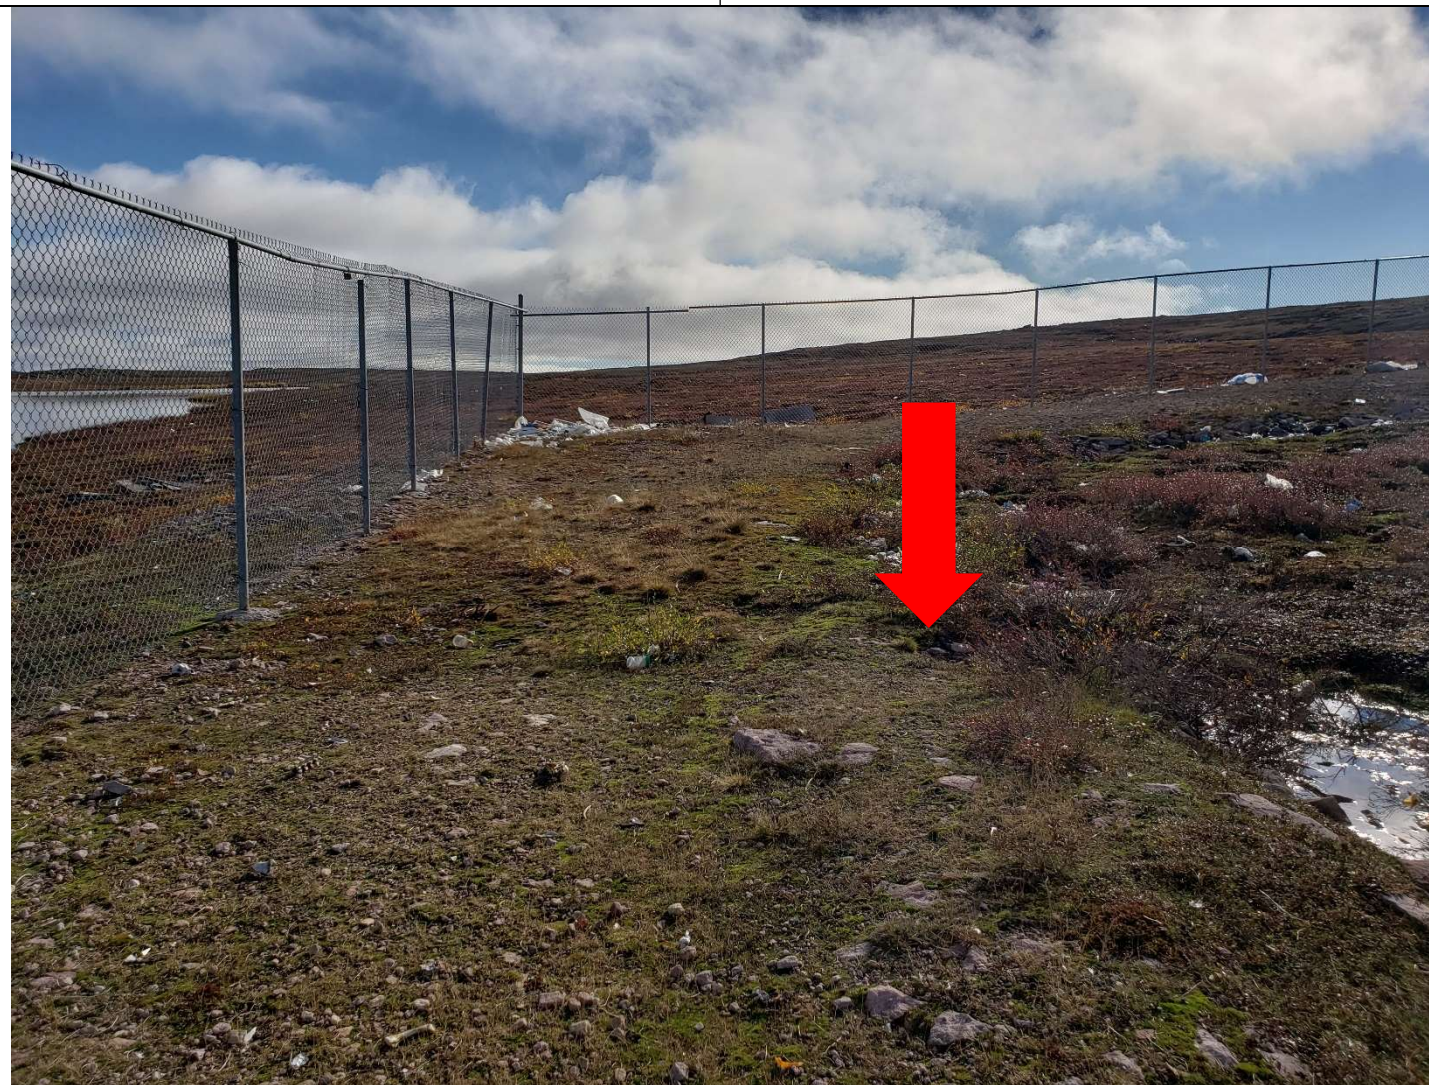
Location of BAK-4, arrow denotes sample location and area where signage is required. A small culvert is in this location where samples should be collected.

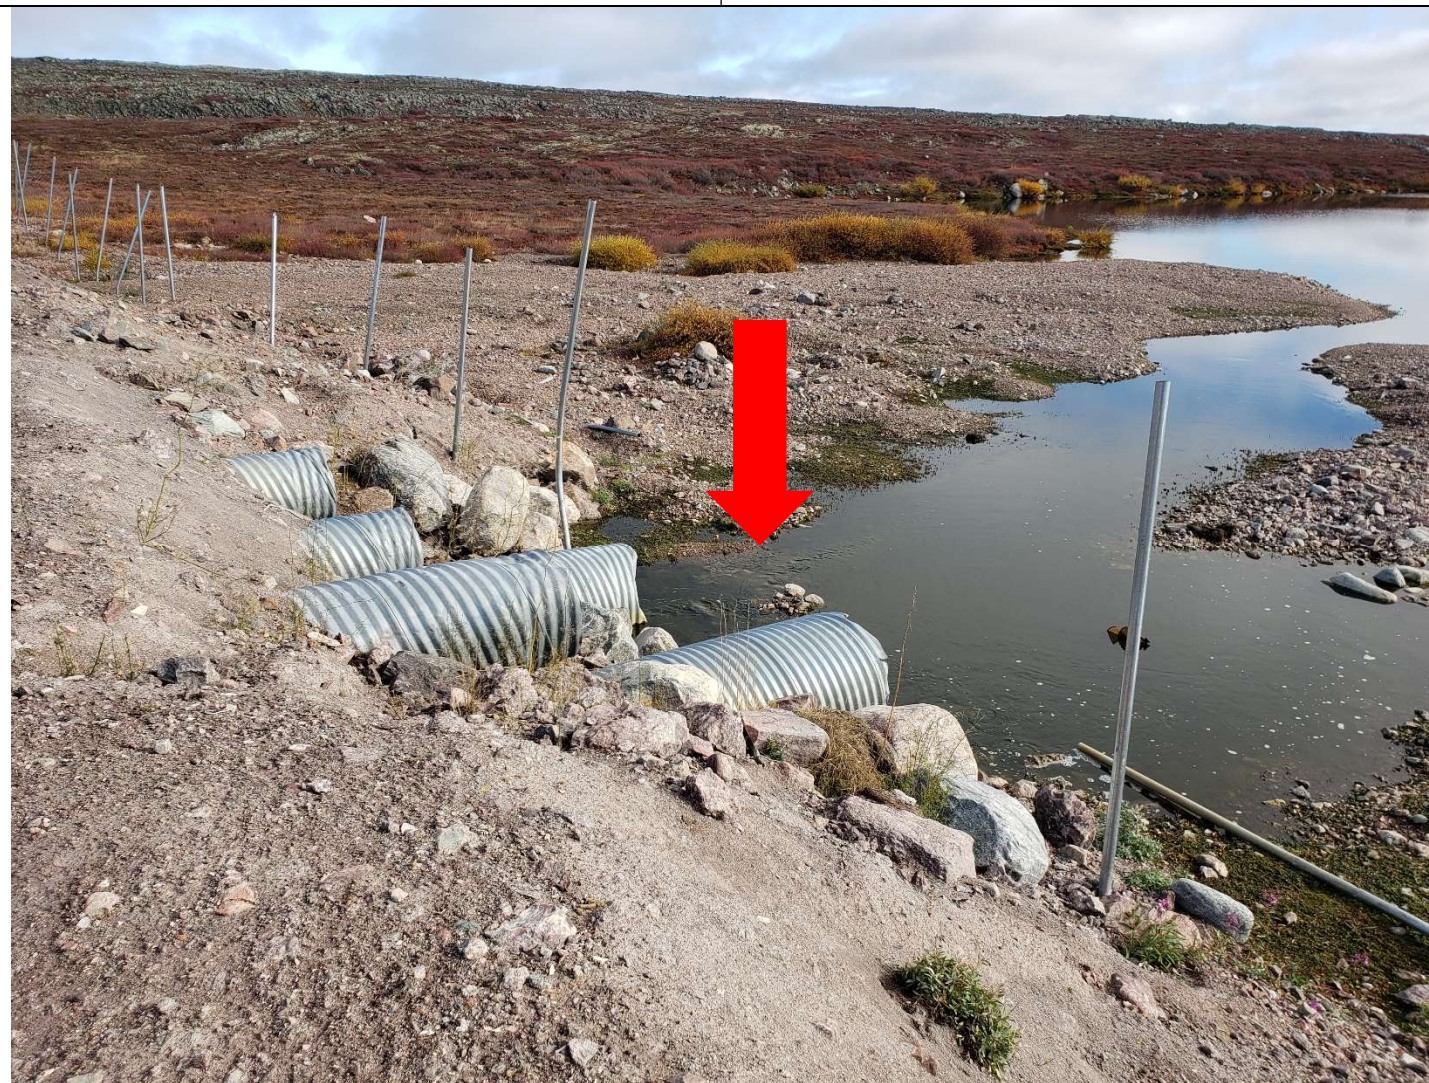
- d. BAK-5 N64° 19' 47.1' W95° 59' 49.7" (photo 9)

Location of BAK-5, arrow denotes sample location. Signage may be installed on existing fence post or where red arrow denotes.
