Indian and Northern
Affairs Canada

**Our file - Notre référence
NWB3CAM0207**

Re: Hamlet of Cambridge Bay Water Licence Inspection September 10, 2007.

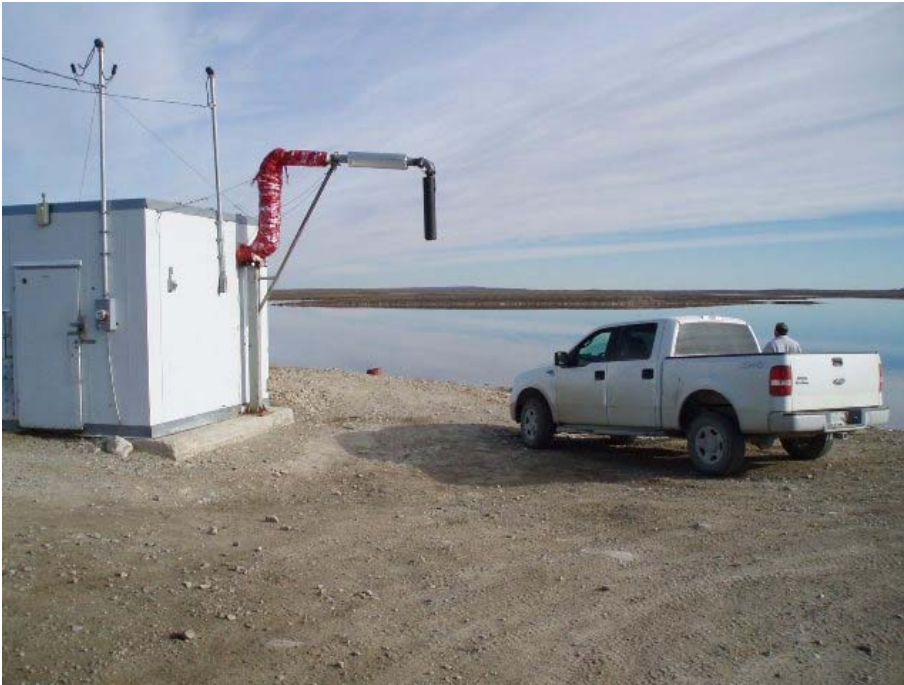
No signs are posted to identify Water Lake as the Hamlets potable water source, and a SNP was not identified for the drinking water source.

Figure 1. Hamlets potable water supply (Water Lake).

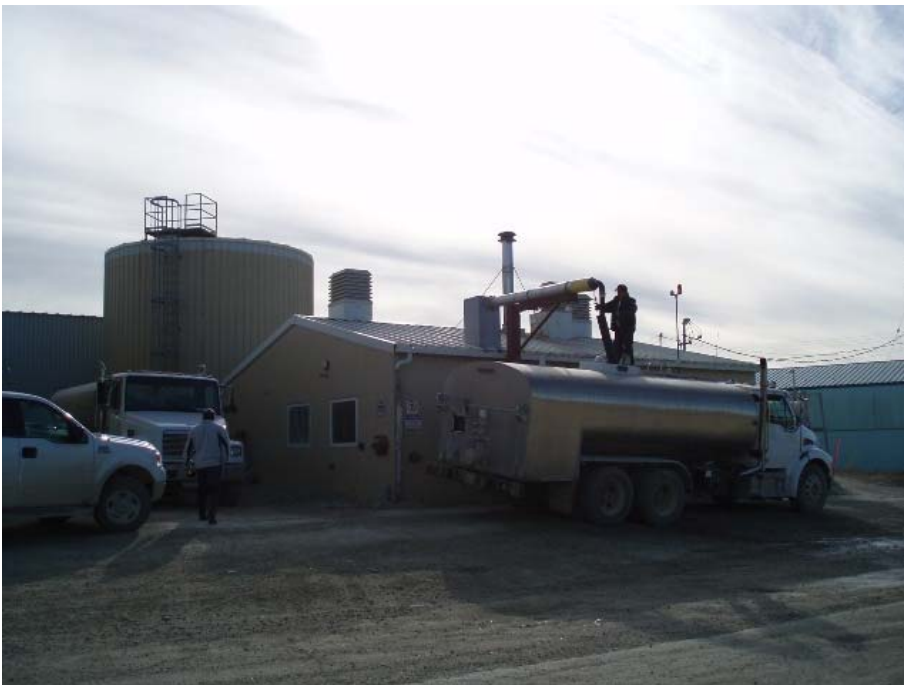
The Hamlet of Cambridge Bay receives its water from Water Lake which is transferred to the treatment plant by pipeline. A sample was taken near the pump house at Water Lake.

Figure 2. Water is transferred from Water Lake to the treatment plant in town.

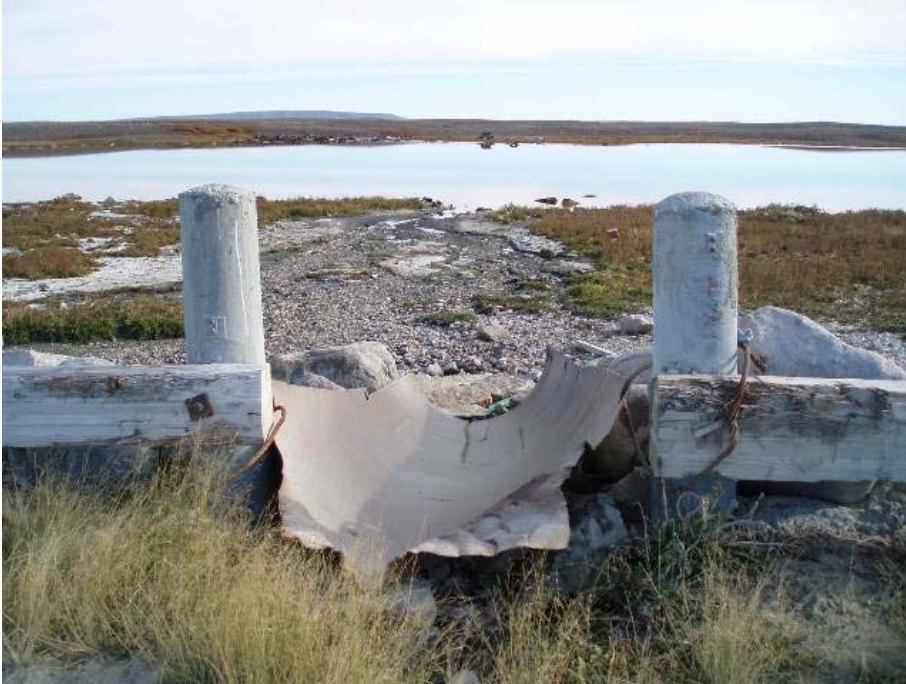
The sewage lagoon is located adjacent to the solid waste storage site (landfill) and upstream of the metal waste site. A considerable amount of garbage was present in and around the sewage lagoon; this should be avoided as much as possible. Installing a fence around the sewage lagoon and/or around the landfill would prevent wind blown garbage from entering the lagoon.

Item 3: The sewage lagoon has insufficient freeboard and allows continuous discharge into a series of ponds before it reaches the ocean. The Hamlet's sewage has very little retention time within the lagoon which results in little treatment of the sewage wastes (mainly solids) before it enters the ocean.

Figure 3. Hamlets dumping station for the sewage lagoon.

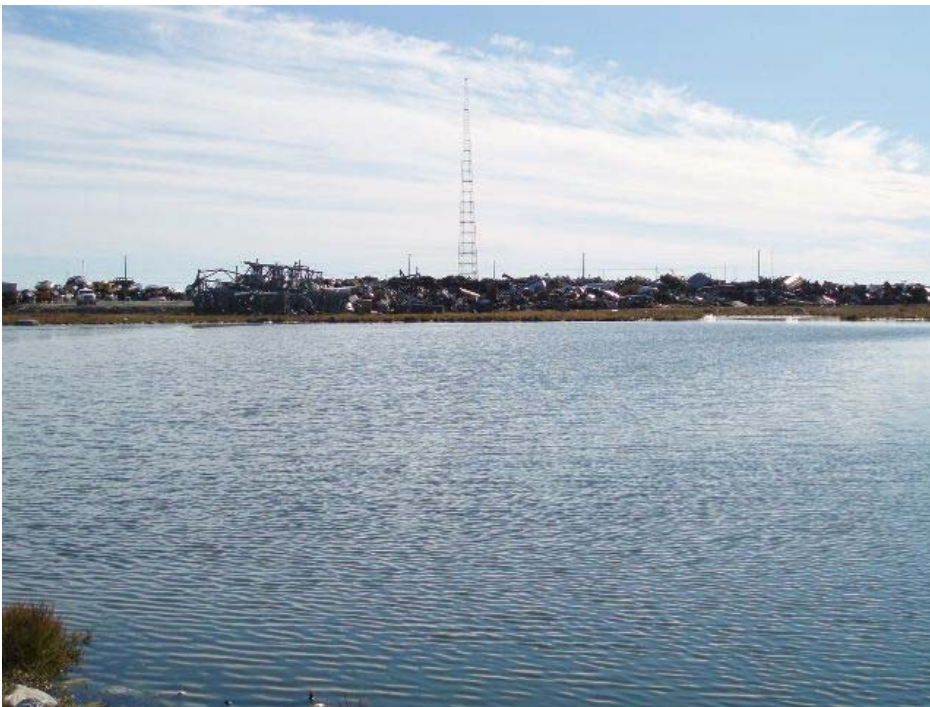
The metal dump is located just down from the sewage lagoon, where the leachate from the dump is allowed to mix with the sewage effluent. The mixing of the dump leachate and sewage effluent could potentially produce a toxic mixture and reduce biological treatment. A sample was taken further down stream near the culvert; the location of this sample was designated as CAM-3.

Figure 4. Metal dump looking from sewage lagoon.

Item 8: Measures are not in place to ensure leachate from the solid waste and metal waste facilities do not mix with the sewage discharge. Fences should be put up around the sewage disposal and solid waste facilities to ensure the general public or wildlife can not enter these areas and to cut down on the amount of garbage that blows around.
