WATER LICENCE INSPECTION FORM

Licensee		Licensee Representative	
Hamlet of Cambridge Bay		Wayne Weese	
Licence No. / Expiry		Representative's Title	
3BM-CAM-1520		Director of Municipal Works	
Land / Other Authorizations		Land / Other Authorizations	
Date of Inspection		Inspector	
5 July 2016		Baba Pedersen	
Activities Inspected			
<input type="checkbox"/> Camp	<input type="checkbox"/> Drilling	<input type="checkbox"/> Mining	<input type="checkbox"/> Construction
<input type="checkbox"/> Roads/Hauling	<input checked="" type="checkbox"/> Other:Municipal	<input type="checkbox"/> Reclamation	<input type="checkbox"/> Fuel Storage

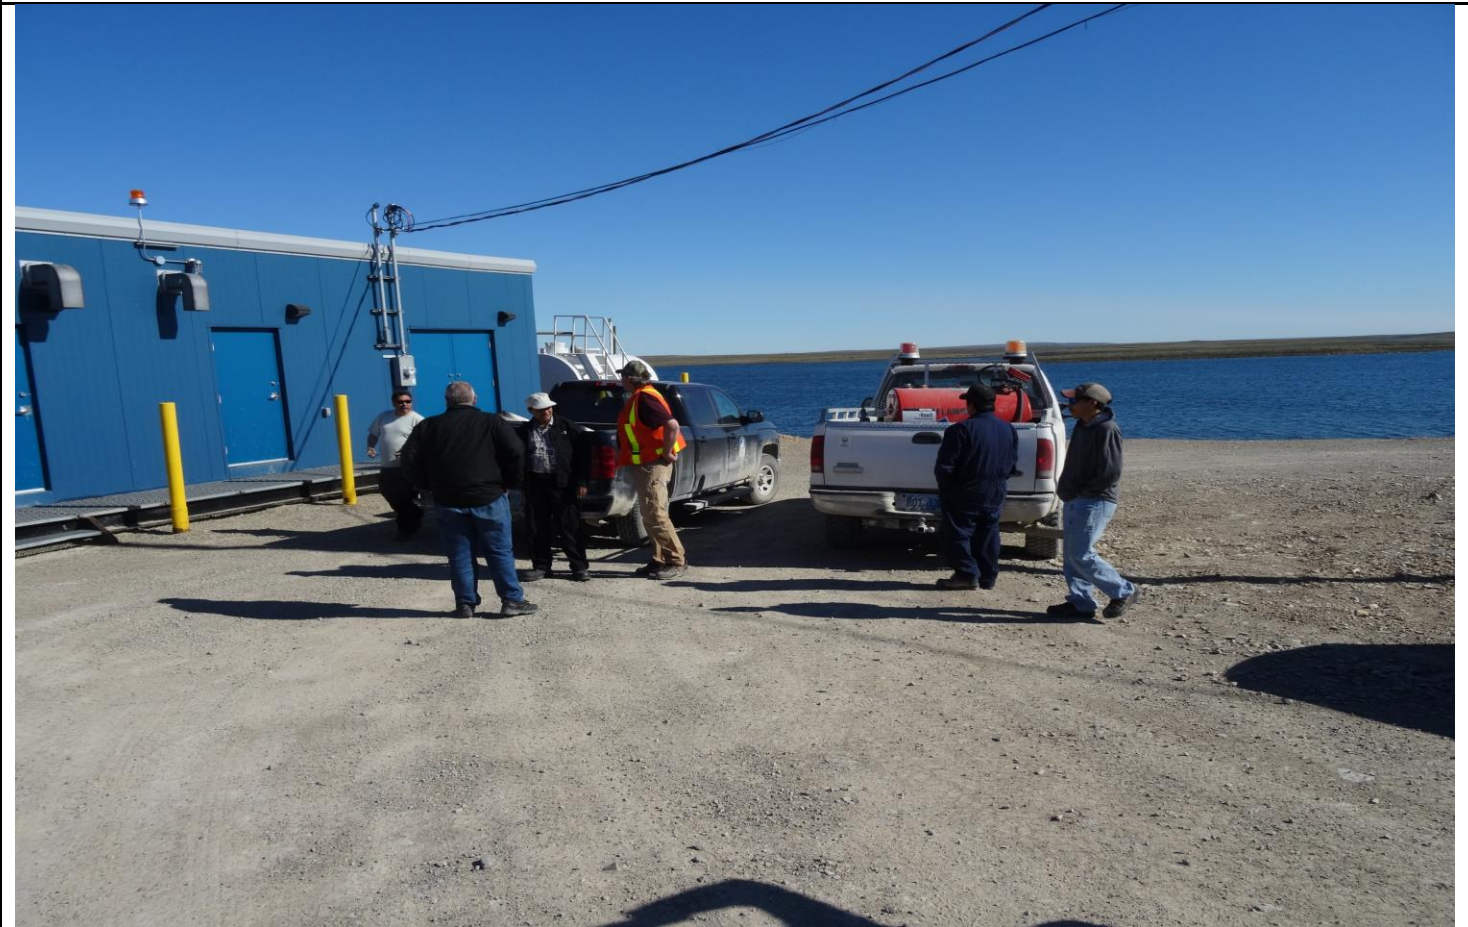
Date	Camera	Inspector	Authorization
5 July 2016		Baba Pedersen	3BM-CAM-1520
Photo Log # 5880		Location	
Photo 1		Water Intake

SECTION 3	<input type="checkbox"/> Comments	<input type="checkbox"/> Non-Compliance with Act or Licence	<input type="checkbox"/> Action Required
1. The Fuel Tank outside the Water Intake Building (photo 1) is only 16 m from the High Water Mark. This should have been noticed and rectified during the Design/Build Process. 2. The Main Dump (photo 2) was well organized and is Fenced and Gated with Staff controlling intake. 3. The Sewage Lagoon (photos 3 and 4) is very large, allowing for ample future expansion when required. It was mentioned that they are still using the old Dumping Station (photo 5) because of Liner Damage (photo 6) at the New Dumping Station. 4. The Metal Dump is very nicely sorted with good Signage directing what items should be placed where. 5. The Lined Berm area within the Metal Dump Site (photos 7, 8 and 9) contains many various containers of a variety of Oils and Lubricants, lots of Mega Bags of Contaminated Soil and Paint and other Containers both Open and Closed. There is approximately 12 inches of water throughout the entire Berm Area, fully or partially submerging everything inside and there are visible Sheens on the surface in a few spots. 6. The Daily, Weekly, Monthly and Annual Water Use Consumption Data is done electronically which made it very difficult for the staff to show me any actual Consumption Amounts (photo 10) as is required in the Water Licence. Staff must be able to show the Inspector Consumption Figures on request.

Description: Fuel Tank on right side of Water Intake Building is only 16 m from the High Water Mark

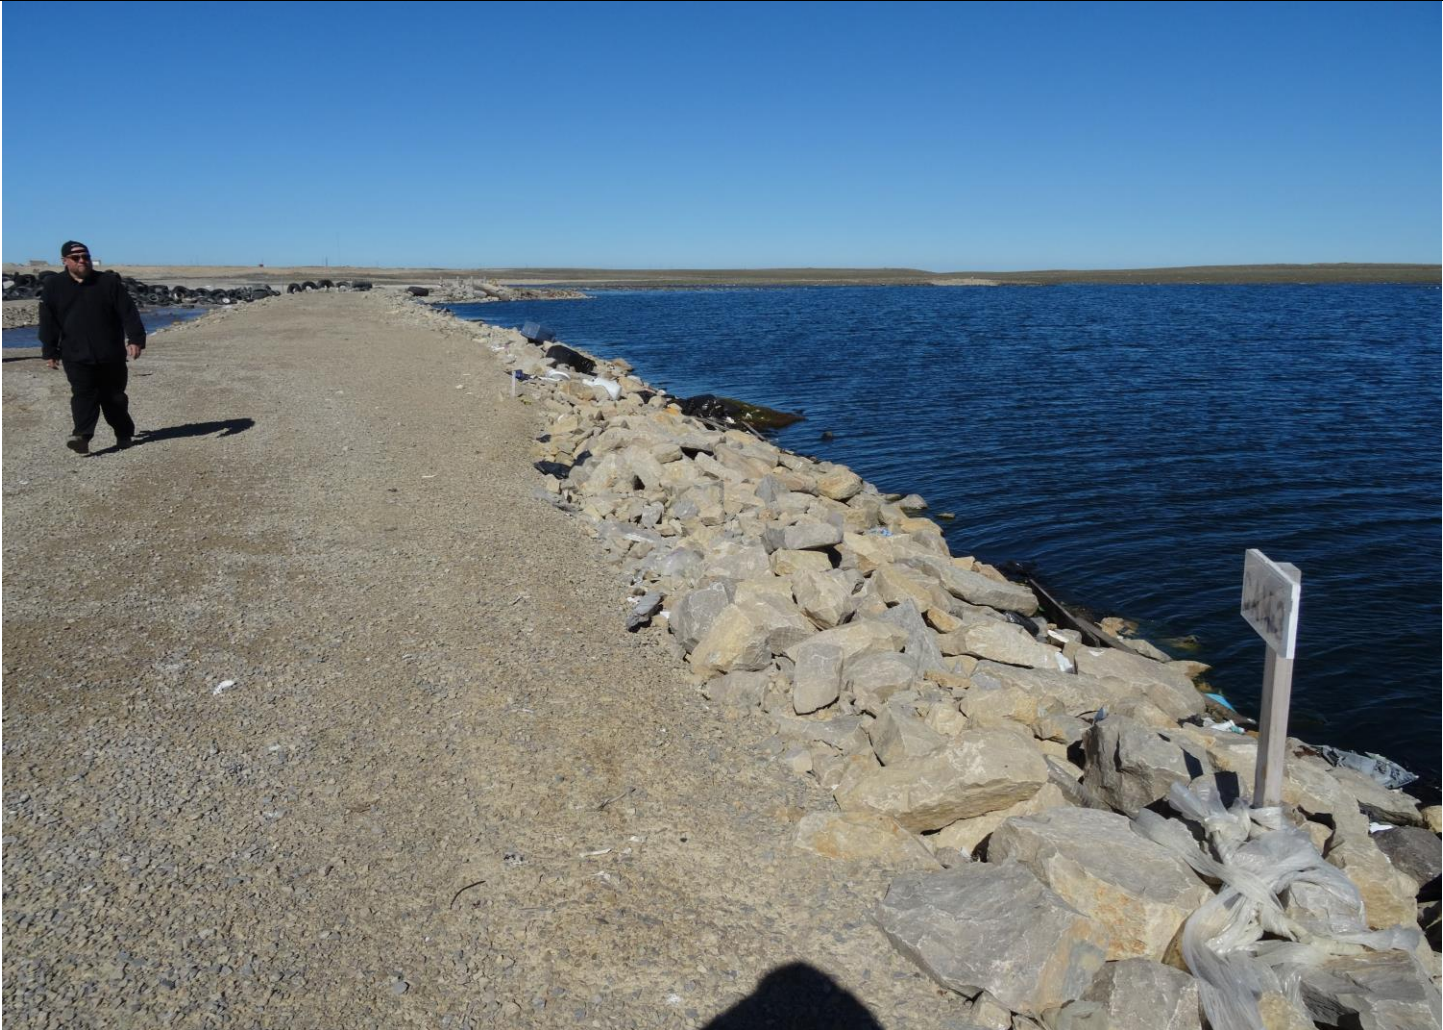
Photo 3

Description: Large Sewage Lagoon with ample area for increased volumes with future community growth (view #1)

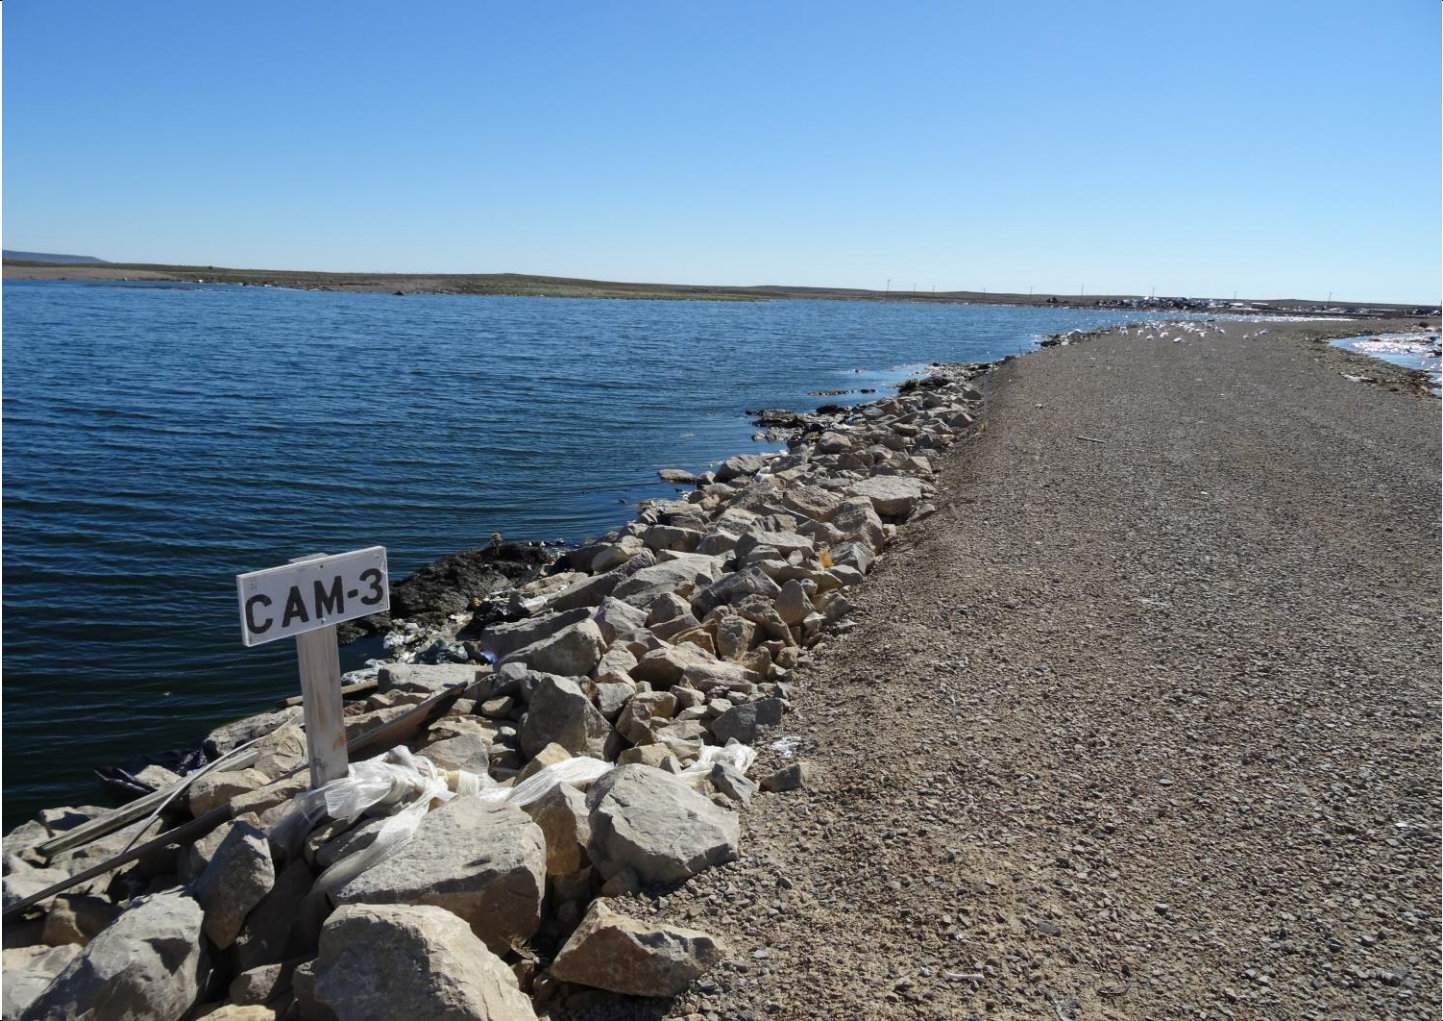
Photo 4

Description: Large Sewage Lagoon with ample area for increased volumes with future community growth (view #2)

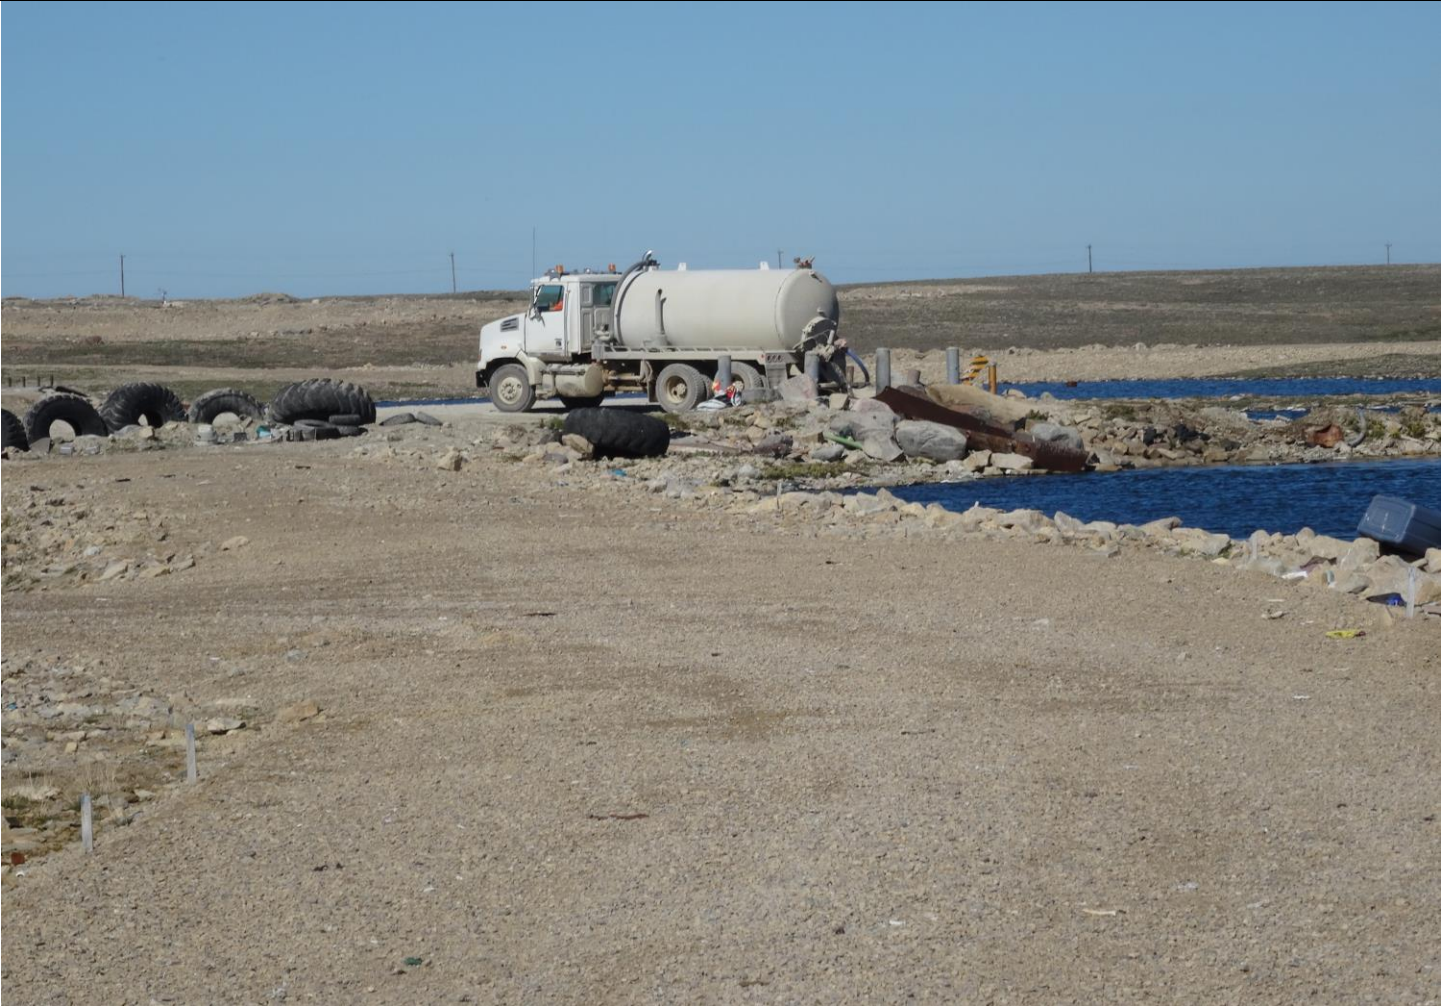
Photo 5

Description: Old Dumping Station still being used

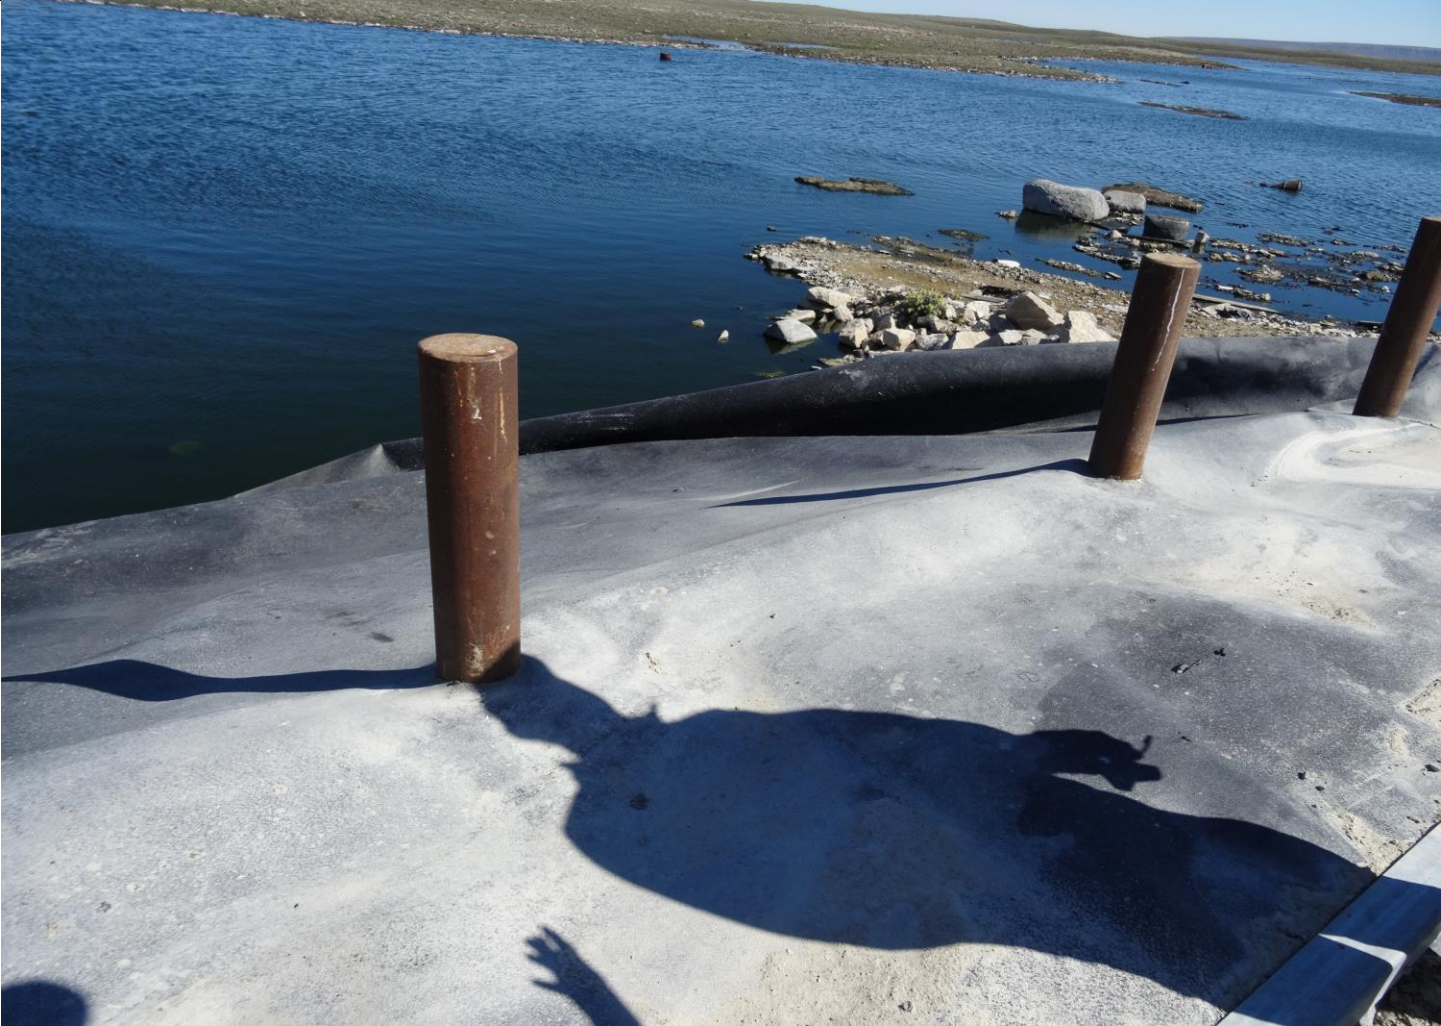
Photo 6

Description: New Dumping Station not being used due to Liner Damage

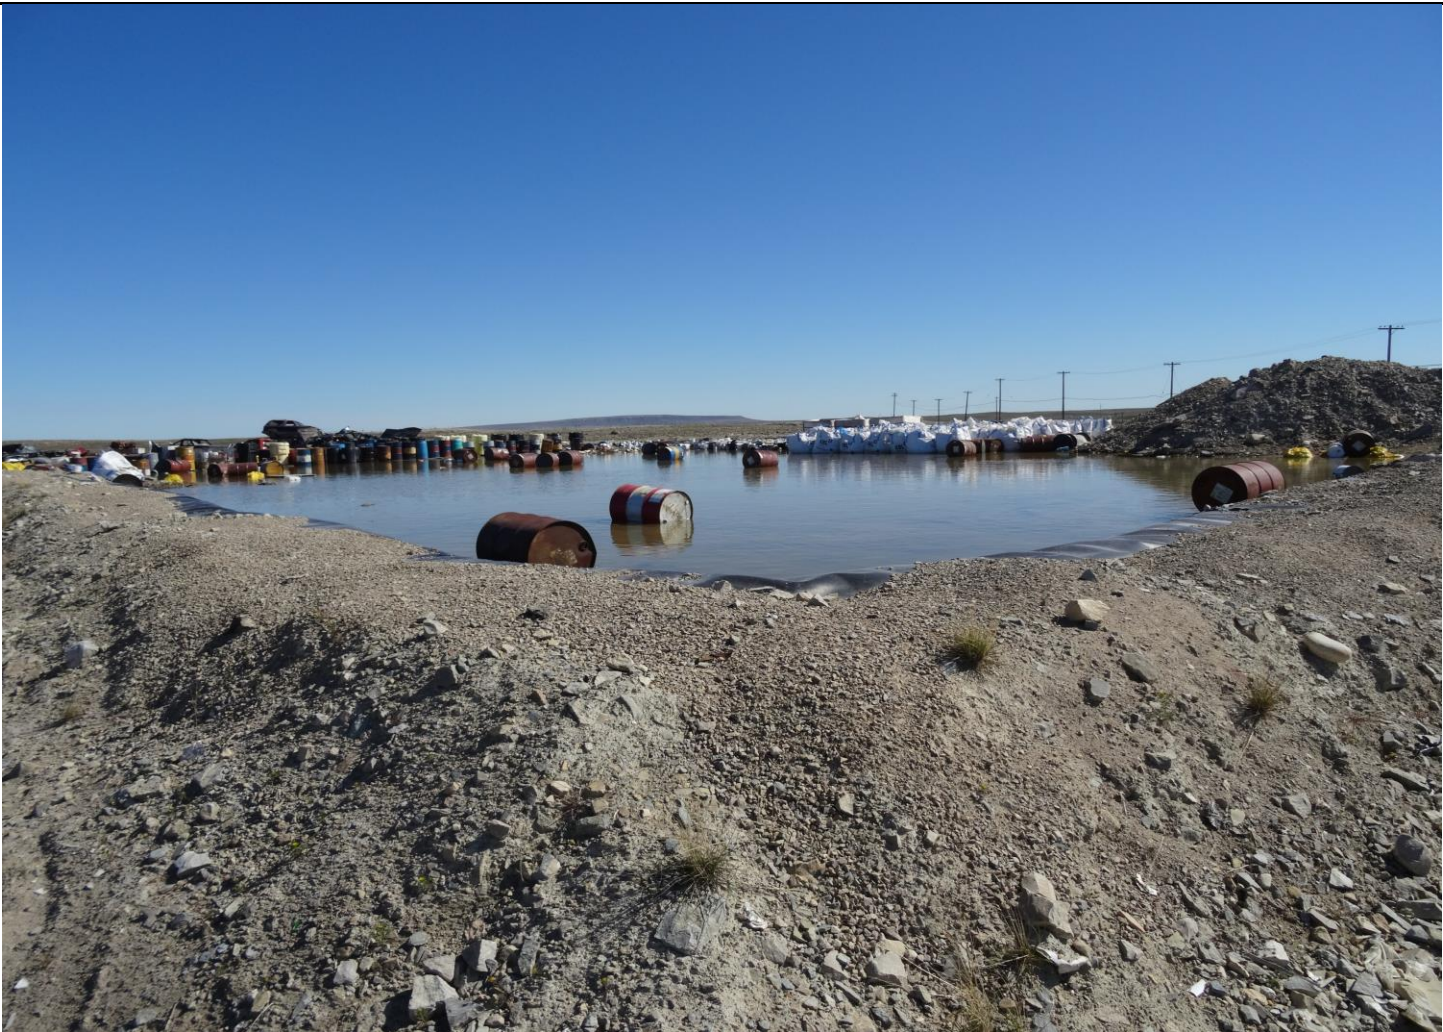
Photo 7

Description: Lined Berm area within Metal Dump (view #1)

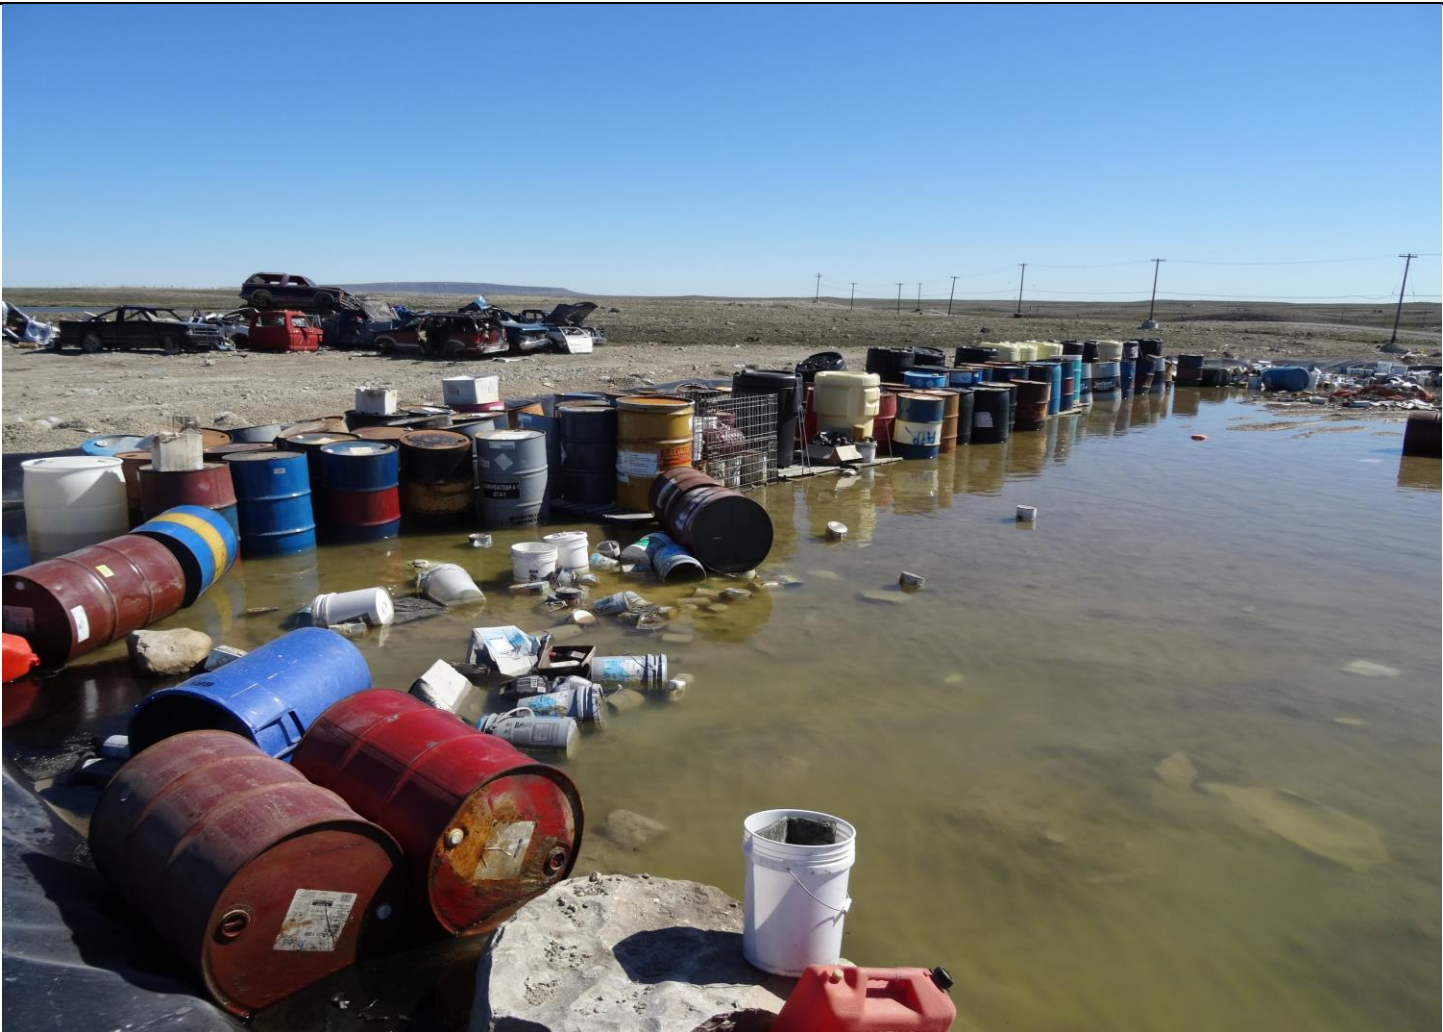
Photo 8

Description: Lined Berm area within Metal Dump (view #2)

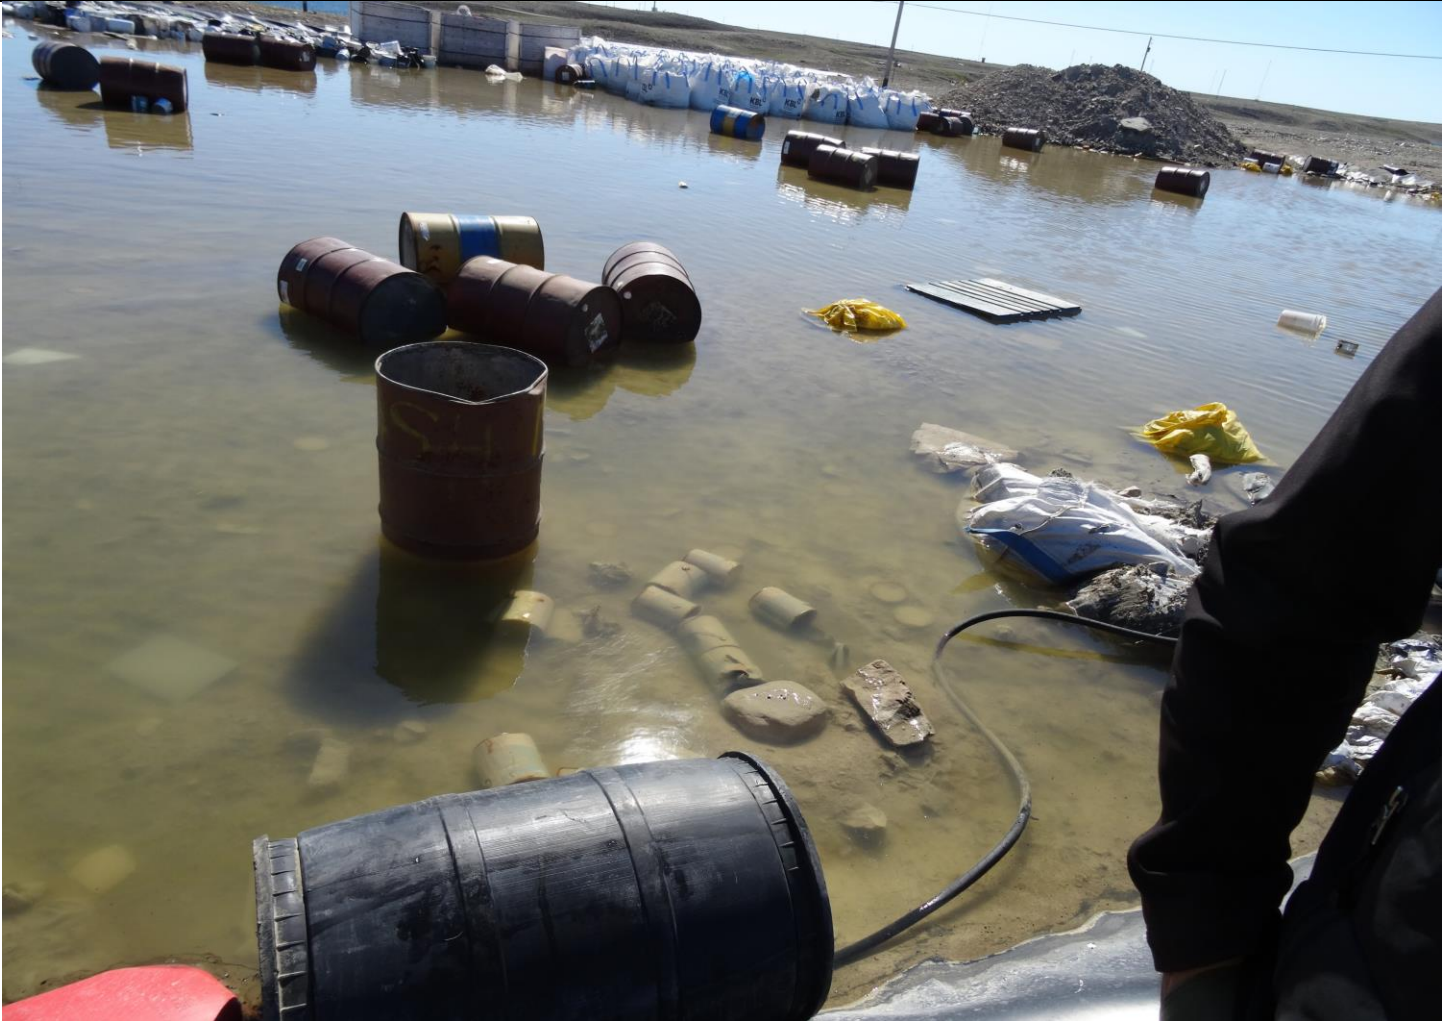
Photo 9

Description: Lined Berm area within metal Dump (view #3)

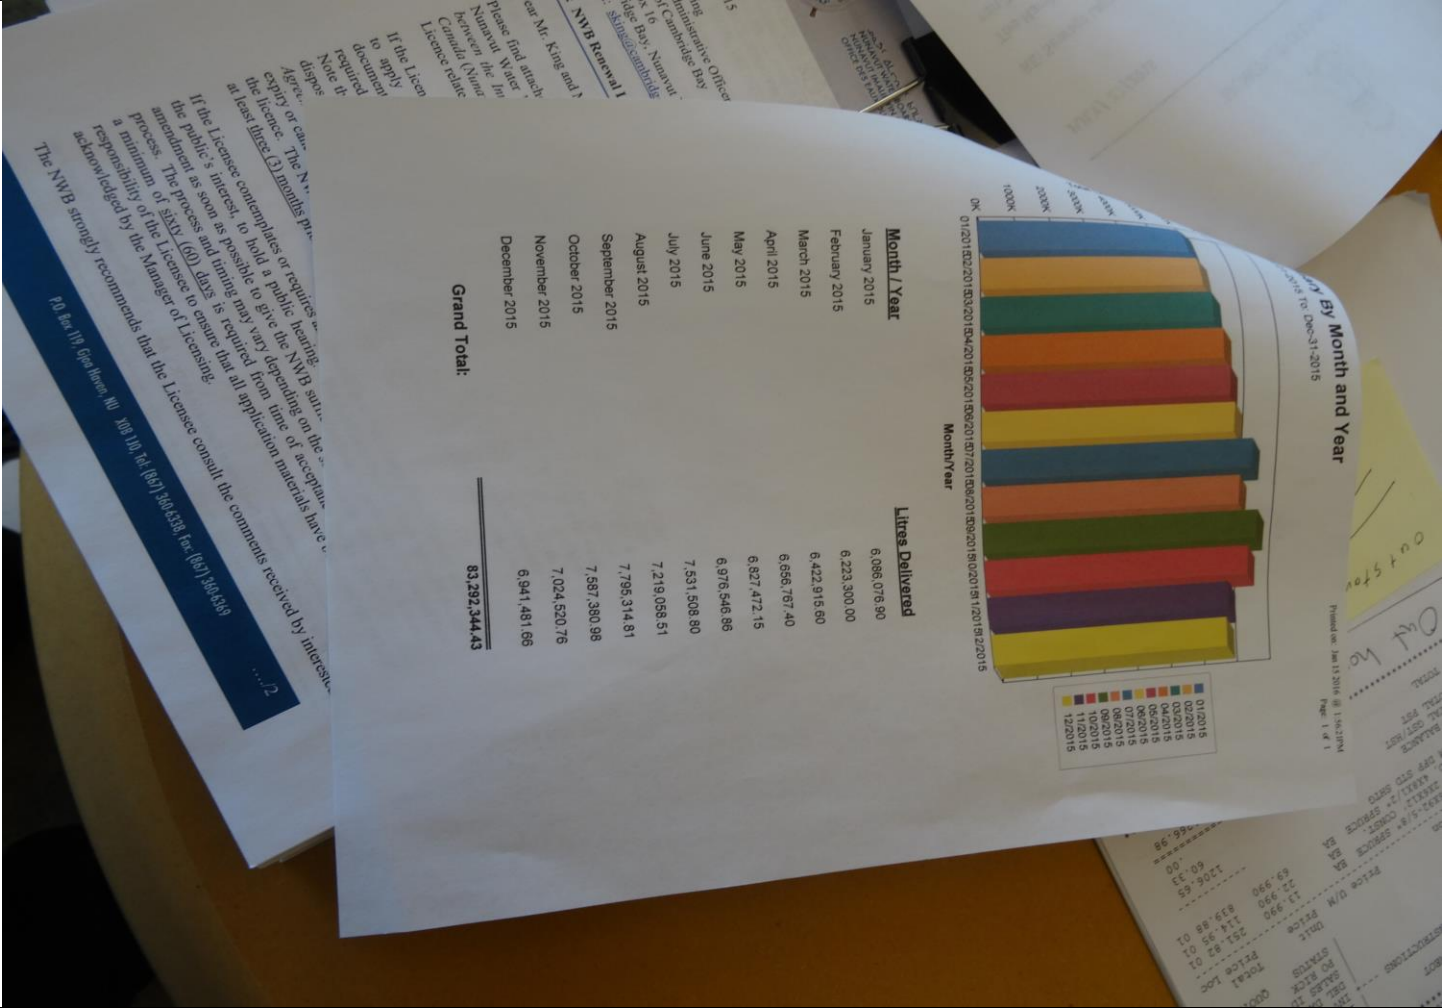
Photo 10

Description: The only Water Consumption Report that I saw
