WATER LICENCE INSPECTION FORM

Licensee		Licensee Representative	
Hamlet of Cambridge Bay		Jim MacEachern	
Licence No. / Expiry		Representative's Title	
3BM-CAM1520		Assistant Senior Administrative Officer	
Land / Other Authorizations		Land / Other Authorizations	
Date of Inspection		Inspector	
July 14, 2017		Baba Pedersen	
Activities Inspected			
<input type="checkbox"/> Camp	<input type="checkbox"/> Drilling	<input type="checkbox"/> Mining	<input type="checkbox"/> Construction
<input type="checkbox"/> Roads/Hauling	<input type="checkbox"/> Other:	<input checked="" type="checkbox"/> Other: Municipal Water License	<input type="checkbox"/> Reclamation
<input type="checkbox"/> Fuel Storage

PHOTO LOG

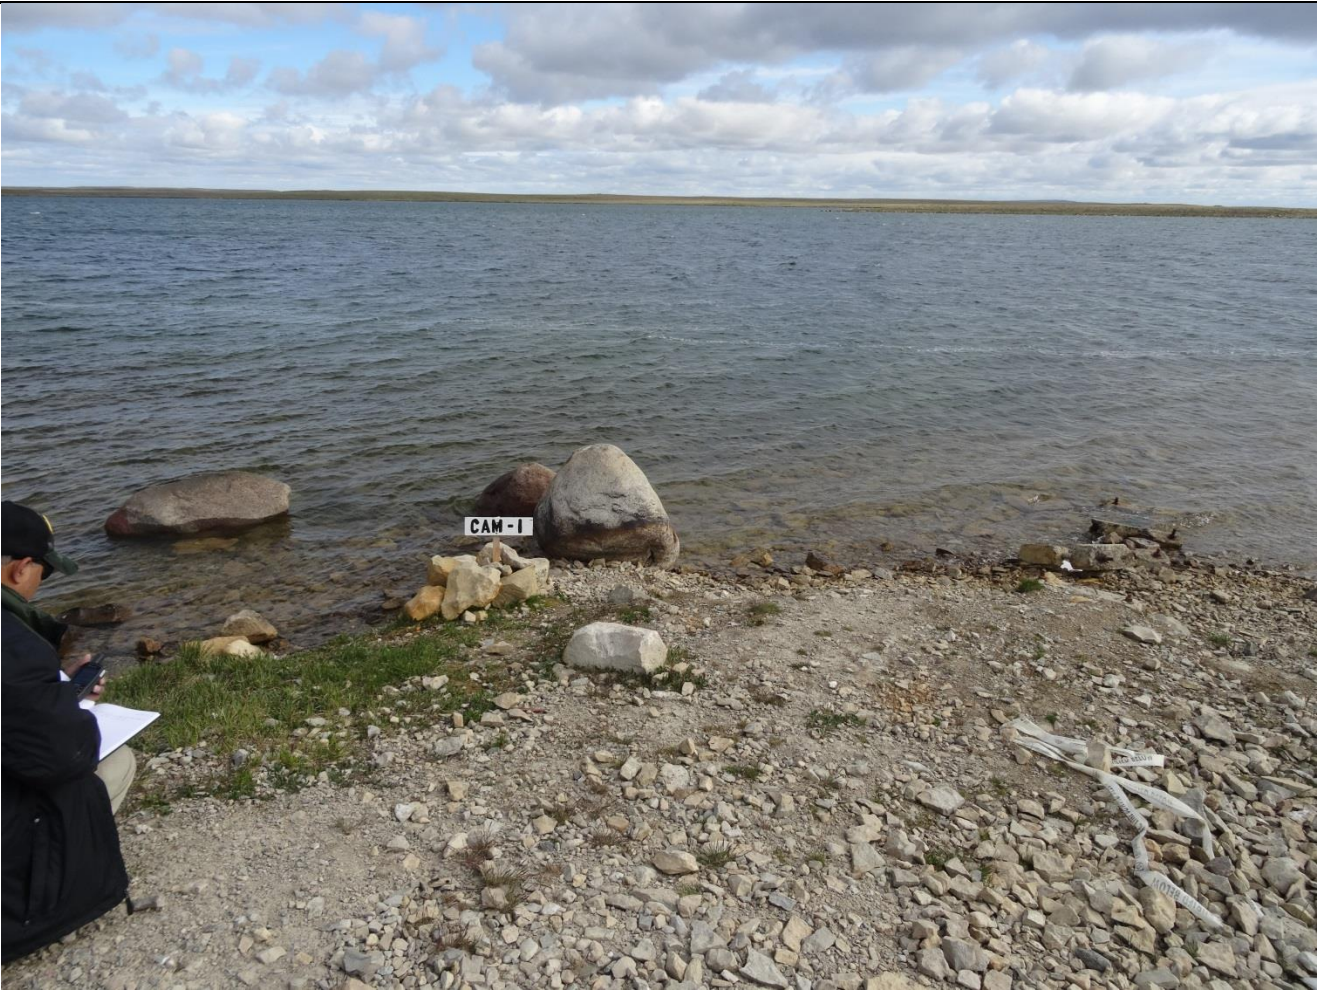
Photo 1

1. At the new Water Intake Building the Fuel Tank, which is a single wall with no berm, is only 16 meters from the edge of the lake. 2. The CAM-1 Sample Station (Photo 1) @ N 69* 08’ 19.6” W 105* 03’ 55.5” is still located at the old location. 3. At the new Water Treatment Plant (Photo 3) I saw the Flow Meter (Photo 2) which records the amount of Raw Water taken out of the lake. They have used 43,307 cubic meters of water to date, which is in allowable limits. 4. At the Sewage Lagoon I saw the Primary Sewage Truck Dumping Station (Photo 4) at N 69* 07’ 41.7” W 105* 02’ 24.1” where the Lagoon Liner has been repaired. 5. At the Garbage Dump there was very nice Signage (Photo 5), and 6. I noticed that the Dump is nicely Organized and Segregated (Photo 6). 7. At the Metal Dump I saw that the Lined Berm Area (Photos 7 & 8) at N 69* 07’ 27.4” W 105* 01’ 29.4” has been Emptied, Dried and Sorted as per my 2016 request, and 8. Hazardous Materials are well organized and segregated (Photo 9) with adequate Signage, and 9. There was very nice Signage (Photo 10) at the Entrance to the Metal Dump. 10. Annual Reports have been submitted on time.

Description: Move this existing Sample Station CAM-1 and Signage to the end of the NEW Water Intake

1. The Fuel Tank MUST be Removed and Relocated a minimum of 31 Meters from the High Water Mark and it MUST either be a Double-Walled Tank or be placed within an approved Secondary Containment Berm. 2. The CAM-1 Sample Station and Signage needs to be moved to the end of the new Intake. 3. Thank you for having a critical part of the Water License Requirements available on request. 4. Nice Job of repairing the tear in the Liner as requested in 2016. 5 & 6. Good Job with the Garbage Dump. 7. Thank you for doing a good job of Emptying, Drying Out and Sorting the Lined Berm area in the Metal Dump as requested in 2016, this is much appreciated. 8 & 9. Good Job with the Metal Dump.

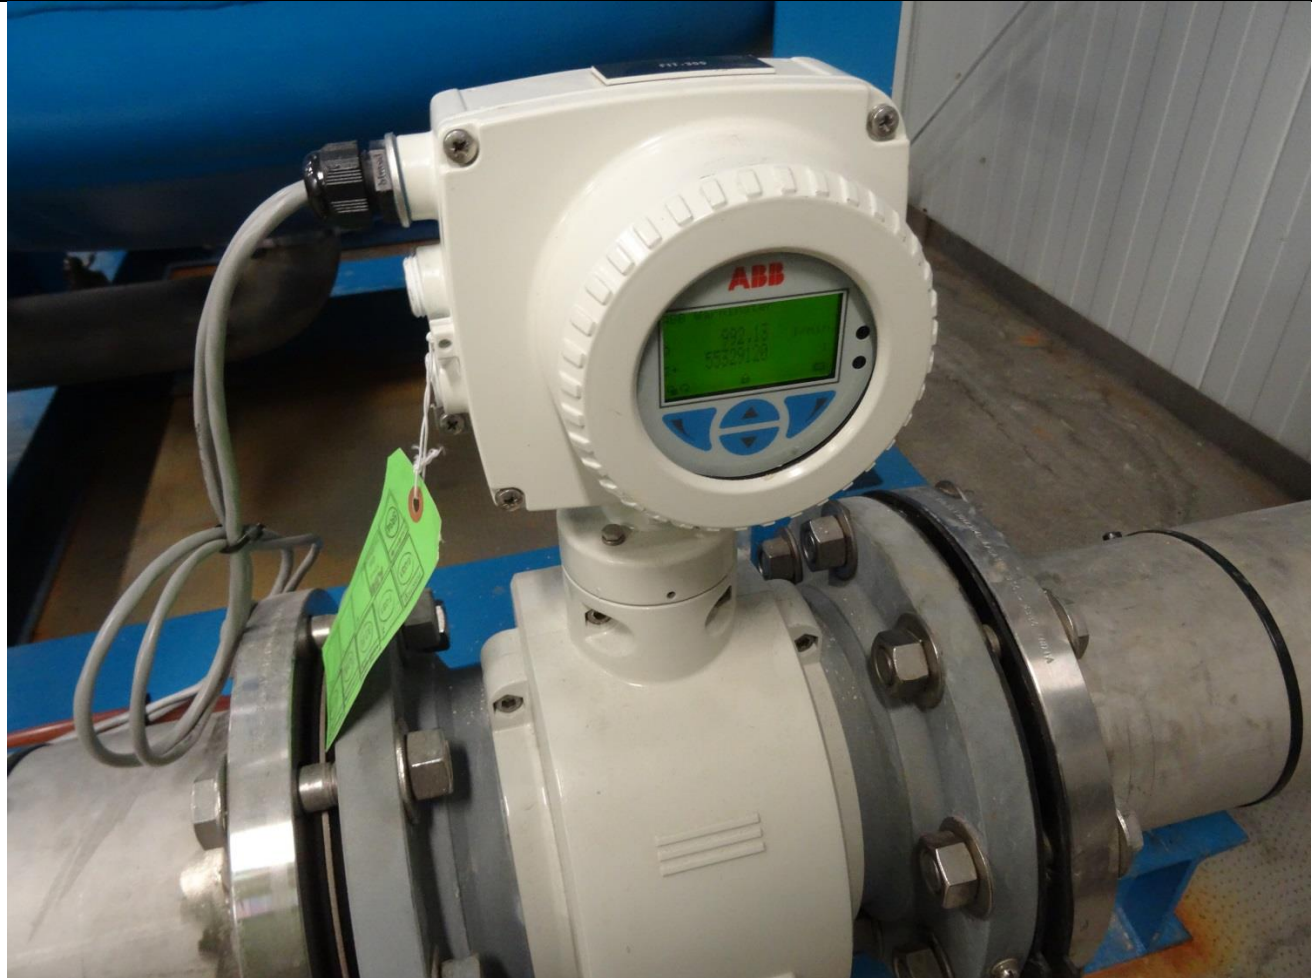
Photo 2

Description: Flow Meter on Raw Water Intake in New Water Treatment Plant – 43,307 Cubic Meters to date

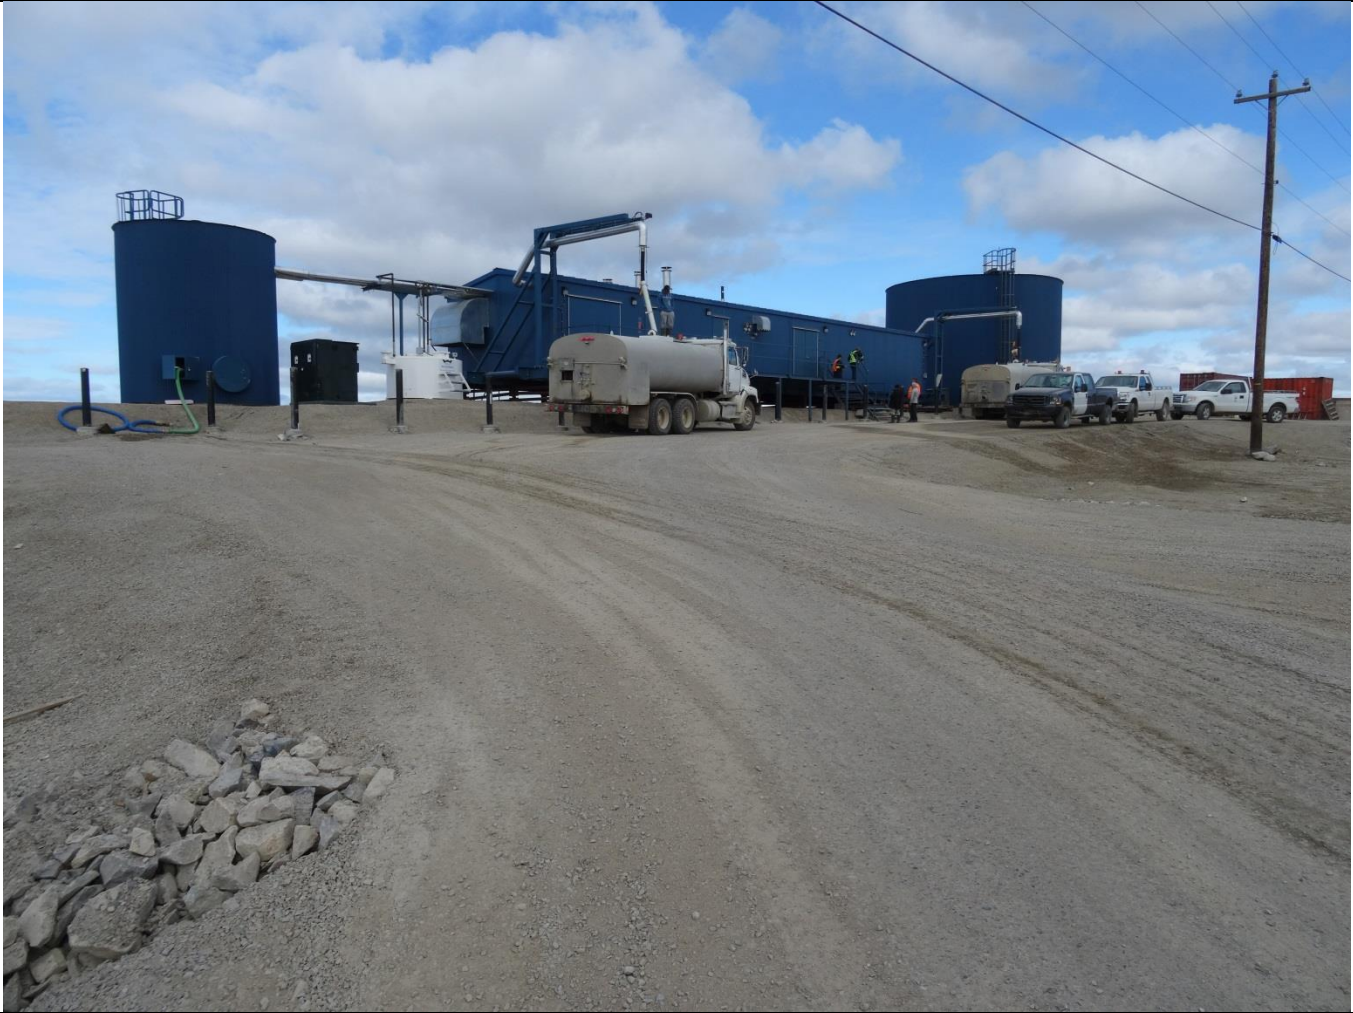
Photo 3

Description: Outside view of new Water Treatment Plant and Truck Fill Station

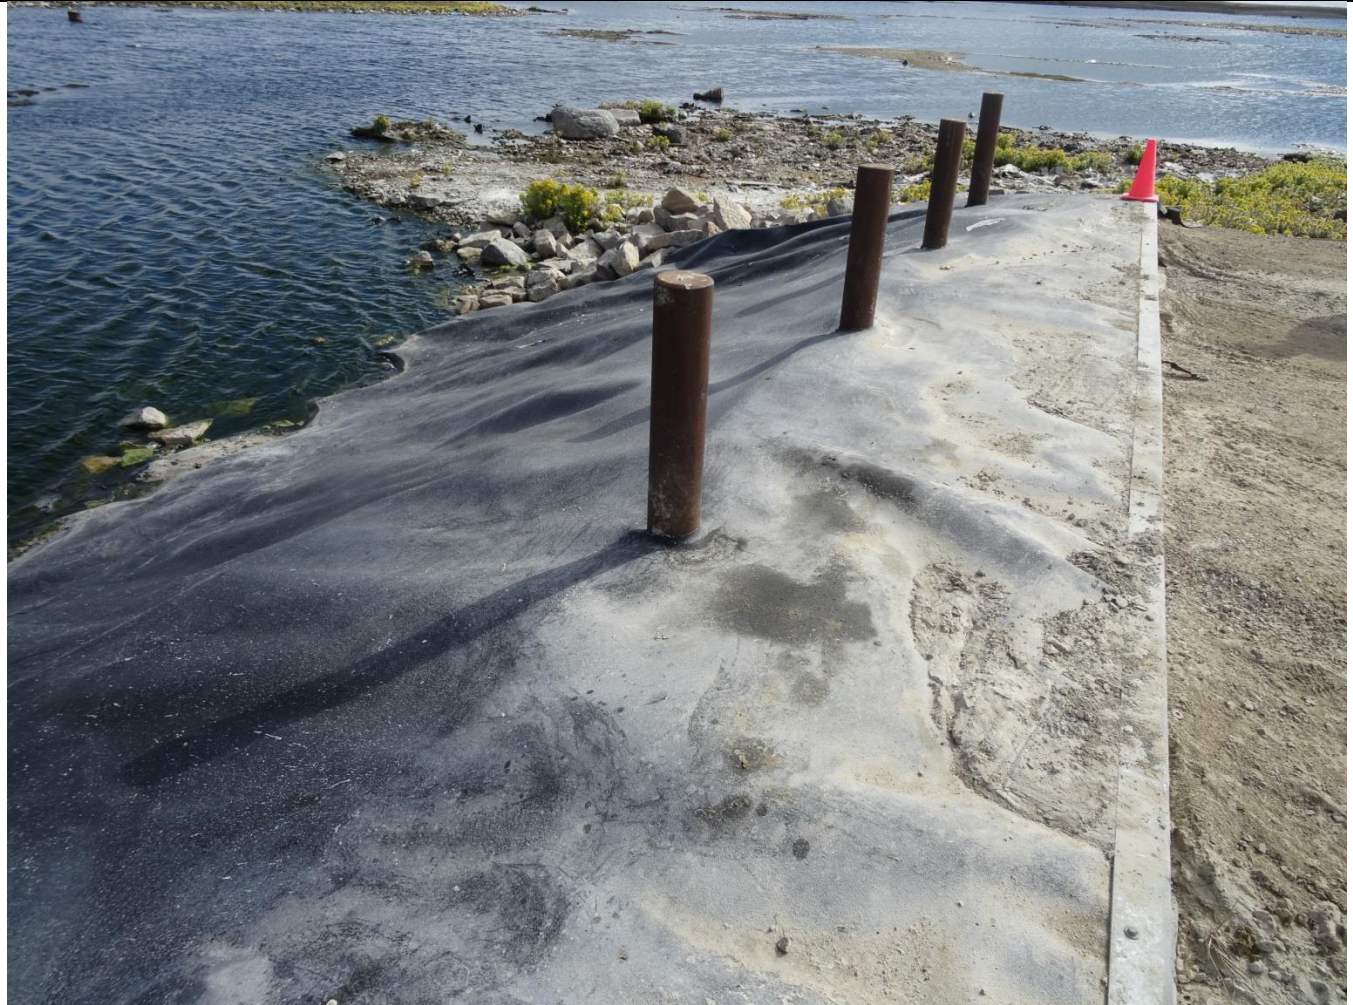
Photo 4

Description: Primary Sewage Truck Dumping Station showing Repaired Liner as per 2016 Inspector Instructions

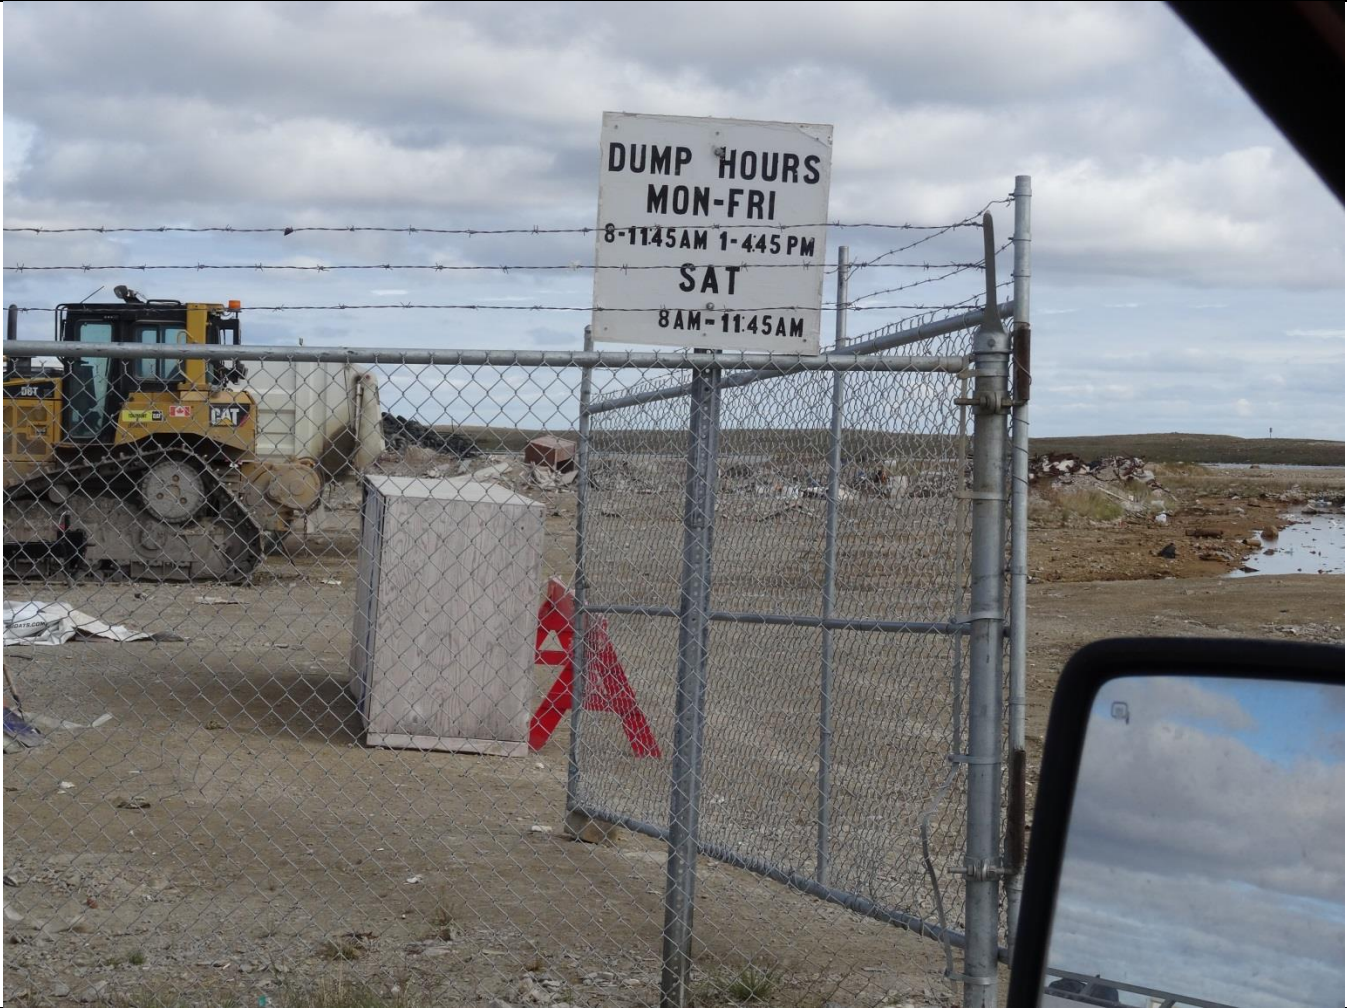
Photo 5

Description: Gated Fence at Garbage Dump with Signage indicating Hours of Operation

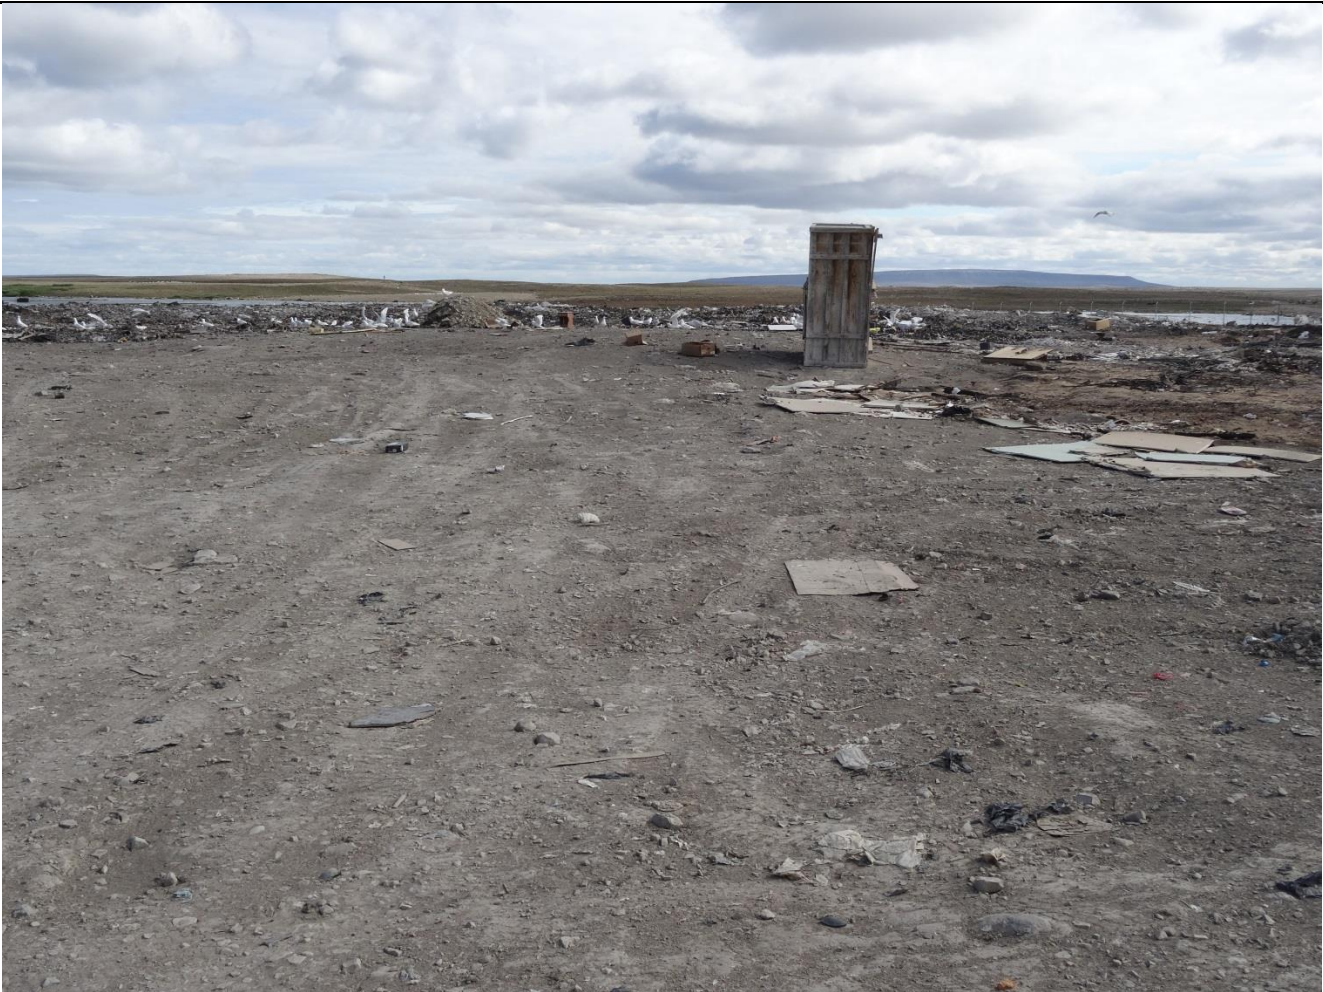
Photo 6

Description: Interior of Garbage Dump is nicely Organized and Segregated

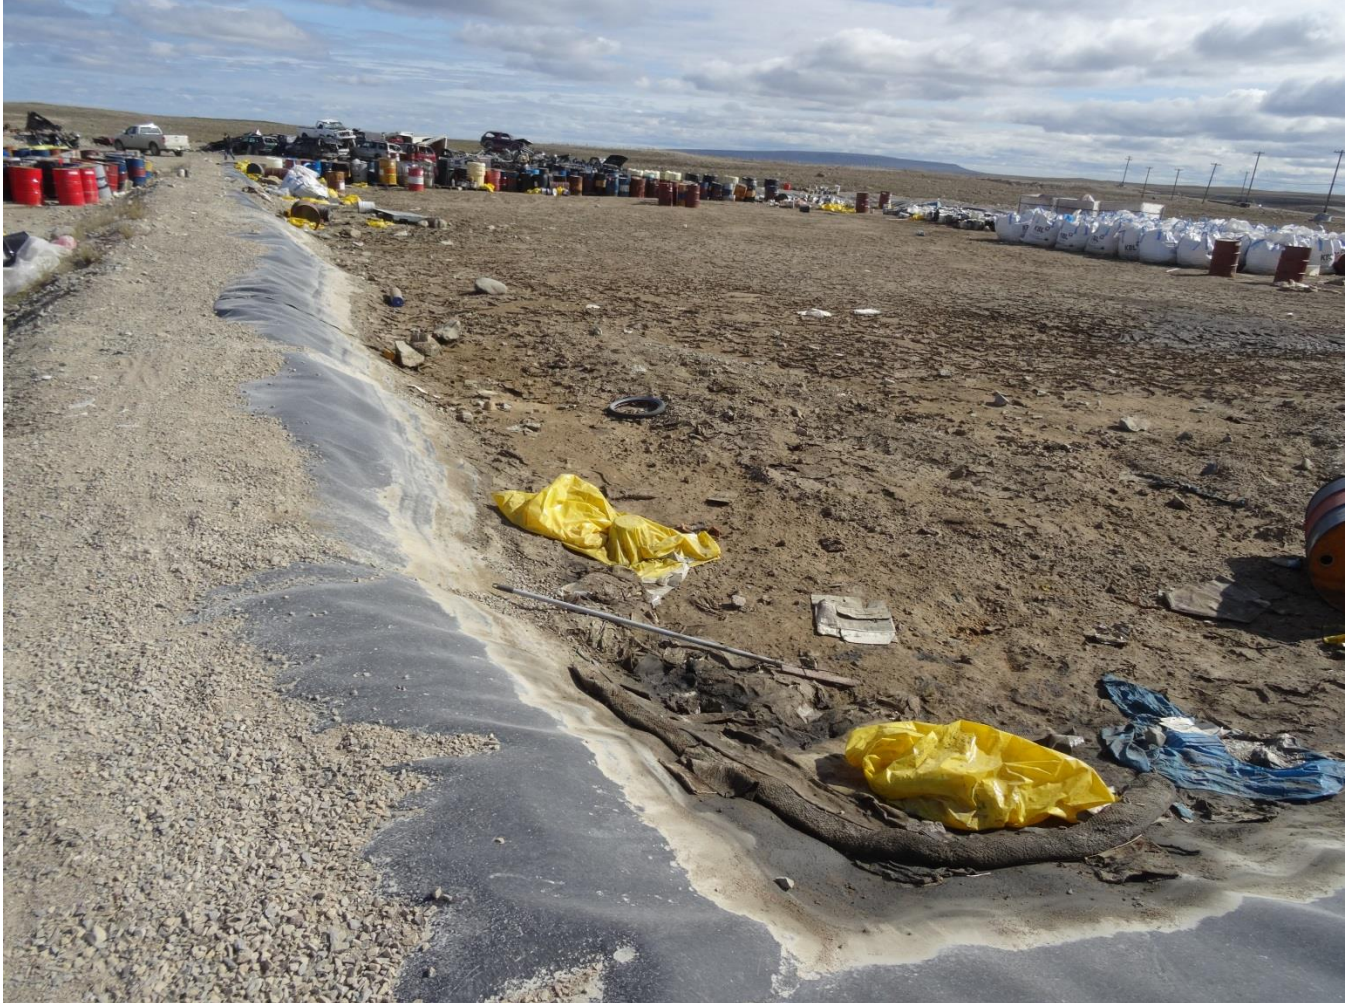
Photo 7

Description: View #1 of Lined Berm Area inside Metal Dump, has been Emptied, Dried and Sorted as per 2016 Inspection – Very Nice Job!

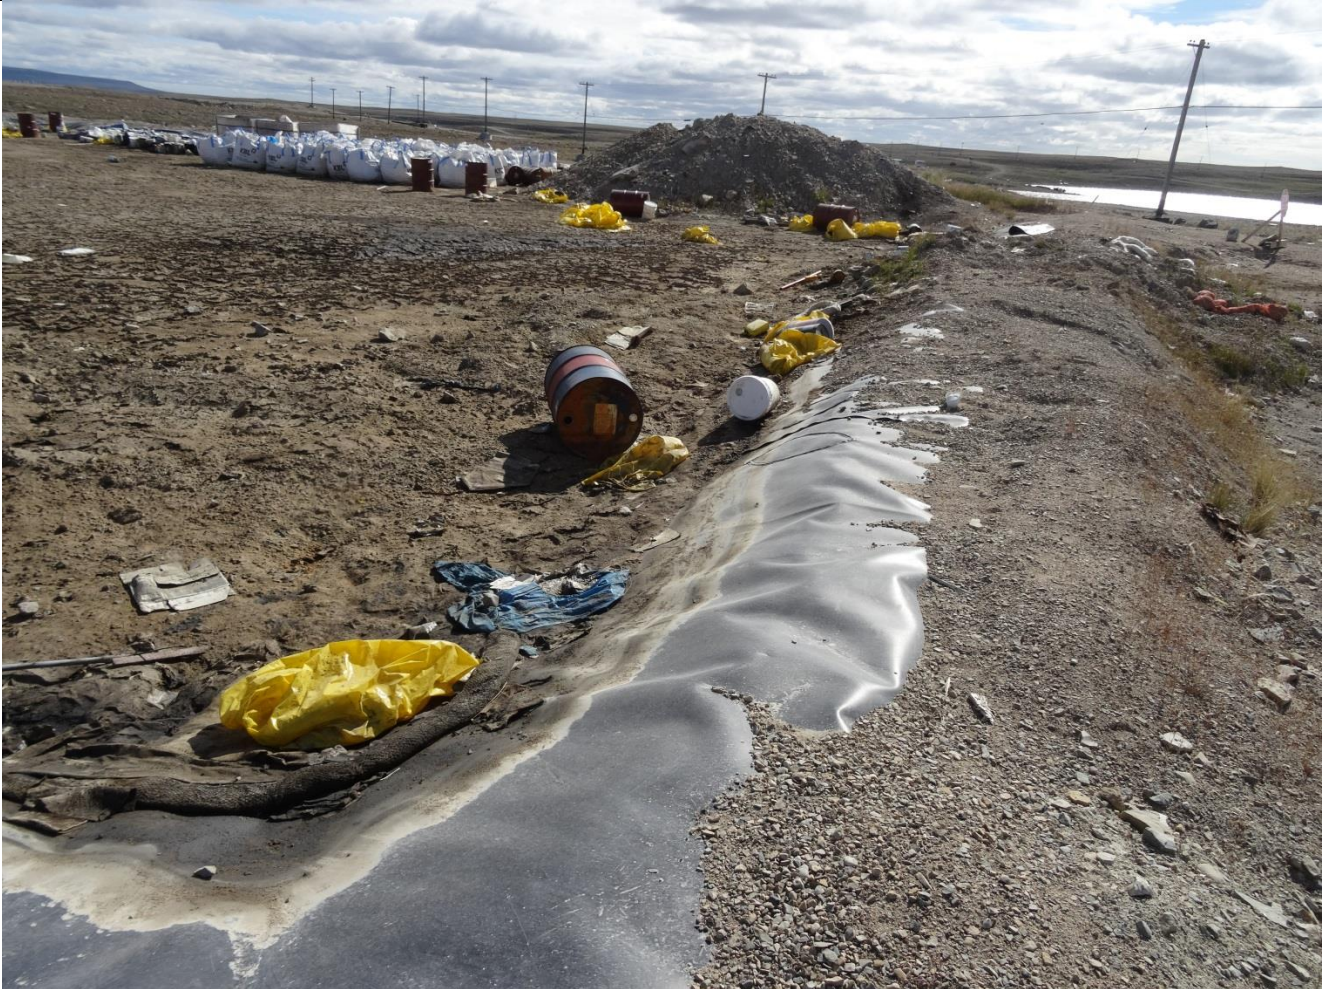
Photo 8

Description: View #2 of Lined Berm Area inside Metal Dump, has been Emptied, Dried and Sorted as per 2016 Inspection – Very Nice Job!

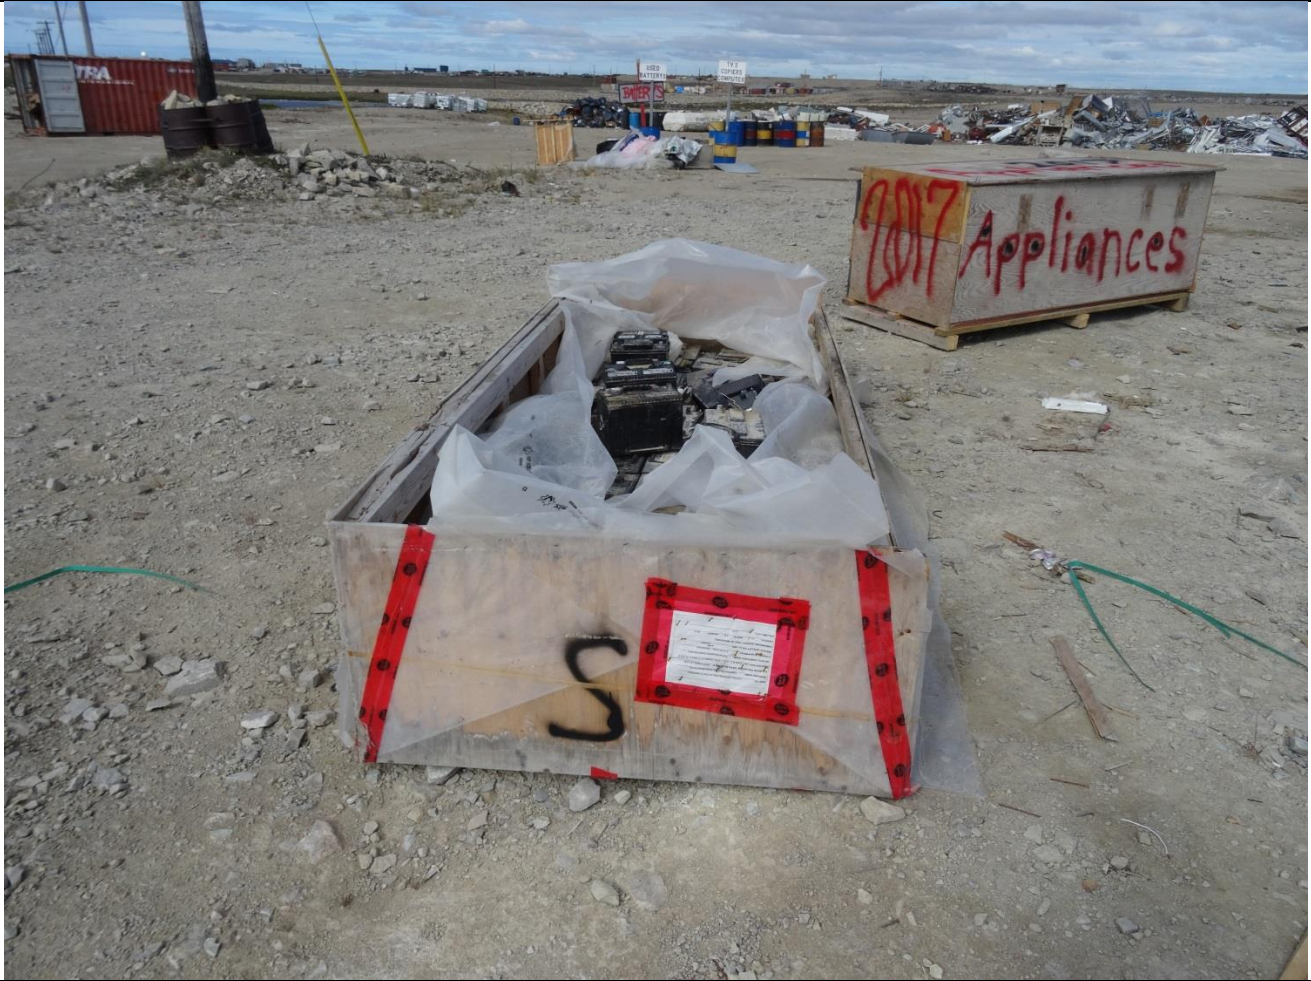
Photo 9

Description: Used Battery Storage in Metal Dump – well Organized and Segregated with adequate Signage

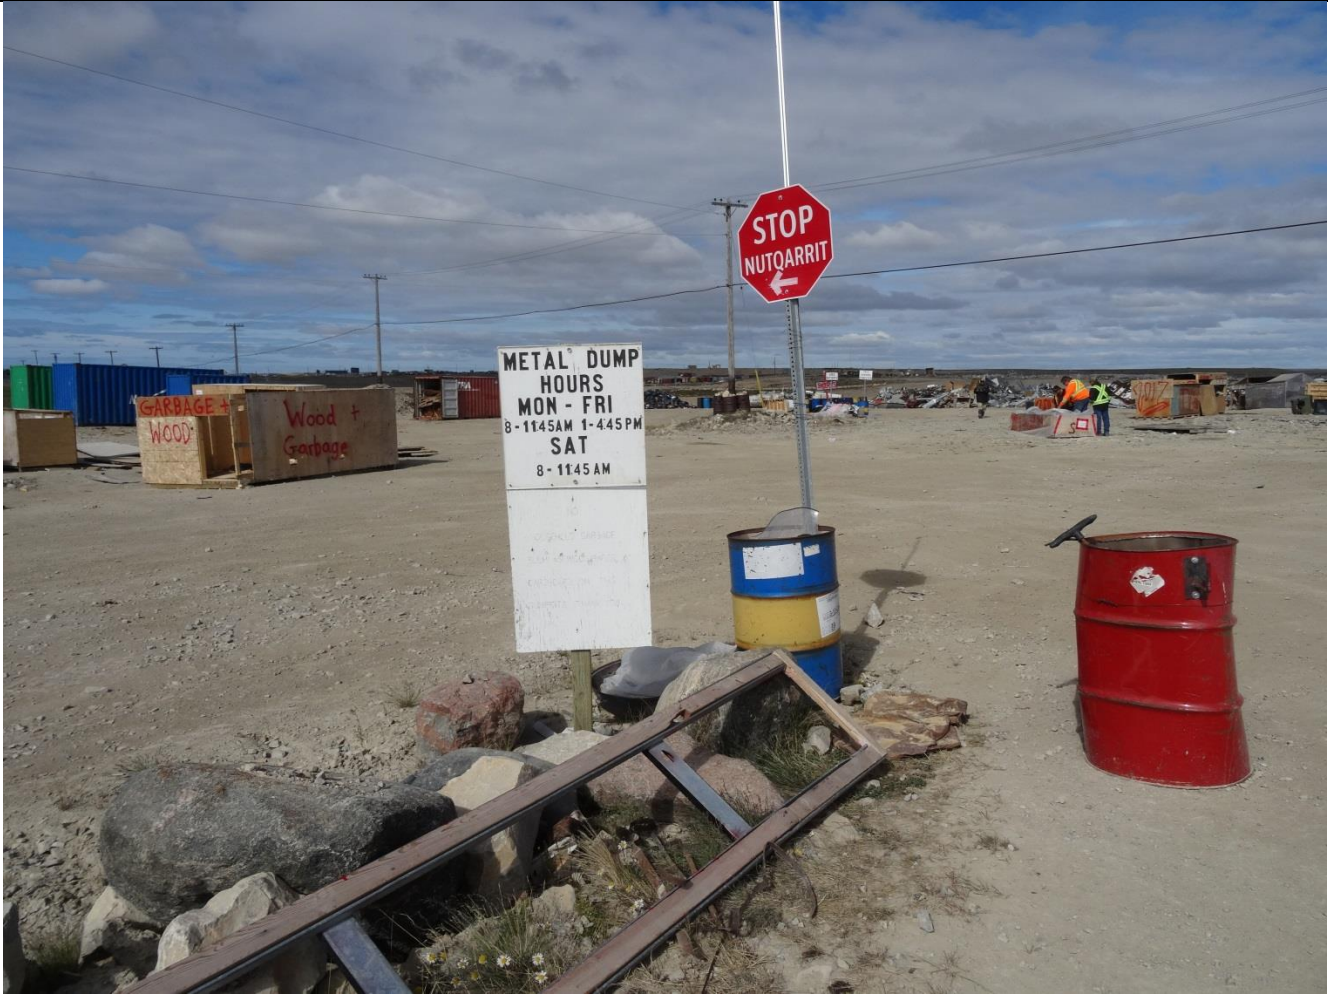
Photo 10

Description: Signage at Entrance to Metal Dump indicating Hours of Operation
