WATER LICENCE INSPECTION FORM

Licensee	Licensee Representative
Hamlet of Cambridge Bay	NA
Licence No. / Expiry	Representative's Title
3BM-CAM2030	NA
Land / Other Authorizations	Land / Other Authorizations
	--
Date of Inspection	Inspector
September 6, 2021	Jonathan MESHER
Activities Inspected	
<div><input type="checkbox"/> Camp<input type="checkbox"/> Drilling<input type="checkbox"/> Mining<input type="checkbox"/> Construction<input type="checkbox"/> Reclamation<input type="checkbox"/> Fuel Storage</div> <div><input type="checkbox"/> Roads/Hauling<input type="checkbox"/> Other:<input checked="" type="checkbox"/> Other: Hamlet waste storage.</div>

On September 06, 2021, I Jonathan Mesher conducted an inspection of the Waste storage facilities to ensure compliance with the terms and conditions of the Water licence 3BM-CAM2030.

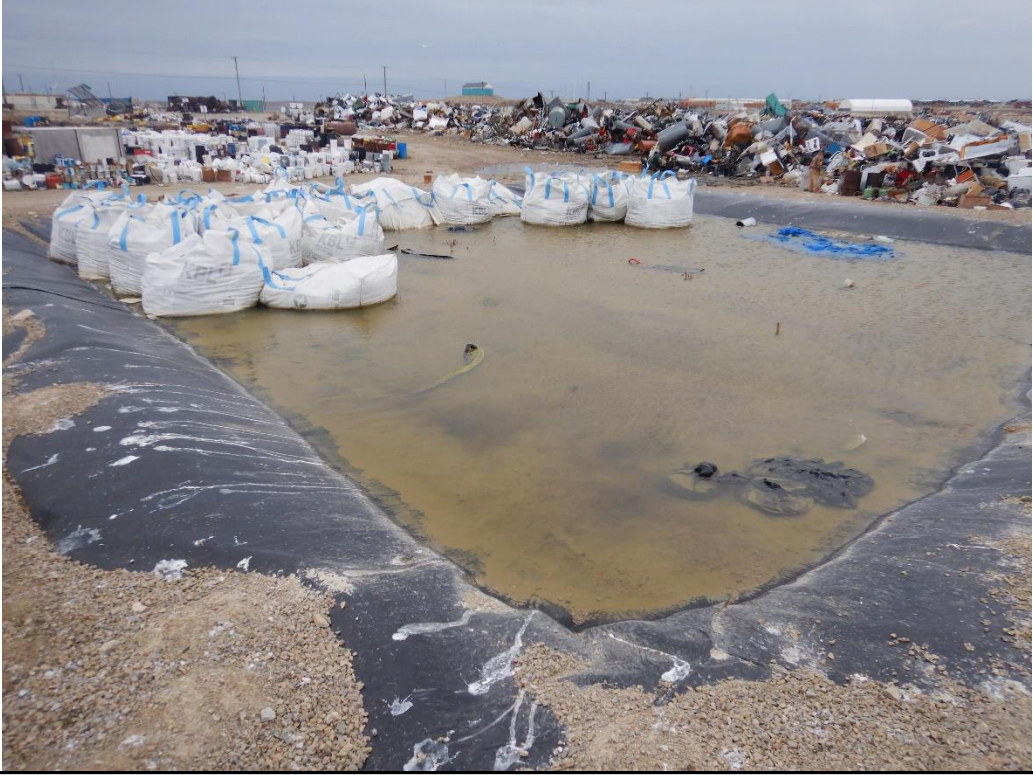
Date	Camera	Inspector	Authorization
	Sony Cyber-shot	J.Mesher	3BM-CAM
Photo Log			
Photo 2

b) During the inspection the Hazardous material containment cells appeared to be retaining water and it appeared that there was significant room in this containment. See photos 2 and 3 for the hazardous material berm.

Description: containment cell with space for waste

1) The licensee is to ensure all Hazardous waste is segregated and stored in a way to prevent waste from entering water, the inspector recommends storing all hazardous waste at the metal waste area within the berms on site.

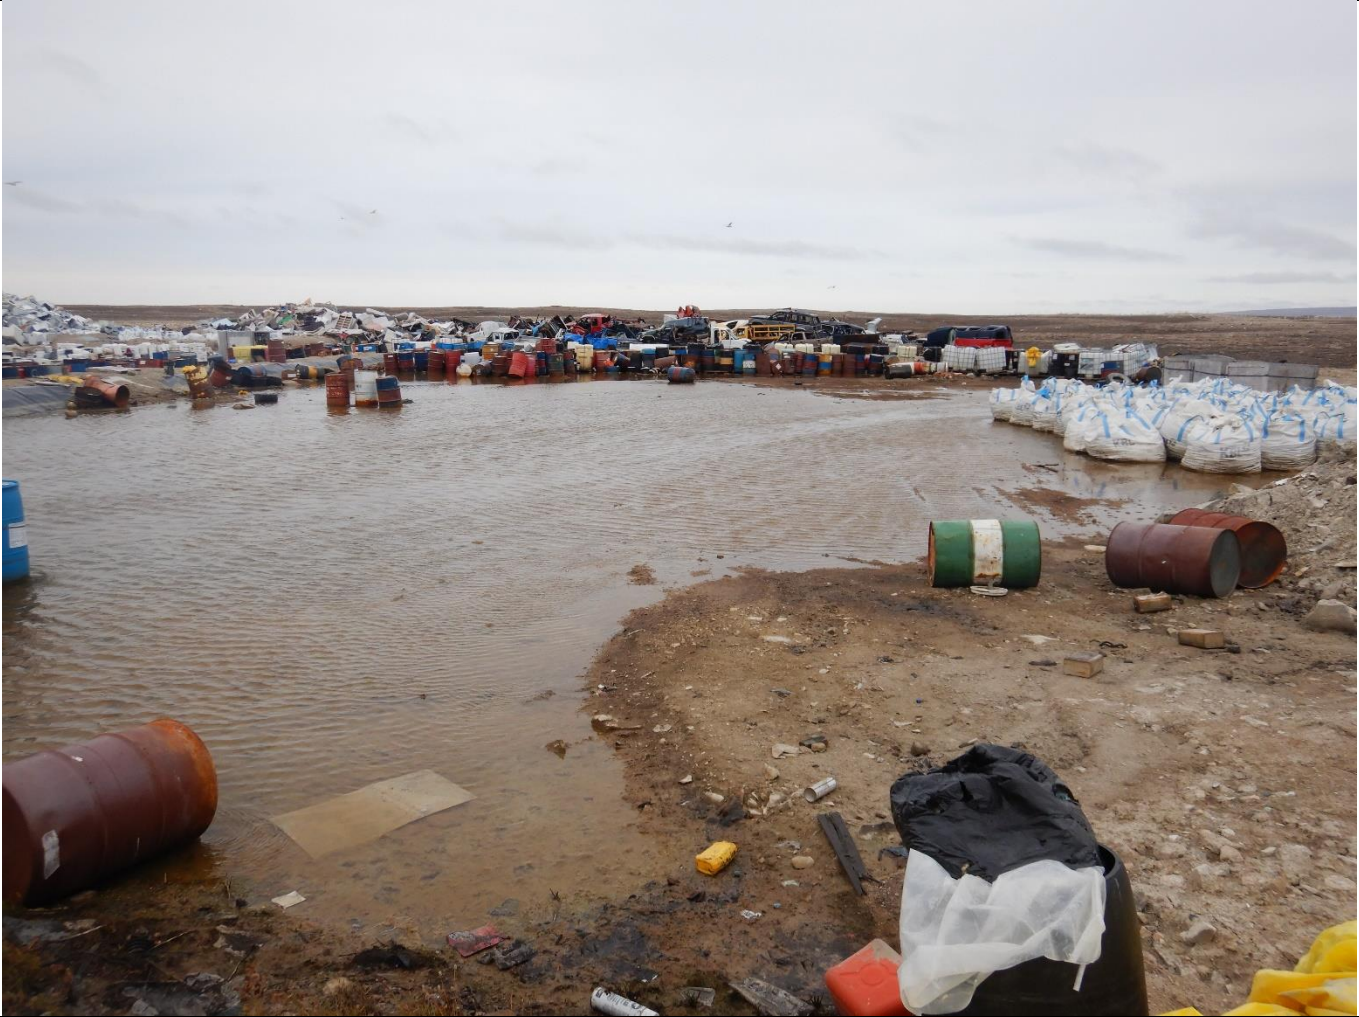
Date	Camera	Inspector	Authorization
	Sony Cyber-shot	J.Mesher	3BM-CAM
Photo Log			
Photo 3

Description: waste outside of containment near pooling water.

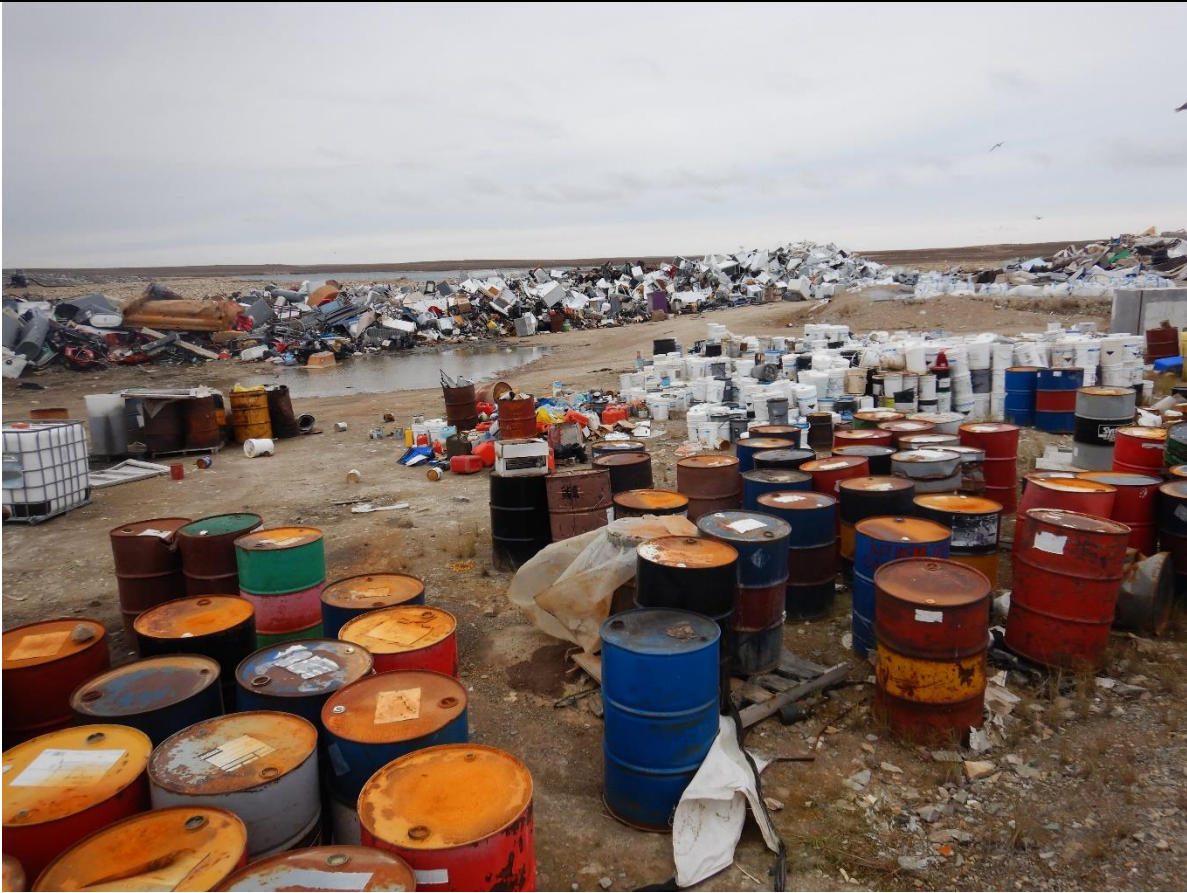
Photo 4

c) The inspector noted significant hazardous material outside on containment within the metal dump. See photos 4, 5 and 6 for the waste mentioned.

Description: various wastes outside of containment

2) The licensee is to provide a plan to sort, package and ship hazardous materials out in the next sealift season to an approved facility.			
3) The licensee is to ensure only approved waste is burnt within the landfill.

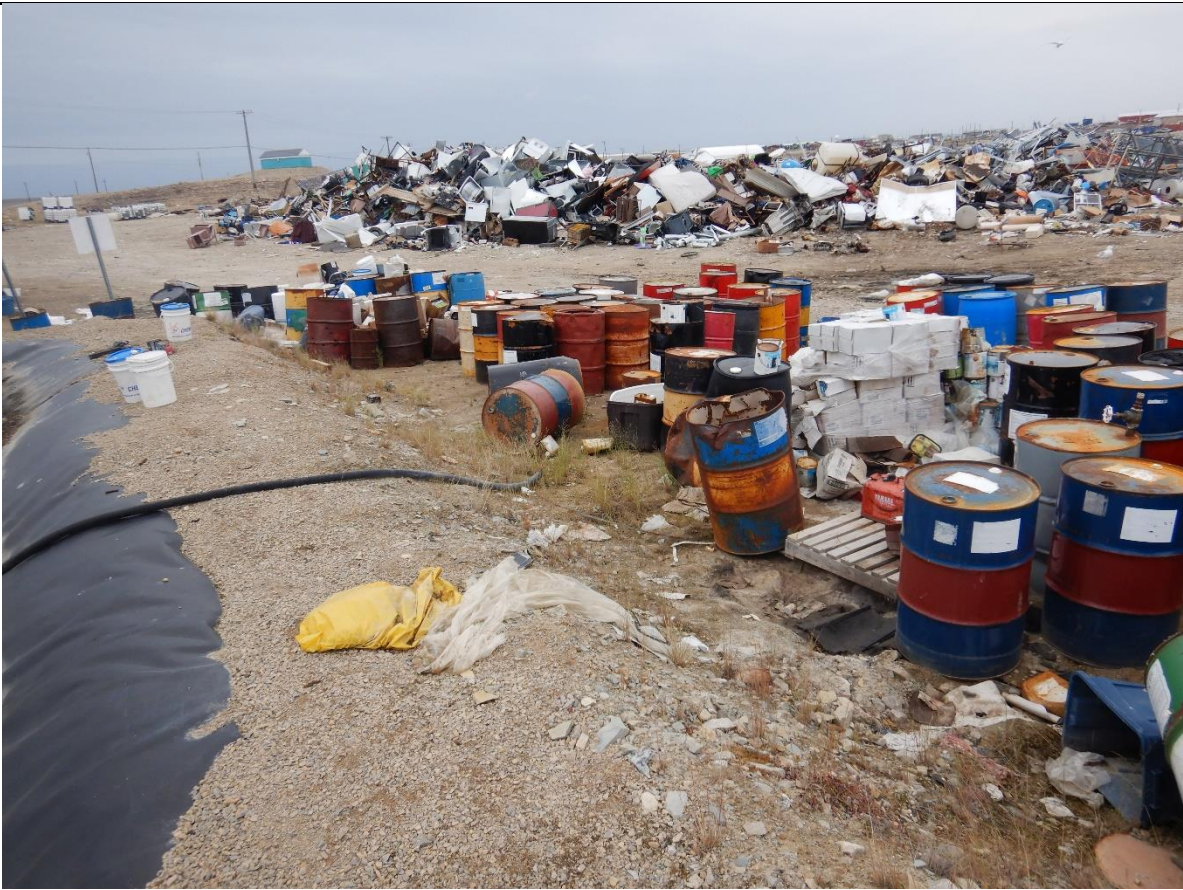
Photo 5

Description: barrels outside of containment

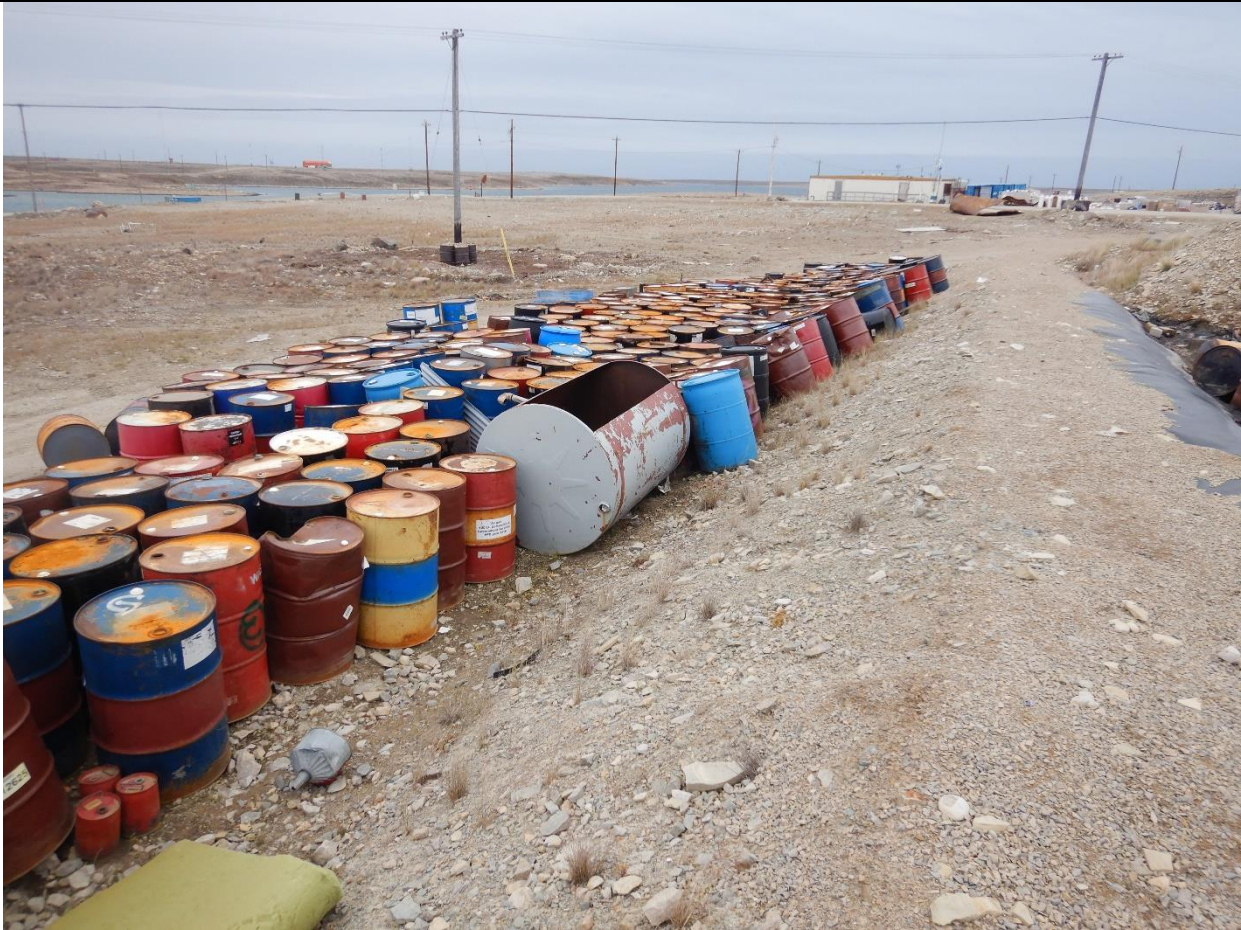
Photo 6

Description: Barrels outside of containment.

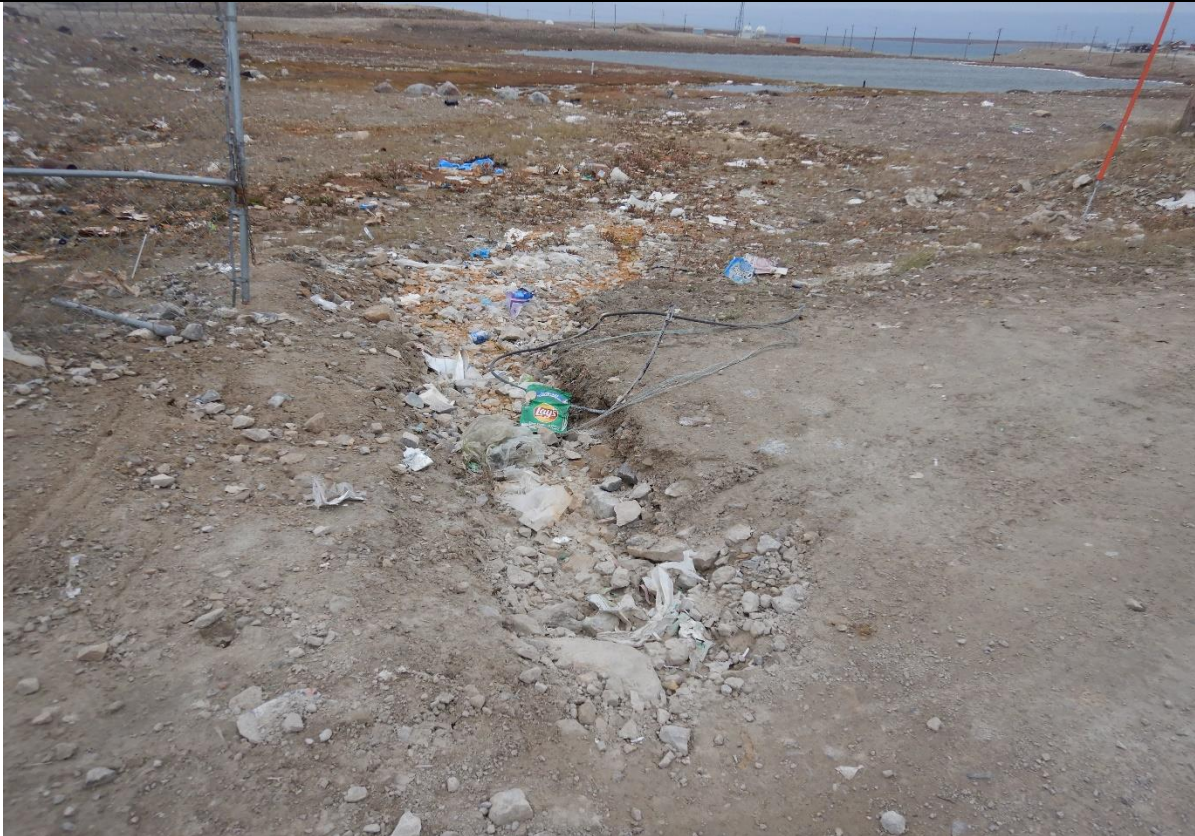
Photo 7

a) During the inspection there was signs of erosion near the landfill gate, the slope of the area indicates the water causing the erosion is originating from within the landfill. PART D item 2 of the licence 3BM-CAM2030 states; “The Licensee shall direct Effluent from the Solid Waste Disposal Facility to the Retention Sewage Lagoon as required.” See photo 7 for the erosion noted.

Description: erosion near landfill entrance indicating effluent leaving the facility

4) The licensee is to ensure all effluent from the landfill is captured in the retention sewage lagoon as required in the licence.			
5) The licensee is to provide water consumption records for 2020 and 2021 to date.			
Inspector's Name			
Jonathan MESHER			
Signature
