WATER LICENCE INSPECTION FORM

Licensee	Licensee Representative
Hamlet of Cambridge Bay	NA
Licence No. / Expiry	Representative's Title
3BM-CAM2030	NA
Land / Other Authorizations	Land / Other Authorizations
	--
Date of Inspection	Inspector
June 30, 2022	Jonathan MESHER
Activities Inspected	
<div><input type="checkbox"/> Camp<input type="checkbox"/> Drilling<input type="checkbox"/> Mining<input type="checkbox"/> Construction<input type="checkbox"/> Reclamation<input type="checkbox"/> Fuel Storage</div> <div><input type="checkbox"/> Roads/Hauling<input type="checkbox"/> Other:<input checked="" type="checkbox"/> Other: Hamlet waste storage.</div>

On June 30, 2022, I Jonathan Mesher conducted an inspection of the Waste storage facilities to ensure compliance with the terms and conditions of the Water licence 3BM-CAM2030. During the 2022 inspection all concerns noted in the September 2021 were still identified as a concern the following is the concerns noted in 2021 and 2022.

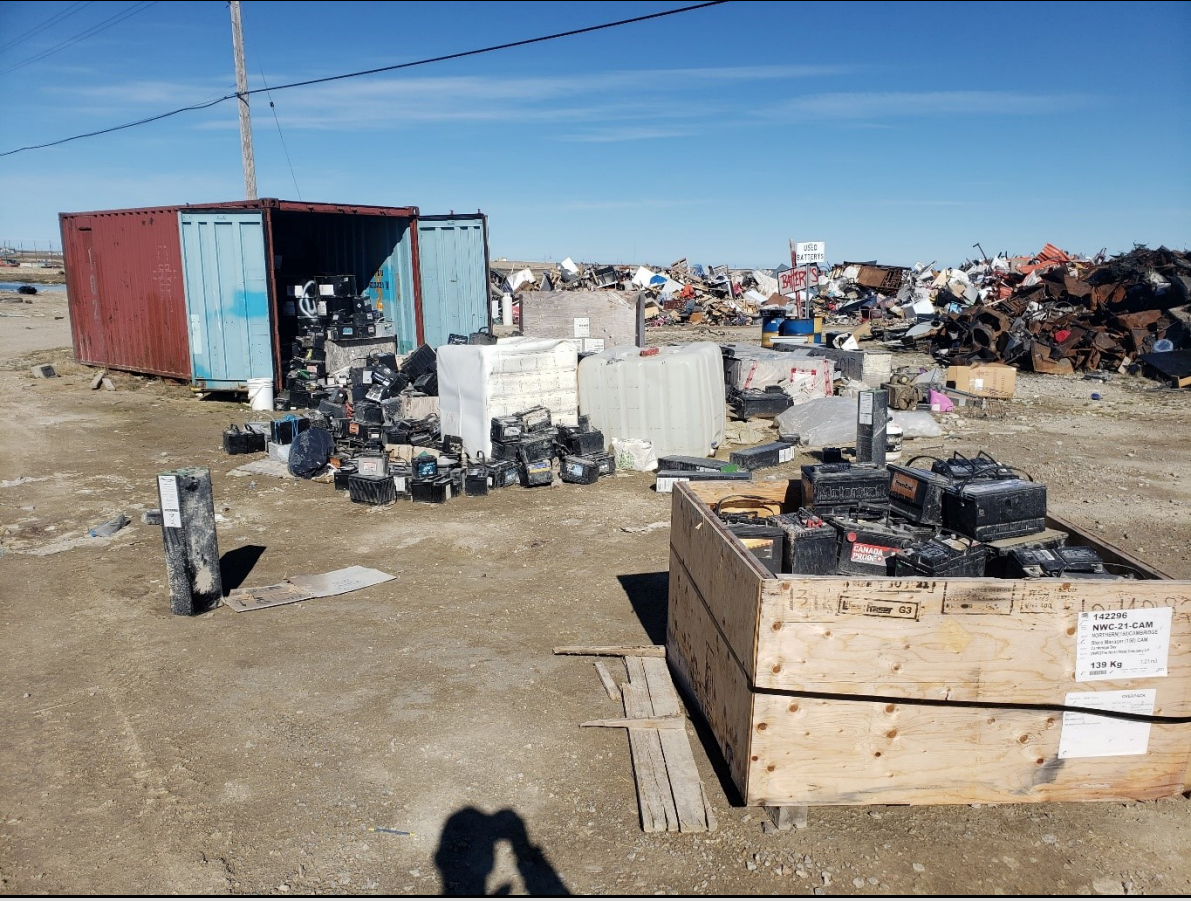
Date	Camera	Inspector	Authorization
June 20, 2022	Sony Cyber-shot	J.Mesher	3BM-CAM
Photo Log			
Photo 1

a) During the inspection there was various batteries stored inside wooden boxes and a sea can, there was also batteries scattered around the storage area outside of containment. PART D, item 11 of the licence 3BM-CAM2030 states; “The Licensee shall segregate and store all hazardous materials and/or hazardous Waste within the Solid Waste Disposal Facility in such a manner as to prevent the deposit of deleterious substances into any Water, until such a time that the materials have been removed for proper disposal at an approved facility.” see photo 1 for the battery storage.

Description: batteries outside of containment

1) The licensee is to ensure all Hazardous waste is segregated and stored in a way to prevent waste from entering water, the inspector recommends storing all hazardous waste at the metal waste area within the berms on site.

2) The licensee is to provide a plan to sort, package and ship hazardous materials to an approved waste management facility due to inability to store the excess of hazardous materials.

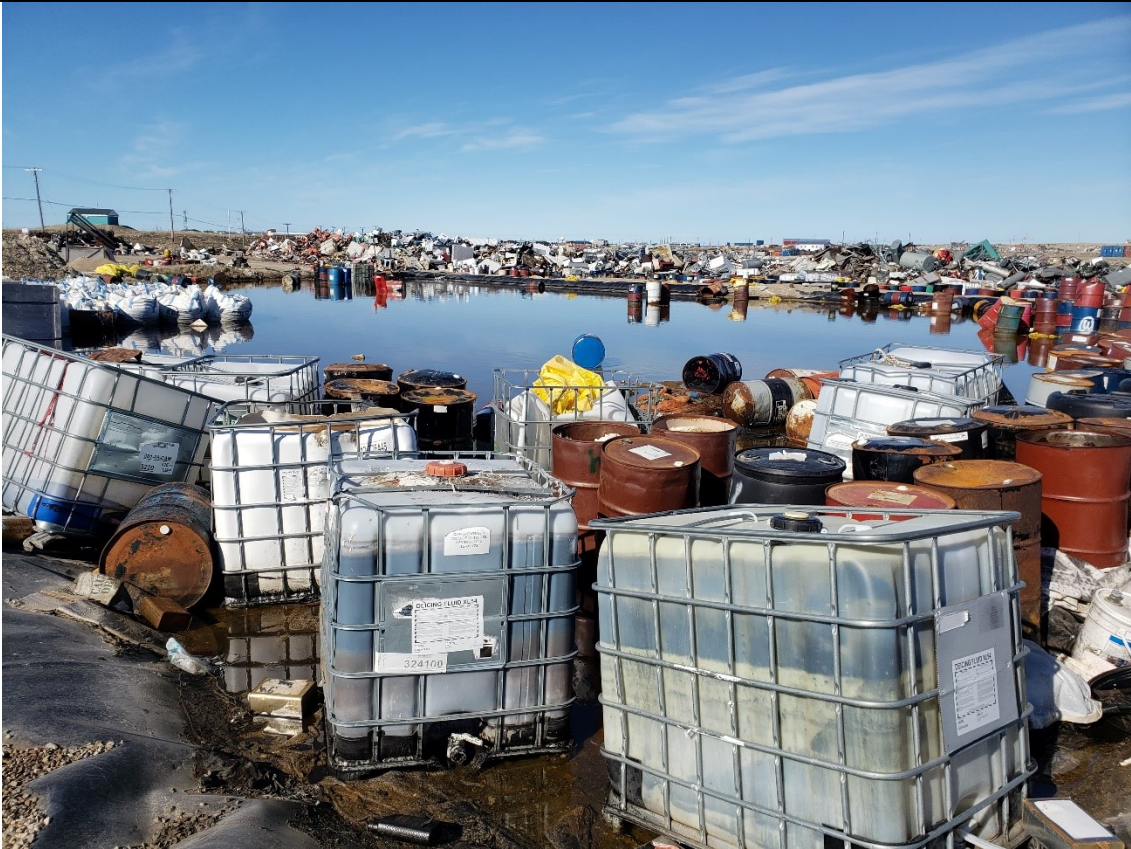
Date	Camera	Inspector	Authorization
June 20, 2022	Sony Cyber-shot	J.Mesher	3BM-CAM
Photo Log			
Photo 2

b) During the inspection the Hazardous material containment cells appeared to be retaining water and it appeared that there was significant room in this containment. See photos 2 and 3 for the hazardous material berm.

Description: containment cell with space for waste
