APPENDIX-E:
AMEC GEOTECHNICAL ENGINEER'S INSPECTION REPORT TO THE NEW
P-LAKE SEWAGE LAGOON, 2008

October 24, 2008

YX00748.100

**Re: Sewage Lagoon Berm Inspection
Cape Dorset, NU**

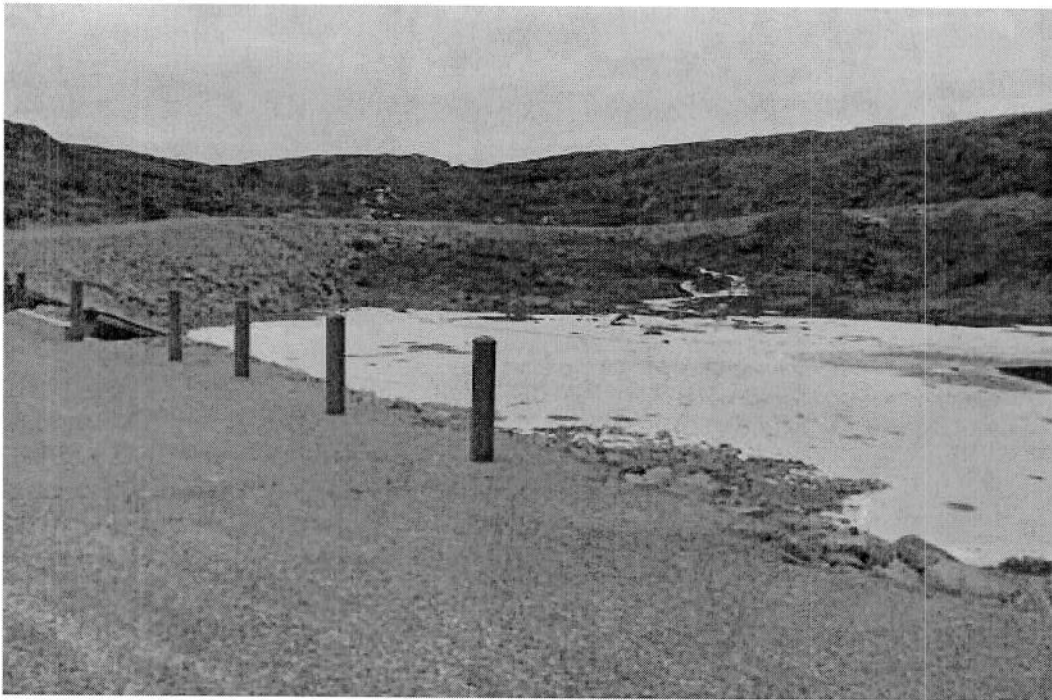
Run-off water seeping through the road way embankment into the lagoon impoundment was identified in two locations along the south roadway connecting the main west berm to the smaller north berm. The first run-off seepage was located about 100 m to 120 m south from the smaller north berm, while the second run-off seepage location was located about 20 m to 40 m south of the main berm. At these locations, water freely seeps through the road embankment, consisting of sandy crushed rock with some fines. The inflow seepage originates as run-off water from the mountain slope which is situated immediately south of the roadway. Both seepage locations are shown on Figure 1, and Photographs 1 and 2, Appendix A.

Photograph 1: First water entry area located about 100 to 120 m

The run-off water that seeps through the road embankment into the lagoon should be diverted away from the lagoon impoundment.

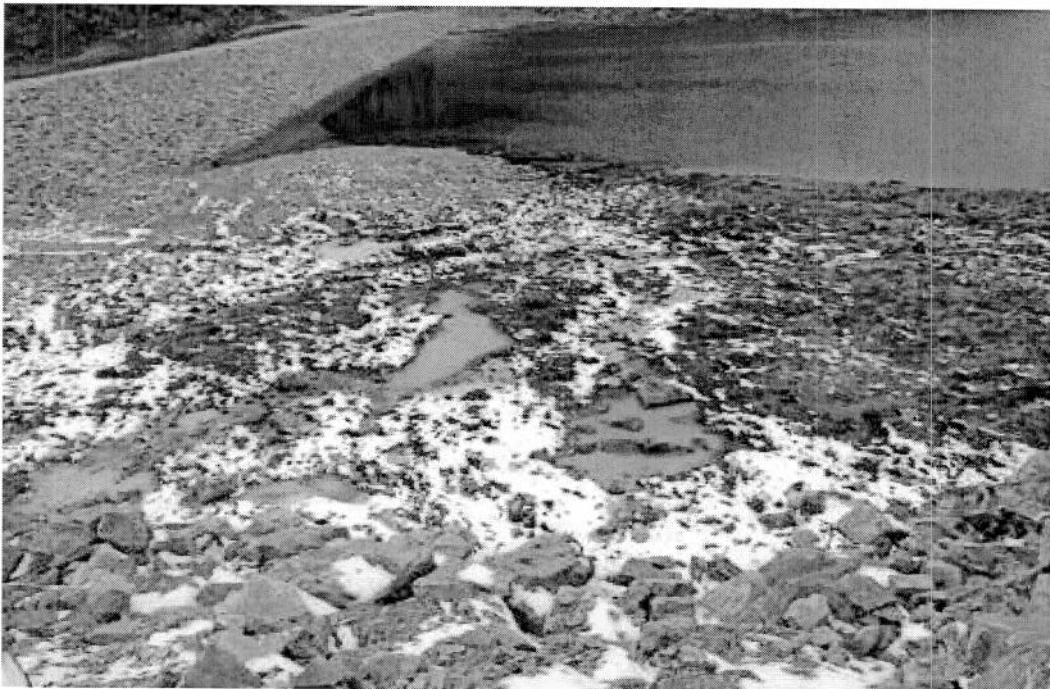
Photograph 2: Second water entry located about 20 to 40 m

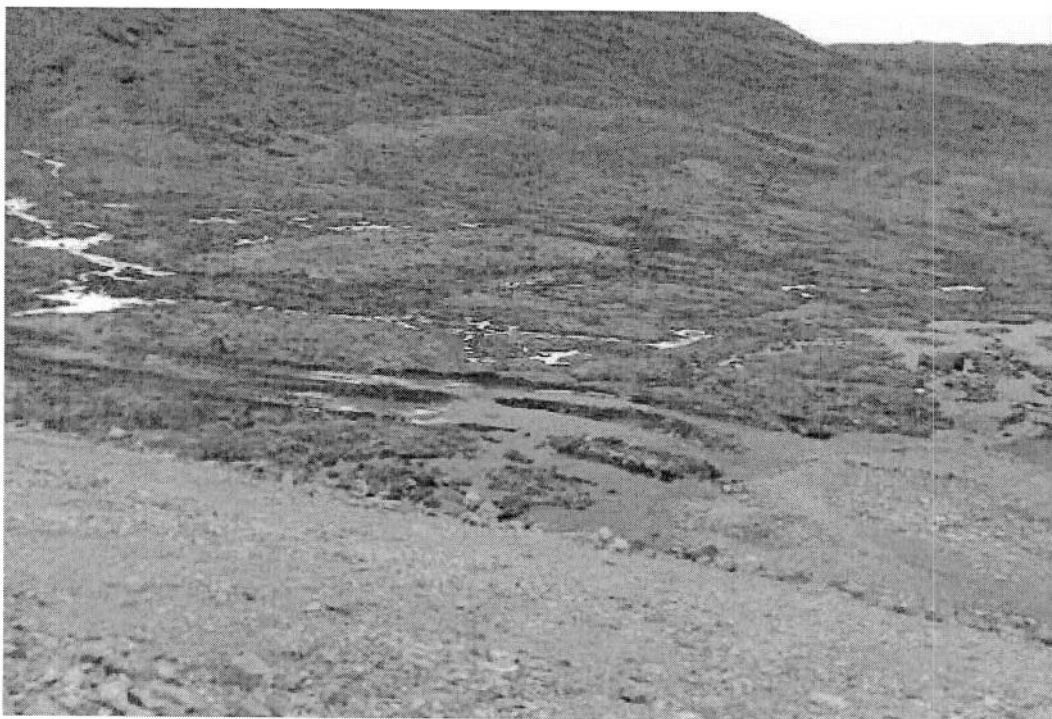
Water leaking from the lagoon impoundment was identified along the toe of the main berm, about 20 to 30 meters south of the emergency spillway (Photograph 3, Appendix A). It is believed that the water is leaking through or underneath the unfrozen larger main berm. It was demonstrated by the geothermal analysis, that at the end of the first summer, the majority of the berm and subgrade remain at temperature just below 0 °C. Thus, by allowing the run-off water to accumulate, premature thermal degradation began to occur within the berm allowing the water to leak under a considerable hydraulic gradient through the berm and around or through the liner. It is believed that the liner could be damaged (torn), or improperly sealed off within the cut-off trench.

Photograph 3: Water exiting the large main berm

No immediate actions are required to reduce the water leaking through the main berm. It is expected that a frozen core will be re-created within the berm after a second winter season (2008/2009) which will significantly reduce or eliminate the water seeping through the main berm.

It is recommended that snow be removed from the crest and sideslopes of the main berm, at least twice per month during 2008/2009 winter season.

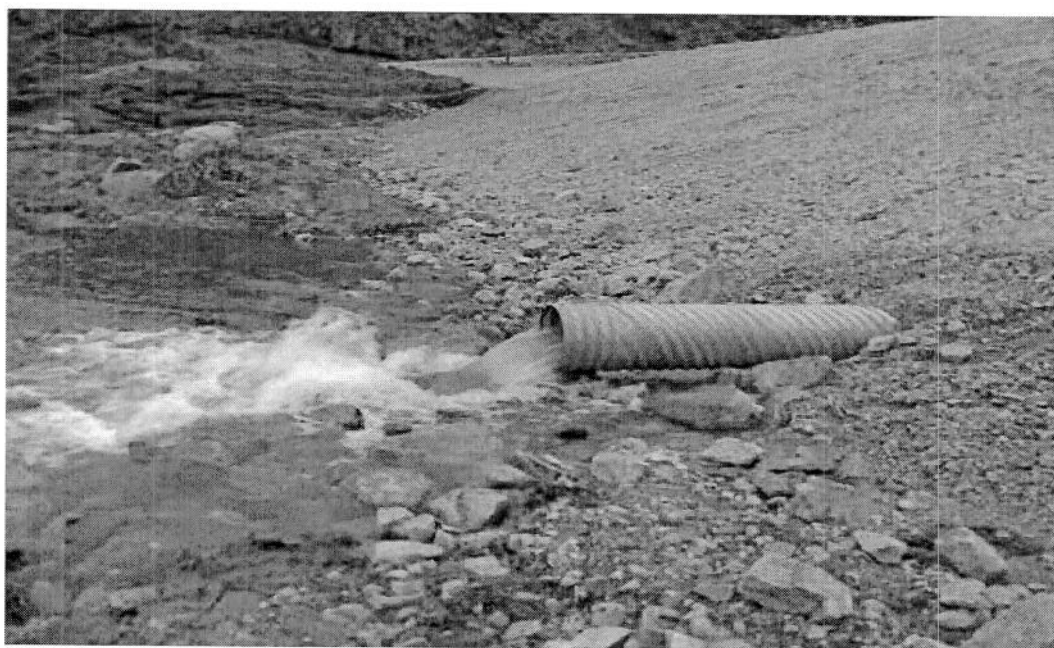
On September 30, 2008 at about 1:30 pm, the valve controlling the lagoon drainage pipe was re-opened allowing run-off water to drain into P-lake (Photograph 4, Appendix A). The water level near the area of the leak dropped down about 20 mm after 3 hours of water flowing through the drainage pipe (Photograph 5, Appendix A). On October 1, 2008, the water flow from the drainage pipe dropped considerably (Photograph 6, Appendix A).

Photograph 4: Water flowing through drainage pipe

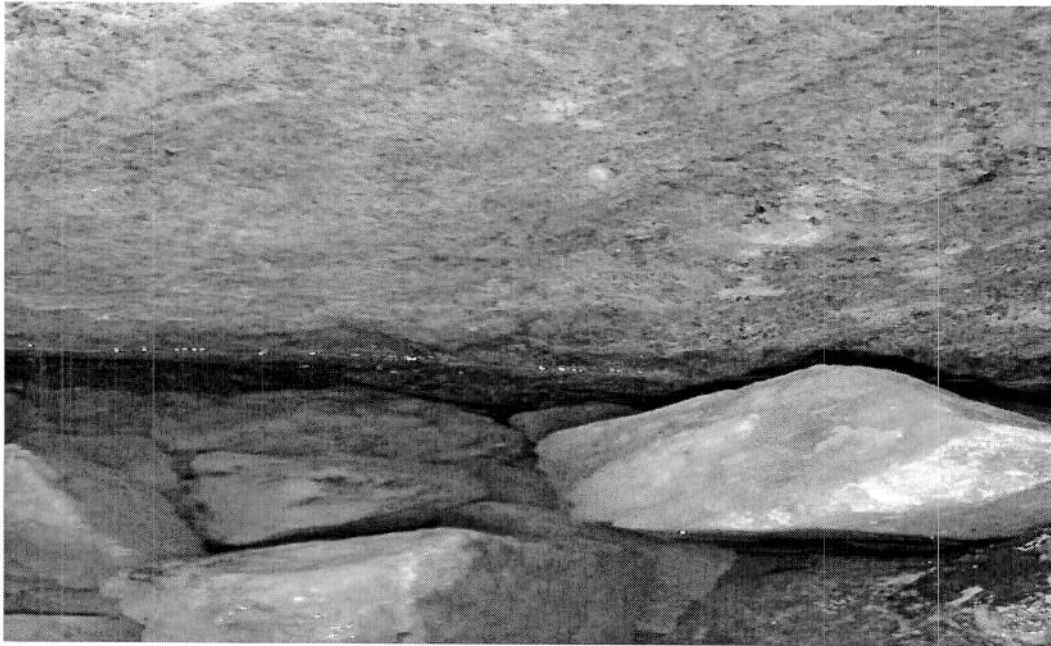
Photograph 5: Water level dropping

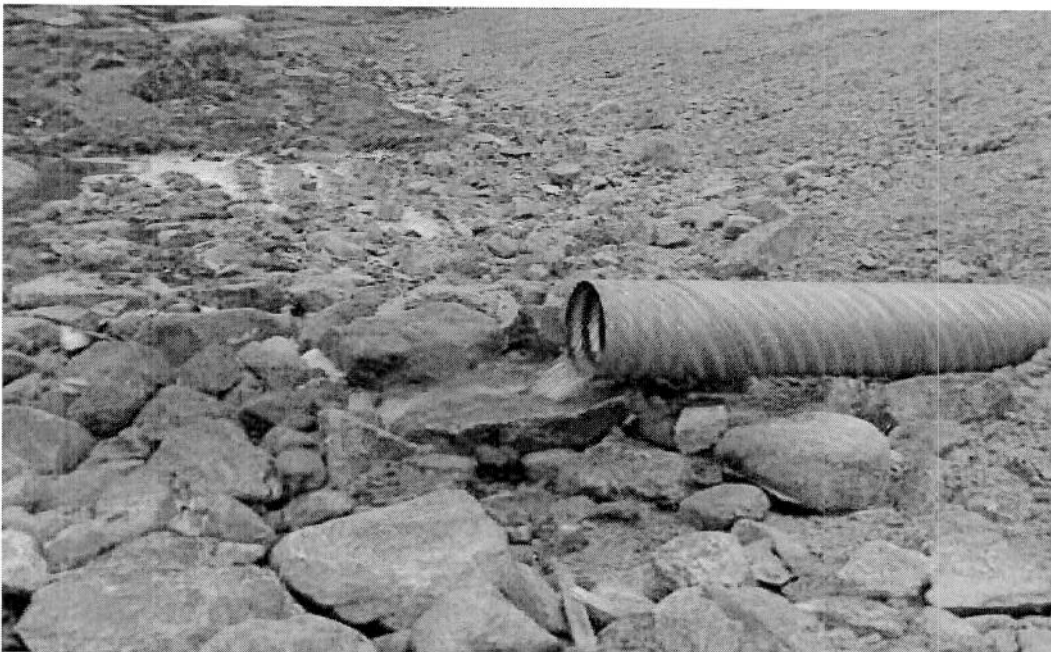
Photograph 6: Water level within drainage pipe dropping
