AMEC GEOTECHNICAL INSPECTION REPORT TO P-LAKE SEWAGE LAGOON, 2008

October 24, 2008

**Re: Sewage Lagoon Berm Inspection
Cape Dorset, NU**

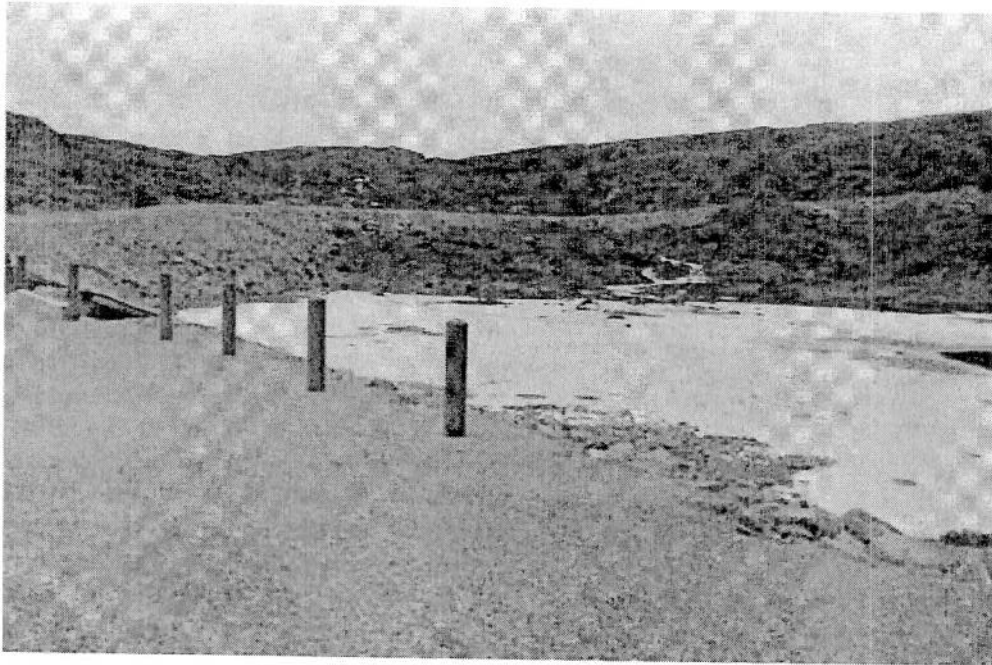
Run-off water seeping through the road way embankment into the lagoon impoundment was identified in two locations along the south roadway connecting the main west berm to the smaller north berm. The first run-off seepage was located about 100 m to 120 m south from the smaller north berm, while the second run-off seepage location was located about 20 m to 40 m south of the main berm. At these locations, water freely seeps through the road embankment, consisting of sandy crushed rock with some fines. The inflow seepage originates as run-off water from the mountain slope which is situated immediately south of the roadway. Both seepage locations are shown on Figure 1, and Photographs 1 and 2, Appendix A.

Photograph 1: First water entry area located about 100 to 120 m

The run-off water that seeps through the road embankment into the lagoon should be diverted away from the lagoon impoundment.

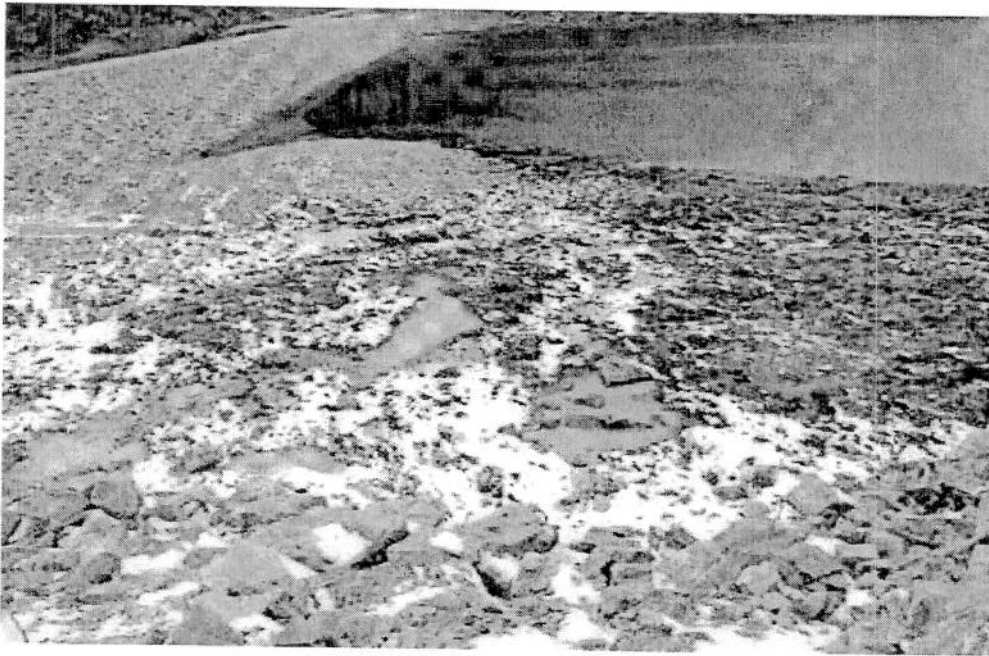
Photograph 2: Second water entry located about 20 to 40 m

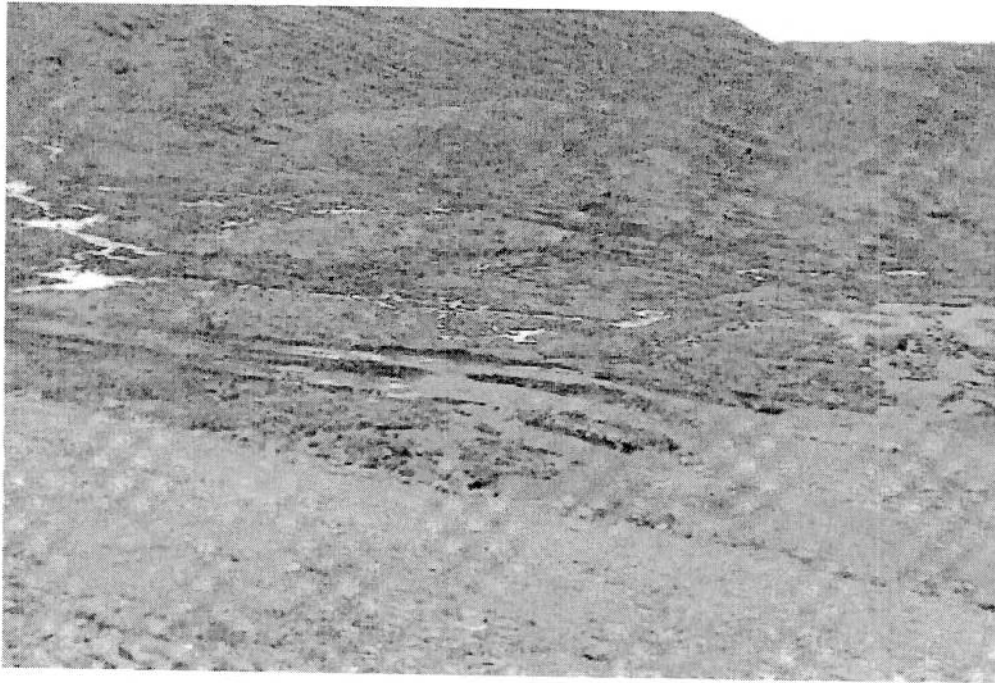
Water leaking from the lagoon impoundment was identified along the toe of the main berm, about 20 to 30 meters south of the emergency spillway (Photograph 3, Appendix A). It is believed that the water is leaking through or underneath the unfrozen larger main berm. It was demonstrated by the geothermal analysis, that at the end of the first summer, the majority of the berm and subgrade remain at temperature just below 0 °C. Thus, by allowing the run-off water to accumulate, premature thermal degradation began to occur within the berm allowing the water to leak under a considerable hydraulic gradient through the berm and around or through the liner. It is believed that the liner could be damaged (torn), or improperly sealed off within the cut-off trench.

Photograph 3: Water exiting the large main berm

No immediate actions are required to reduce the water leaking through the main berm. It is expected that a frozen core will be re-created within the berm after a second winter season (2008/2009) which will significantly reduce or eliminate the water seeping through the main berm.

It is recommended that snow be removed from the crest and sideslopes of the main berm, at least twice per month during 2008/2009 winter season.

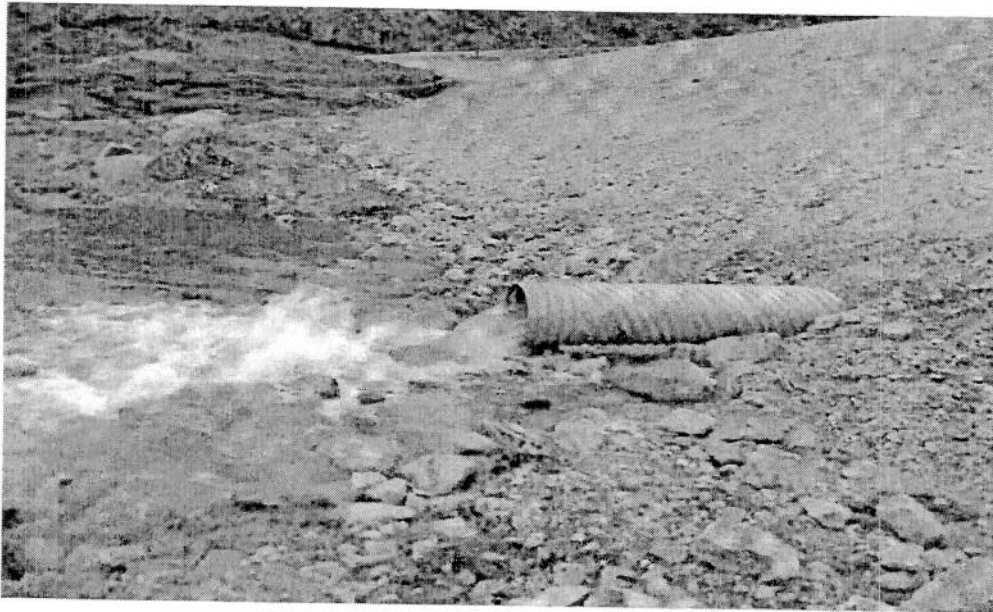
On September 30, 2008 at about 1:30 pm, the valve controlling the lagoon drainage pipe was re-opened allowing run-off water to drain into P-lake (Photograph 4, Appendix A). The water level near the area of the leak dropped down about 20 mm after 3 hours of water flowing through the drainage pipe (Photograph 5, Appendix A). On October 1, 2008, the water flow from the drainage pipe dropped considerably (Photograph 6, Appendix A).

Photograph 4: Water flowing through drainage pipe

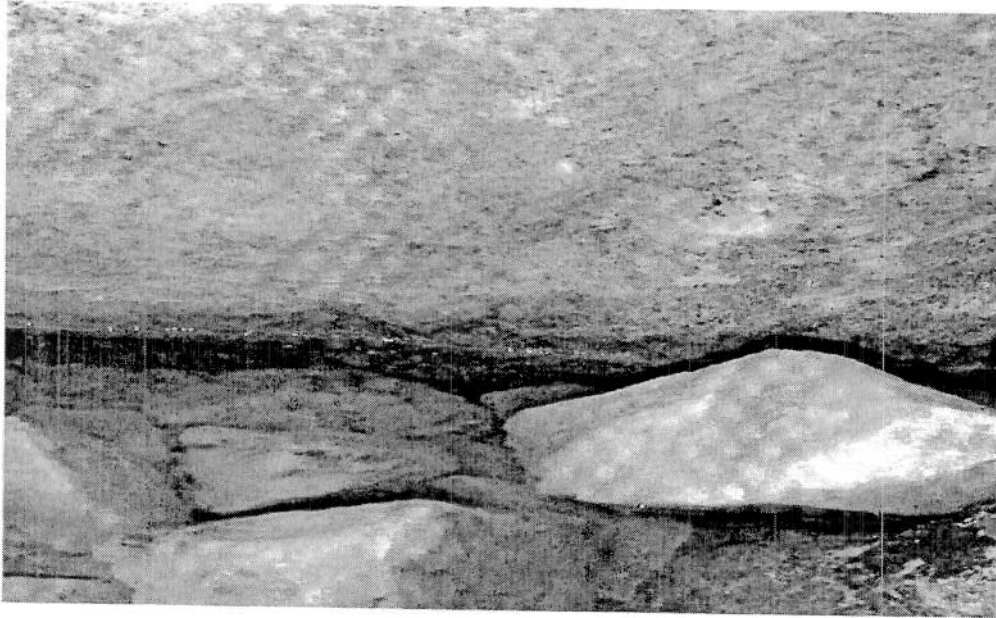
Photograph 5: Water level dropping

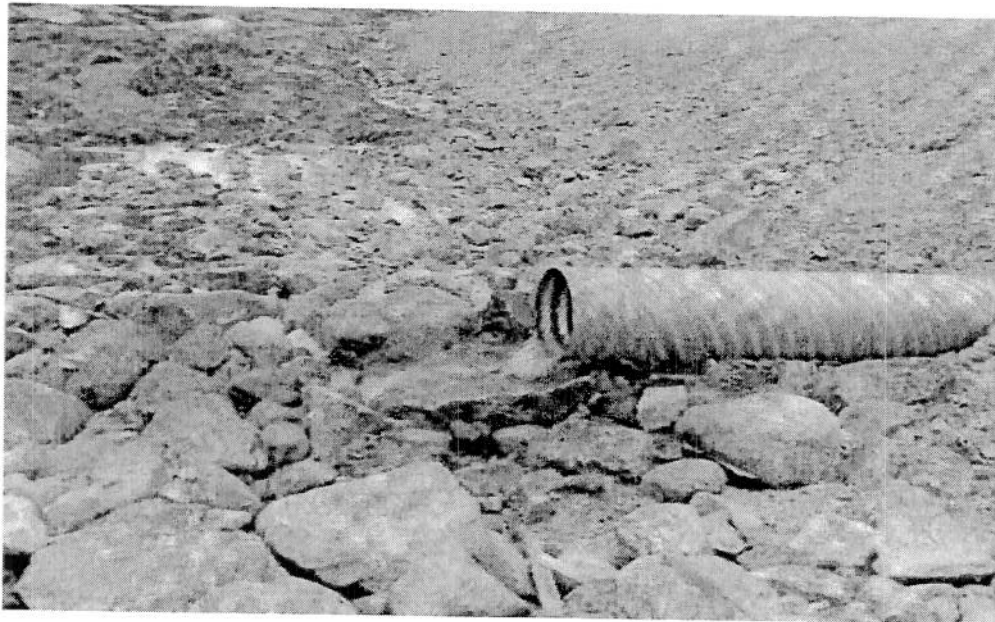
Photograph 6: Water level within drainage pipe dropping
