Dam Safety Review

Dam Safety Review
Sewage Lagoons and Water Reservoir
Cape Dorset, Nunavut

OTT-00209248-A0

September 13, 2013

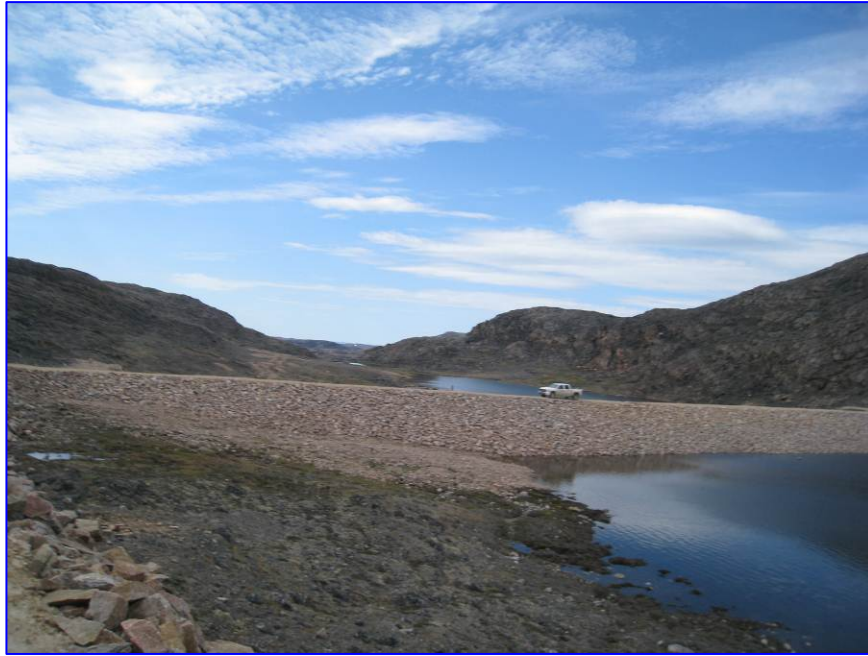
- 1.) The west berm is approximately 4 m wide and with side slopes of 2.5H:1V. It has been constructed with sand and gravel fill in accordance with the project specifications. The upstream and downstream slopes of the berm have been provided with rip rap.
- 2.) At the time of the visit, the west berm of the lagoon was leaking from an area south of the emergency overflow weir. The leak was observed to take place at the interface of the berm and the natural ground. However, a representative of the Government of Nunavut indicated that

during the spring melt, water was also observed to seep through the berm in this area. The representative also indicated that during construction, the design of the berm was modified and that the bentonite liner was not installed vertically in the centre of the cross section of the berm but along the downstream slope of the berm. Currently, it is not known whether the liner was sealed into the bedrock.

Photograph No. 1
View of upstream slope of west berm

It is recommended that the liner should be replaced as soon as possible since side slopes of 2.5H:1V for a seepage berm are not considered stable. The downstream slope of the berm is susceptible to failure. It is recommended that the bentofix liner should be replaced as it cannot be repaired.

For this purpose, it would be necessary to pump the lagoon dry, remove the rip rap and any underlying materials to expose the liner. The liner should be removed and discarded. The new liner should be sandwiched between 150 mm thick sand layers. It should be embedded at least 0.5 m into the bedrock. A minimum of 300 mm of Type II granular material should be placed on the sand cushion on top of the liner prior to placing the rip rap. Extreme care should be exercised during the placement of the rip rap to ensure that the liner is not damaged.

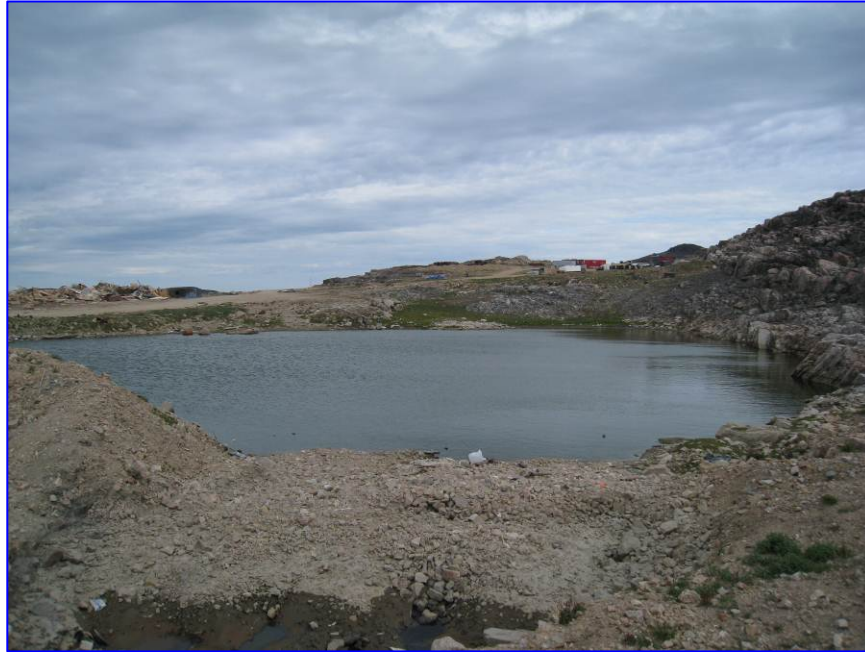
Visual examination of the lagoon did not reveal any concerns related to slope stability or erosion.

Photograph No. 9
View of emergency lagoon

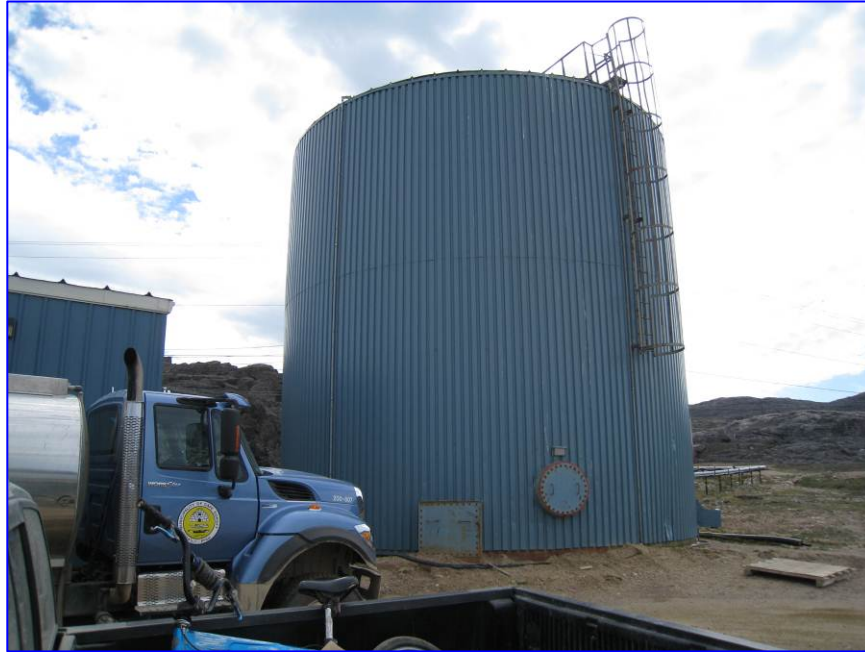
Visual observations indicated that the equipment is in reasonably good condition.

Photograph No. 13
Water storage tank at water treatment plant

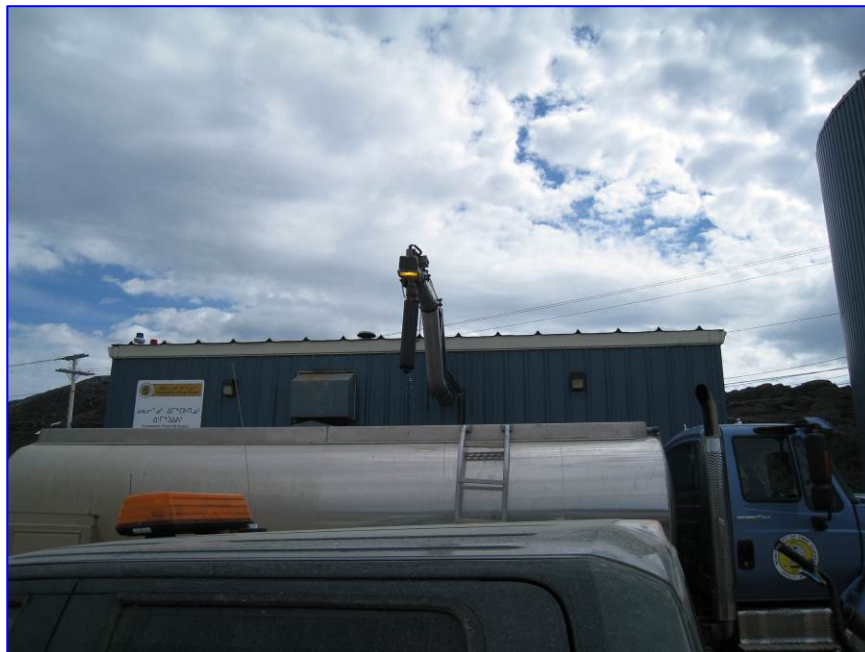
Photograph No. 14
Truck fill station
