FEASIBILITY STUDY ON METAL WASTE SITE, 2009

**Hamlet of Cape Dorset Metals
Disposal Site Study**

Cape Dorset, Nunavut

*Final Report
December 11, 2009*

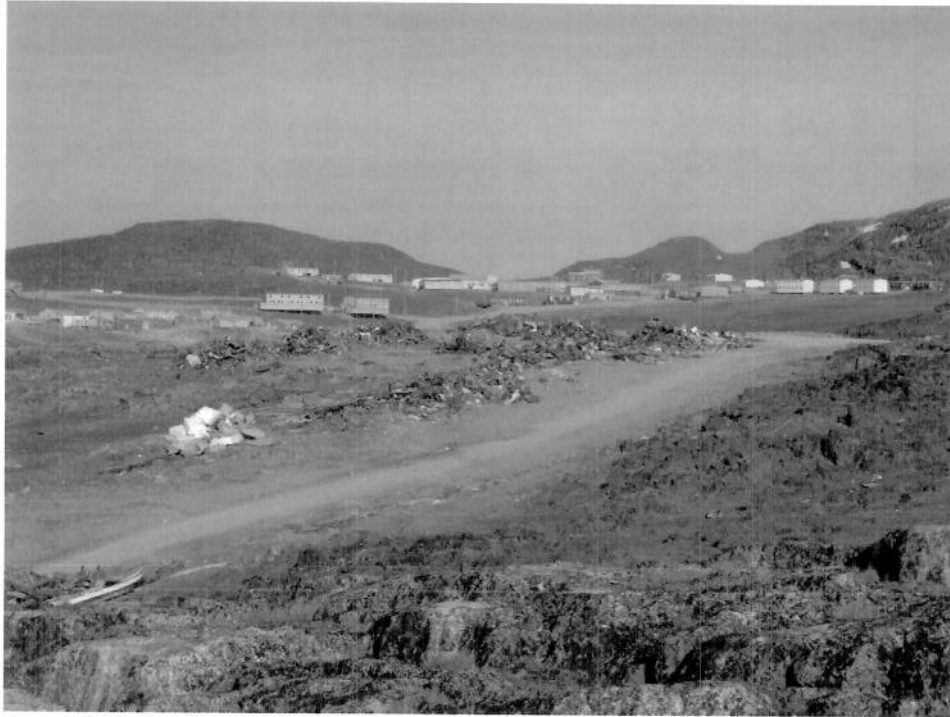
The waste at the metals disposal site may be divided into two main areas (Appendix A, Attachment 2, Site Location and Attachment 3, Site Survey). The first area (upper site) is located on the southern part of the site adjacent to the main road leading to the sewage lagoons and municipal landfill. The materials found in upper site are distributed among several moderately sized piles. Some segregation of the material has taken place in this area, but the majority of the piles are of mixed composition (Appendix B, Photograph 1).

Photograph 1: Looking southeast across the upper portion of the metals waste disposal site.

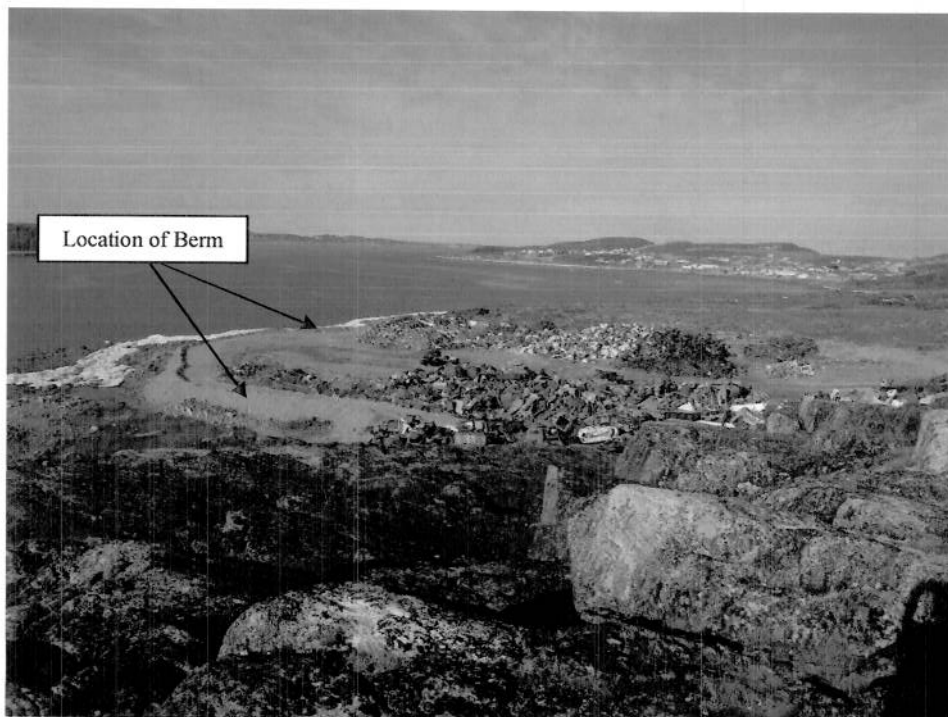
The second main area (lower site) is located on the northern half of the site adjacent to Telik Inlet. Two large piles are located on the west side of the main access road. The remaining waste is distributed among several smaller piles present on the east side of the main access road. An approximately 1.5 meter high berm surrounds the entire northern edge of the lower site (Appendix B, Photograph 2). Materials in this area have been roughly sorted.

Photograph 2: Looking northeast across the lower portion of the metals waste disposal site towards the Hamlet of Cape Dorset. Note the berm surrounding the portion of the site adjacent to Telik Inlet.

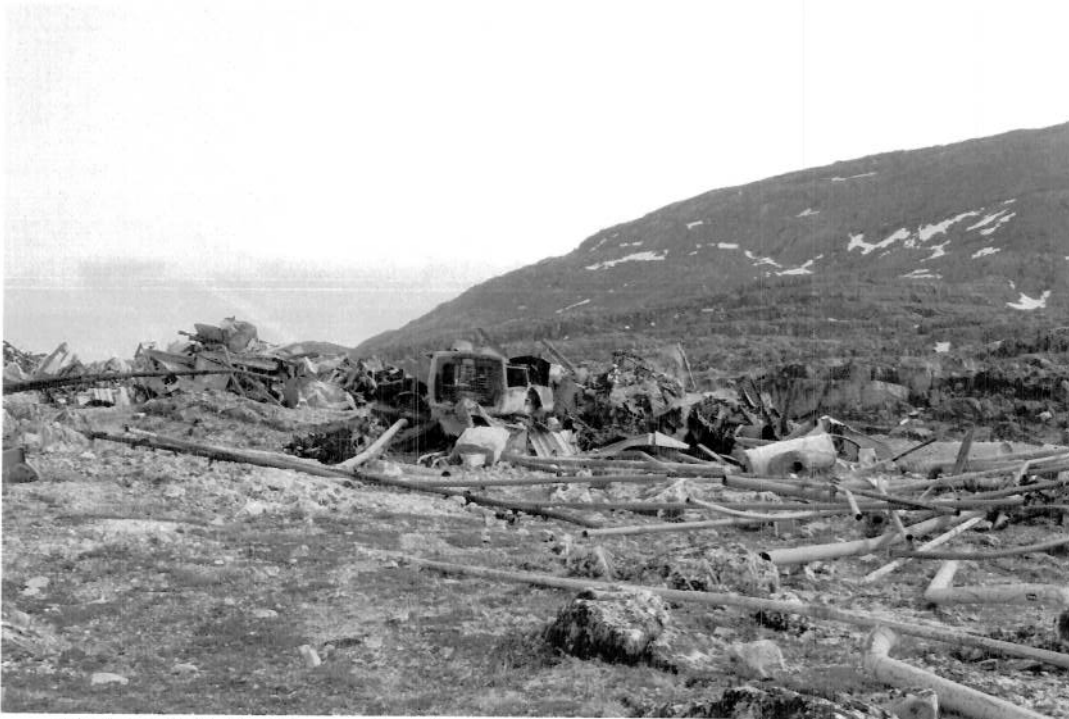
Photograph 3: Looking southwest across the upper portion of the metals disposal site.

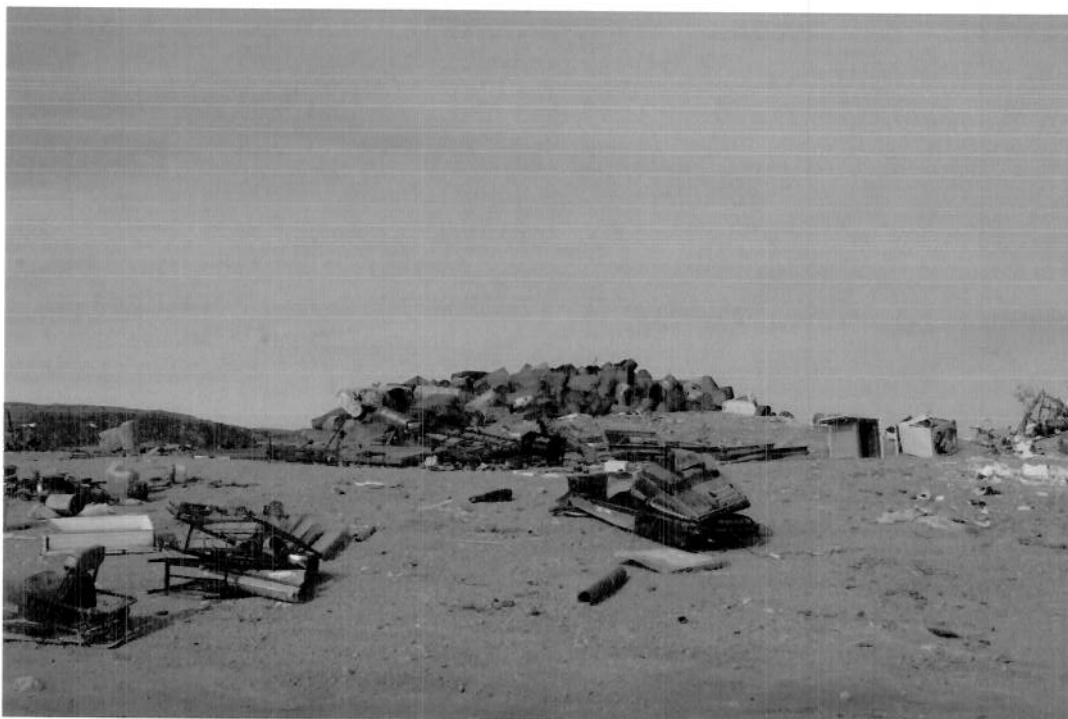
Photograph 4: Heating oil tanks and drums located in the upper site.

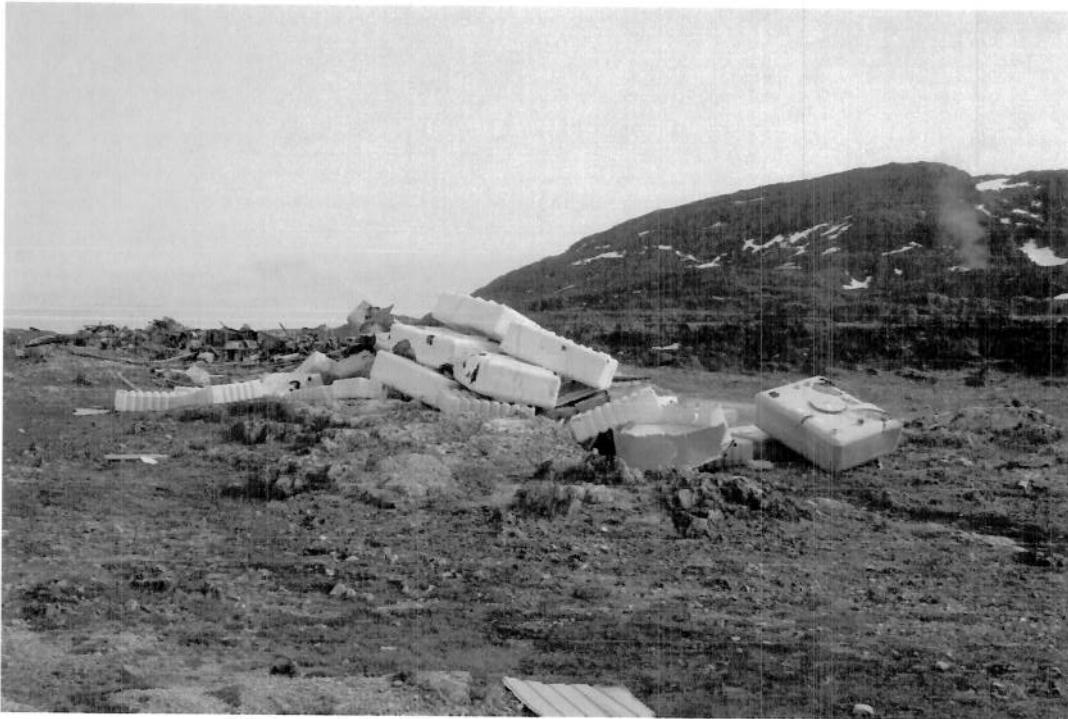
Photograph 5: Fiberglass tanks located in the upper site.

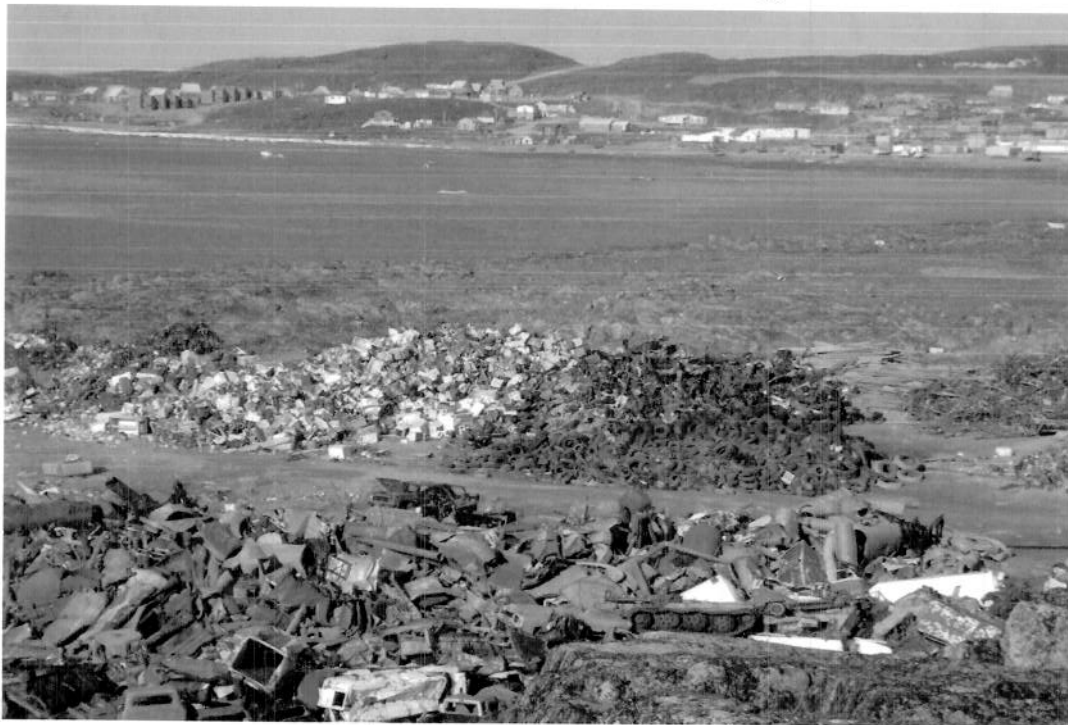
Photograph 6: Looking northeast across the lower portion of the metals waste disposal site.

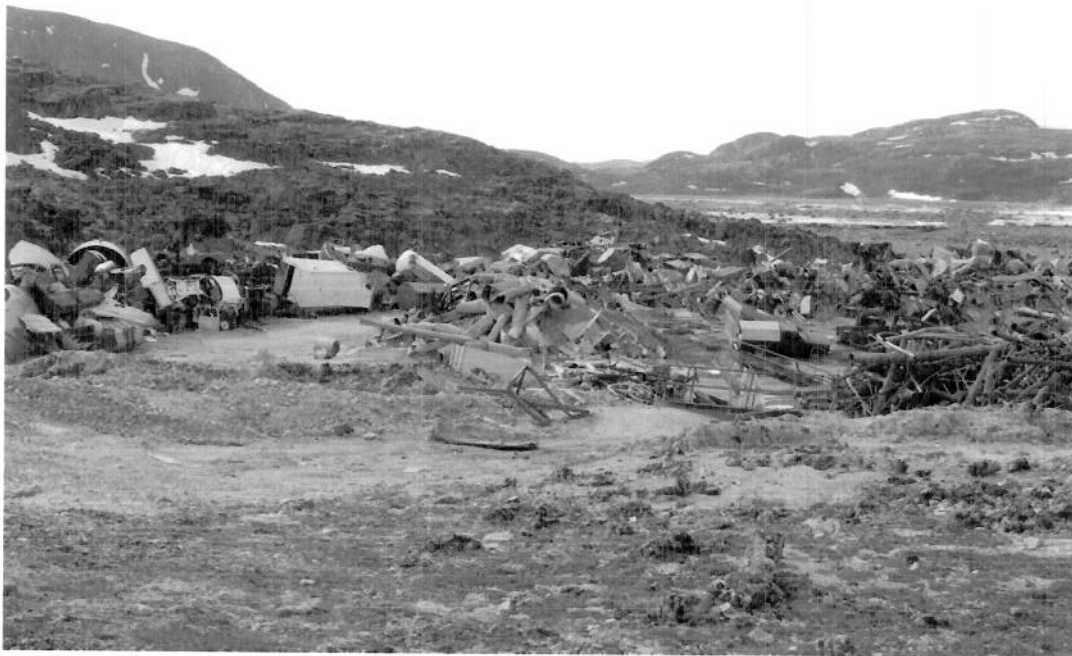
Photograph 7: Looking southwest across the lower portion of the metals waste disposal site towards Telik Inlet.

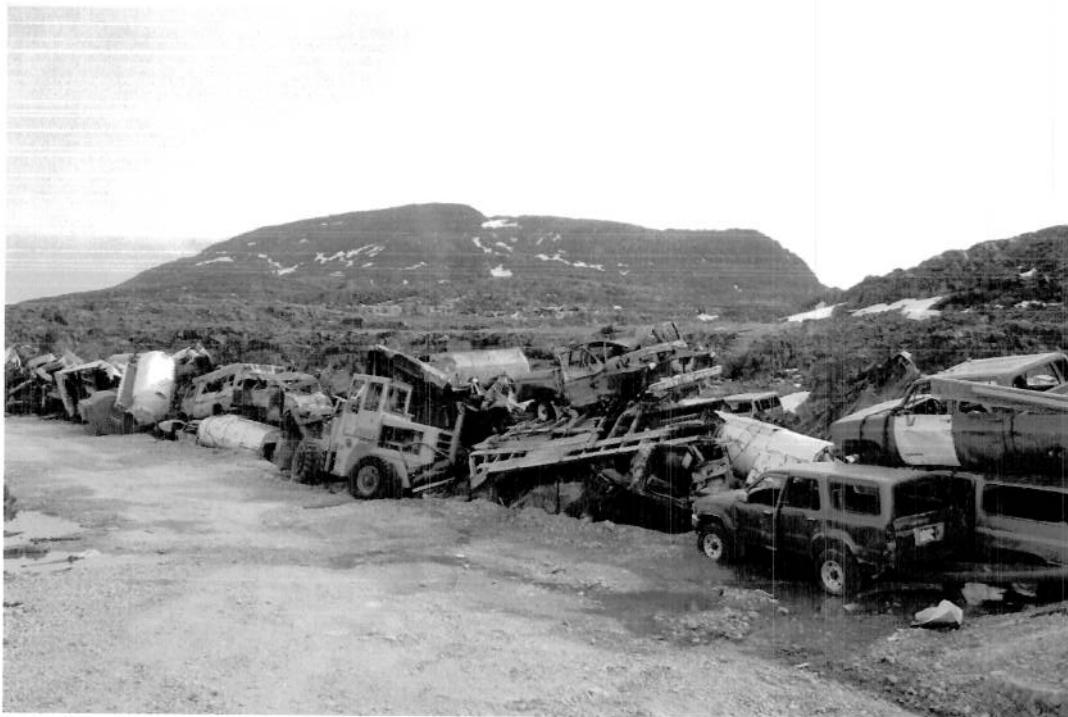
Photograph 8: Large pile of assorted vehicles at the lower site. View is to the southwest.

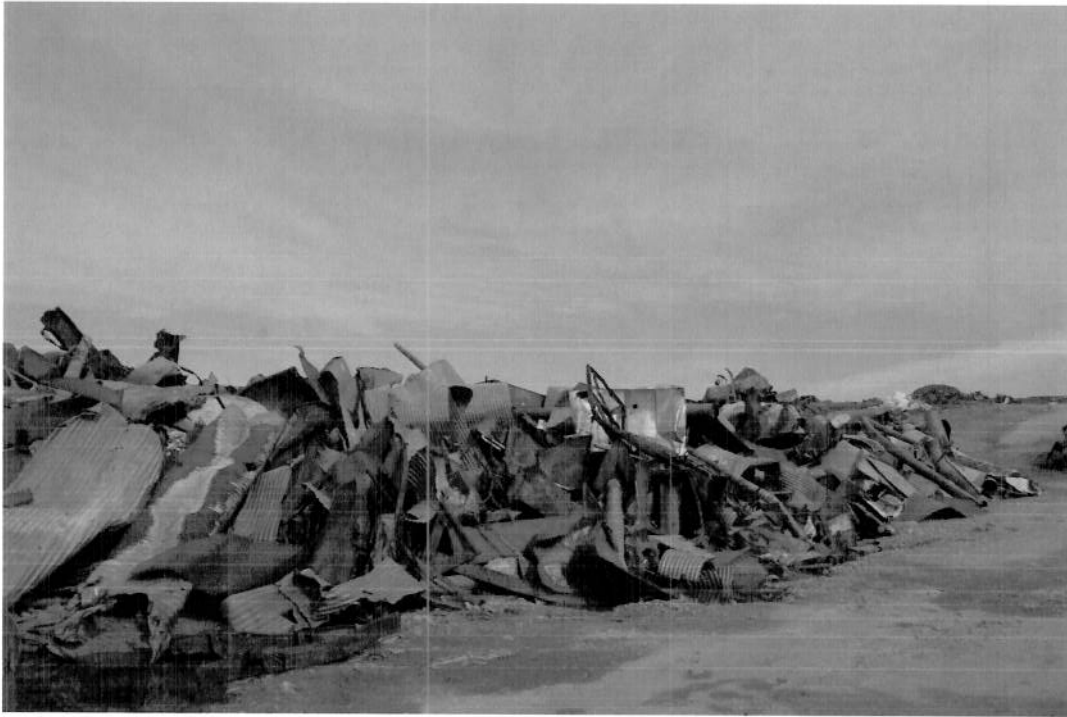
Photograph 9: Large pile of mixed metal located directly opposite photograph 8 above. View is to the southeast.

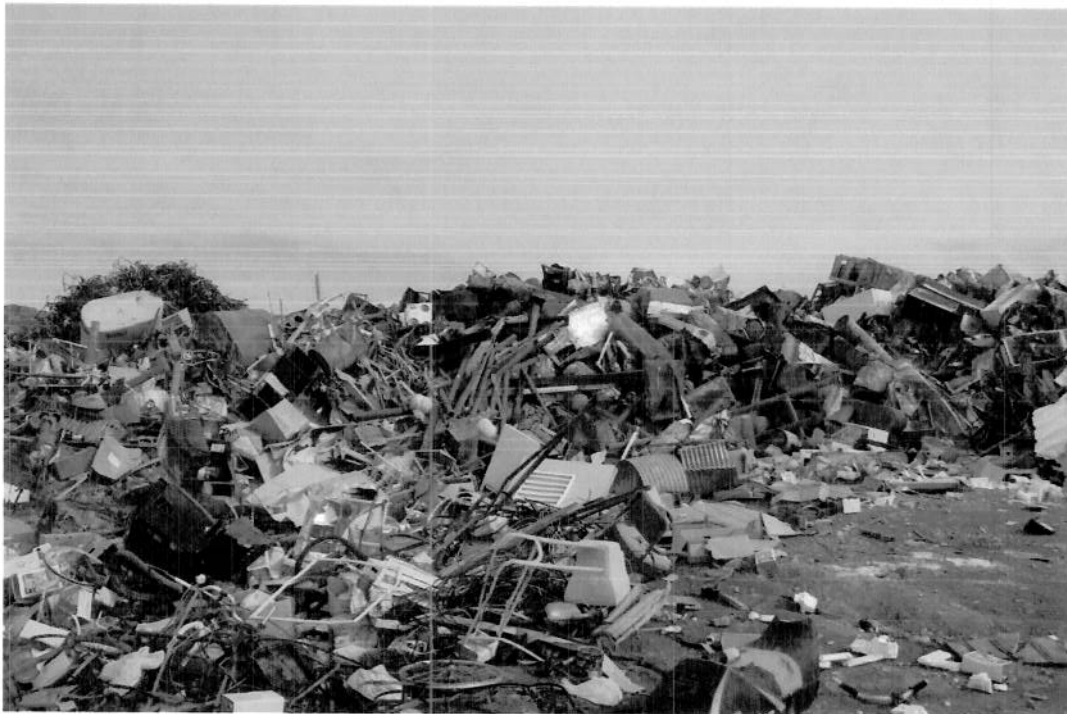
Photograph 10: Mixed metal including white goods located in the lower site. View is to the southeast.

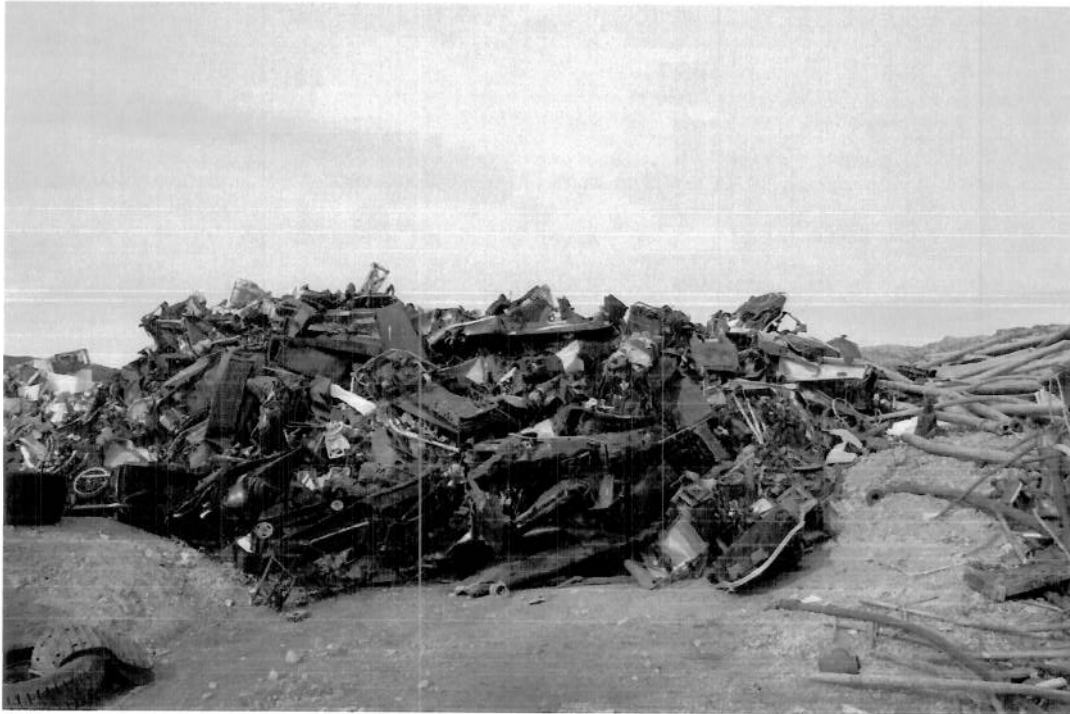
Photograph 11: Snowmobiles present at the lower site. View is to the east.

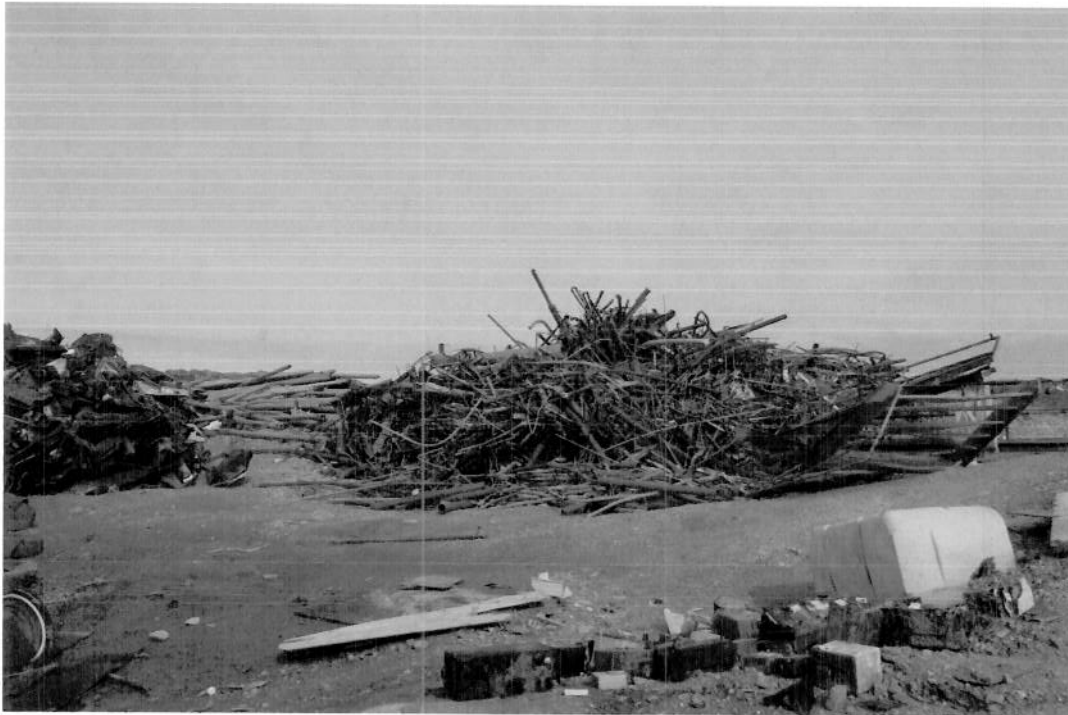
Photograph 12: Pipe present at the lower site. View is to the east.

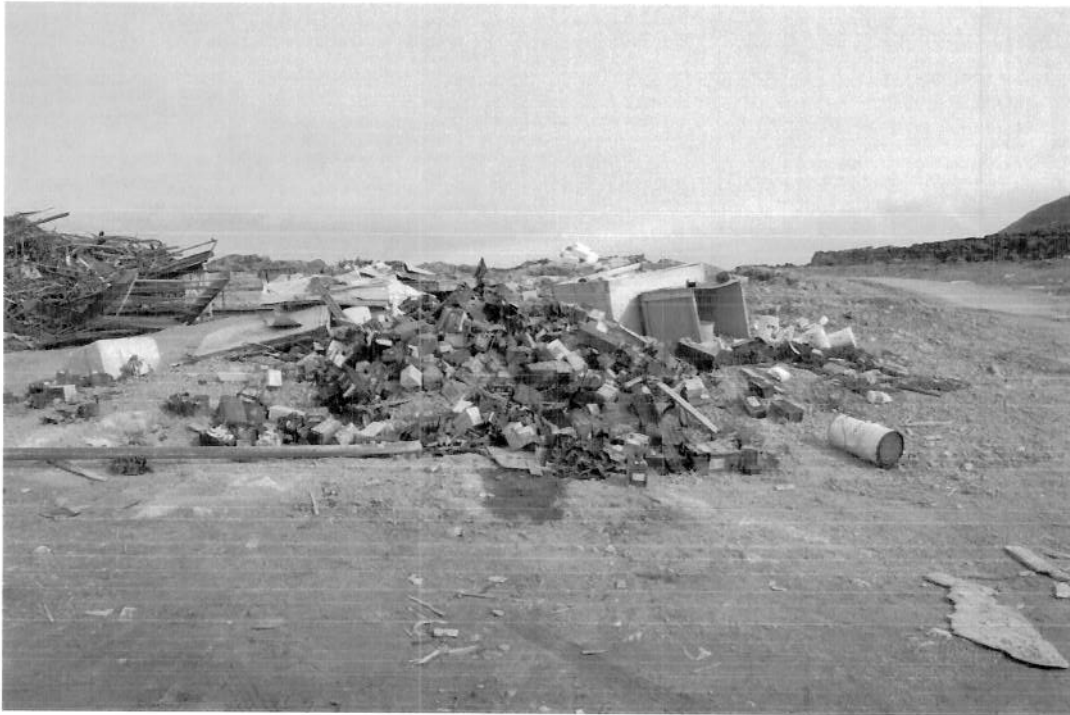
In addition to the above, hazardous materials including partially full paint cans, vehicle batteries and vehicles fluids are present at the site. Chlorofluorocarbons (CFCs) and hydrochlorofluorocarbons (HFCs) in refrigeration equipment present at the site may also be a concern. The majority of these types of wastes are located at the lower site although some are scattered throughout the upper site as well.

Photograph 13: Uncontained and leaking batteries at the lower site. View is to the south.

It is critical that all hazardous materials are dealt with correctly and efficiently. Whenever possible, hazardous materials should be stored in their original containers. When this not possible as for example with batteries and fluids drained from vehicles, containers that are sealable and leak proof such as drums provide a viable alternative. Containers must also be appropriately labeled. Typically in the north, batteries, paint cans and drums containing liquid waste are stored in secured sea cans. Attention must be given, however, to the storage of incompatible wastes. Information on storage and labeling requirements for specific wastes is available in seven guides developed by the Nunavut Environmental Protection Services (see Section 3). It should be noted that the removal of CFC's must be done by a licensed technician. Finally, hazardous wastes should be removed on an annual basis via seallift backhaul.

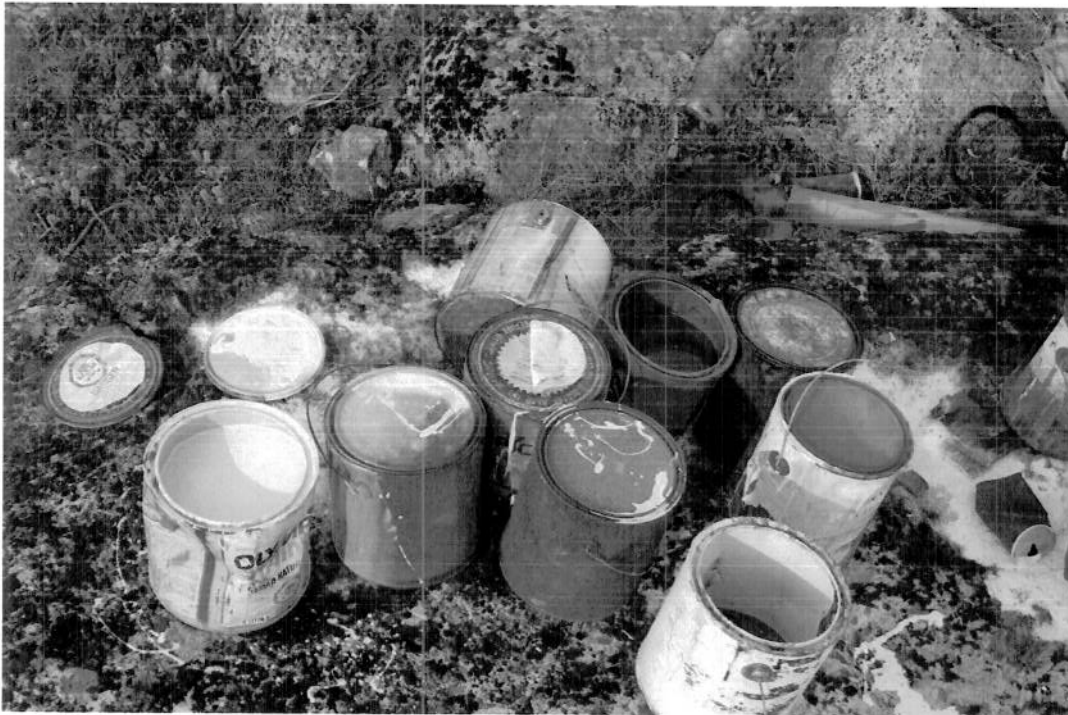
Photograph 14: Partially full paint cans present in the lower site.

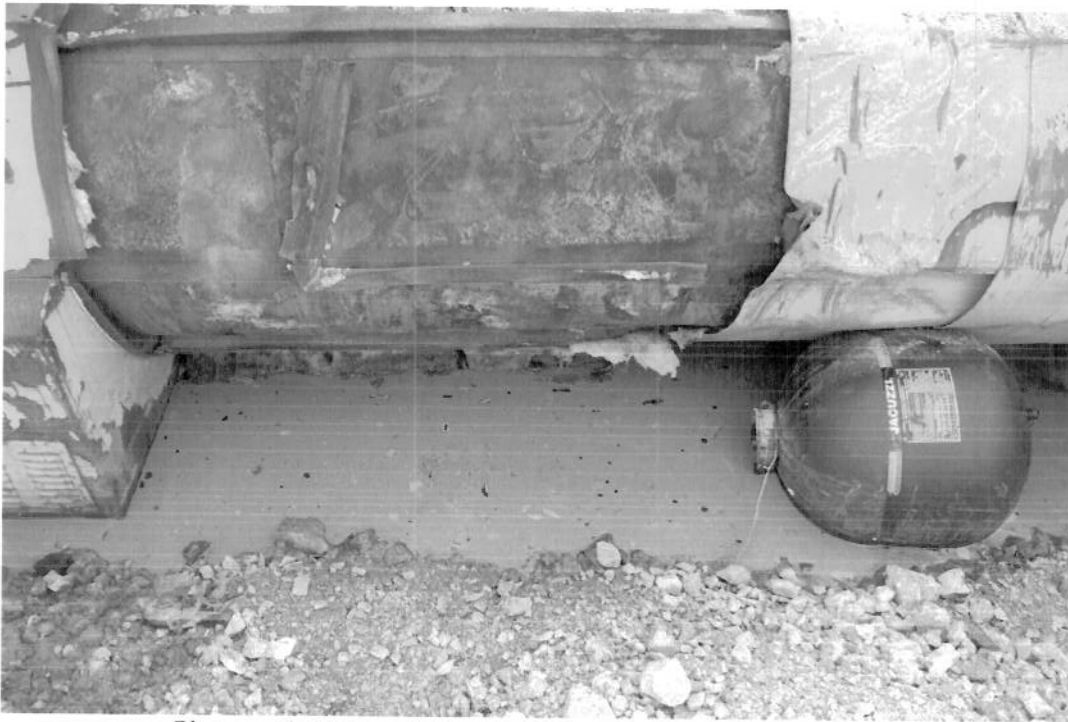
During the July inspection of the metals disposal site, several issues of concern were noted. A section of the berm located directly north of the main pile of vehicles had been breached. Surface water was observed to be moving through the site towards Telik Inlet. Several vehicles were sitting in water and were leaking fluids into the water and on to the ground surface. Animal carcasses and potentially hazardous wastes including batteries, paint cans, and drums were scattered throughout the site (Appendix B, Photographs 13-16). During the three days that Concentric was in Cape Dorset, the berm was repaired and absorbent pads were placed beneath the leaking vehicles.

Photograph 15: Possible transmission fluid leaking from vehicle.

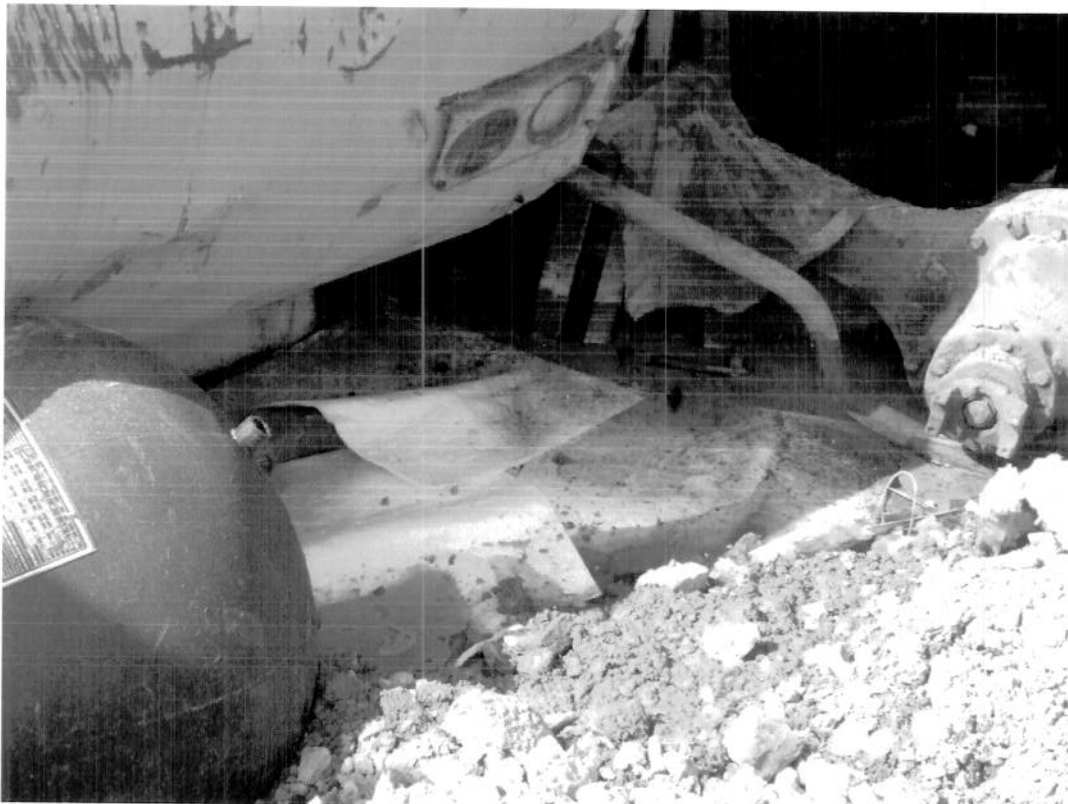
Photograph 16: Possible transmission fluid leaking from vehicle.

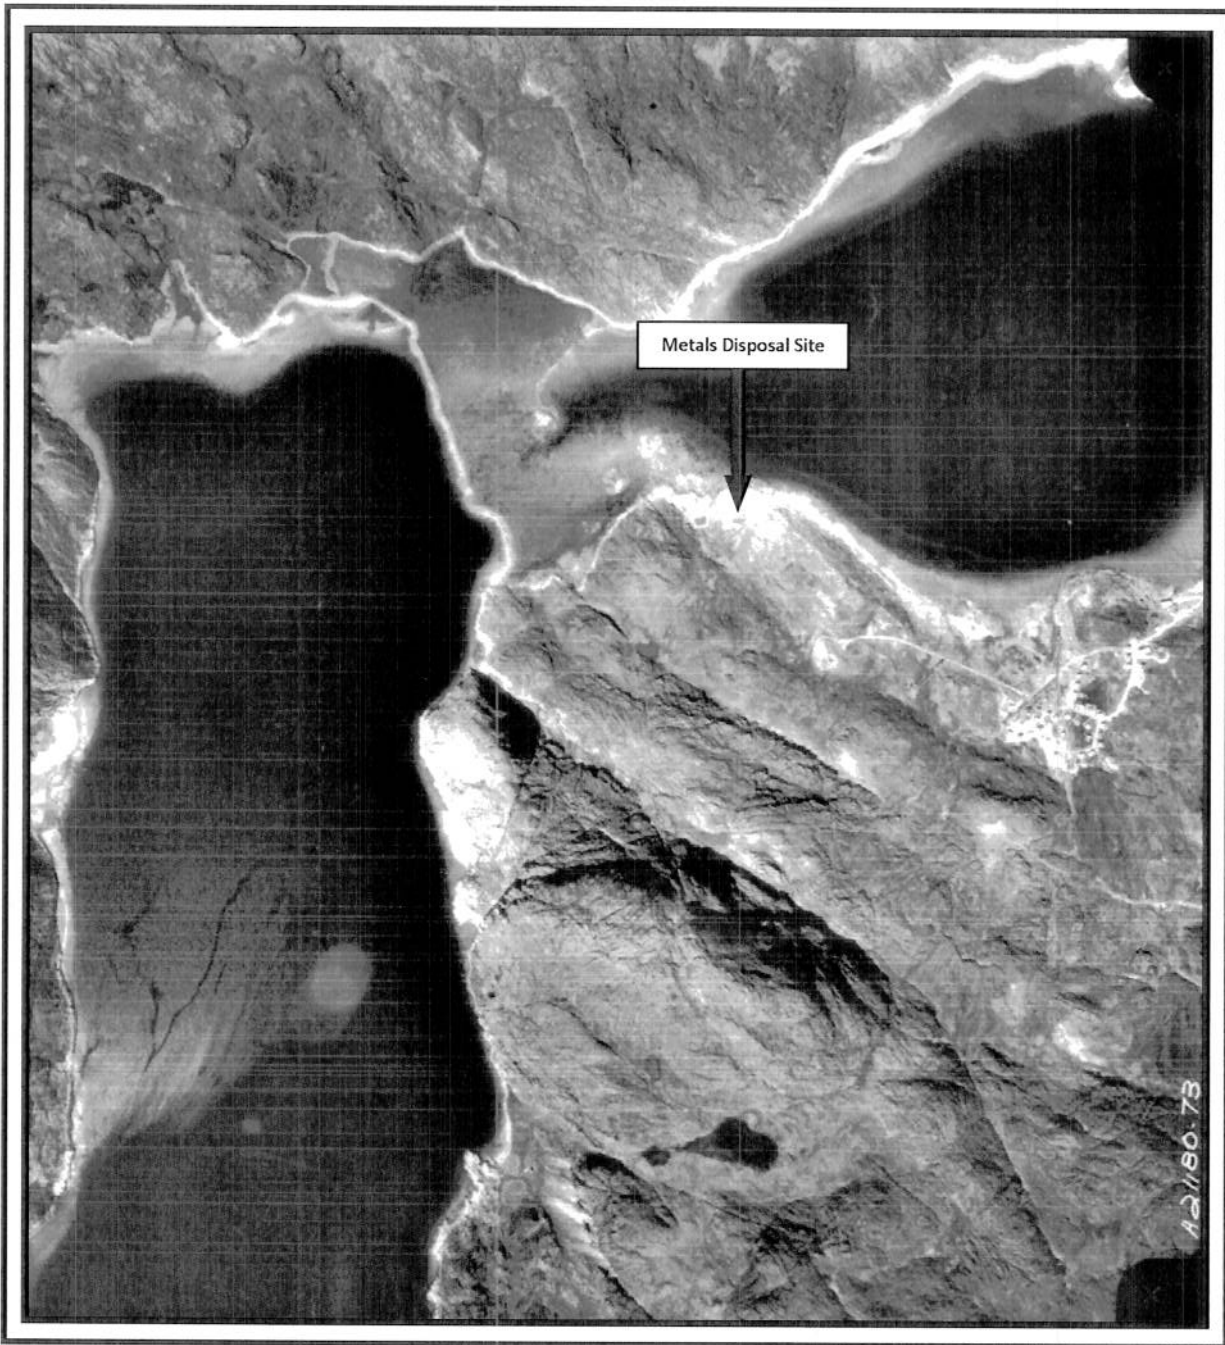
Photograph 1: 1969 Aerial Photograph – Cape Dorset Metals Disposal Site.

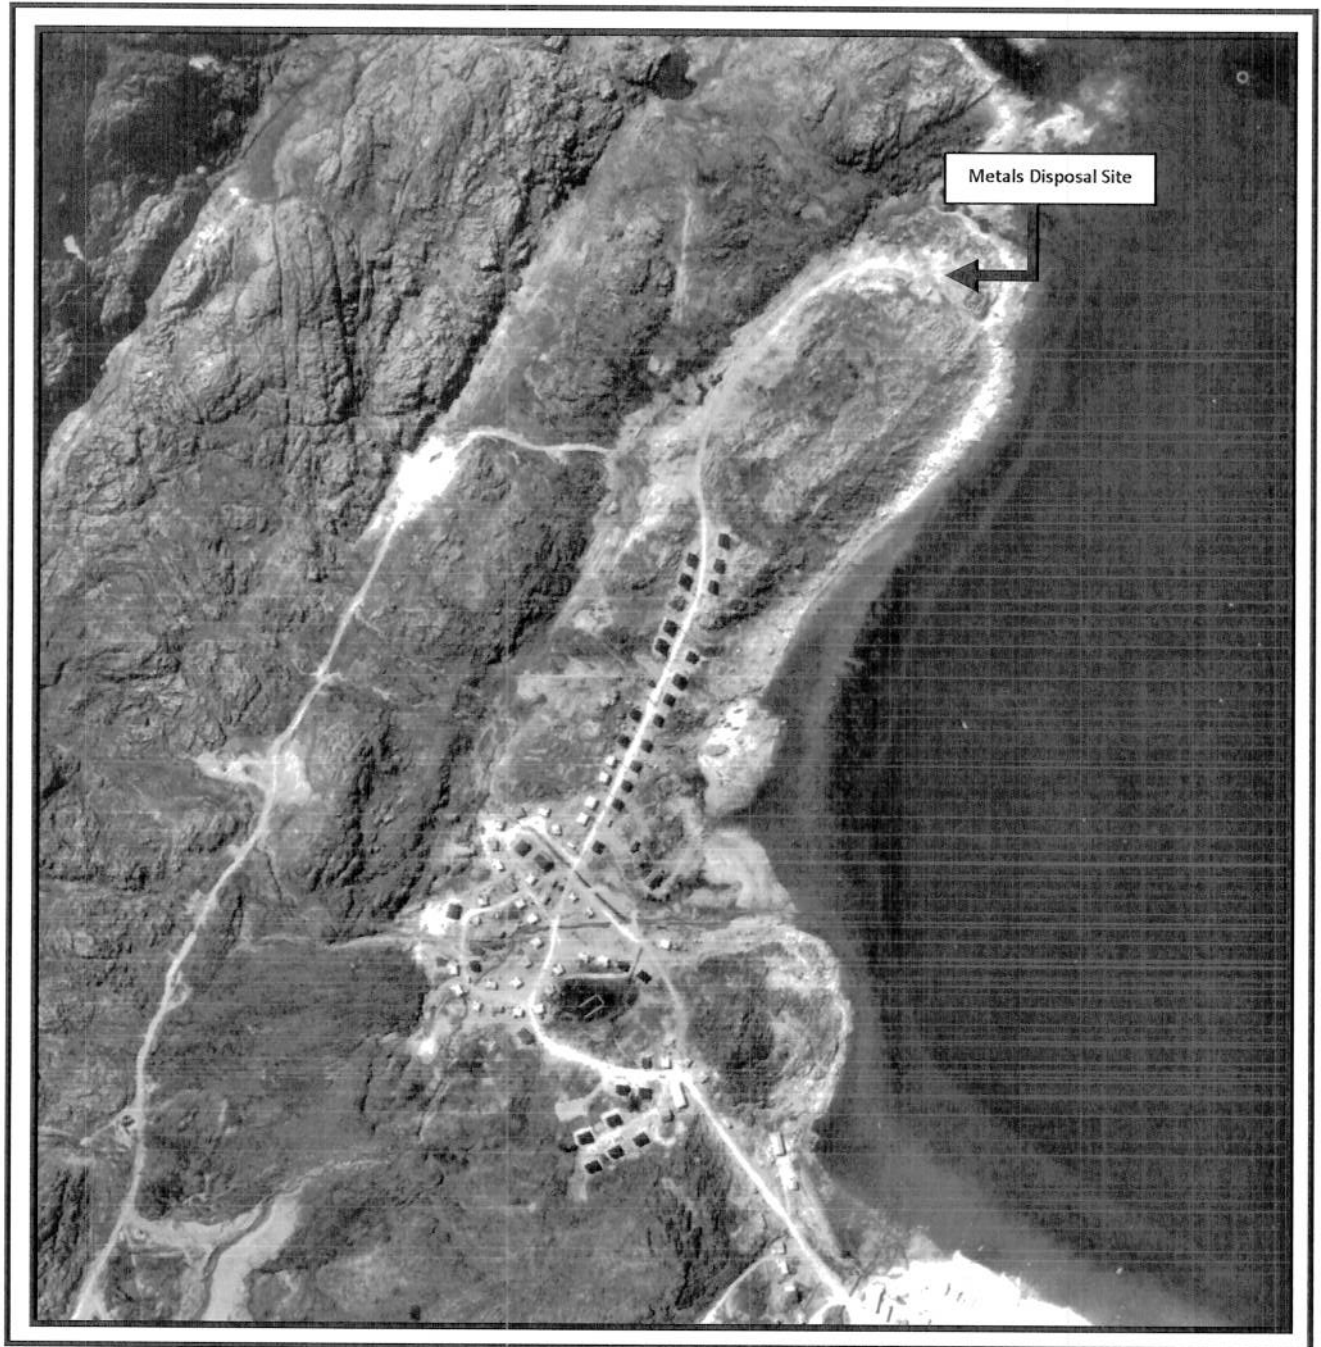
Photograph 2: 1972 Aerial Photograph – Cape Dorset Metals Disposal Site.

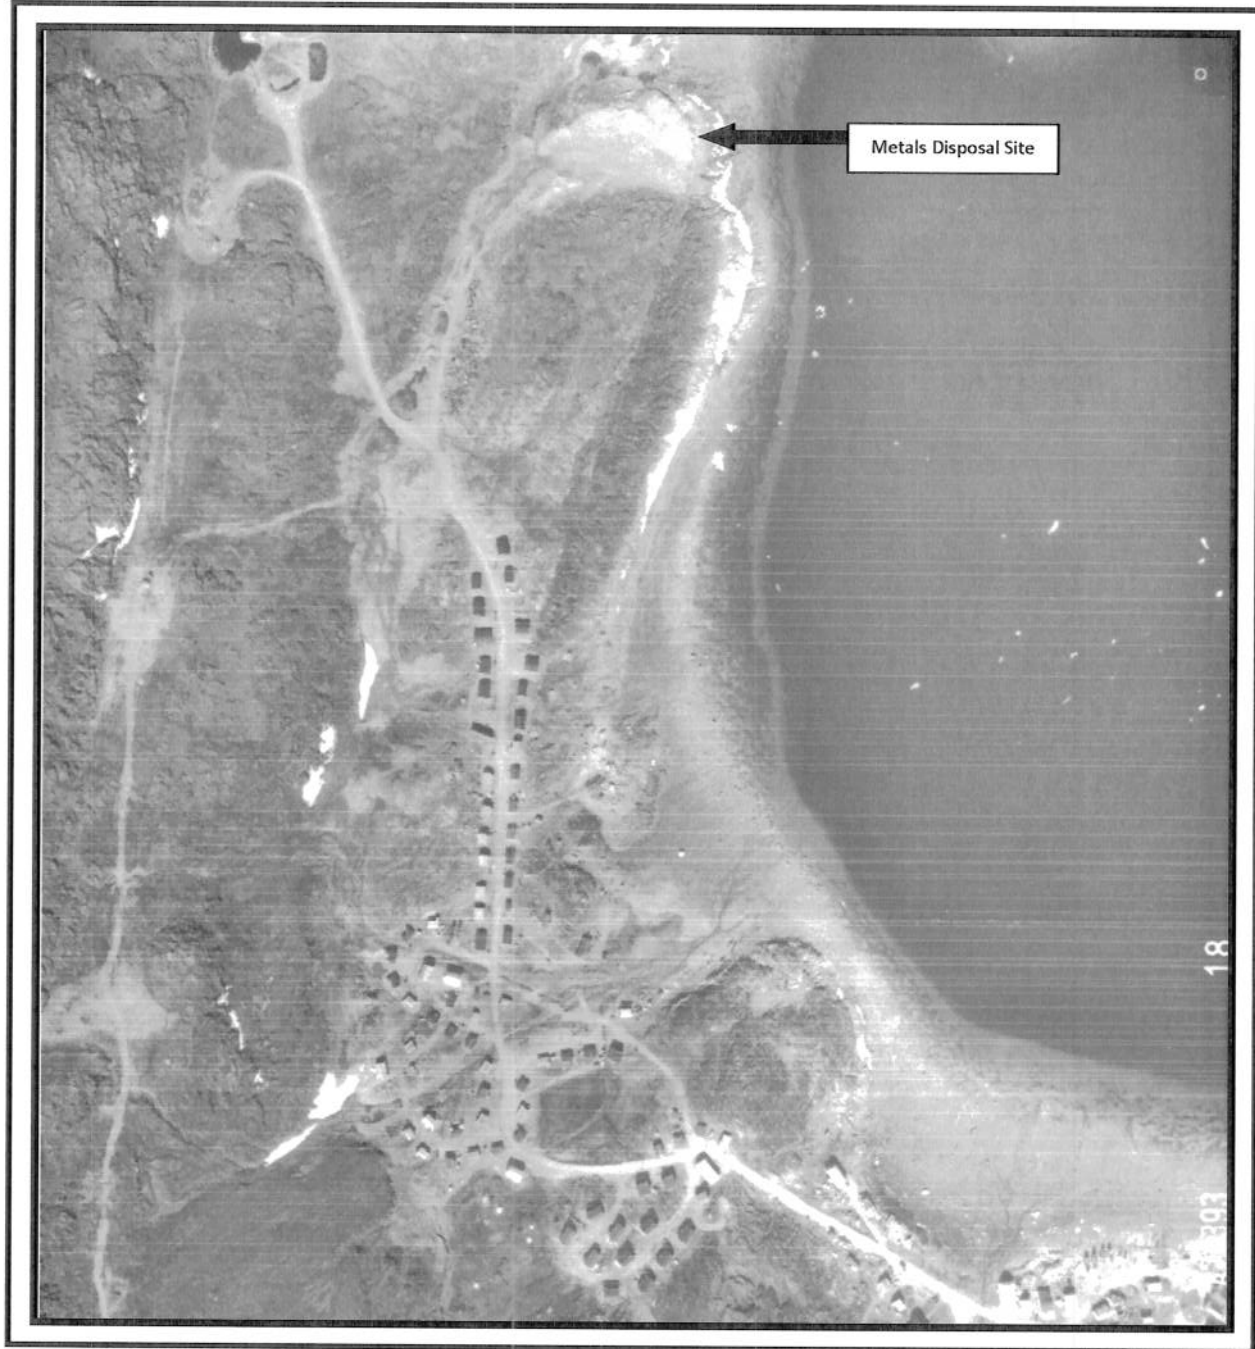
Photograph 3: 1983 Aerial Photograph – Cape Dorset Metals Disposal Site.

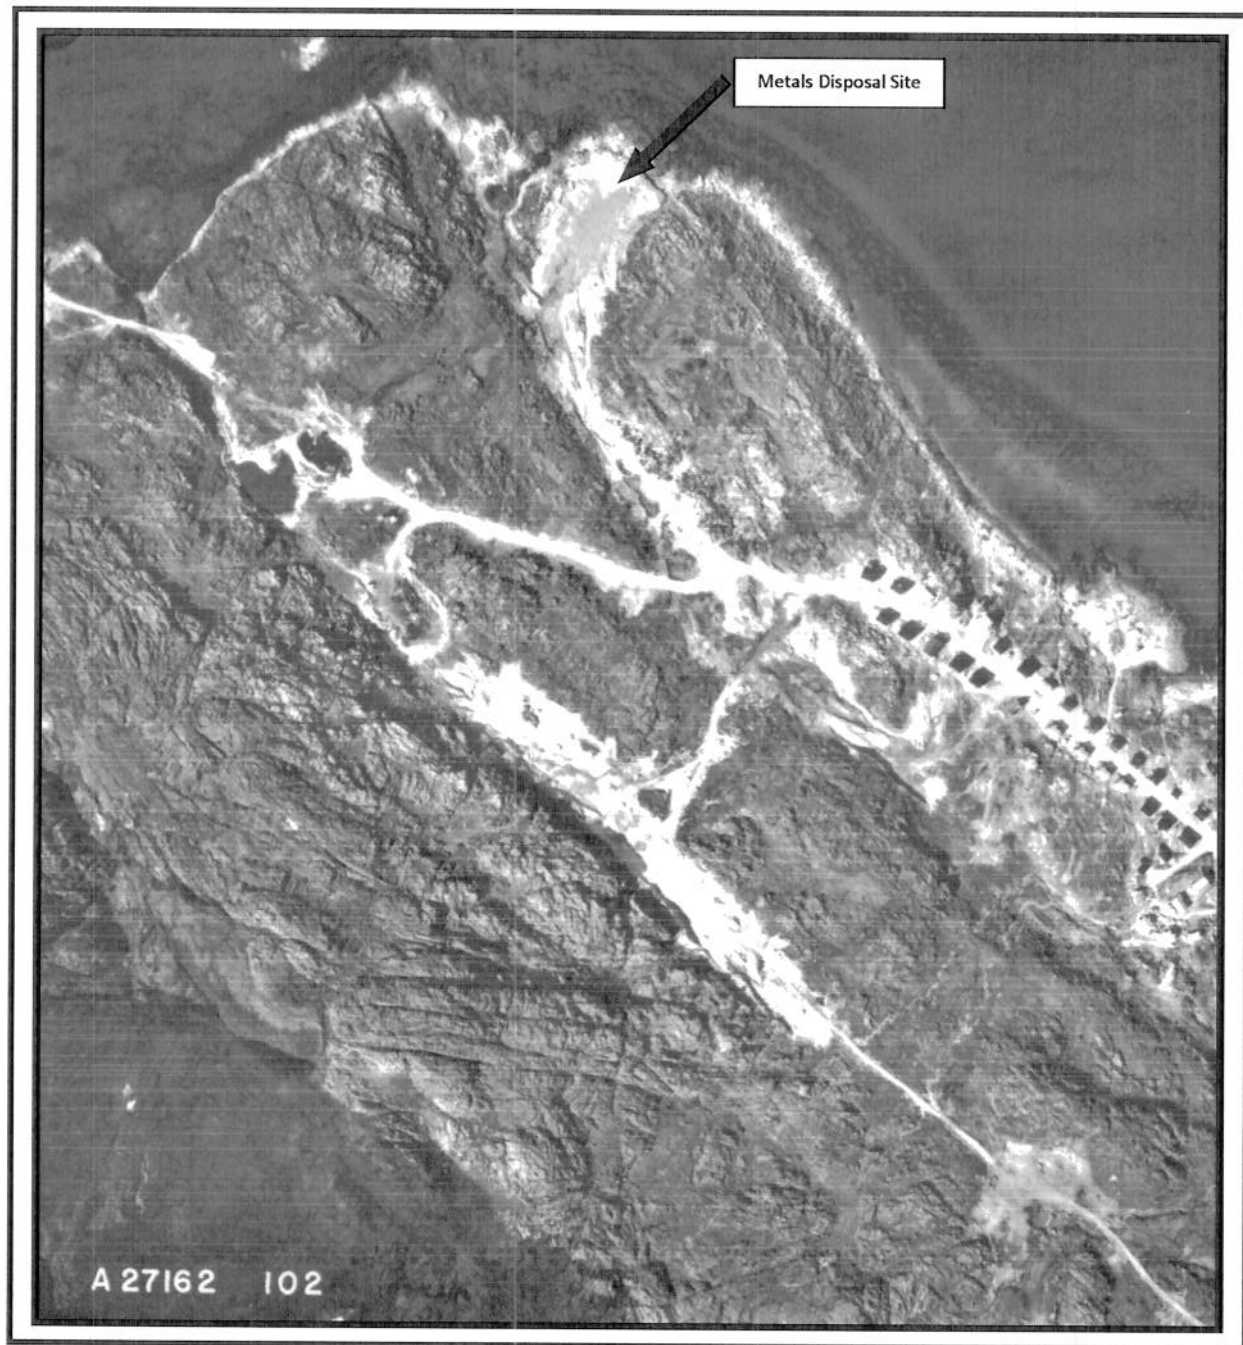
Photograph 4: 1987 Aerial Photograph – Cape Dorset Metals Disposal Site.

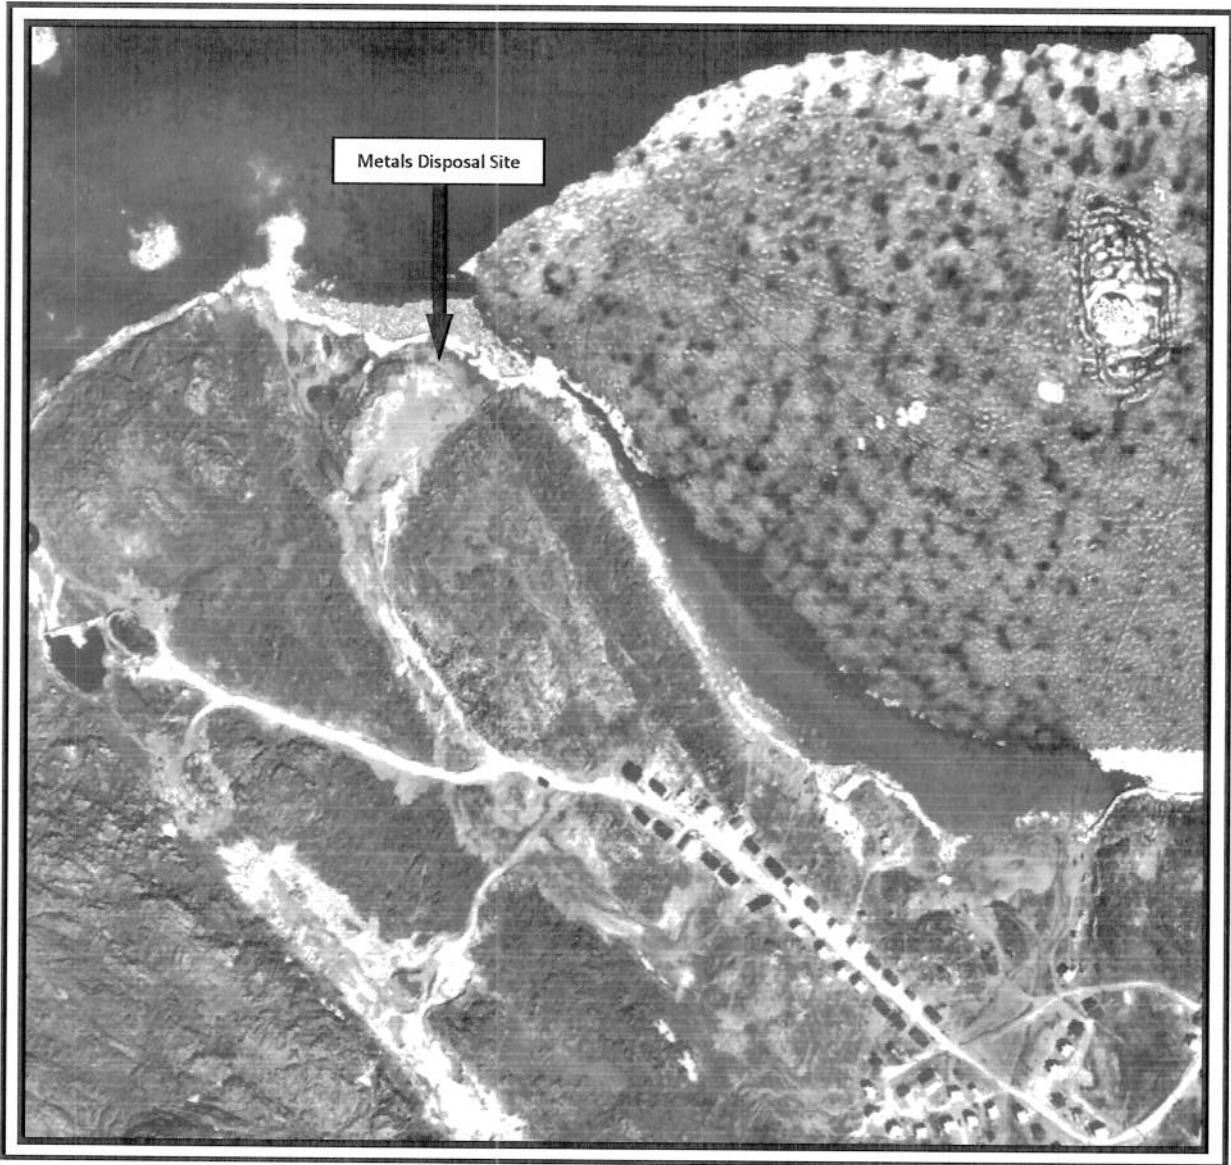
Photograph 5: 1989 Aerial Photograph – Cape Dorset Metals Disposal Site.
