FEASIBILITY STUDY ON METAL WASTE SITE, 2009

**Hamlet of Cape Dorset Metals
Disposal Site Study**

Cape Dorset, Nunavut

*Final Report
December 11, 2009*

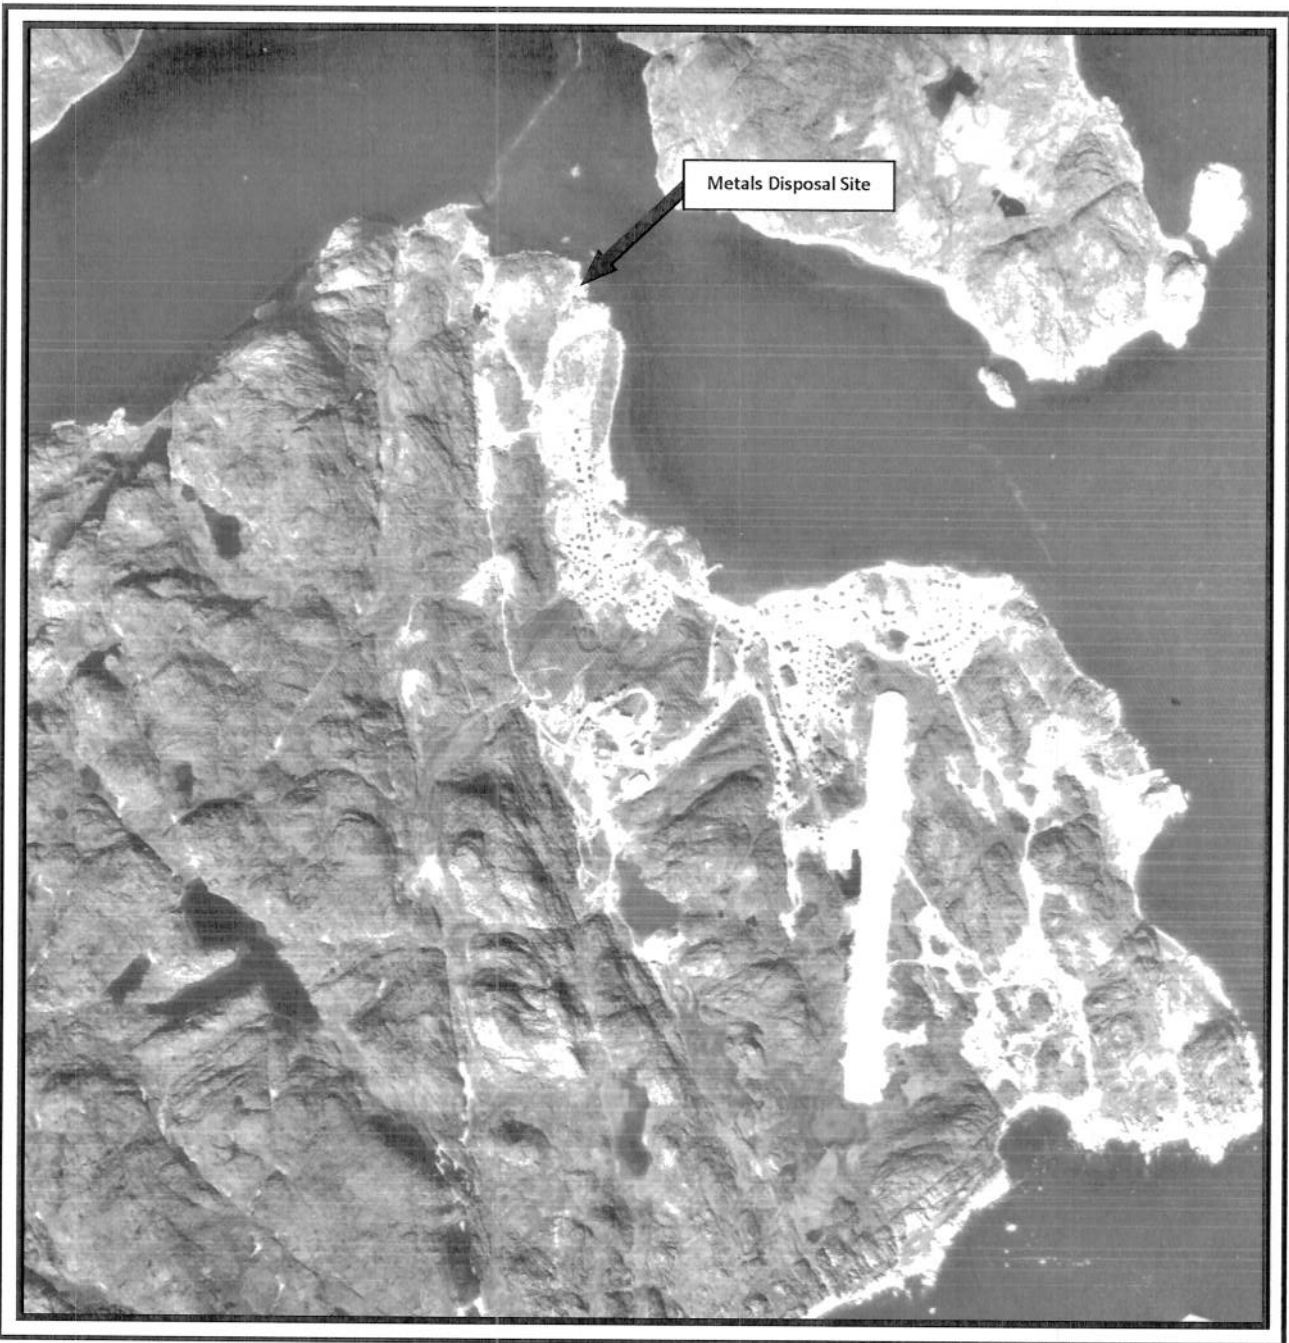
Photograph 6: 1992 Aerial Photograph – Cape Dorset Metals Disposal Site.
