- **Government of Nunavut**

## **Dam Safety Review**

Dam Safety Review  
Sewage Lagoons and Water Reservoir  
Cape Dorset, Nunavut

OTT-00209248-A0

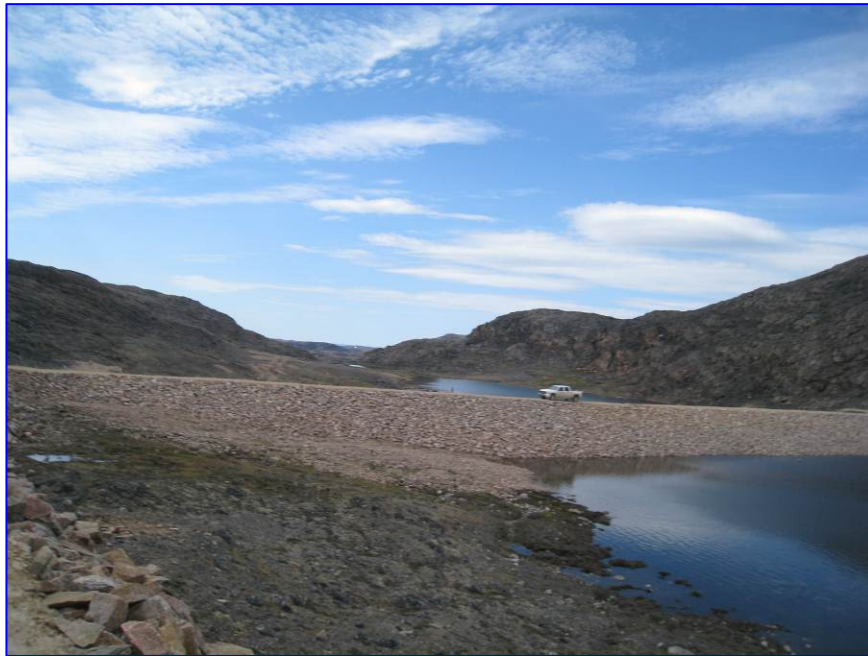
- 1.) The west berm is approximately 4 m wide and with side slopes of 2.5H:1V. It has been constructed with sand and gravel fill in accordance with the project specifications. The upstream and downstream slopes of the berm have been provided with rip rap.
- 2.) At the time of the visit, the west berm of the lagoon was leaking from an area south of the emergency overflow weir. The leak was observed to take place at the interface of the berm and the natural ground. However, a representative of the Government of Nunavut indicated that

during the spring melt, water was also observed to seep through the berm in this area. The representative also indicated that during construction, the design of the berm was modified and that the bentonite liner was not installed vertically in the centre of the cross section of the berm but along the downstream slope of the berm. Currently, it is not known whether the liner was sealed into the bedrock.

**Photograph No. 1**  
View of upstream slope of west berm

It is recommended that the liner should be replaced as soon as possible since side slopes of 2.5H:1V for a seepage berm are not considered stable. The downstream slope of the berm is susceptible to failure. It is recommended that the bentofix liner should be replaced as it cannot be repaired.

For this purpose, it would be necessary to pump the lagoon dry, remove the rip rap and any underlying materials to expose the liner. The liner should be removed and discarded. The new liner should be sandwiched between 150 mm thick sand layers. It should be embedded at least 0.5 m into the bedrock. A minimum of 300 mm of Type II granular material should be placed on the sand cushion on top of the liner prior to placing the rip rap. Extreme care should be exercised during the placement of the rip rap to ensure that the liner is not damaged.

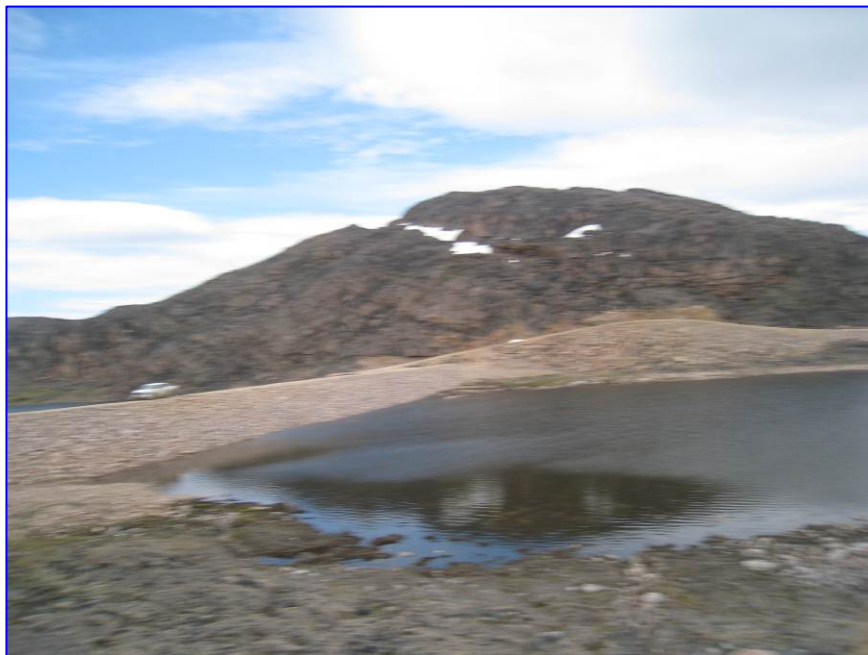
**Photograph No. 2**  
View of north and west berms of lagoon

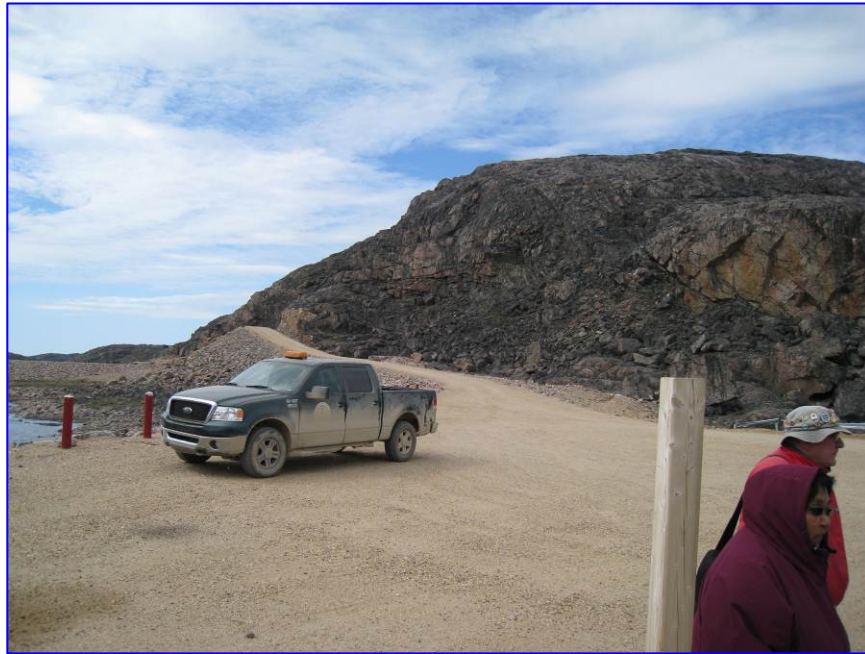
**Photograph No. 3**

The lagoon road located on the north berm is narrow and has been constructed at a very steep gradient, which has resulted in a blind spot until top of the hill is reached. At this location, there is also a bend in the road, which constitutes dangerous driving conditions, specifically during the winter months with snow and icy conditions. It is recommended that the road should be lowered by 3 m approximately so its elevation is close to that of the west berm. In addition, the road should be widened. It is noted that lowering of the elevation of the road would necessitate blasting of the bedrock.

View of north berm of lagoon. Note hump in berm.

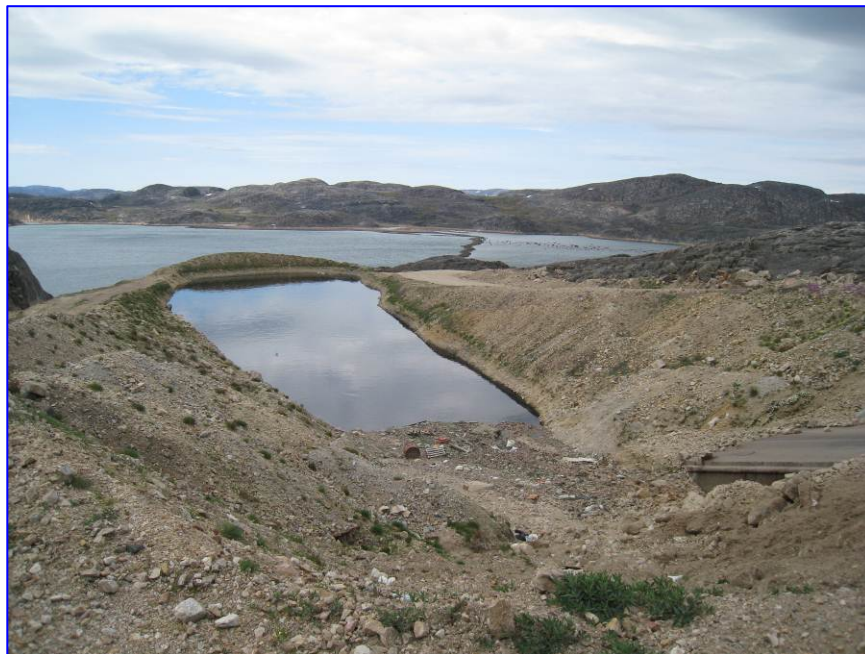
**Photograph No. 4**

The effluent is discharged into the first pond by trucks (Photo 4 and 5). During the summer months, the effluent flows from the first pond to the second pond (Photo 6) via an overflow pipe. Similarly, the effluent from the second pond flows into the third pond through an overflow pipe (Photo 7). From the third pond, the effluent is discharged into the ocean via an overflow pipe (Photo 8). During the winter months when the decant and outlet structures are frozen, water is pumped from one sewage lagoon cell to the subsequent cell on an as-required basis. It is reported that this facility has to be decanted during the winter months due to insufficient storage capacity. A visual examination of the ponds and surrounding area was undertaken. The review did not raise any concerns related to slope stability or erosion.

Upper pond of active lagoon

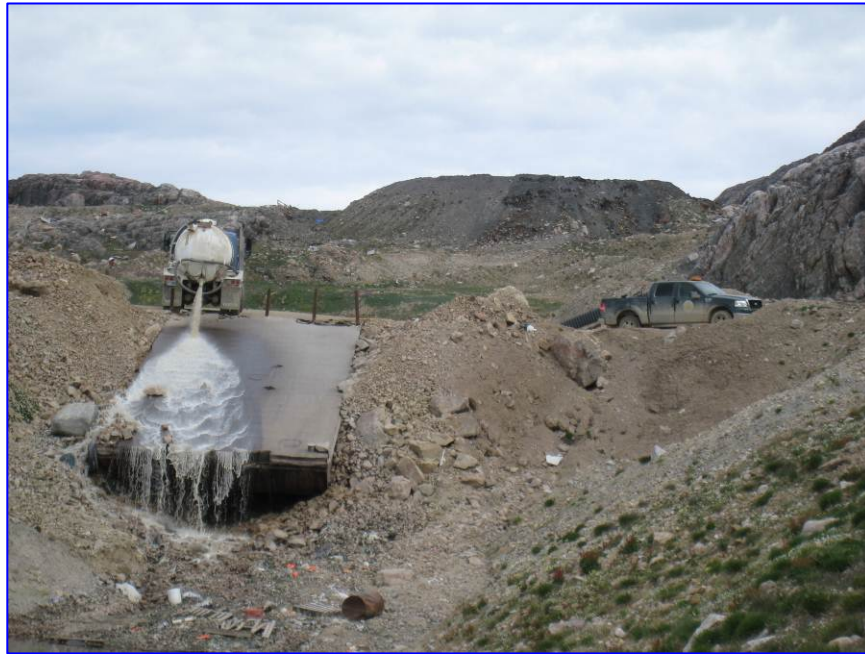
**Photograph No. 5**

Truck discharge facility at upper pond of active lagoon

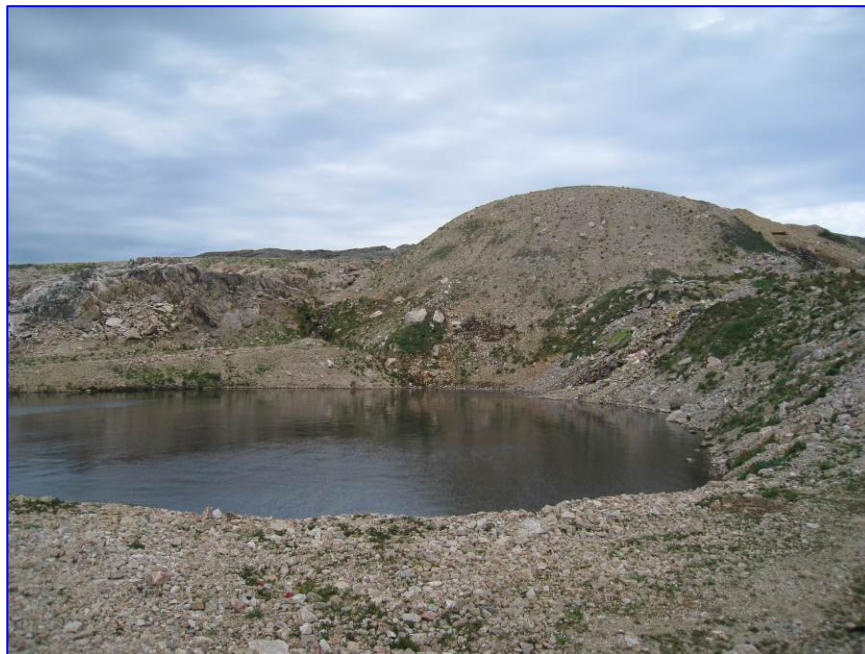
**Photograph No. 6**

View of middle pond of active lagoon

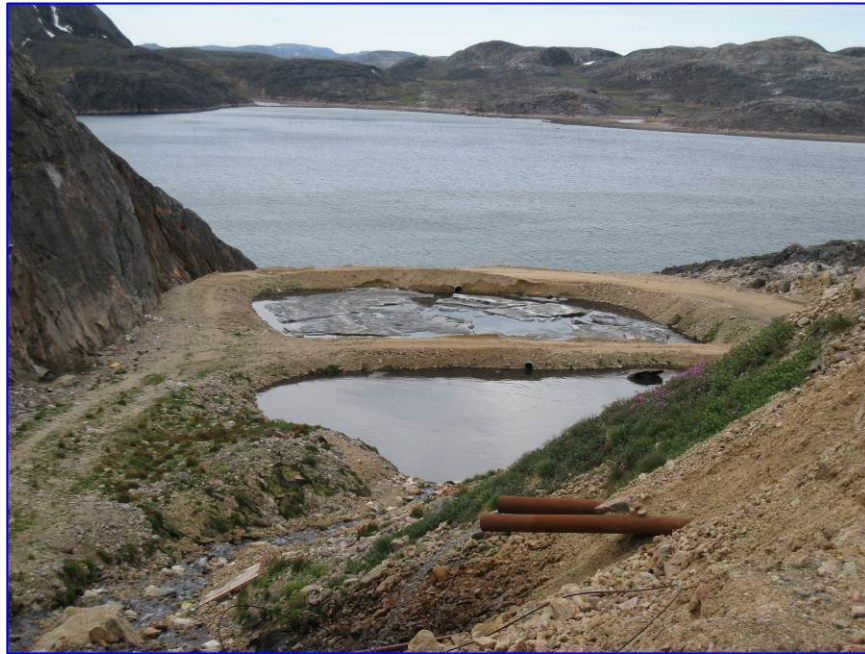
**Photograph No. 7**  
View of middle and lower ponds of active lagoon

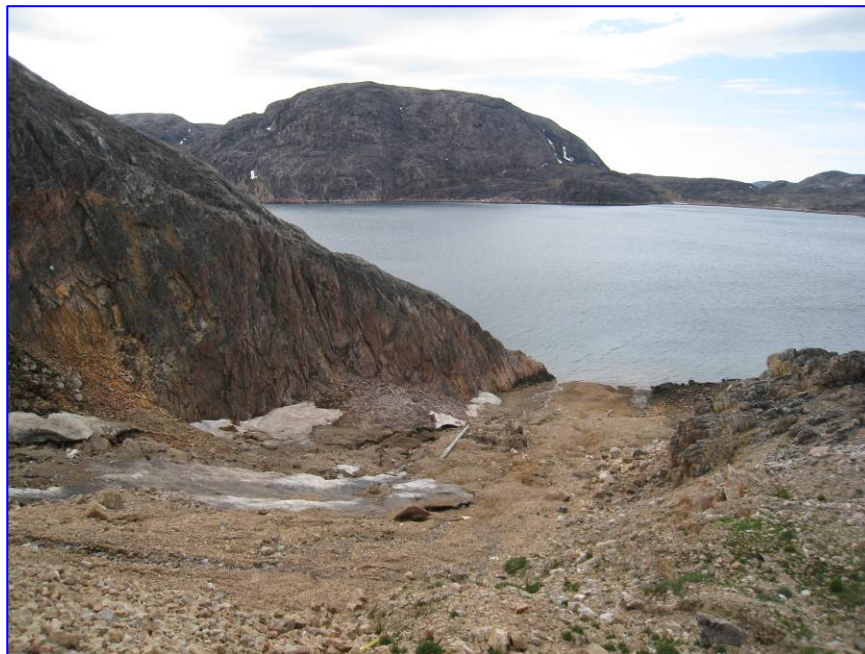
**Photograph No. 8**  
Discharge from lower pond to Foxe Inlet

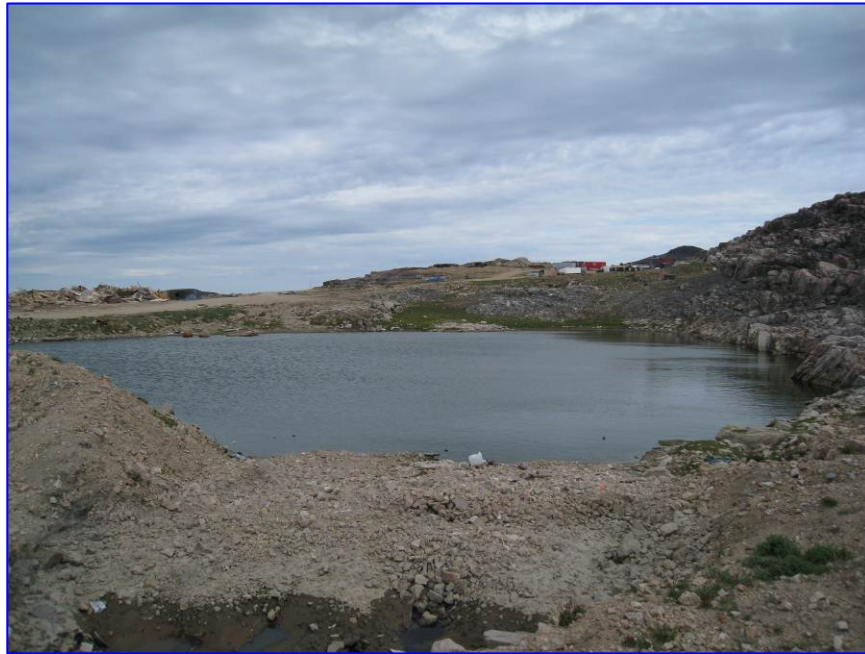
Visual examination of the lagoon did not reveal any concerns related to slope stability or erosion.

**Photograph No. 9**  
View of emergency lagoon

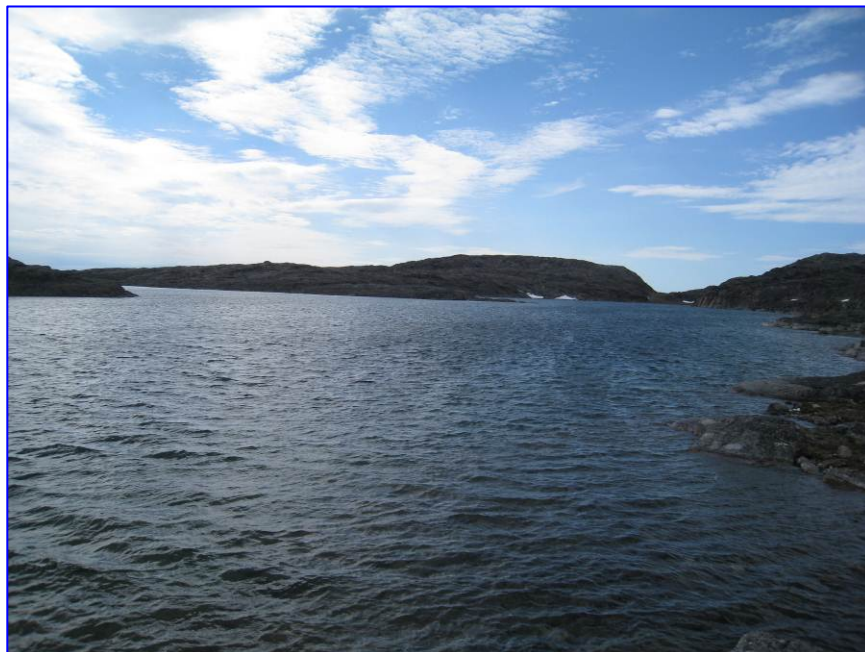
A visual examination of the water reservoir was undertaken. It did not reveal any signs of slope instability or erosion.

**Photograph No. 10**  
View of Tee Lake

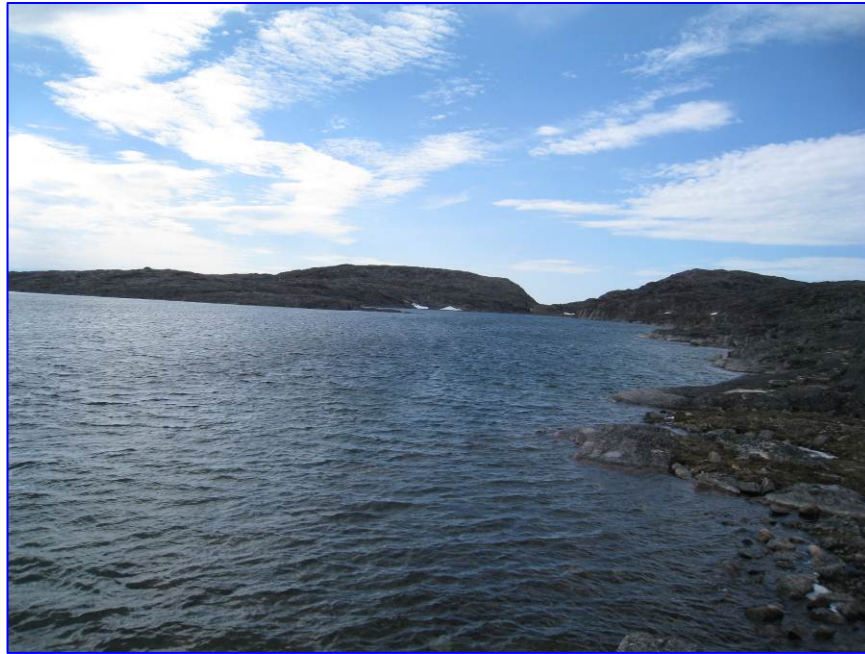
**Photograph No. 11**  
Another view of Tee Lake

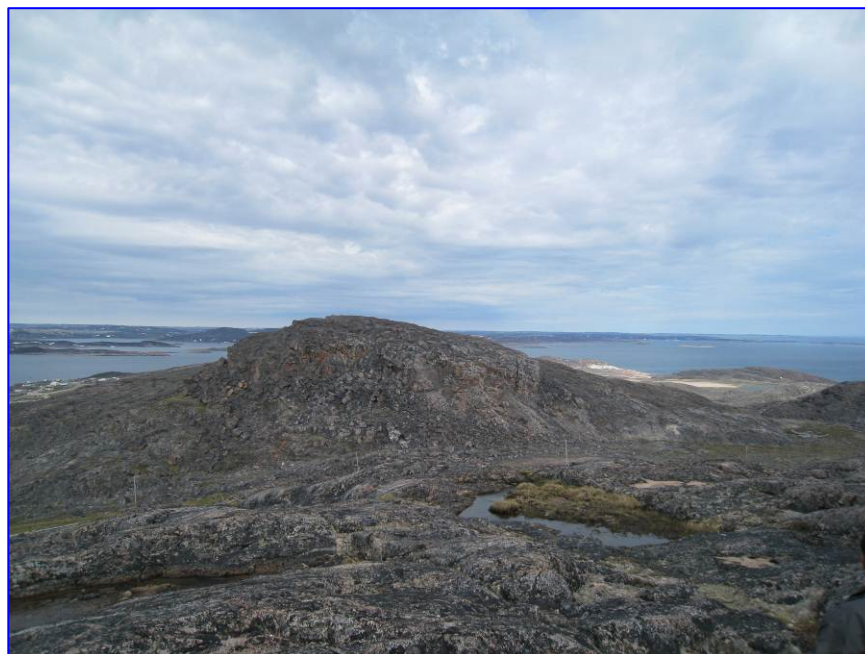
**Photograph No. 12**  
Transmission pipeline from reservoir to truck fill station

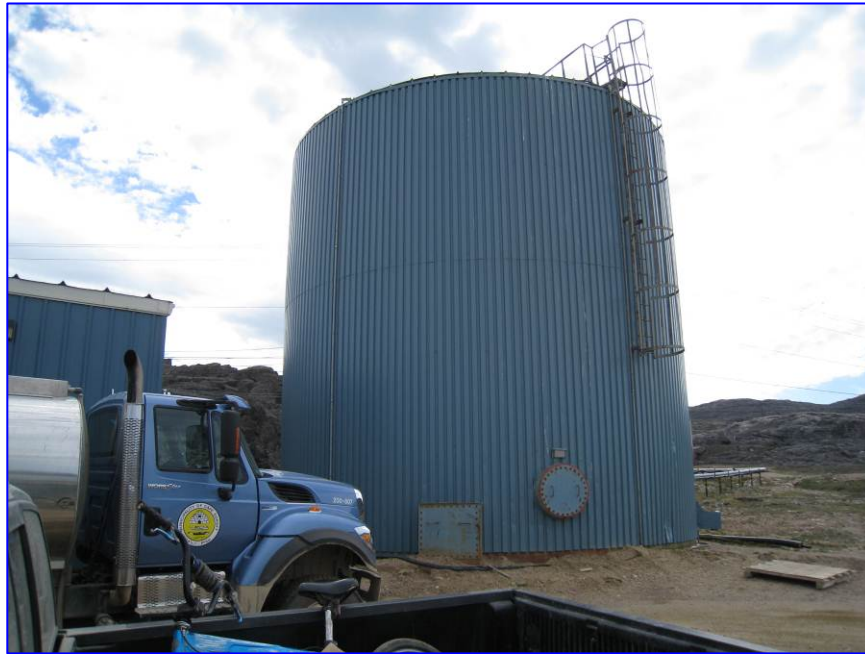
**Photograph No. 13**  
Water storage tank at water treatment plant

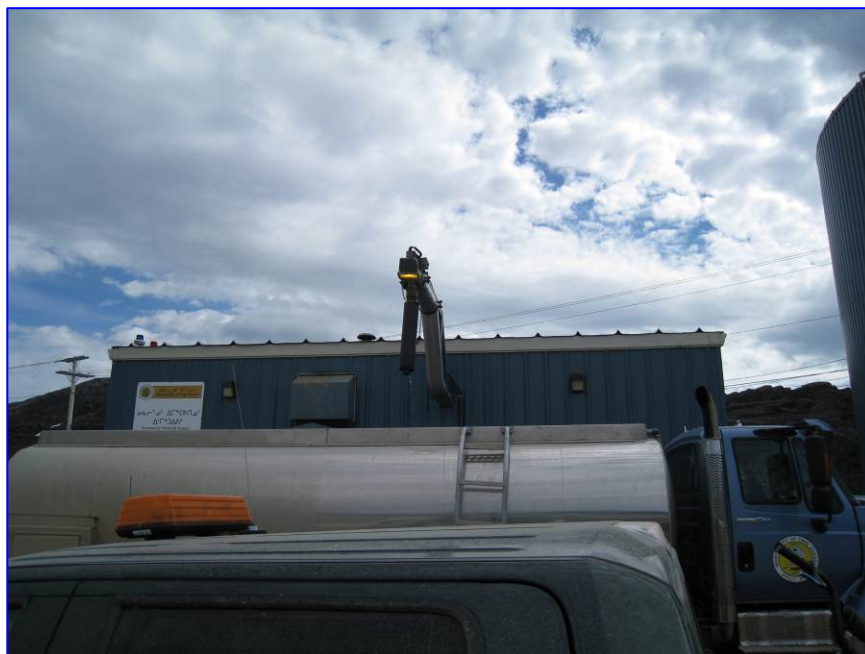
Visual observations indicated that the equipment is in reasonably good condition.

**Photograph No. 14**  
Truck fill station

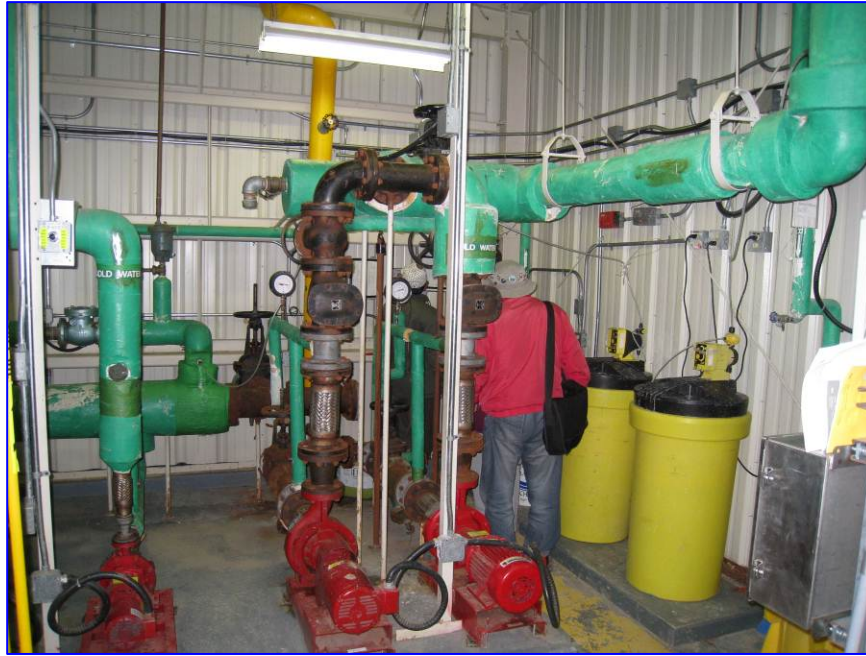
**Photograph No. 15**  
View of water treatment plant interior
