September 5, 2000 Municipal Water Use Inspection - Report

MUNICIPAL WATER USE INSPECTION FORM

Date: 2000/09/05 Licensee Rep. (Name/Title): Dan Holmes / Director, Municipal Operations
Licensee: Municipality of Cape Dorset Licence No.: unlicensed

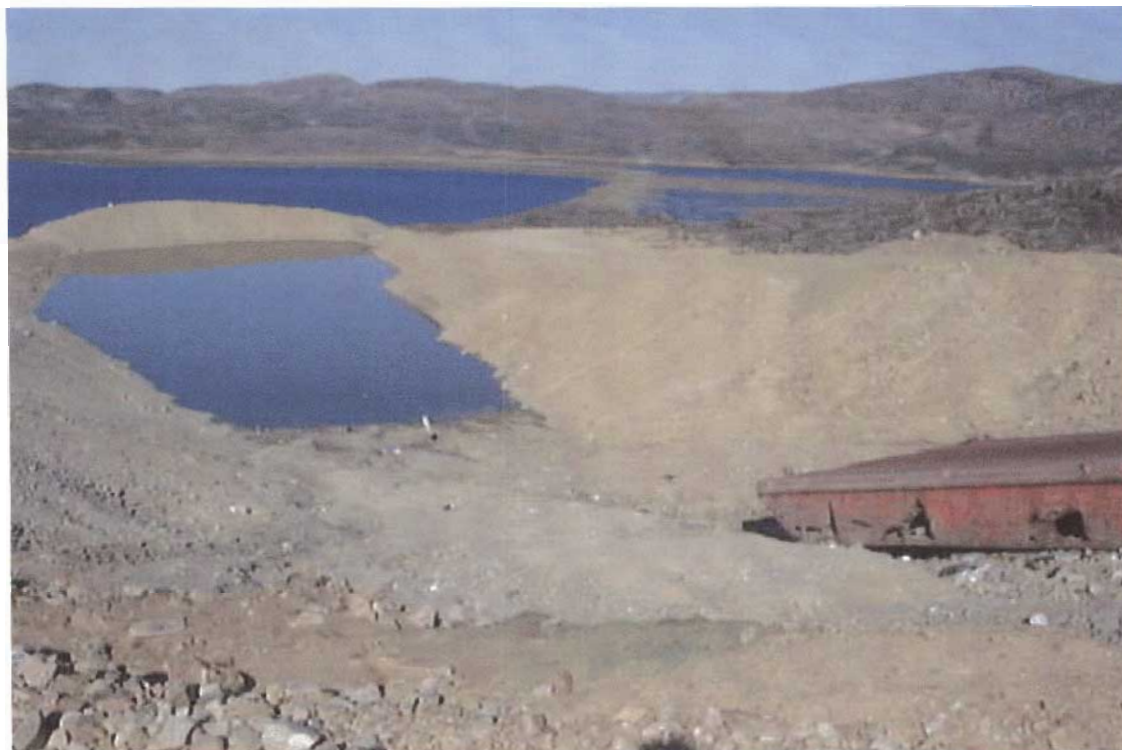
- **Sewage waste disposal:** At the time of the inspection, the uppermost cell of the new sewage disposal facility was filled to capacity (figure 1), and effluent was decanting downslope (figure 2). As extensive spring runoff essentially rendered the second cell useless by washing out its berms (figure 3), sewage effluent from the first cell of the new sewage disposal facility (figure 4) basically flowed unhindered through the breached lower cell (figure 5), into receiving waters (figure 6). Nevertheless, the attached analytical results relating to the discharge from the new sewage disposal facility reveal relatively acceptable concentrations of tested parameters. However, due to the excessive springtime erosion along the current sewage and solid waste disposal valley, the Municipality had to temporarily revert to the old, undersized sewage lagoon (figure 7) although it admittedly provides very minimal effluent treatment prior to discharge (figure 8).

figure 1. Chute and first cell of the new sewage disposal facility; 2000/09/05.

This being said, the Inspector strongly questions the viability of the new sewage disposal facility. Indeed, the recurring nature of runoff-related damage undeniably jeopardizes the effectiveness of the facility. Accordingly, it is the Inspector's belief that resources annually directed to patch up work might be more suitably allocated to the investigation of alternate long-term locations, or perhaps even technologies, of sewage treatment facilities appropriate for the Municipality. Thus, by copy of this letter to Community Government and Transportation (GC&T), the Inspector trusts that this avenue will at least be considered.

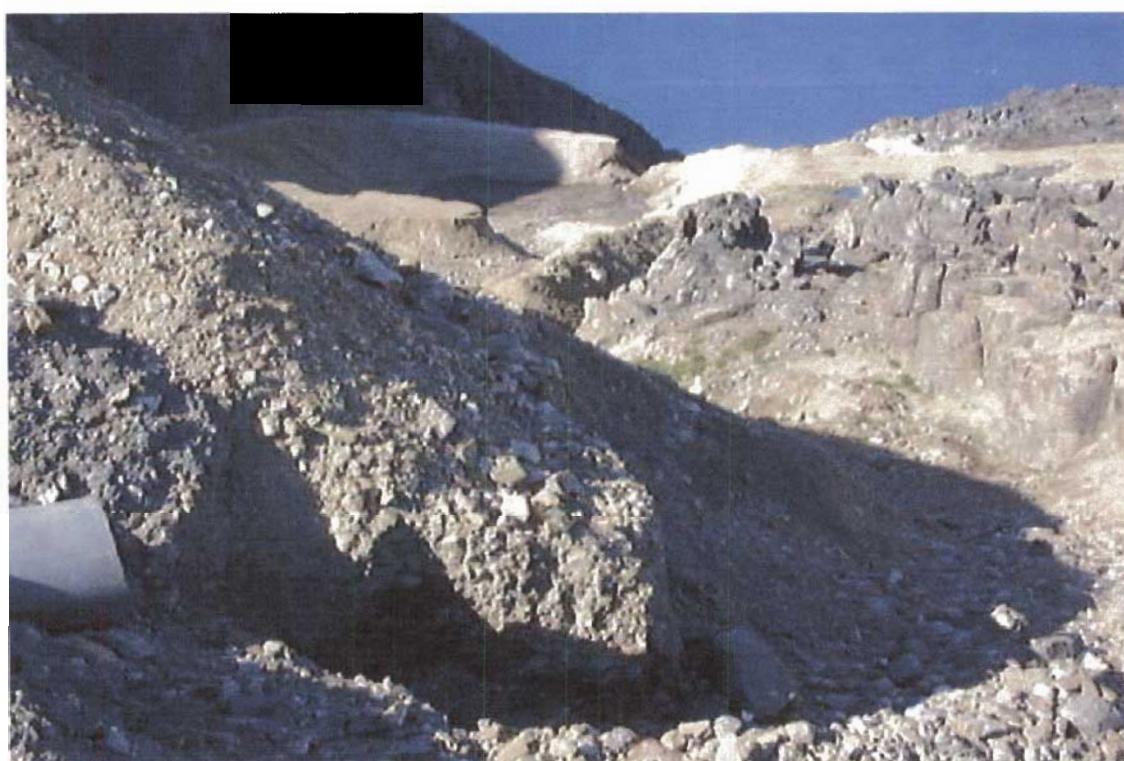
figure 2. Path of discharge from the first cell of the new sewage disposal site; 2000/09/05.

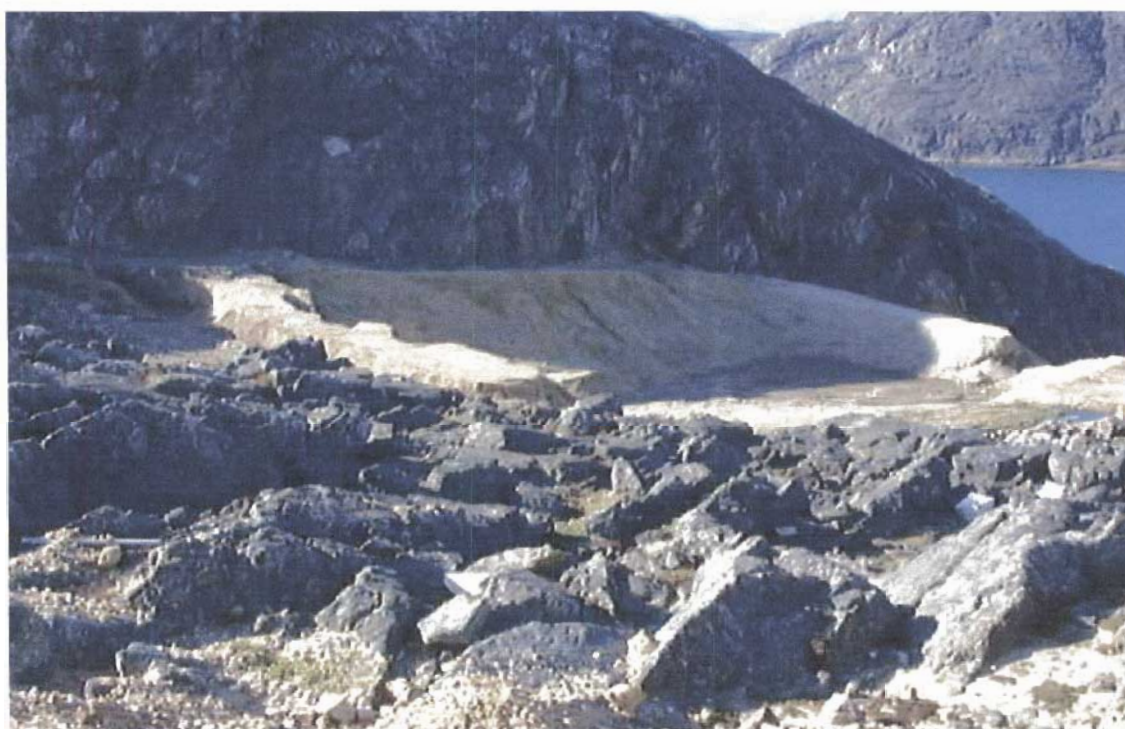
Comments: Extensive spring runoff washed out the lower cell of the new sewage disposal facility. Upper cell and old sewage lagoon utilized alternatively, until full. Sewage effluent at both facilities flowing downslope without much prior retention time. Unfenced solid waste disposal facility appears regularly burned, and is well compacted and covered. Concerns noted with the quantity of observed, and potential, runoff flowing through the site. The toe of the bulky metal wastes disposal site lies under the high tide mark. No form of containment provided for hazardous materials. Waste oil is adequately stored and disposed of at the Hamlet garage (furnace).

figure 3. Breached berms, new sewage disposal facility; 2000/09/05.

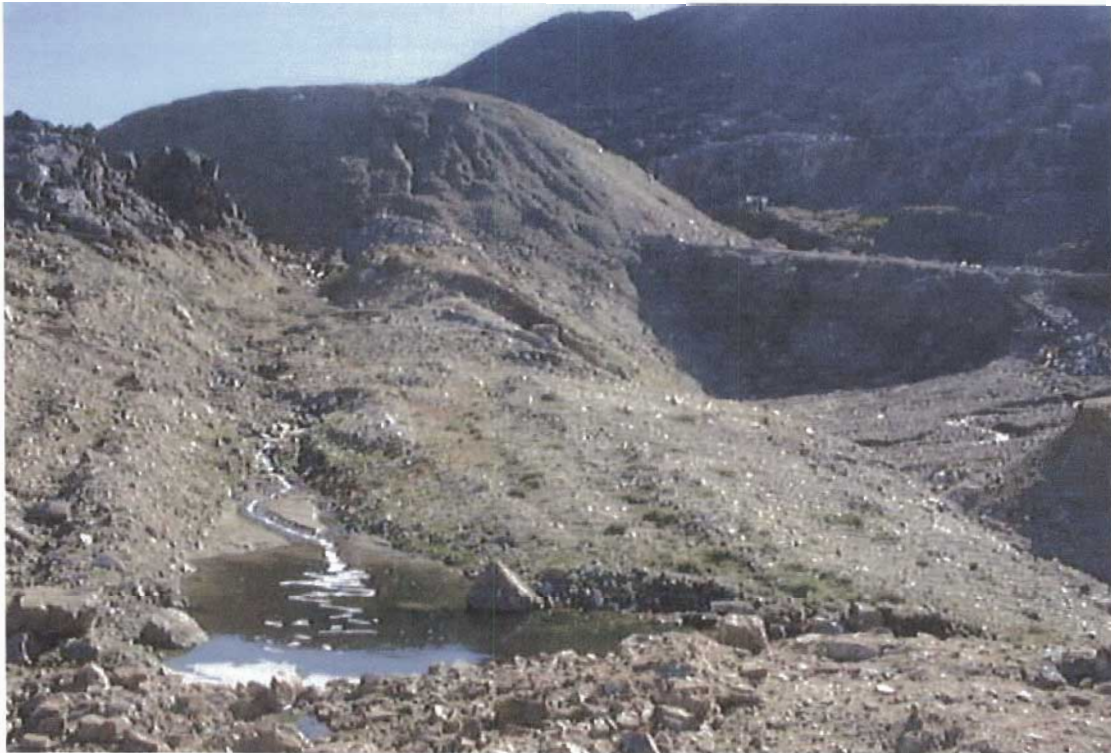
figure 4. Main veins of discharge from the first cell and the dump; 2000/09/05.

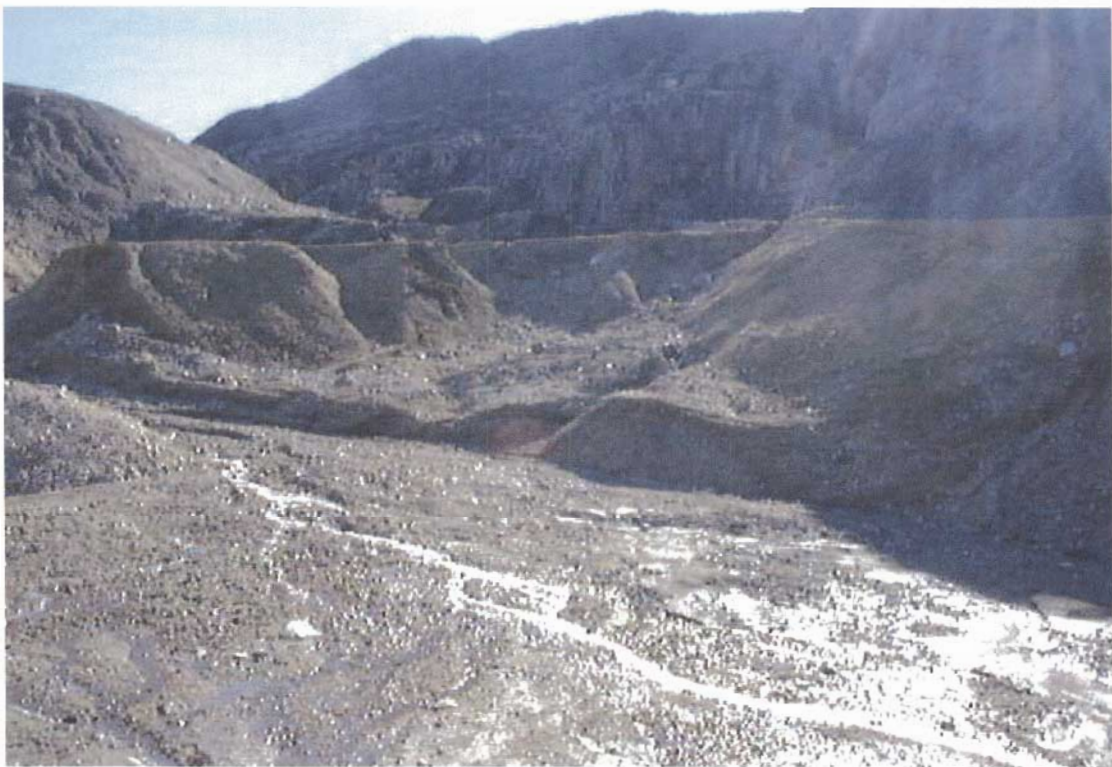
figure 5. Second cell of the new sewage disposal facility; 2000/09/05.

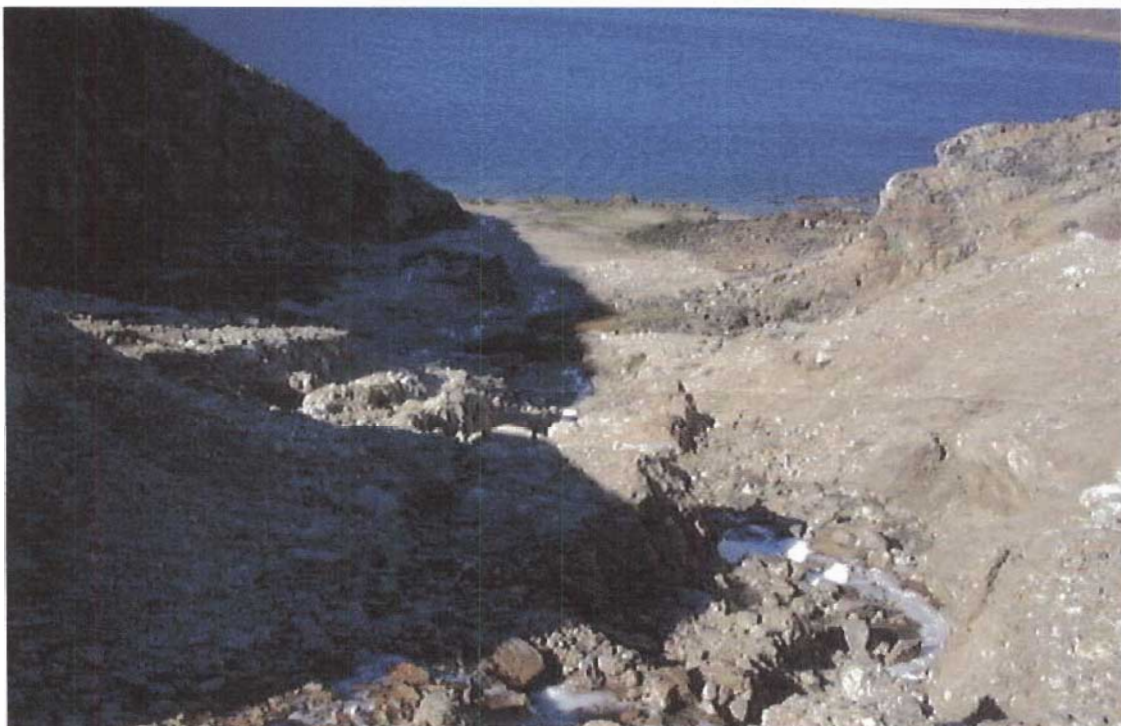
figure 6. Path of discharge from the new sewage disposal facility; 2000/09/05.

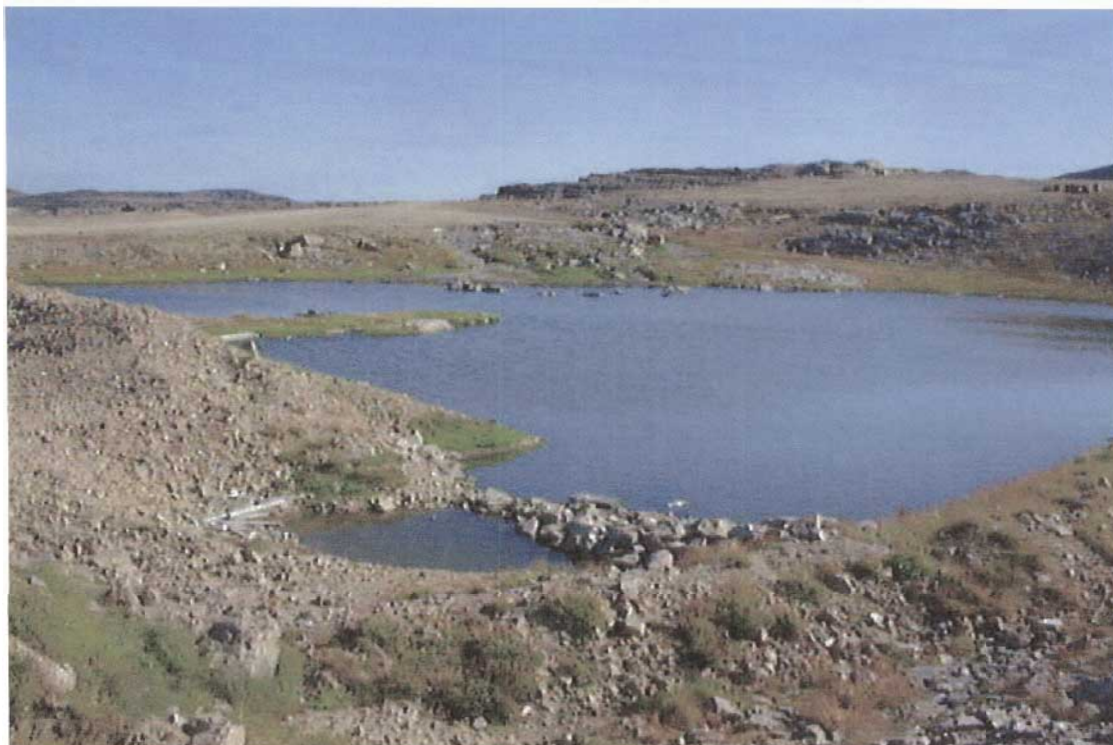
figure 7. Old sewage disposal facility; 2000/09/05.

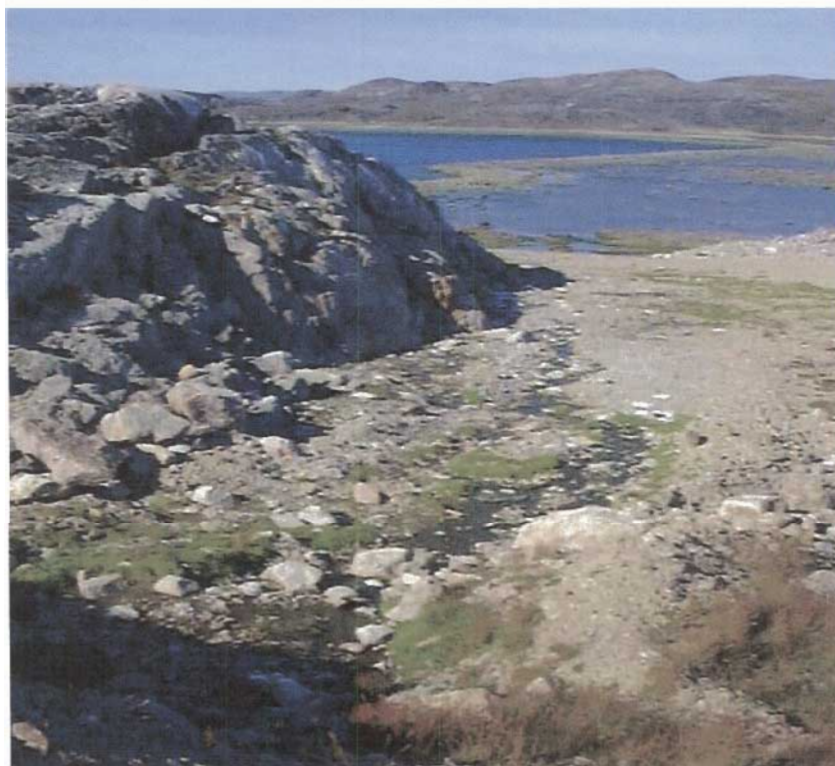
figure 8. Path of discharge from the old sewage disposal facility; 2000/09/05.

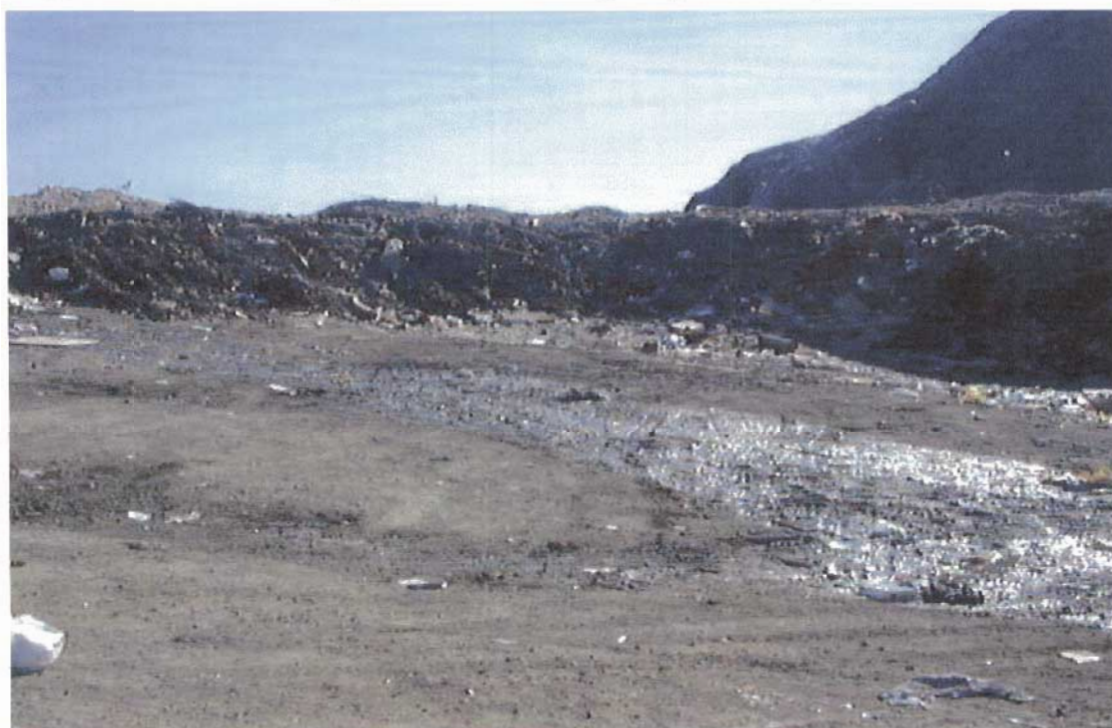
- **Solid waste disposal:** Much of the above erosion and runoff issues equally apply to the solid waste disposal facility situated within the same drainage valley. Although the wastepile is well compacted and covered, and household combustible waste appears to be burned on a regular basis (figure 9), concerns remain over the quantity of runoff flowing through the site and its implications in regards to leachate production (figure 10). However, the attached analytical results indicate that the sampled leachate from the solid waste disposal facility was, at the time of the inspection, relatively benign. On a side note, should erosion be successfully controlled, the instalment of a perimeter fence would further contain the waste within the facility, and likely minimize complications related to wildlife attraction.

figure 9. Solid waste disposal facility; 2000/09/05.

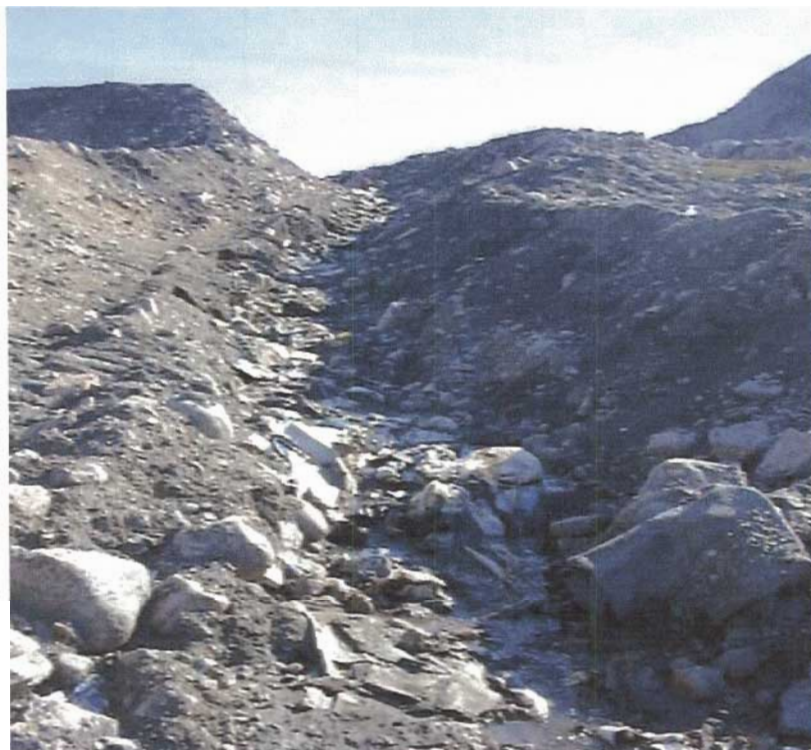
figure 10. Leachate from the solid waste disposal facility; 2000/09/05.

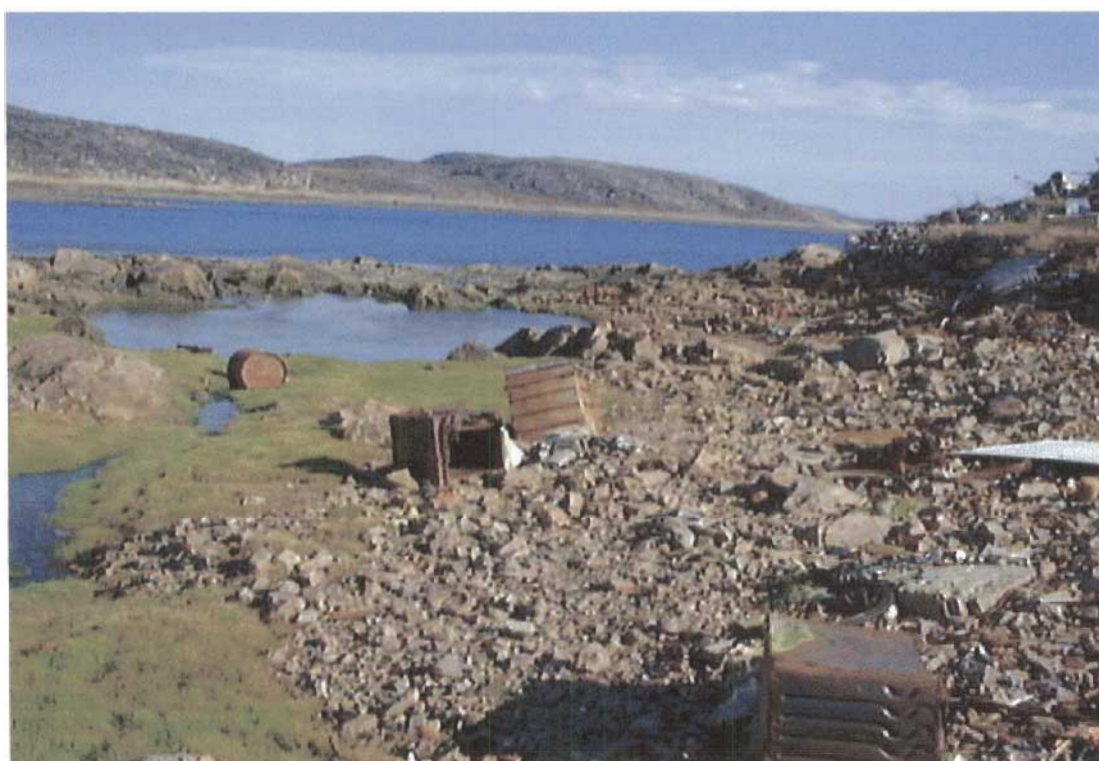
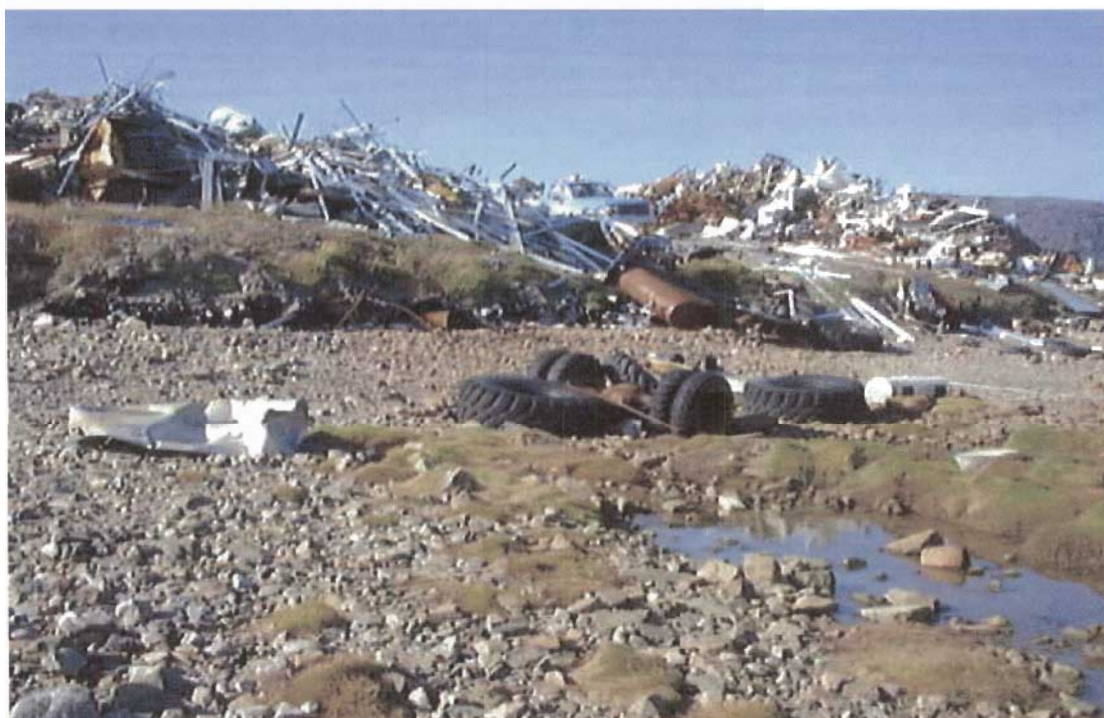
In parallel, both condition and location of the bulky metal wastes disposal site are causes for concern, although the attached analytical results are not disturbing. Indeed, an impressive volume of bulky wastes, the toe of which lies below the high tide mark, is accumulated along a section of shoreline (figures 11-12). Further, hazardous material is simply discarded at the site, since no specific form of containment is provided. Consequently, the inspector commends the Municipality for recognizing the need to cleanup the site, and for taking appropriate steps in this direction; such as contacting the EcoAction community program towards the restoration of this and other waste disposal sites within municipal boundaries, and investigating with the Canadian Coast Guards the possibility of shipping out bulky metal wastes on sealift backhauls.

figure 11. Bulky metal wastes disposal facility; 2000/09/05.

figure 12. Bulky metal wastes disposal facility; 2000/09/05.
