Re: July 21, 2003 Municipal Water Licence Inspection

MUNICIPAL WATER USE INSPECTION REPORT

Licensee: Hamlet of Cape Dorset

Licence No.:NWB3CAP0207

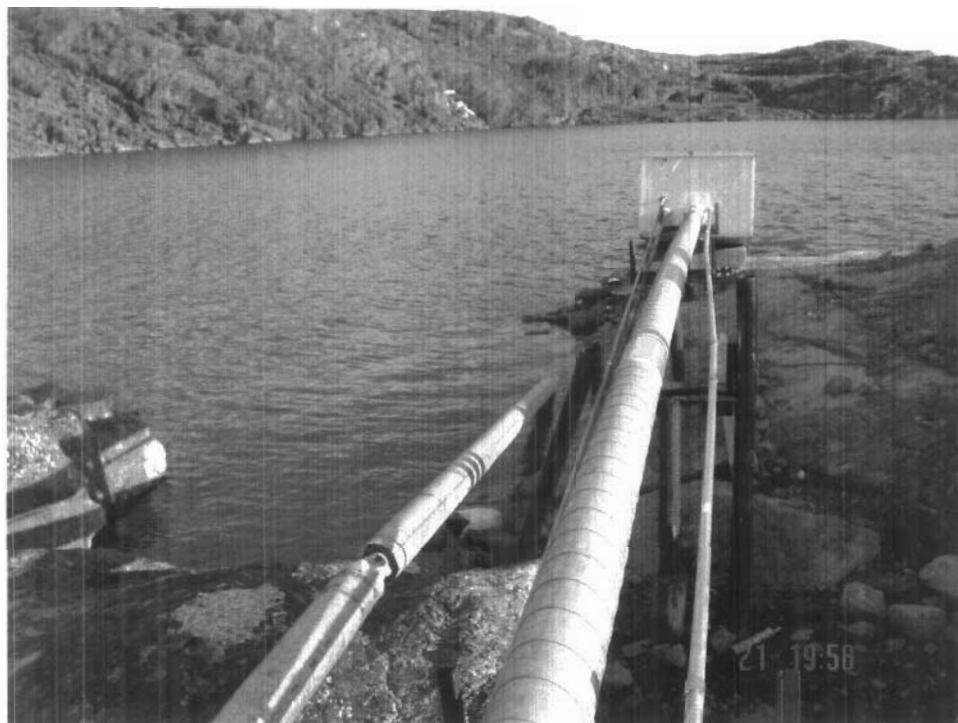
In order to eliminate difficulties experienced with the pipeline between Tee Lake and the pumphouse (figure 1) a contractor was hired to build a replacement/back up pipeline. The new pipeline is now in place, however, Mr Nason expressed concern that the lack of galvanized hinges, exposed wires and inadequate allowance for shifting of the pipeline could significantly reduce its useful life. He felt that addressing these problems would greatly increase the longevity and functionality of the new pipeline.

Figure 1. Cape Dorset pipeline running from Tee Lake to the municipal pumphouse.

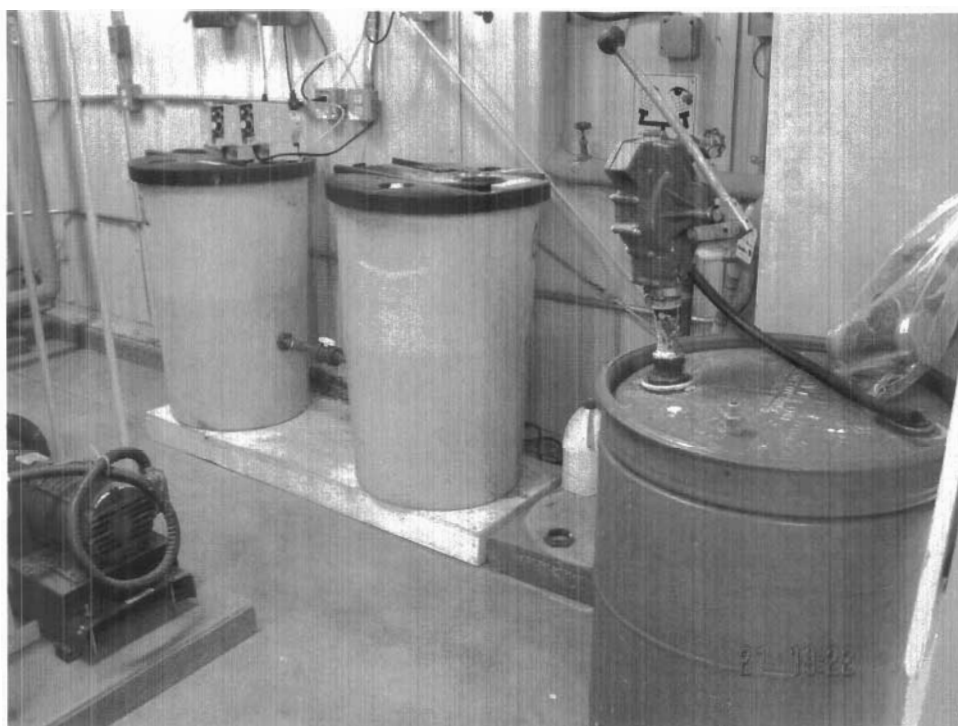
The pumphouse and chlorination system are well maintained and Mr Nason is committed to maintaining daily records of water use and chlorine residual concentration in the water supply.

Figure 2. Chlorination system at the Cape Dorset pumphouse.

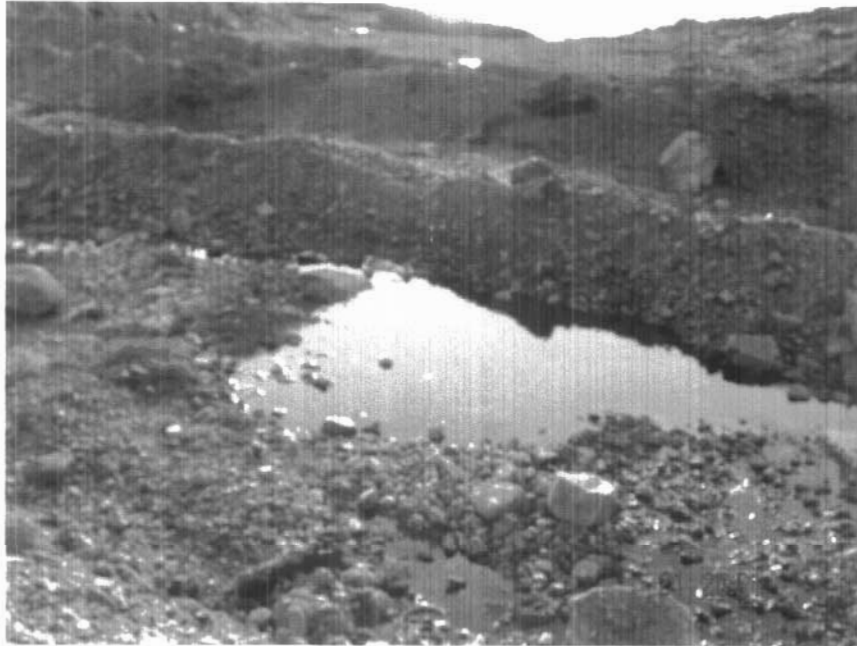
The old single celled sewage lagoon was brought back into service because of the problems with the 3-celled sewage lagoon. However, there is a serious leak in the old lagoon and it's capacity is not sufficient to support the community. In an

effort to increase the lagoons retention time the municipality placed a row of three berms at the bottom of the lagoon between the leaking lagoon and Telik Inlet (figure 3). The berms have created some ponding and it is possible that they improve the quality of the sewage effluent before it reaches Telik Inlet but it is obviously not an acceptable solution to the problem. Water observed running into Telik Inlet is greyish and foamy with a noticeable odour. A considerable amount of algae is visible in the stream and grass is growing quite thickly below the berms almost all the way to Telik Inlet. The increased plant and algae growth is consistent with high nutrient content consistent with sewage effluent. Constantine Bodykevich advised Art Stewart that the flow needs to be stopped or at the very least, reduced significantly.

Figure 3. Berms placed between the old sewage lagoon in Cape Dorset and Telik Inlet to increase the lagoons "retention time".

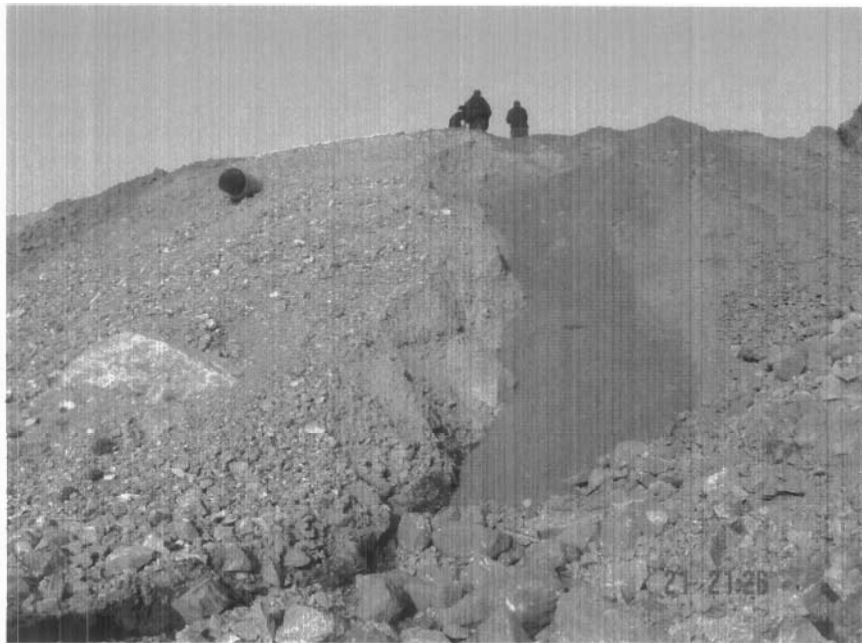
The municipality has attempted to repair the three cell sewage lagoon but so far the repairs have not been effective (figure 4). There is a small leak from Cell one along the road which then flows into cell two from the northeast side. There is also a ditch on the opposite side of cell two that runs from an overflow culvert in cell one, parallel to cells two and three, before flowing down to Telik Inlet. There was only a slight trickle of water originating in the landfill but if cell one were operating effluent would run directly from cell one into Telik Inlet. According to Art Stewart the overflow culvert was designed to run into cell two but it did not appear to be working properly. Repairs on the berm and overflow culvert between cells two and three appeared to be near completion but the berm was still quite unconsolidated and I suspect that spring runoff will likely wash it away again.

Figure 4. Attempted repairs to the 3rd cell in the Cape Dorset sewage lagoon.

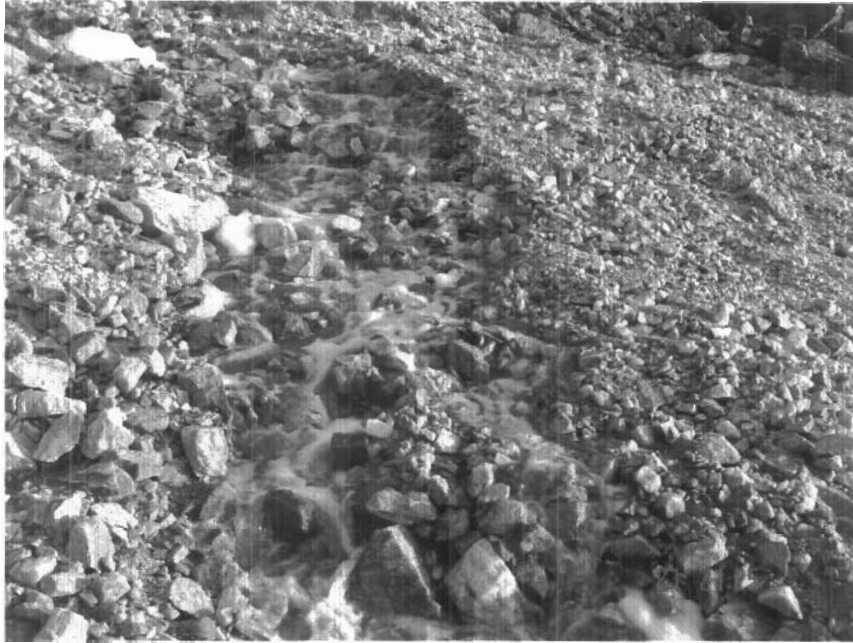
Repairs have also been attempted on the final berm in cell three but effluent was still visible flowing from beneath the final berm into Telik Inlet. The Municipal Engineer, Sameh Elsayed suggested that the rapidly flowing water below cell three may be a result of an underground spring. This did not appear to be the case however, as the water was quite grey and foamy with algal growth on the rocks and a very strong odour that I would associate with sewage effluent.

Analysis performed by Taiga Laboratory in Yellowknife showed the water running below the final berm of the sewage lagoon to have some characteristics consistent with primary sewage effluent (Environment Canada website). The effluent was within the parameters of the water licence for the parameters tested but it is notable that time constraints prevented analysis for BOD and Fecal Coliforms, both required parameters in the water licence. Samples of the outflow showed that it was quite high in Cadmium 0.1ug/l (Canadian Water Quality Guidelines for the Protection of Aquatic Life of 0.12 ug/l) and Iron 6210 ug/l (no guideline) but Ammonia -Nitrogen (17.4 mg/l) and Phosphorous were quite low.

Figure 5. Flow observed below the 3rd cell in the Cape Dorset sewage lagoon.

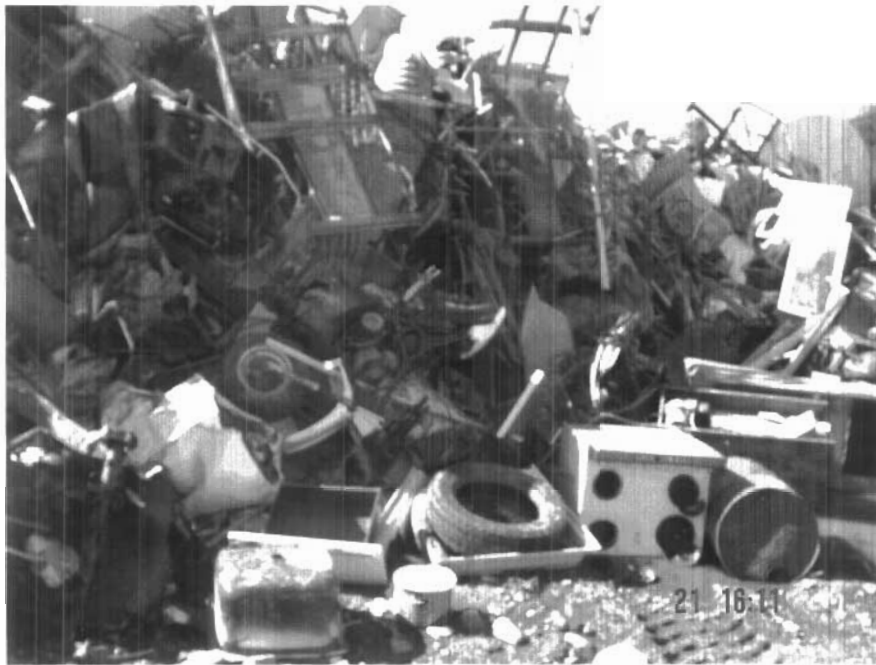
The current state of the metal dump is unacceptable. There is no segregation of materials at the site (figure 6) and no containment of hazardous materials. Tires, solvent containers, dead animals and used 12V batteries were all visible at the site. No measures are in place to prevent contaminated runoff from flowing into Telik Inlet and water was visible seeping out of the metal dump. A sample of the seep was taken at coordinates N 64°13'36.1" W076°34'19.6" and preliminary results are attached to this report.

According to results obtained from Taiga Laboratory in Yellowknife; Iron, with a concentration of 2253ug/L is much greater than the Canadian Environmental Quality Guideline for the Protection of Freshwater Aquatic Life (CEQGPAL, 300ug/L) but no guideline has yet been developed for Marine Aquatic Life. Phenols were measured at a concentration of 7.4 ug/l which also exceeds the Canadian Environmental Quality Guideline for the Protection of Freshwater Aquatic Life (4ug/l). The remainder of parameters measured were within Canadian Guidelines.

Figure 6. Unsegregated materials visible in the Cape Dorset Metal dump.

Art Stewart indicated that the metal dump is scheduled for clean up in the early fall of 2003. A clean up of the metal waste disposal sight should include segregation of materials, containment of hazardous waste, diversion of run-off and containment of precipitation to prevent contamination of Telik Inlet.

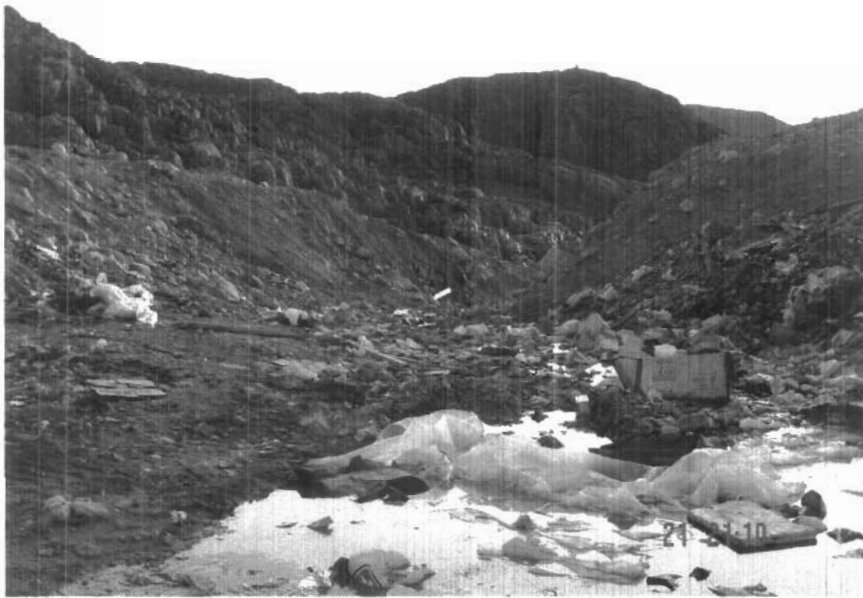
There is a significant amount of runoff passing through the landfill. This runoff along with precipitation, needs to be contained to ensure it does not carry contaminants into Telik Inlet. Currently, water running off the hills passes directly through the landfill before it continues on toward the Inlet. Signage needs to be put up identifying the landfill site and a fence needs to be built around the landfill to help contain waste.

Figure 7. Runoff passing through the Cape Dorset landfill.
