Our file - Notre référence
NWB3CAP0207

May 27, 2004

Re: Cape Dorset Lagoon/ Sewage Spill Follow up, May 5, 2004

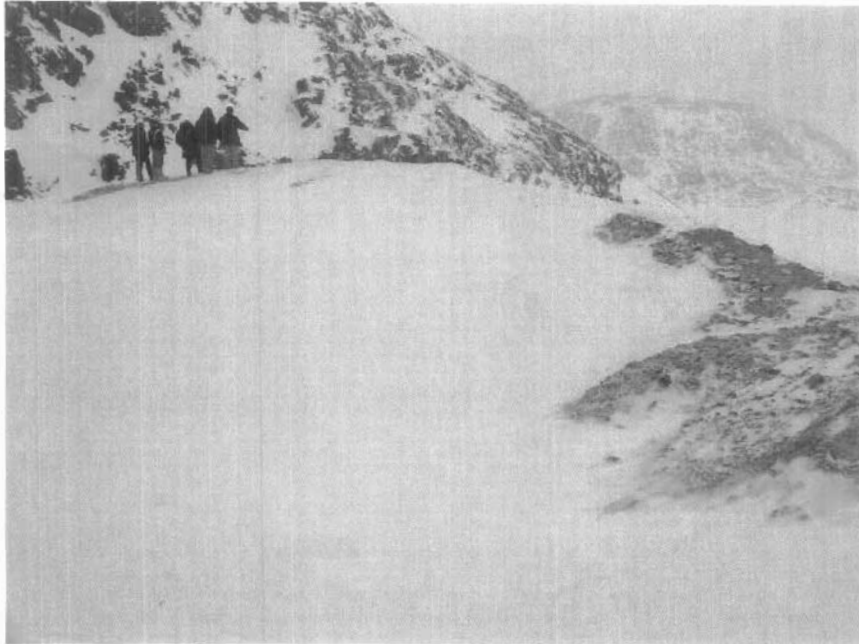
that the 3-celled lagoon is in imminent danger of overflowing and washing out as soon as the spring melt begins. The first cell is close to the level of the overflow culvert (Figure 1) while the second cell is full above the overflow culvert and has surpassed the surface of the berm in one area (Figure 2 and Figure 3). The sewage that has overflowed from cell one is flowing along the diversion channel on the mountain side of cell two. This overflow from cell one has produced a large build up of ice that is moving down the side of cell two (Figure 4). It appears that this sewage shall both erode the side of cell two and possibly flow along the mountain side, by-passing the third cell entirely. The situation could potentially result in a catastrophic failure of cells two and three of the lagoon.

Figure 1. The berm in the first cell of the new Sewage Lagoon in Cape Dorset.

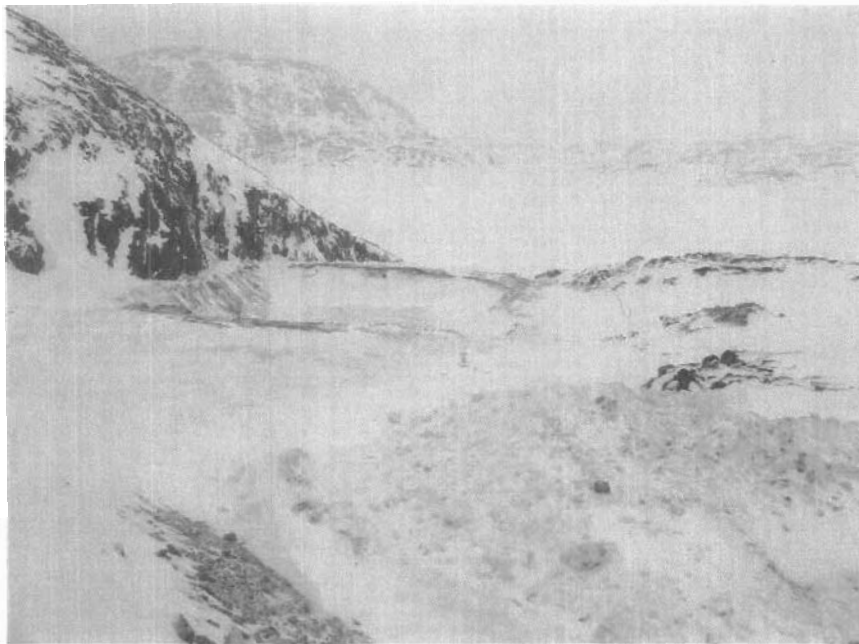
Figure 2. The second and third cells of the Cape Dorset Sewage Lagoon with the second cell full to overflowing.

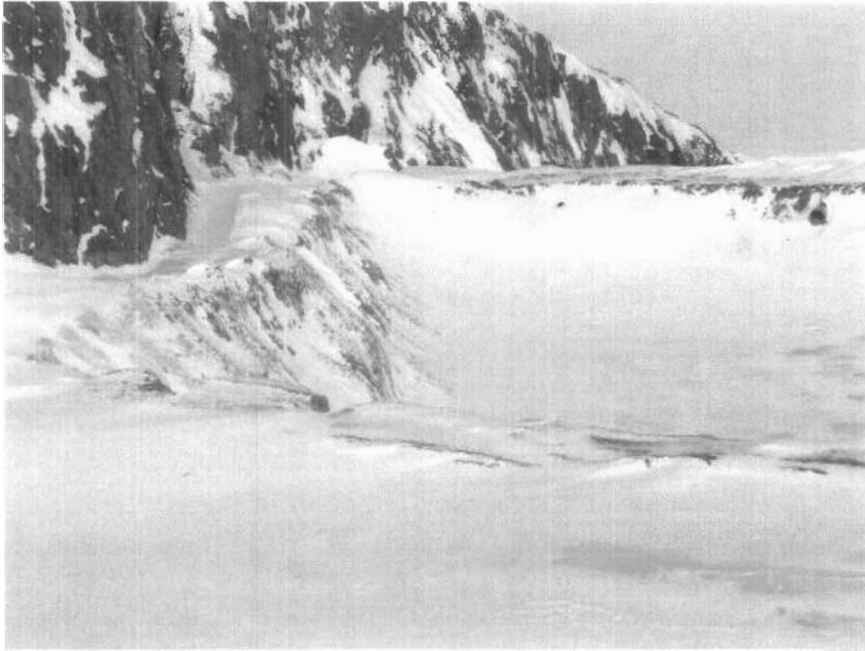
Figure 3. Visible erosion of the berm between the second and third cells of the Cape Dorset Sewage Lagoon.

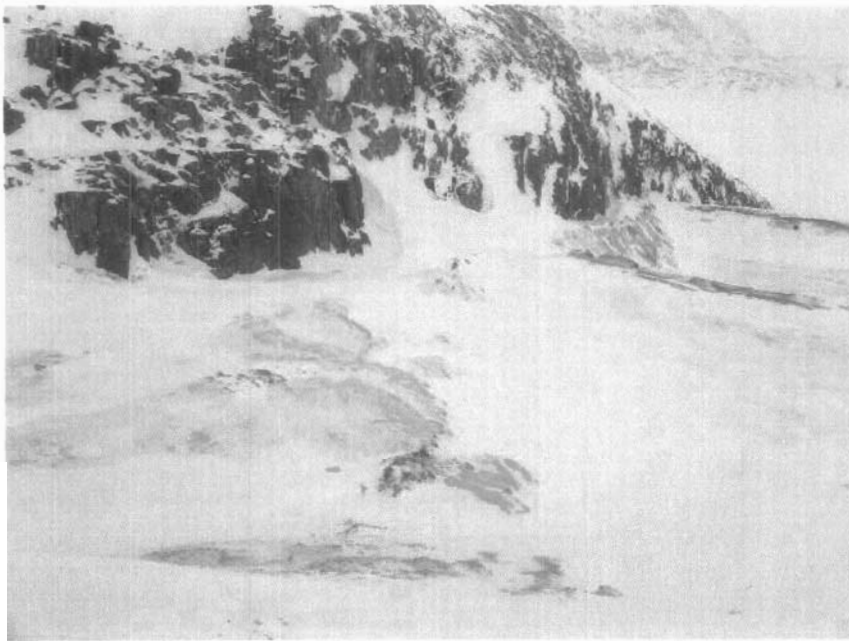
Figure 4. Build up of ice along the mountain side of cell two of the new Cape Dorset Lagoon with the eroding second berm visible in the upper right quadrant of the photo.

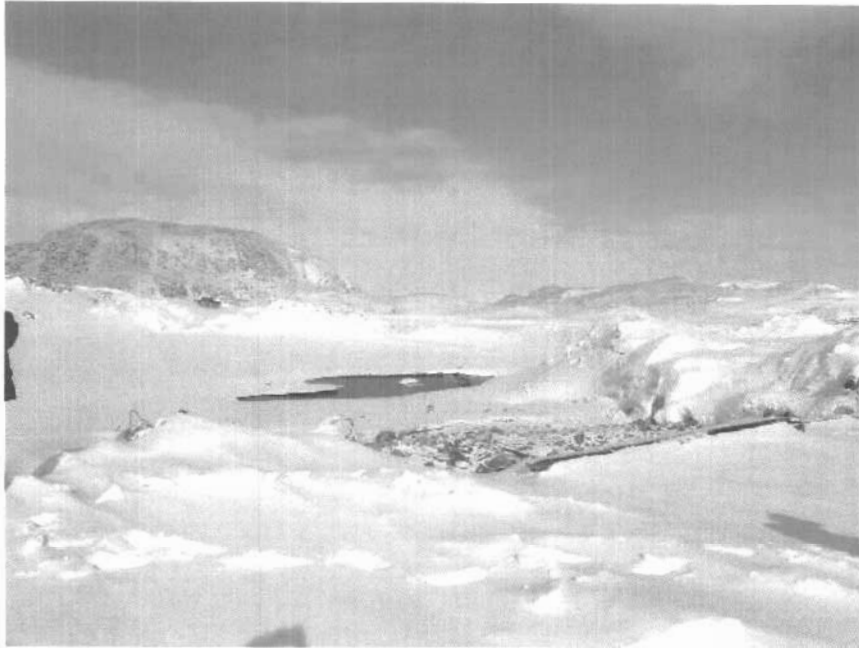
The original lagoon (Figure 5), which has been brought back into service does not have sufficient capacity to treat the communities sewage and the lagoon discharges continuously with minimal retention time. Additional retention berms put in place last summer to increase the retention time of the lagoon have been ineffective (Figure 6). The sewage effluent has surpassed the level of the additional berms and it flows virtually unimpeded into Telik Inlet. Consequently, there is a deposit of minimally treated sewage effluent visible on the ice in Telik Inlet.

Figure 5. The original Sewage Lagoon in Cape Dorset with the truck discharge point visible in the foreground.

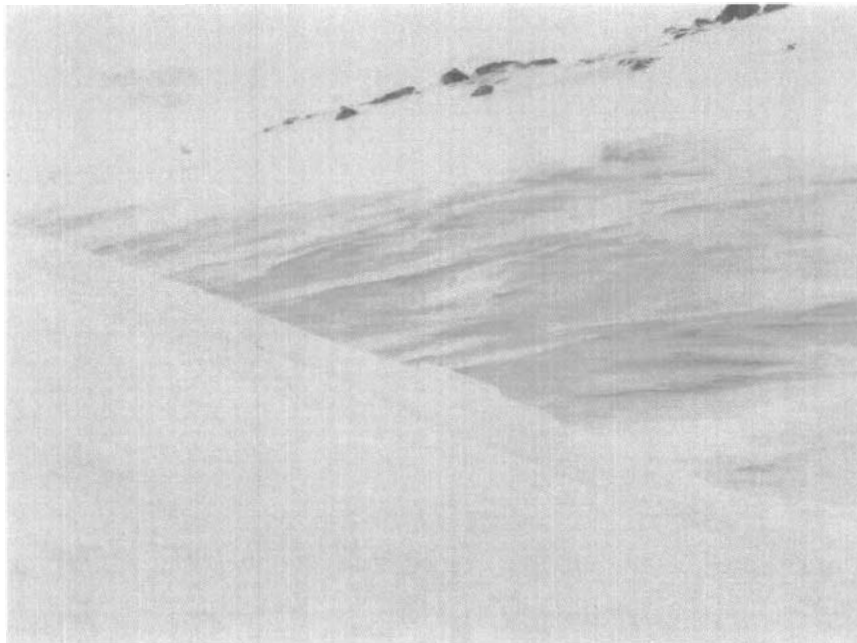
Figure 6. Frozen sewage build up flowing to Telik Inlet below the original Cape Dorset Sewage Lagoon.
