July 29-30/12 Cape Dorset: Inspection of license number 3BM-CAP0810 – *Expired*

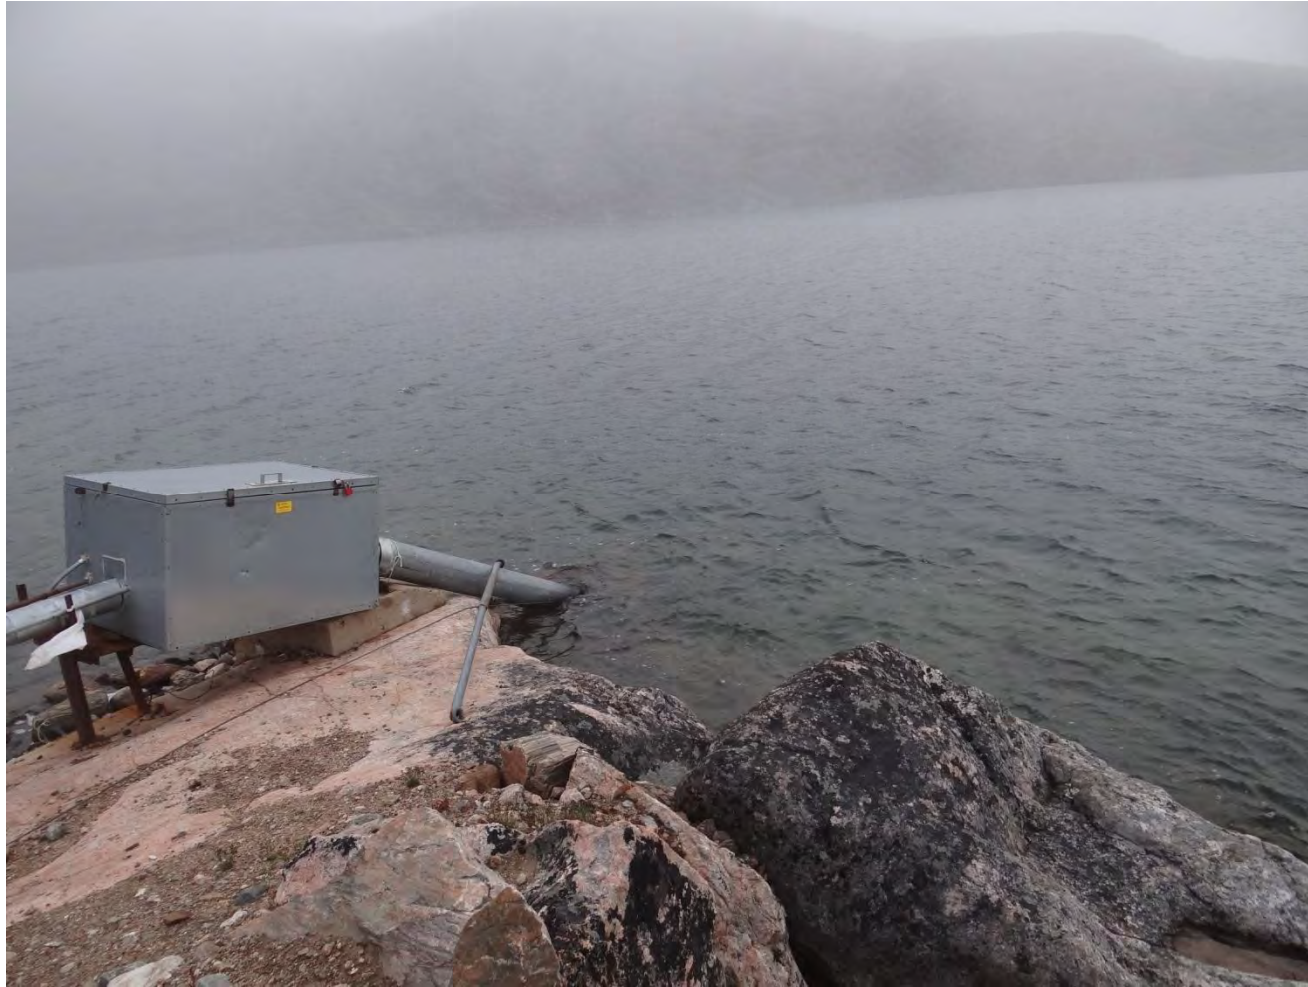
Water intake System

- A visual inspection was conducted of the pipeline and intake system at Tee Lake. No issues were noted.

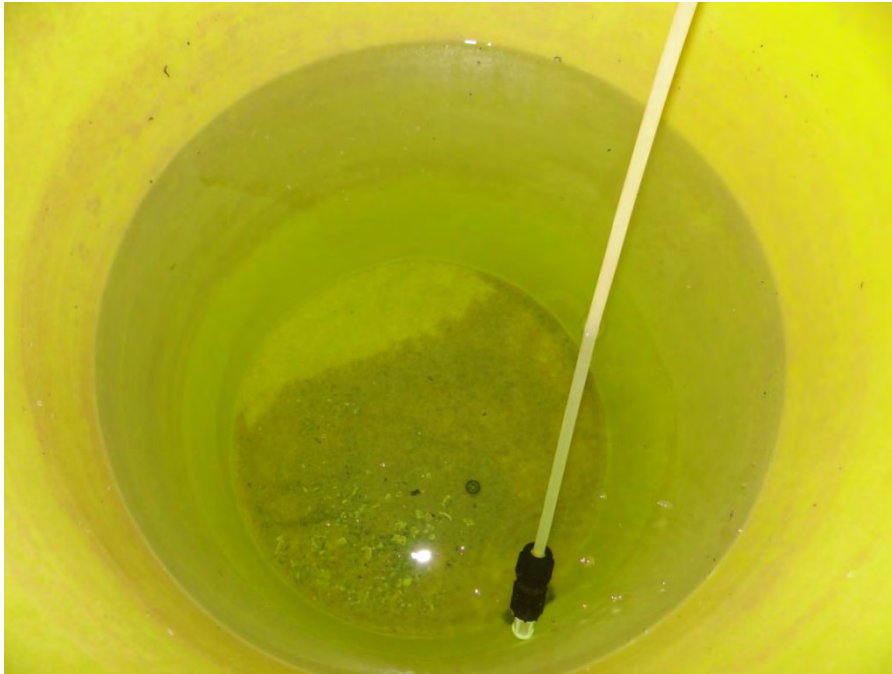
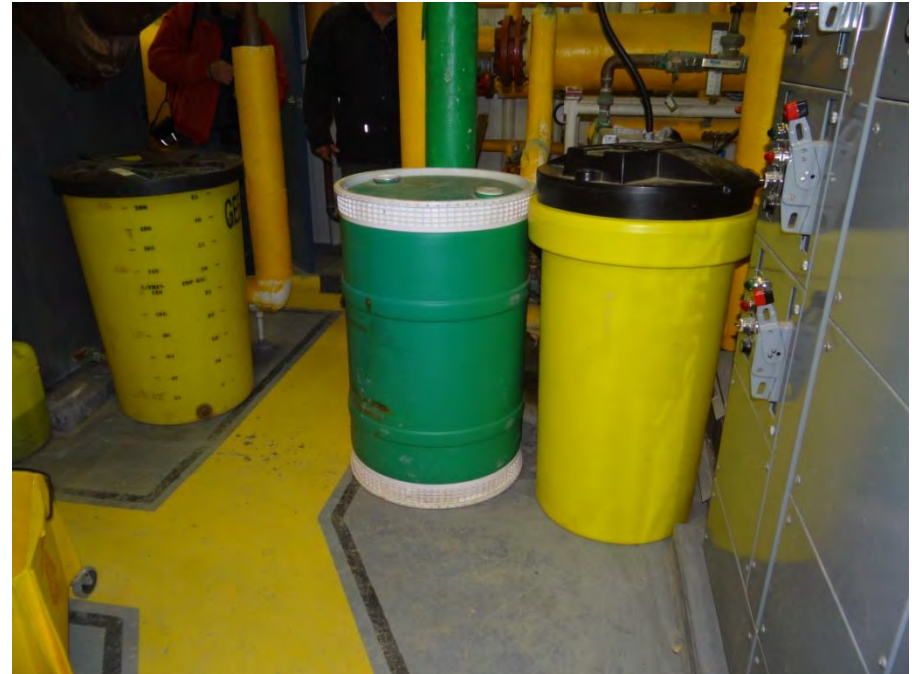
Water Treatment Facility

- Dirt in the chlorine tank that has settled to the bottom, also a barrel of glycol in the facility at the time of inspection

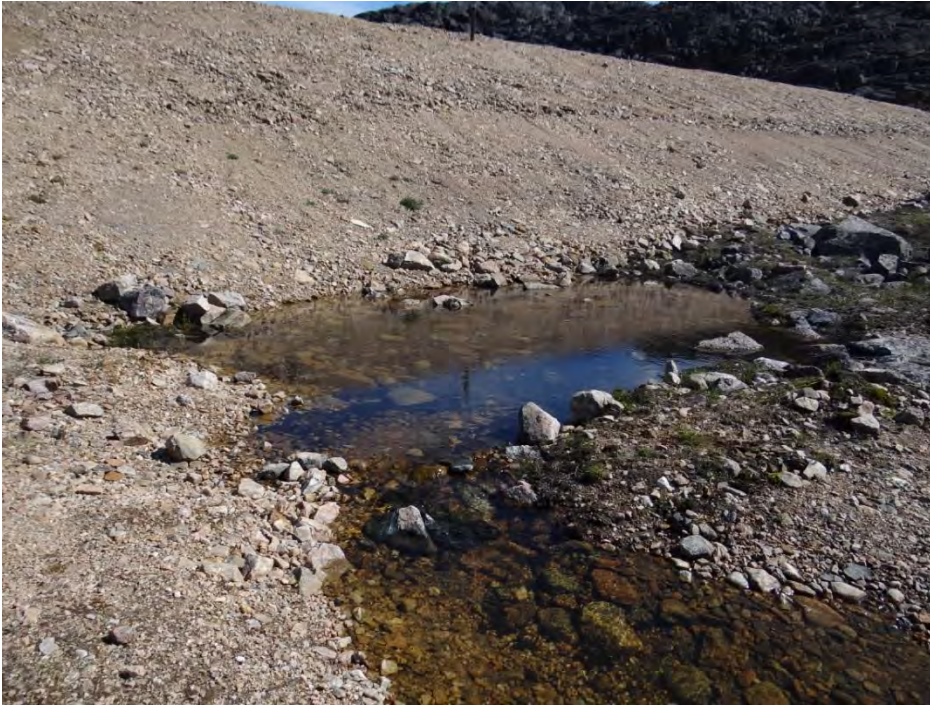
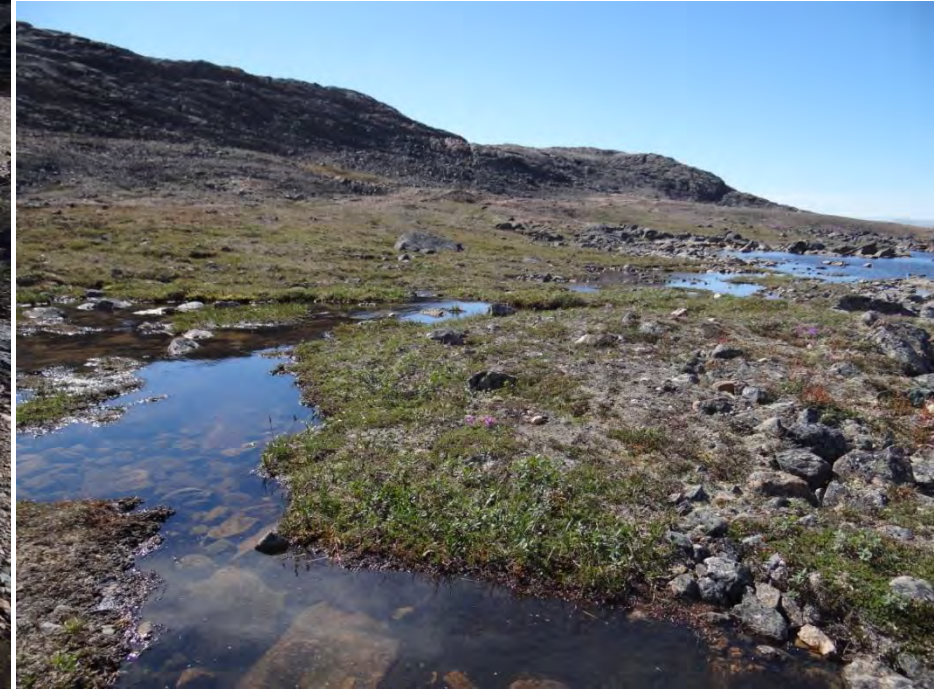
Leakage at New Lagoon

- There is a continues flow of water at the toes of the lagoon. This was an issue in previous inspections also.

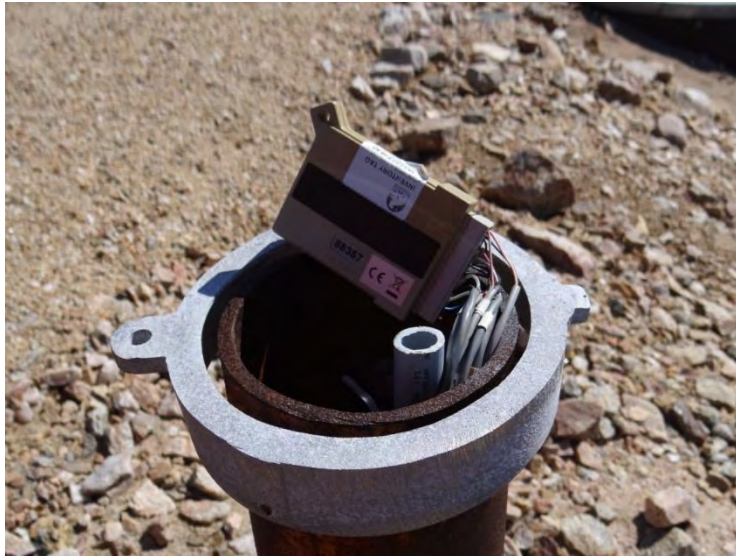
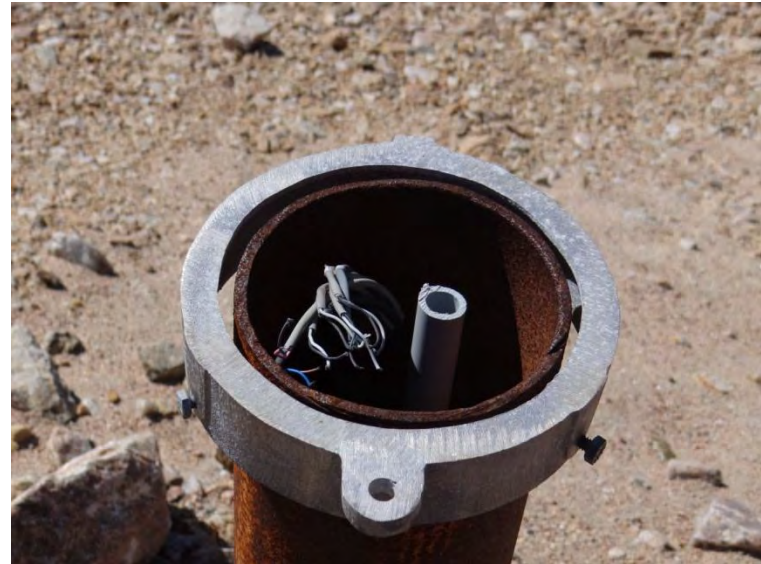
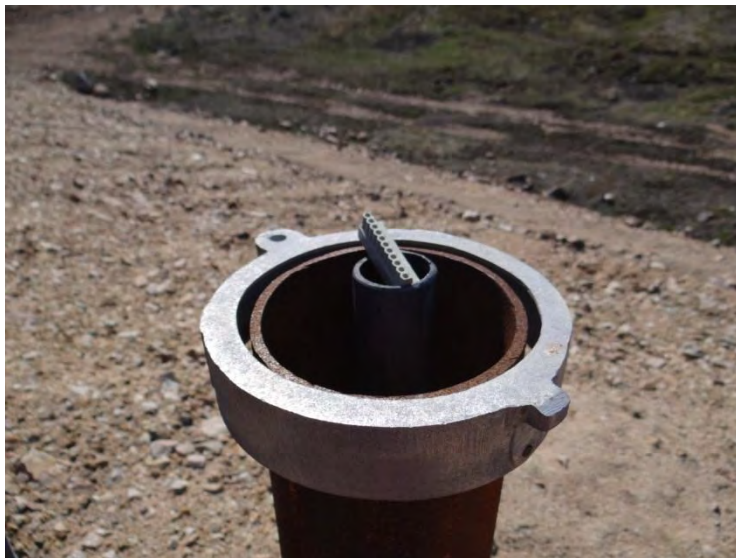
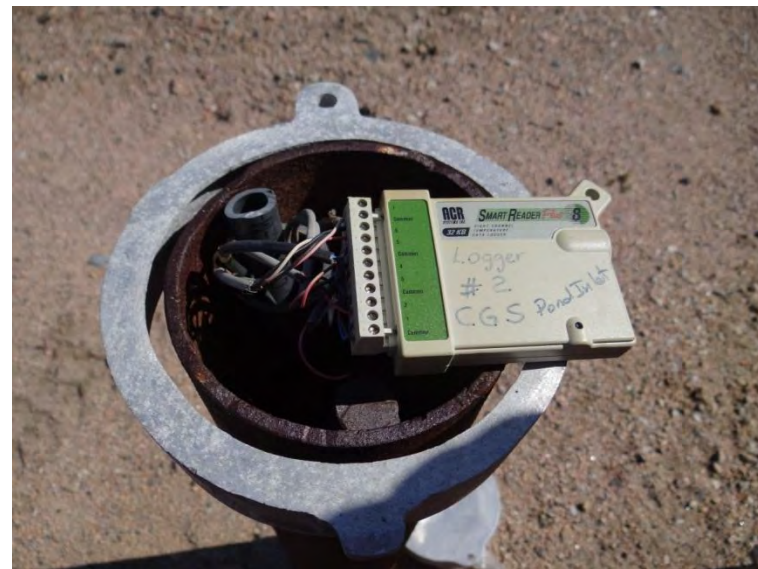
- 2 of the 4 thermistors onsite at the new sewage lagoon appears to be vandalized and do not have any data loggers attached to them.

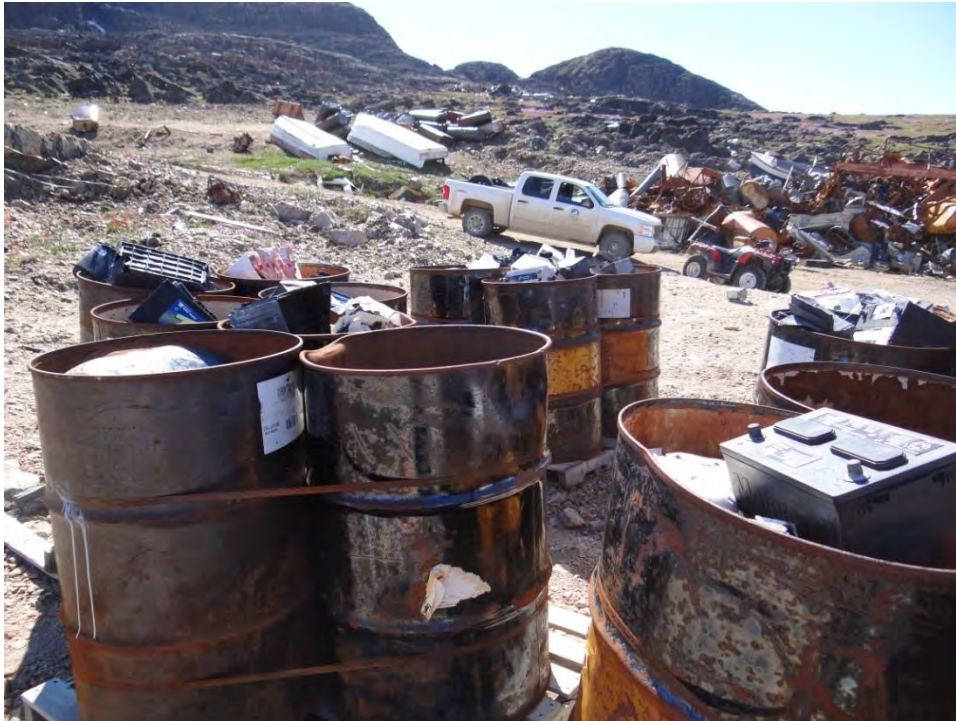
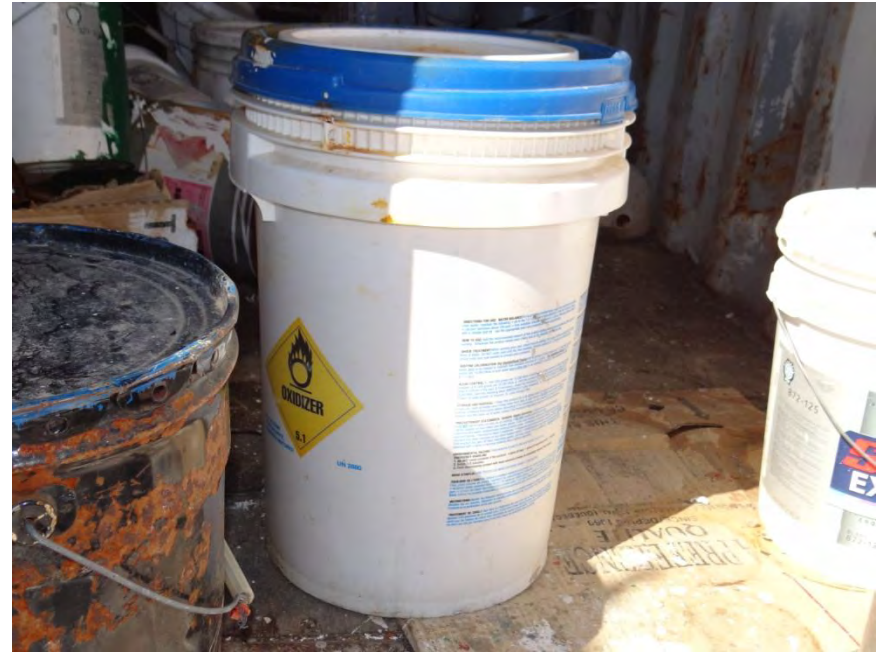
Metal Dump and Hazardous Waste Material

- Old batteries were being stored outside in 45 gallon drums that had been mixed with water. A recommendation was given in 2011 to separate the batteries and water and to dispose properly. Also a bucket of oxidizer was in one of the sea lift cans segregated for old paint and hazardous materials.

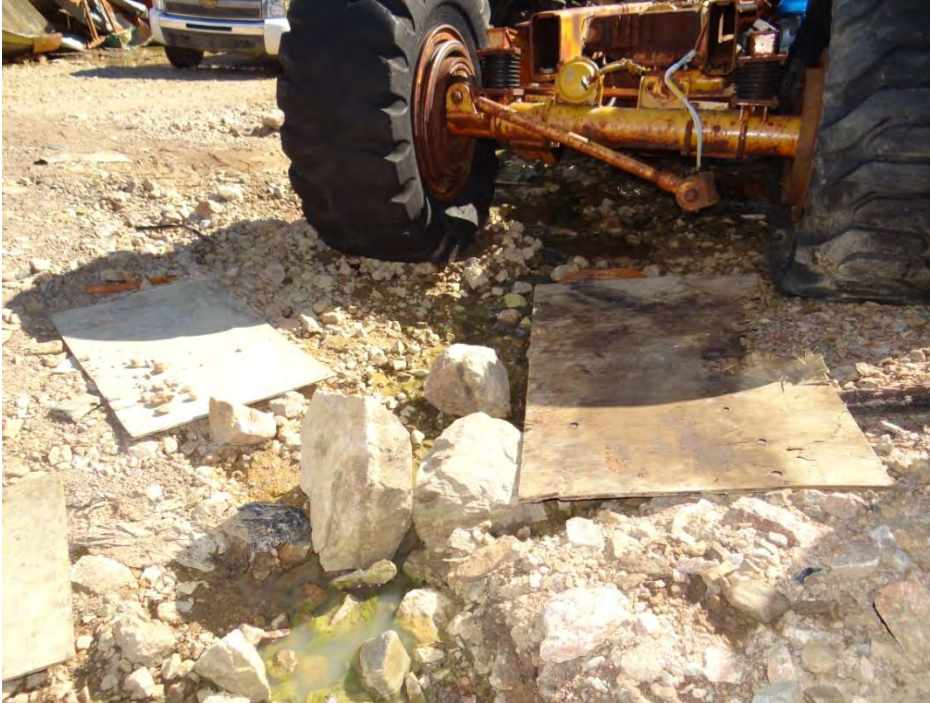
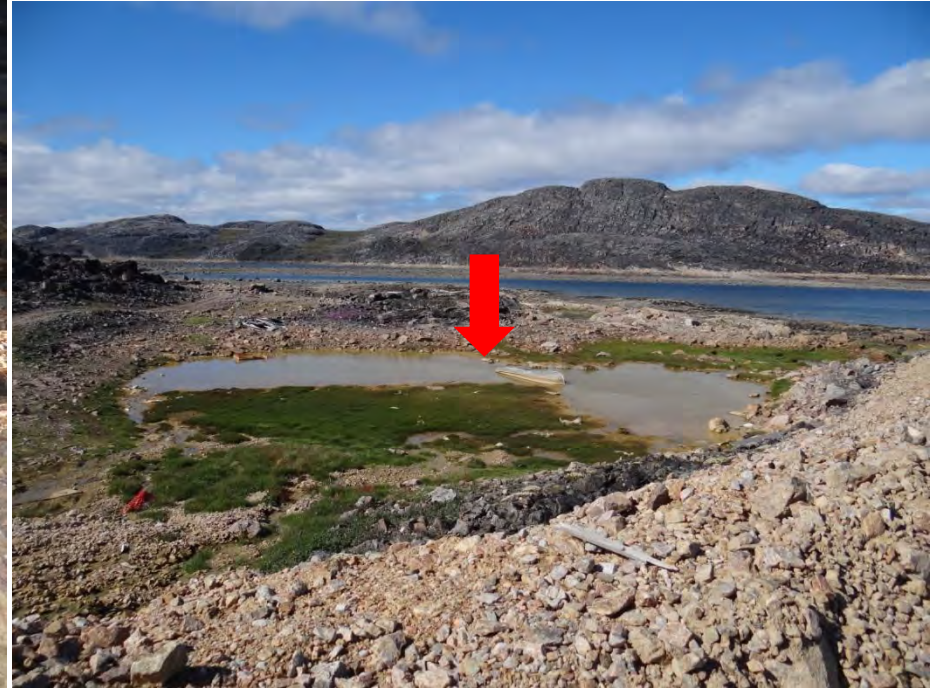
Runoff at the Metal Dump, Sampling area

- Collected sample where the red arrow is pointing, runoff from the metal dump that has formed a small pond.

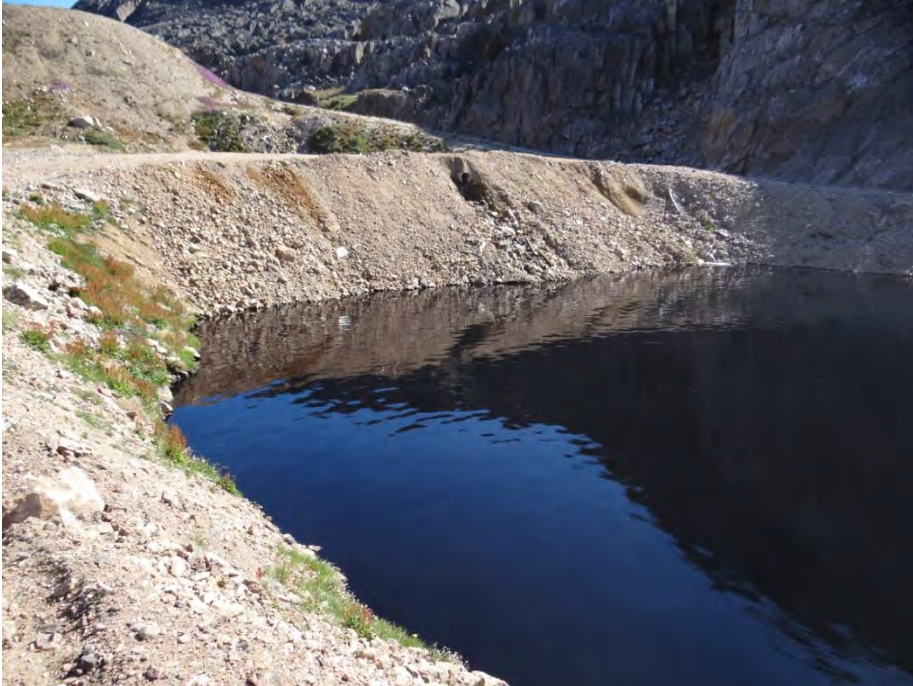
3 Tier Lagoon system

- The outside wall of the third tier of the three tier lagoon system had considerable erosion and was in a poor state of repair, also an issue in previous inspections. The effluent color in all cells was black and still visible in the stream running down from the third cell of the lagoon into Telik Inlet. A recommendation was given in the 2011 inspection for sampling to be done on the effluent to find out why it is black; no results were submitted for review.

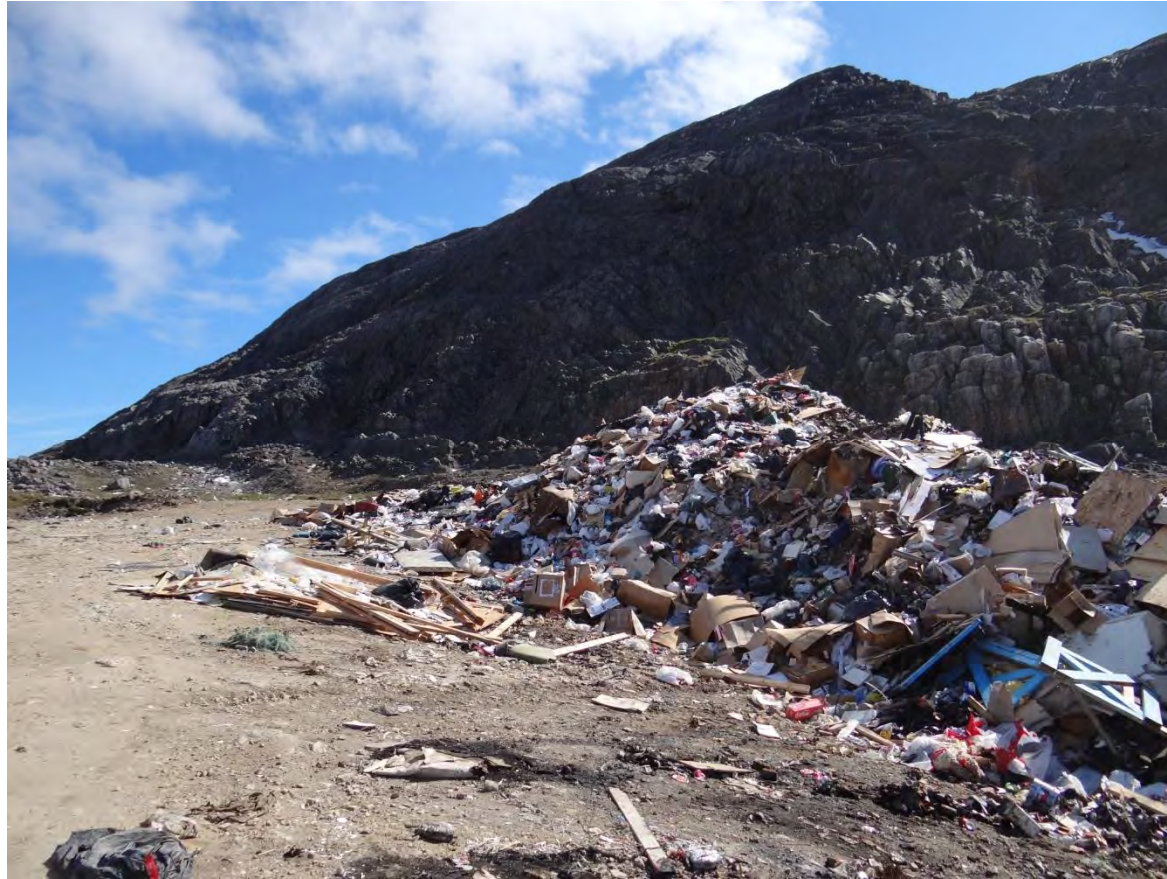
Dump

- The municipality still has not installed a fence around the dump so wind blown garbage continues to spread.

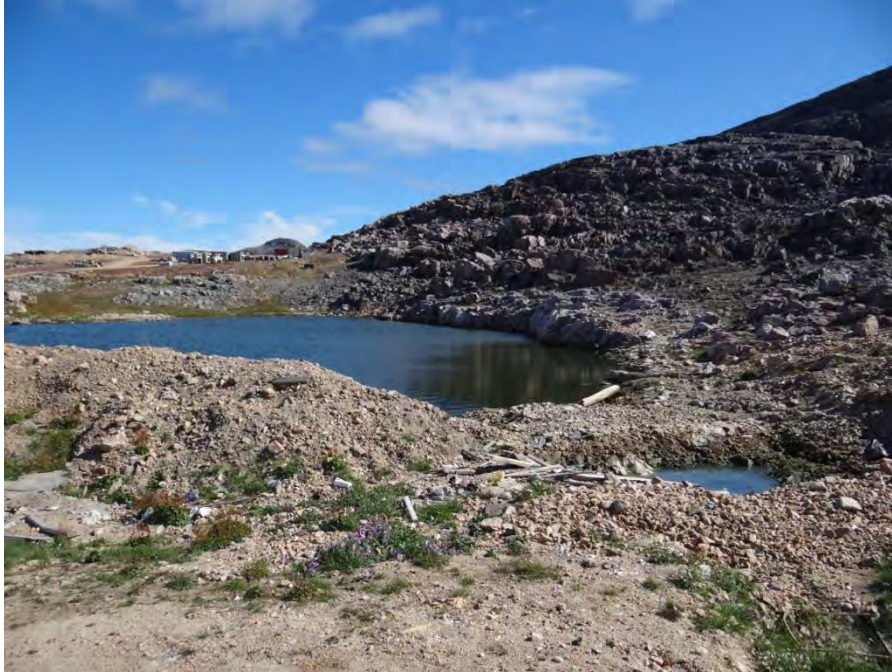
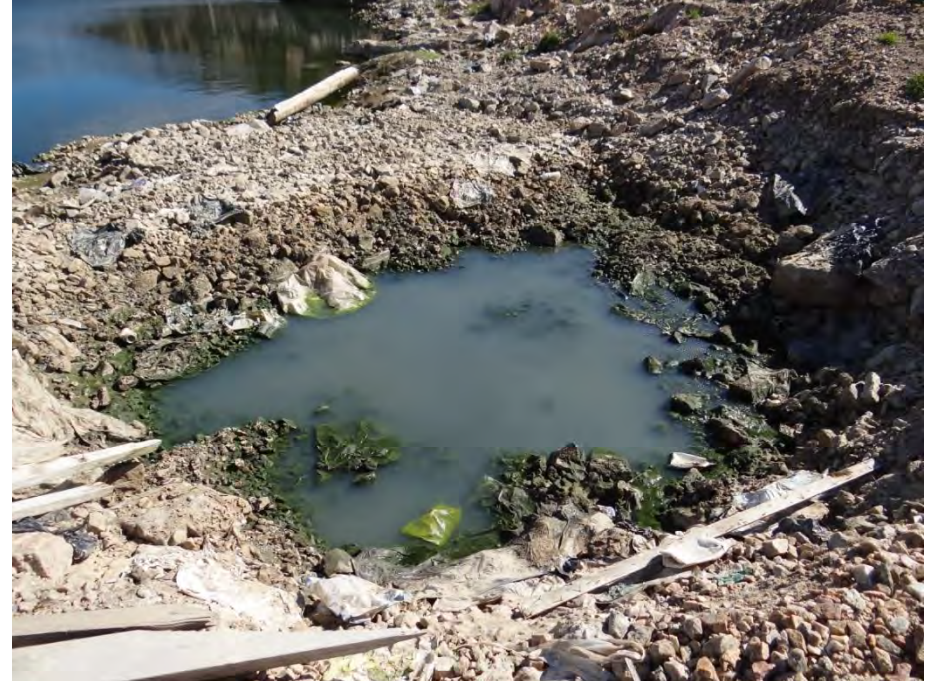
Old sewage lagoon

- Still a continuous flow under the berm and down the hillside releasing raw effluent into the marine environment, this was also an issue in previous inspections. A ditch was also created along side of the lagoon that is filled with effluent, it was not present in previous inspections.

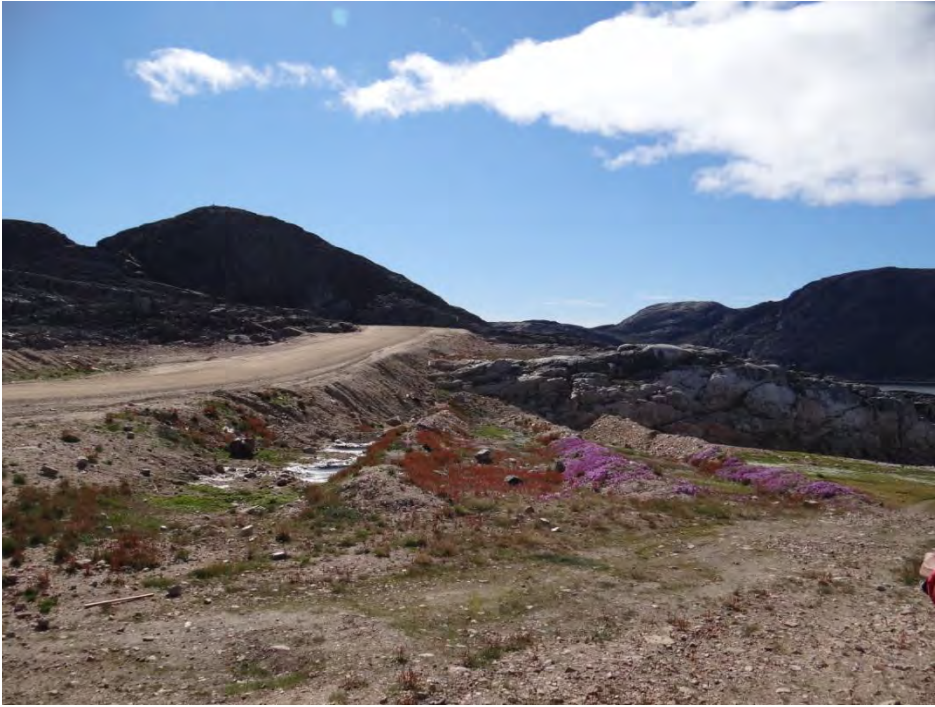
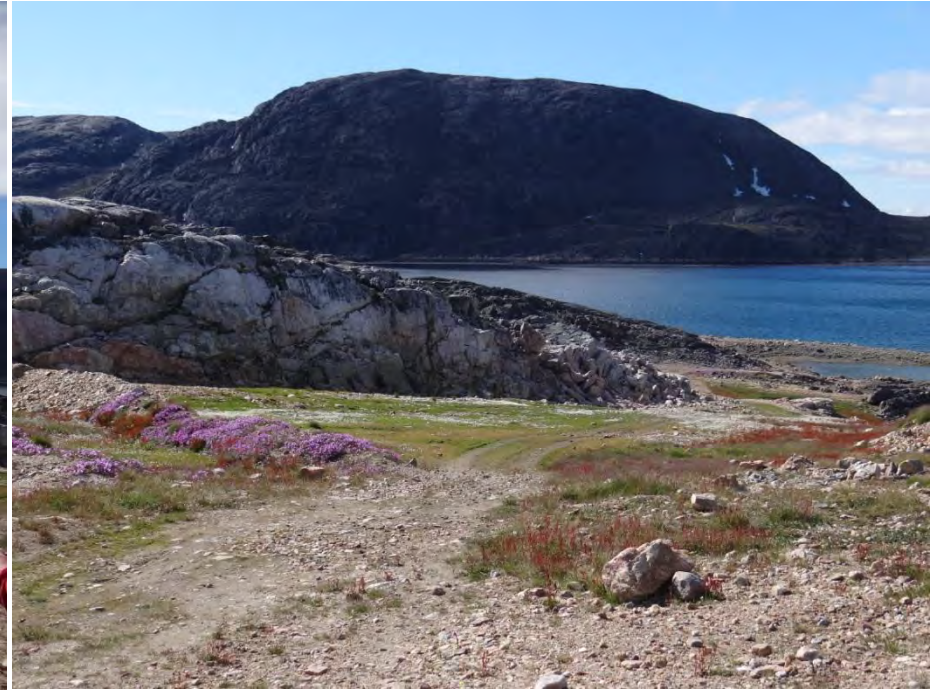
Old lagoon Flow

- The flow goes underneath the road and down the hill side into Telik Inlet
