WATER LICENCE INSPECTION FORM

Licensee		Licensee Representative	
Mike Hayward Senior Administrative Officer Hamlet of Cape Dorset, Baffin Region, P.O. Box 30 Cape Dorset, Nunavut X0A 0C0 E-mail: muncdsao@capedorset.ca		Steve Weedmark	
Licence No. / Expiry		Representative's Title	
3BM-CAP0810		Director – Public Works	
Land / Other Authorizations		Land / Other Authorizations	
Date of Inspection		Inspector	
10/08/2014		A.Keim	
Activities Inspected			
<div><input type="checkbox"/> Camp</div> <div><input type="checkbox"/> Roads/Hauling</div> <div><input type="checkbox"/> Drilling</div> <div><input type="checkbox"/> Other: Water Discharge</div> <div><input type="checkbox"/> Mining</div> <div><input type="checkbox"/> Construction</div> <div><input checked="" type="checkbox"/> Other: Municipal</div> <div><input type="checkbox"/> Reclamation</div> <div><input type="checkbox"/> Fuel Storage</div>

Photo Log			
Date	Authorization	Camera	Inspector
August 10 2014	3BM-CAP0810	Sony Cyber shot	A. Keim

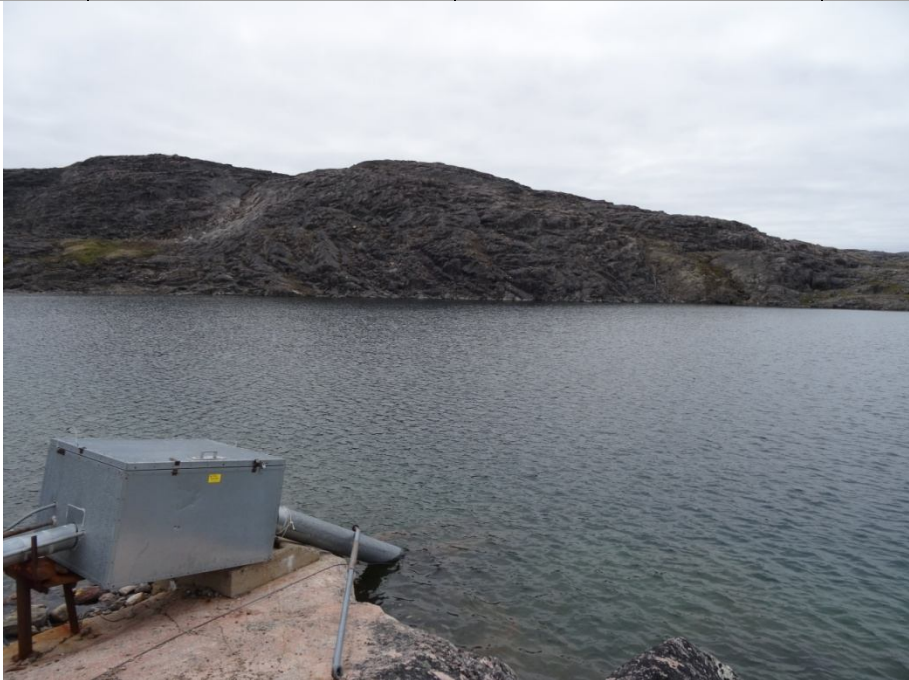
Tee Take water intake was found free of litter and in operation. The pipeline system that transfers water to the water point holding tank was again experiencing issues. As detailed by Municipal staff, at some point over the recent weeks during routine maintenance by Northwestel, the phone lines that send the signals between the automatic fill pump and the water point tank was disconnected. This has resulted in the municipality having to send someone to the pumping station on a daily basis to transfer water between the lake and the holding Tanks at Water point.

No signage or warnings were noted at the water Intake location.

Figure 1 Tee Lake Raw Water Intake

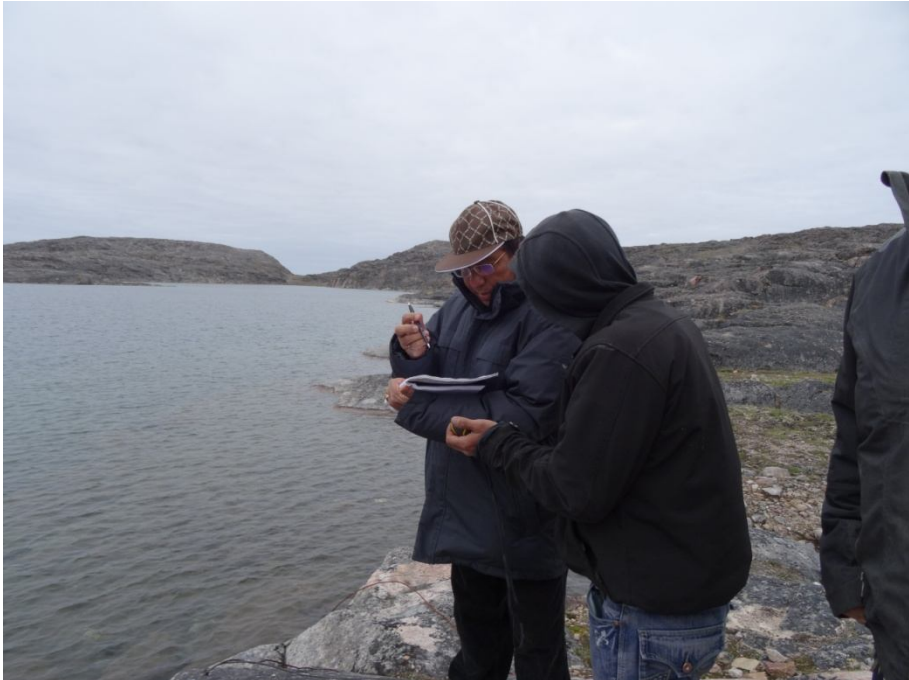
Figure 2 Raw water - Tee Lake - B. Roy

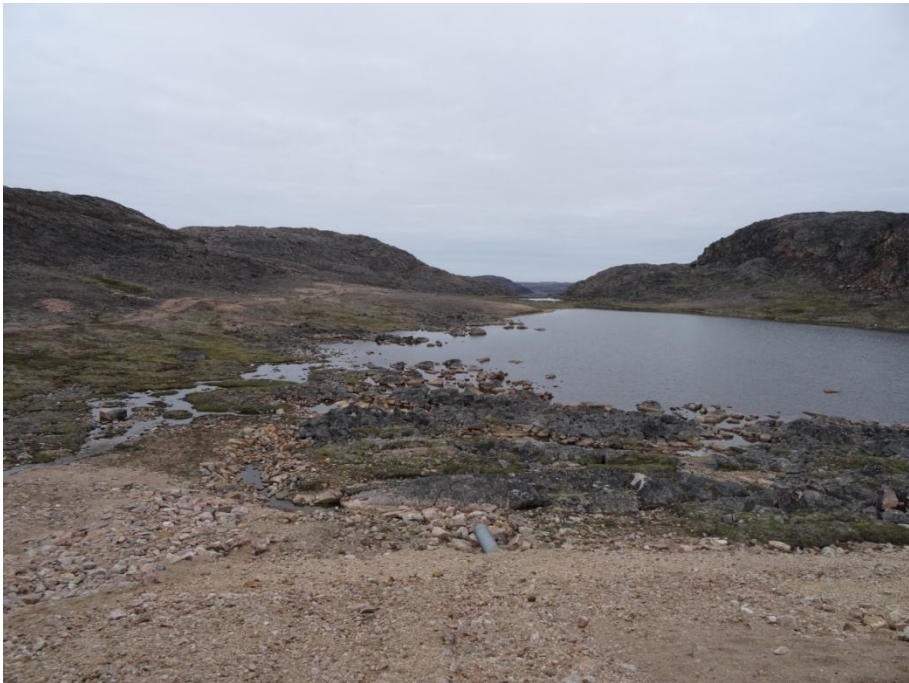
The 2007 lagoon system was found with water within the containment. Again, this year water was noted flowing out through a washout below the berm wall. It is unclear what GN-CGS plans to do to address this and no new information was provided during the Inspection. It is clear that the community will remain in non-compliance with the effluent discharge criteria until a new system for waste water treatment becomes available within the community.

Figure 3 2007 Lagoon - Leakage from under berm wall

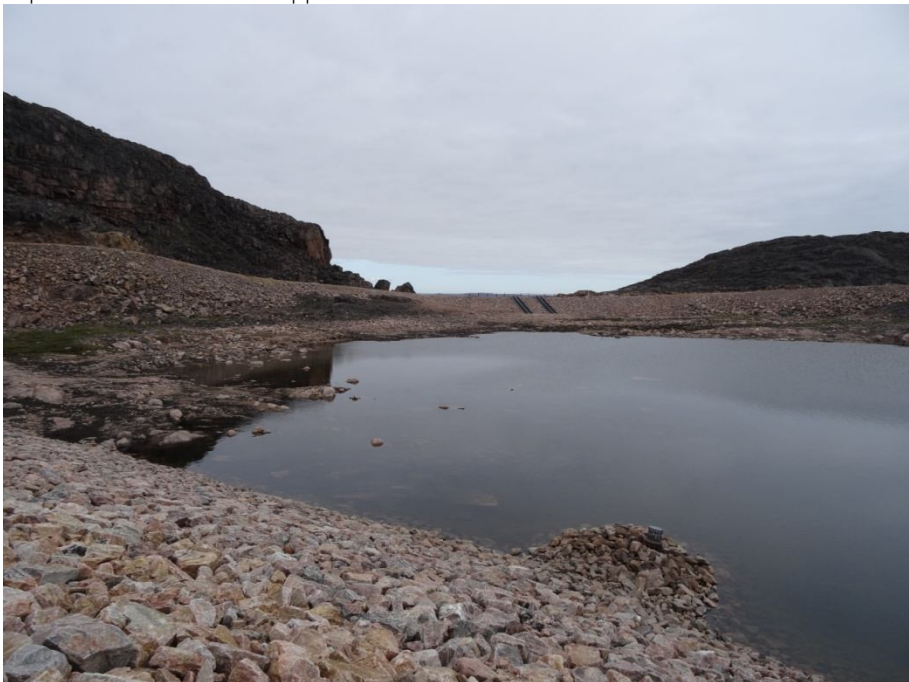
Figure 4 2007 Lagoon - inside the holding cell

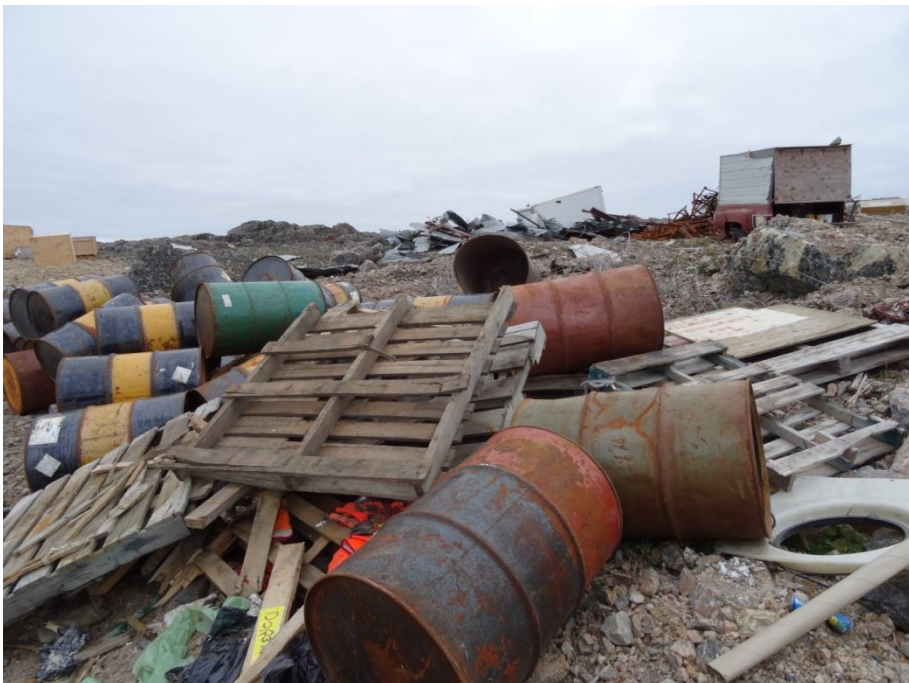
Figure 5 Solid Waste Management Area

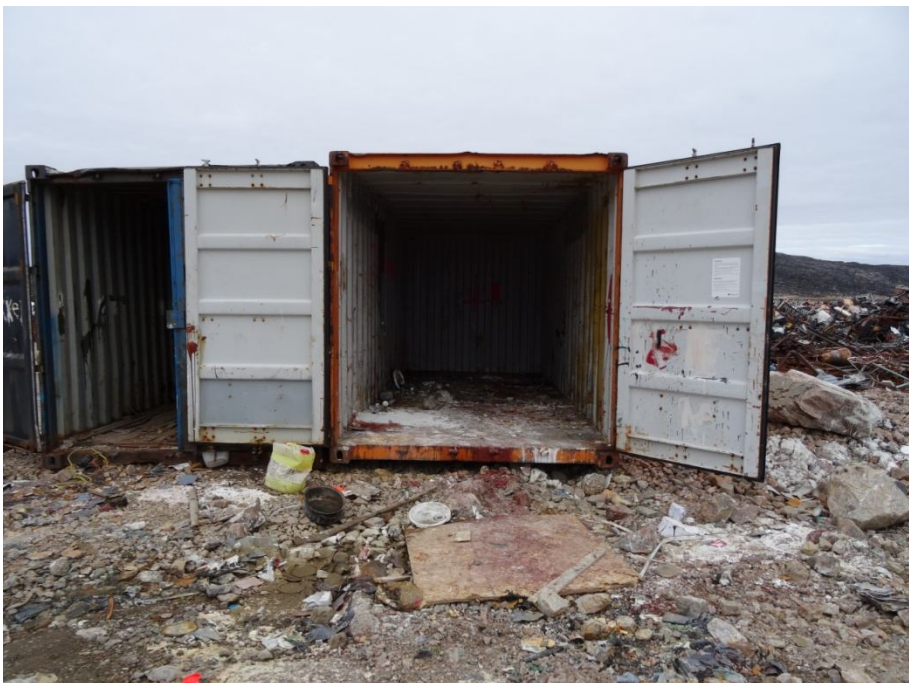
Figure 6 Hazardous materials storage location in the SWMA

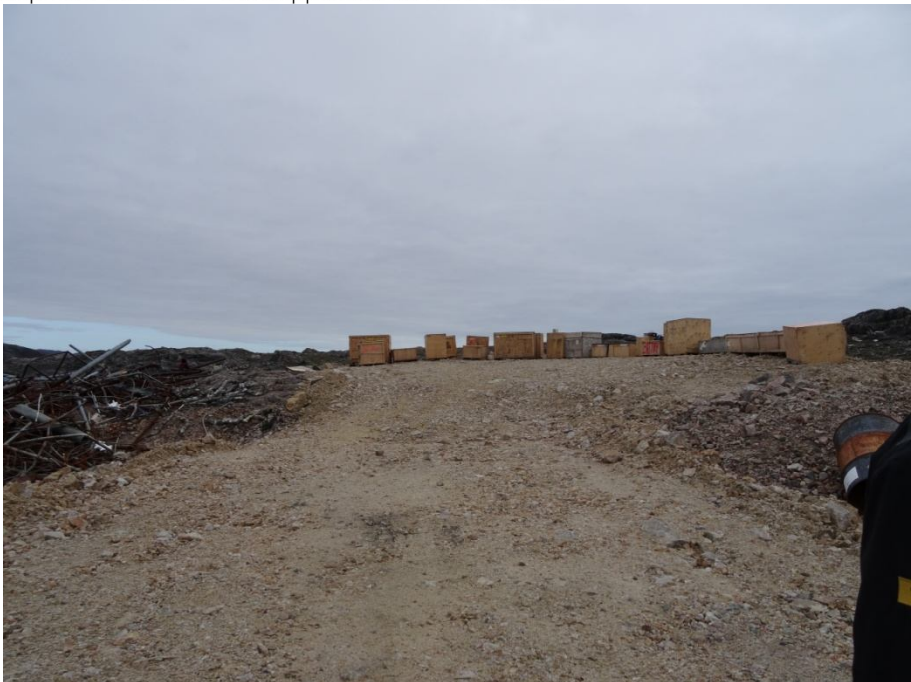
During the period of Inspection the Inspector and GN representative were very happy to note that all of the Batteries and a large percentage of other hazardous wastes that had been accumulating in the Sea-cans at the Bulk metals waste area had been crated and prepared for seal lift out of the community. While it was not expected that they would make sea-lift this year it was a great

improvement to have these items sealed away in crates.

Figure 7 Wood crates with Haz Mat to be shipped off site

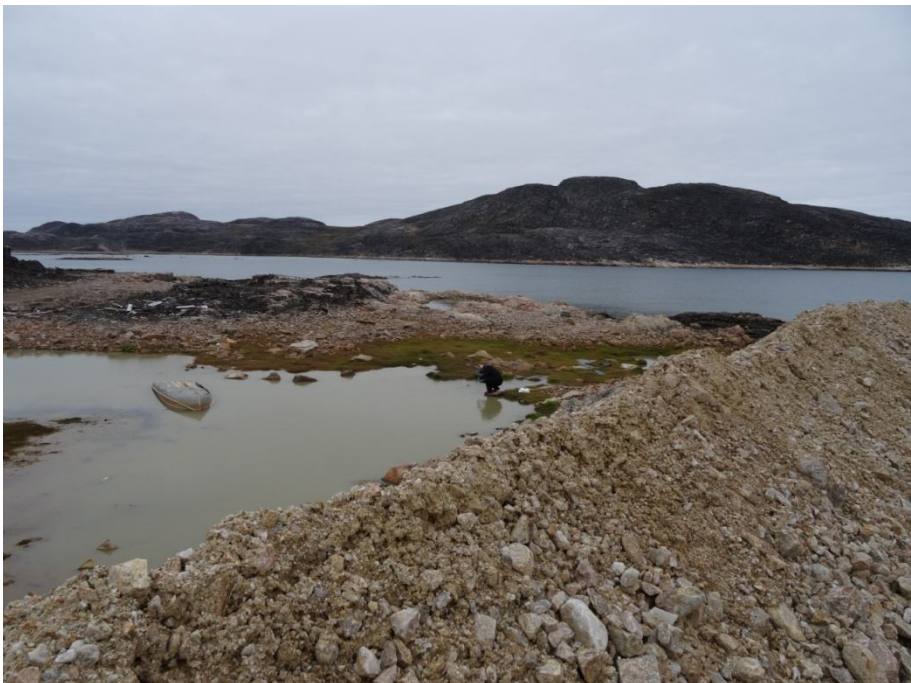
Samples were collected from the pond below the facility.

Figure 8 Leachate from the Solid Waste Management Area

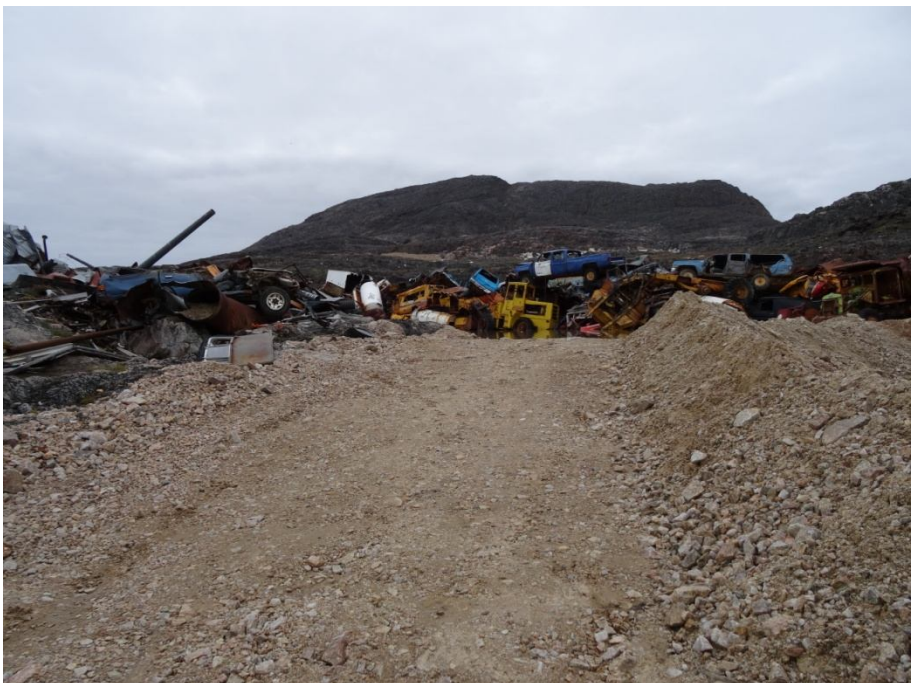
A berm has been installed around the perimeter of the facility to retard the flow of contact water and reduce leaching off the site. During the Inspection the lowest area at the bottom of the facility had flooded with nearly 1 meter of water that accumulated as a result of run-off through the facility during two days of heavy rain. This was an unusual rain event.

Figure 9 Berm slowing the flow of water off the Solid Waste Management Area

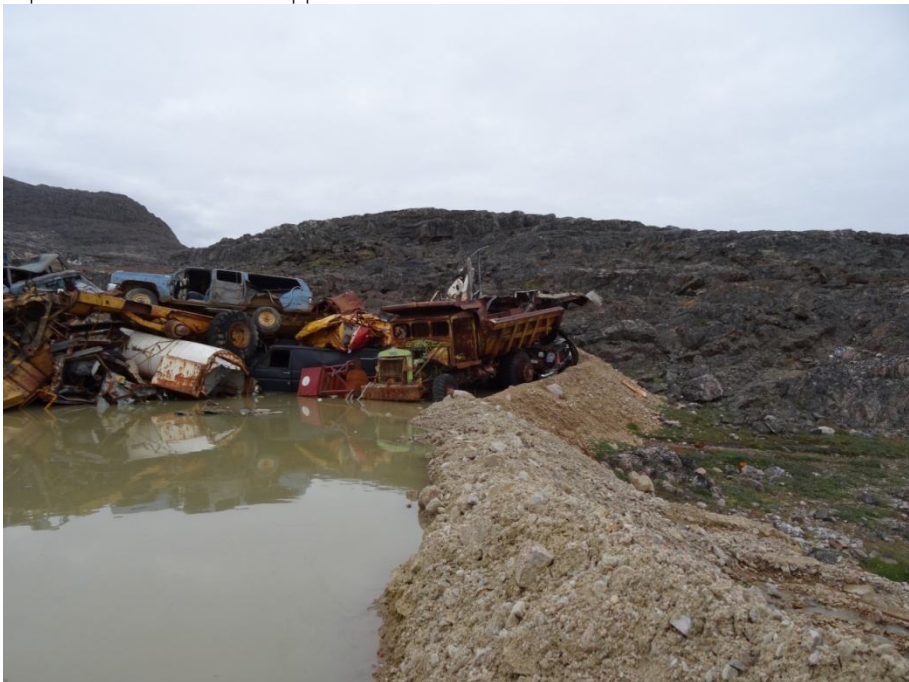
Figure 10 Water built up from run off (rain) within the Solid Waste Managment Area

The facility requires a diversion of water imposed on the up gradient side of the facility. It was noted that a culvert under the roadway has channeled water into the facility. It was recommended during the inspection that the culvert be redirected across/ under the roadway to channel water westward and along the outside perimeter of the facility.

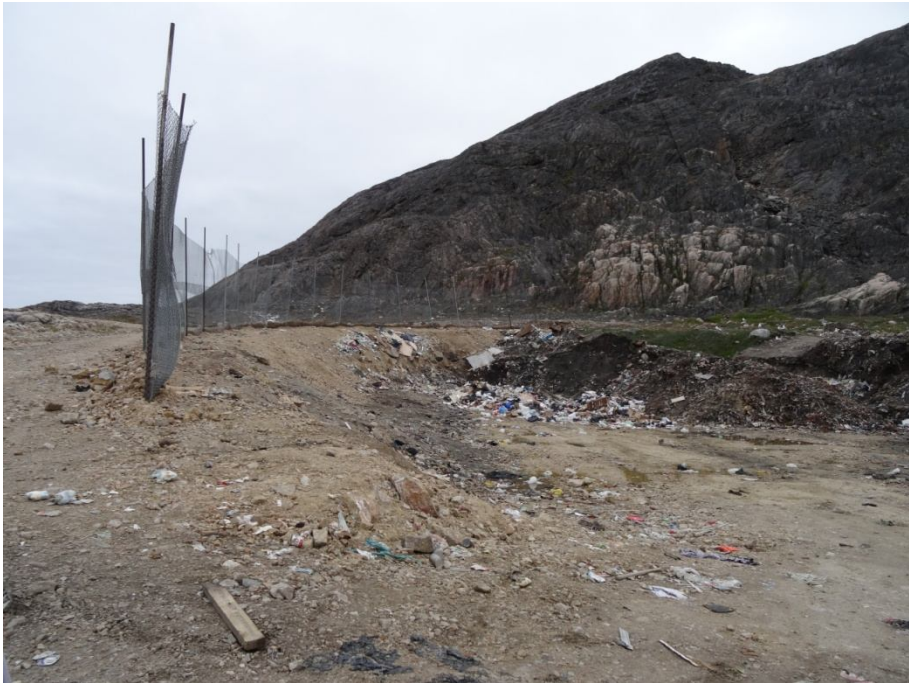
The Municipal burn and bury was found to have a 8 meter fence erected around two sides of the facility to prevent the ejection of materials.

Figure 11 Fencing installed on two sides of the Municipal Waste Management Area

It was however noted during the Inspection that the Municipality has moved ahead on its own over the last year and installed a fence on two sides of the Municipal Waste Management Area. It is hoped that over the next year the remaining sides will also be fenced as required.

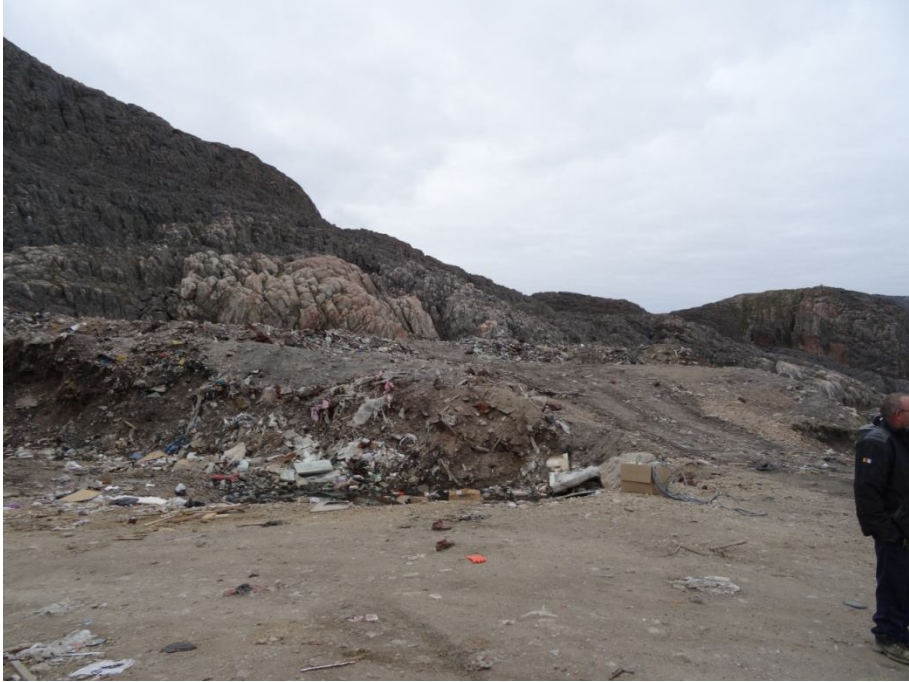
The facility was found to have recently been burned with materials moved to the adjacent side where they are placed and then covered by 1 meter of cover material that is then compacted. The facility appears to be well managed and while some metals and other items were noted within the materials on site it appears that the domestic waste is being efficiently managed. This is a great improvement over previous inspections. It was noted that the community did this without any outside funding or support.

Figure 12 Municipal wastes under cover materials

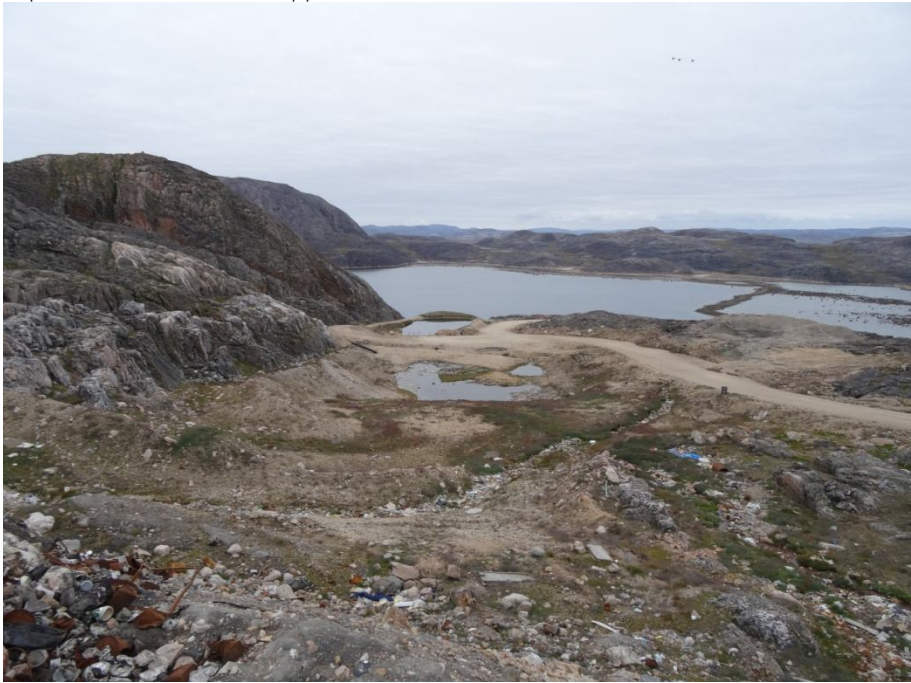
Figure 13 View from top of the Municipal Waste Management Area

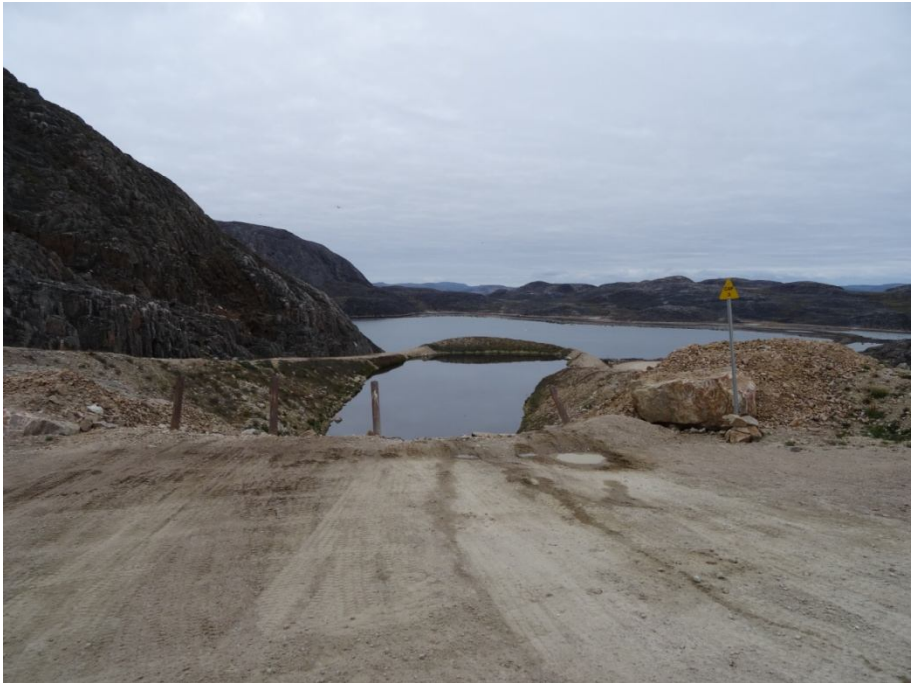
The three tier lagoon system was found to be at capacity and all three cells were spilling off into the next with little to no accumulated holding time. There is very little, if any, treatment with this constant flow. The Lagoon is operating at above it's intended capacity and is a risk annually of a catastrophic failure.

Figure 14 Lagoon Cell 1 of three tier lagoon system

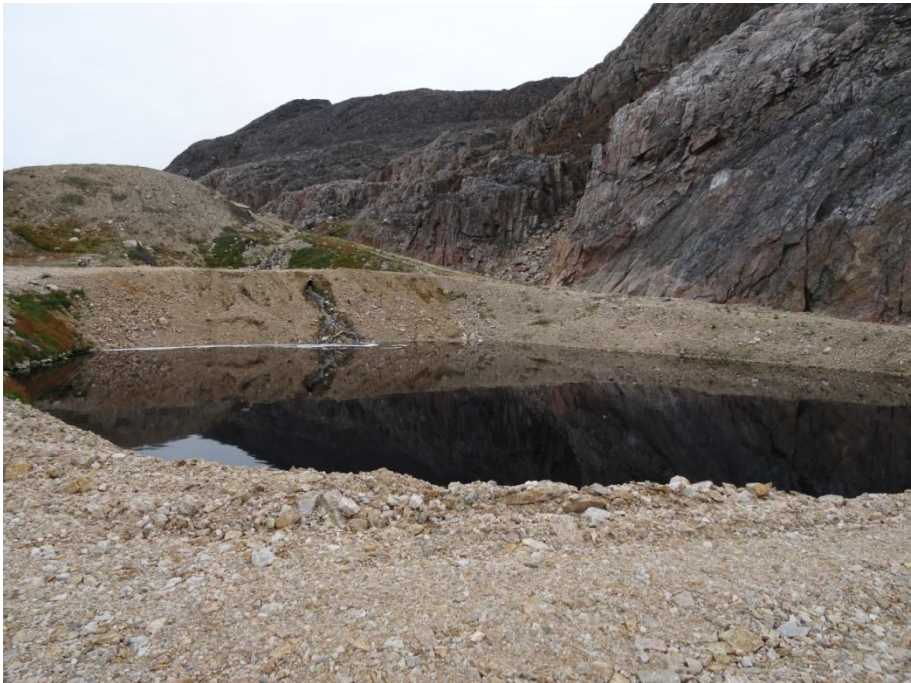
The berm wall of the third and final cell was found to have recently been built up and properly compacted. This is a huge improvement over previous years' inspections where effluent levels were found to be above the required 1 meter freeboard limit. The installed overflow pipe was found to be clear and operating as intended to prevent a structural failure of the cell wall.

Figure 15 Cell 3 of three tier Lagoon system

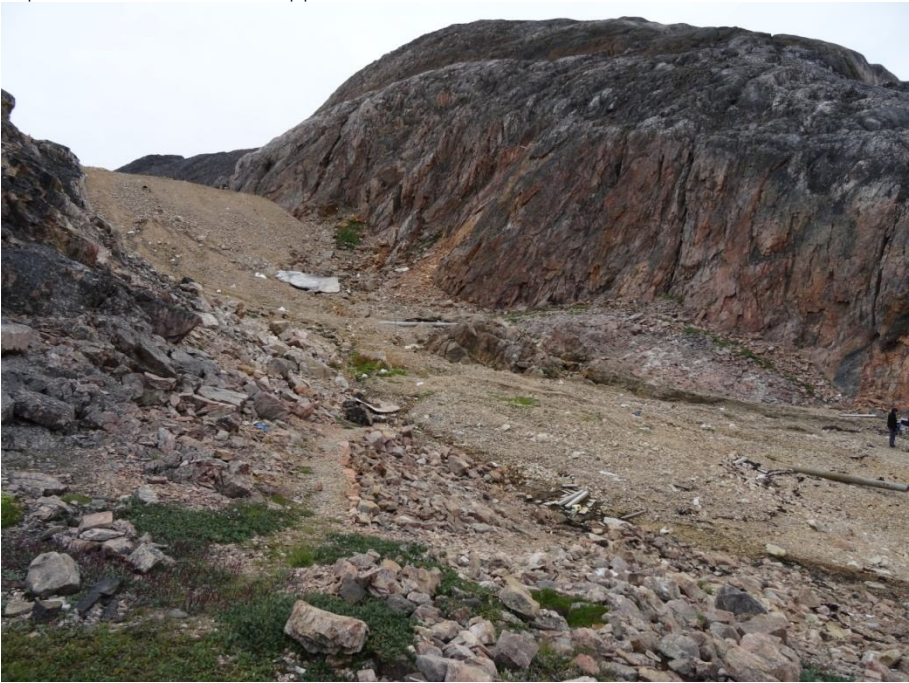
Figure 16 View from shoreline blow cell three of the three tier lagoon system

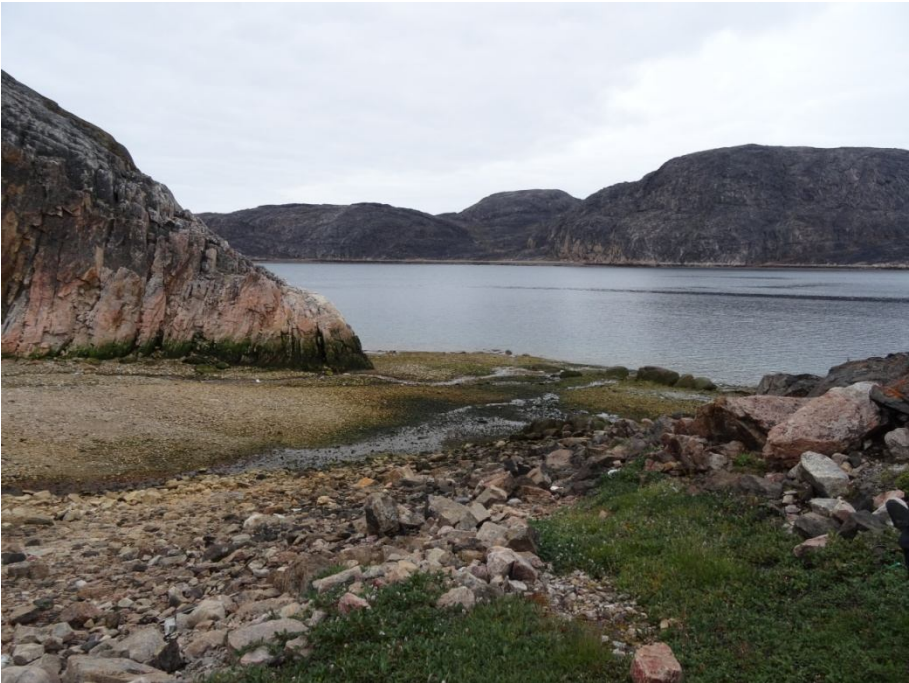
Figure 17 Outfall to ocean from three tier lagoon system
