WATER LICENCE INSPECTION FORM

Licensee	Licensee Representative
Hamlet of Cape Dorset	Bhabesh Roy, William Koonoo
Licence No. / Expiry	Representative's Title
3BM-CAP0810	Municipal Engineer, Municipal Technical Clerk,
Land / Other Authorizations	Land / Other Authorizations
Date of Inspection	Inspector
July 9, 2018	Joseph Monteith & Jonathan Mesher
Activities Inspected	
<input type="checkbox"/> Camp	<input type="checkbox"/> Drilling
<input type="checkbox"/> Roads/Hauling	<input type="checkbox"/> Mining
	<input type="checkbox"/> Construction
	<input checked="" type="checkbox"/> Other: Potable Water Source, Waste Disposal Facility, and Solid Waste Facility
	<input type="checkbox"/> Reclamation
	<input type="checkbox"/> Fuel Storage
	<input type="checkbox"/> Other:

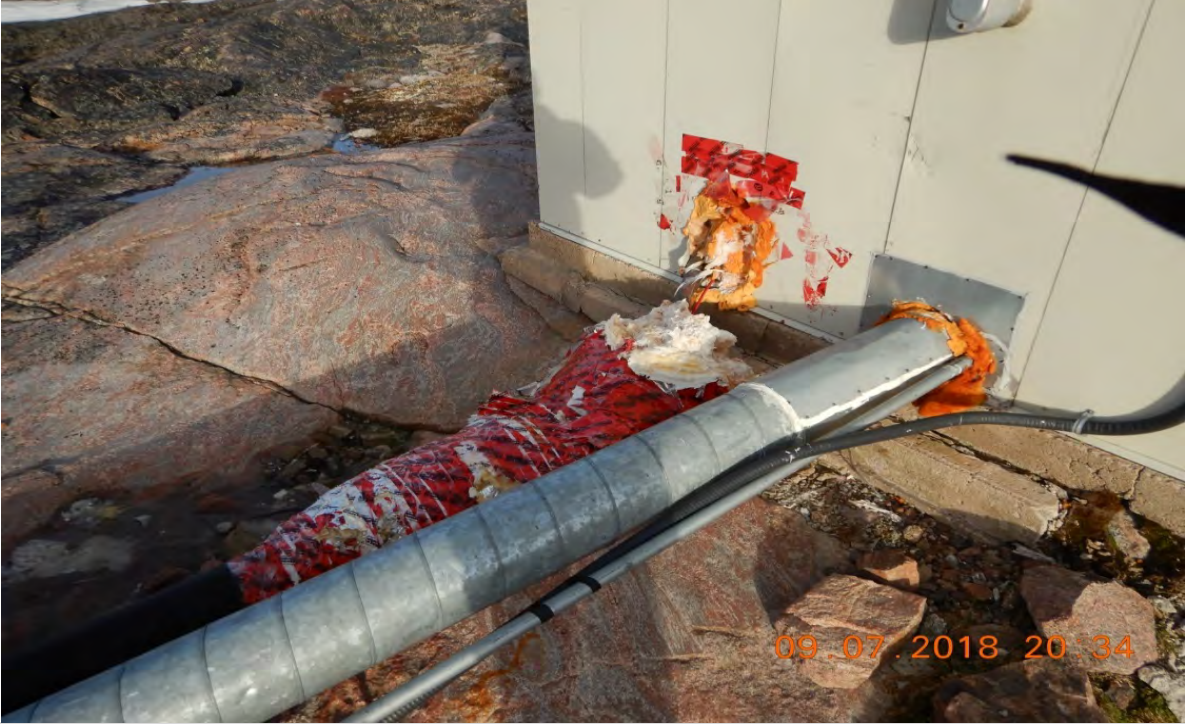
Photo 1

10. Old damaged piping still existed following the path of the operating pipe. The operating pipe appeared to be operating as intended, with no signs of leaking or damage. The pump house appears to have signs of damage in regards to the connection points of the old pipe (Photo 1).

Description: Pump House – Old Pipe, Damage to connection point of old pipe.

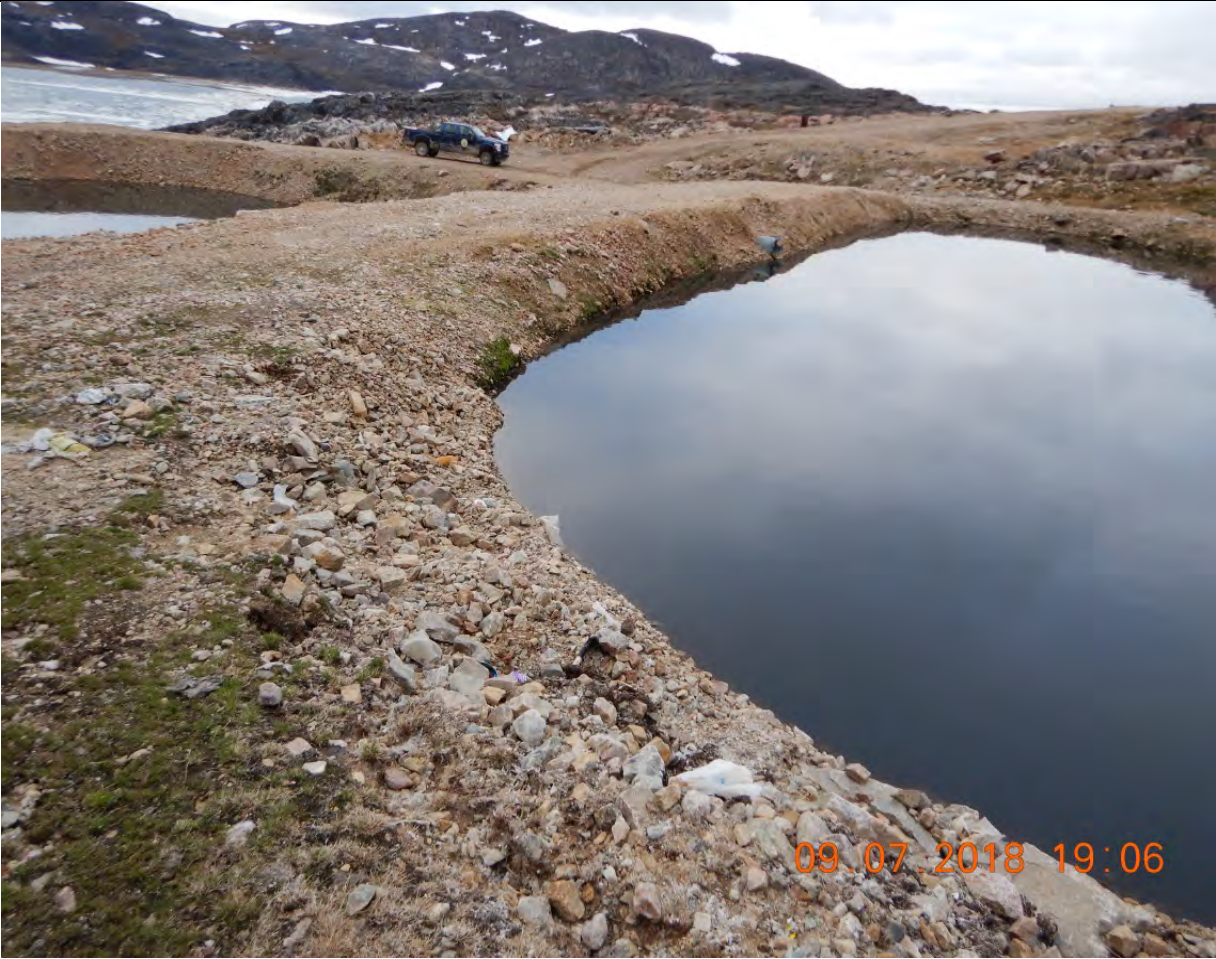
Photo 2

14. The freeboard for highest upper cell was at the level of the culvert, which is approximately 1 metre from the top of the sewage lagoon cell wall. The second cell also had a culvert which appeared to be an overflow culvert to maintain the 1 metres freeboard on the lagoon. The cell wall on the second tier middle lagoon was not even in height. The culvert may have been installed to maintain the 1 metre freeboard, but in other areas of the walls, the freeboard was below 1 metre (Photo 2). The corner of cell 2 appeared to have no lining, and waste was leaking through to the third tier by exfiltration. Monitoring Station Cell-4 should be here, but the sign was down. The third and last cell was full to the lower culverts spilling out. No 1 metre freeboard on the lower cell with sewage table at the lower culvert.

Description: 2nd Cell Lagoon Culvert 1 metre freeboard, north side corner less than 1 metre freeboard.

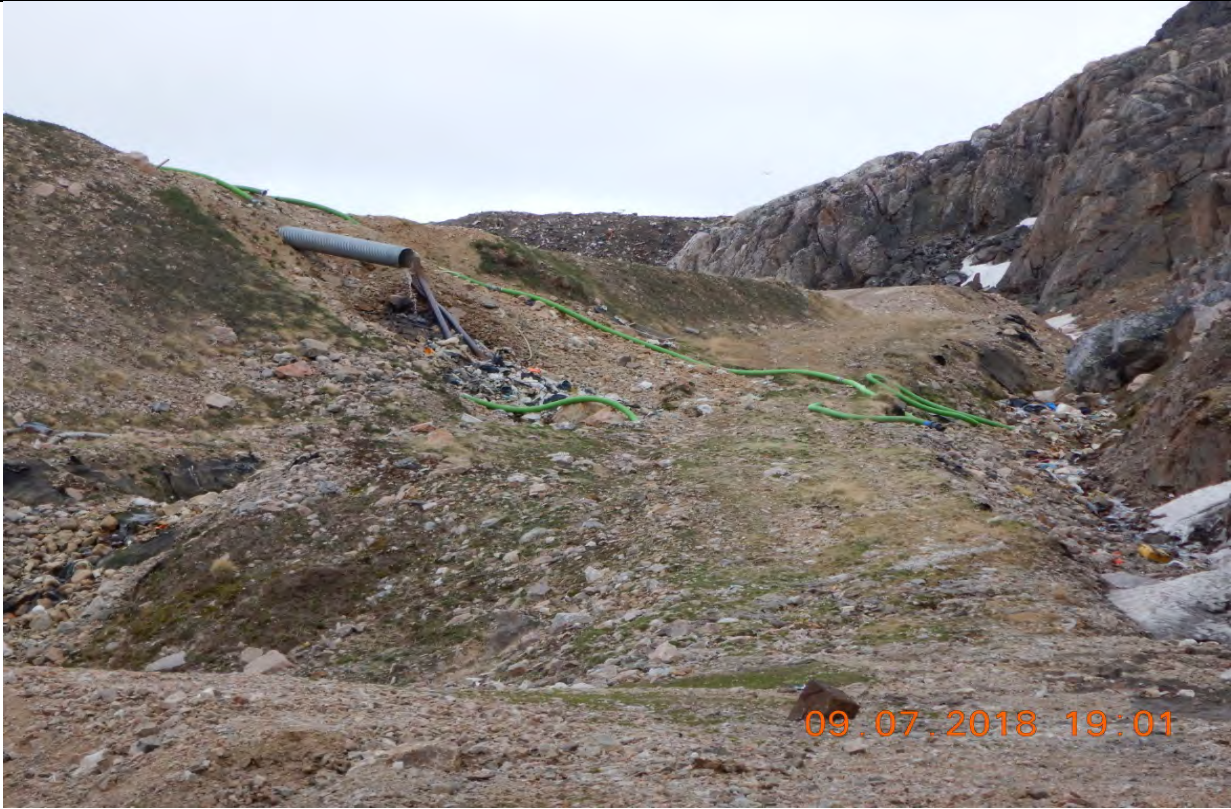
Photo 3

13. At the time of the inspection the sewage lagoon, a 3 tiered cell sewage lagoon much like a sump pit was in-use and appeared to be operating as intended. The top two cells have culverts to maintain sufficient freeboard. The third and lowest cell has a couple of culverts to maintain a freeboard, but if the intent of the sewage lagoons is to settle all suspended solids and decant at specific times of the year, this lagoon isn't doing that. As each cell fills up, it drains into the next cell. But once at the bottom cell, the intent should be to hold the waste, and decant after notifying the inspector. The current method if intended is to always maintain a freeboard, and allow waste to flow out at the culverts when the cells are filled to the culvert line. After the third and lowest cell, the run off has approximately 100 metres counting the distance from the top of the cell wall to the ocean. A drainage ditch was created along the south side of the lagoon, to divert any runoff from Nungaaait Mountain and the solid waste facility. This drainage ditch has a monitoring station titled CAP-3. The drainage ditch also showed signs of overflow from the sewage lagoon cells (Photo 3). An Emergency Lagoon was also observed at the time of the inspection.

Description: signs of overflow and migration to drainage ditch south side of sewage lagoon cell.

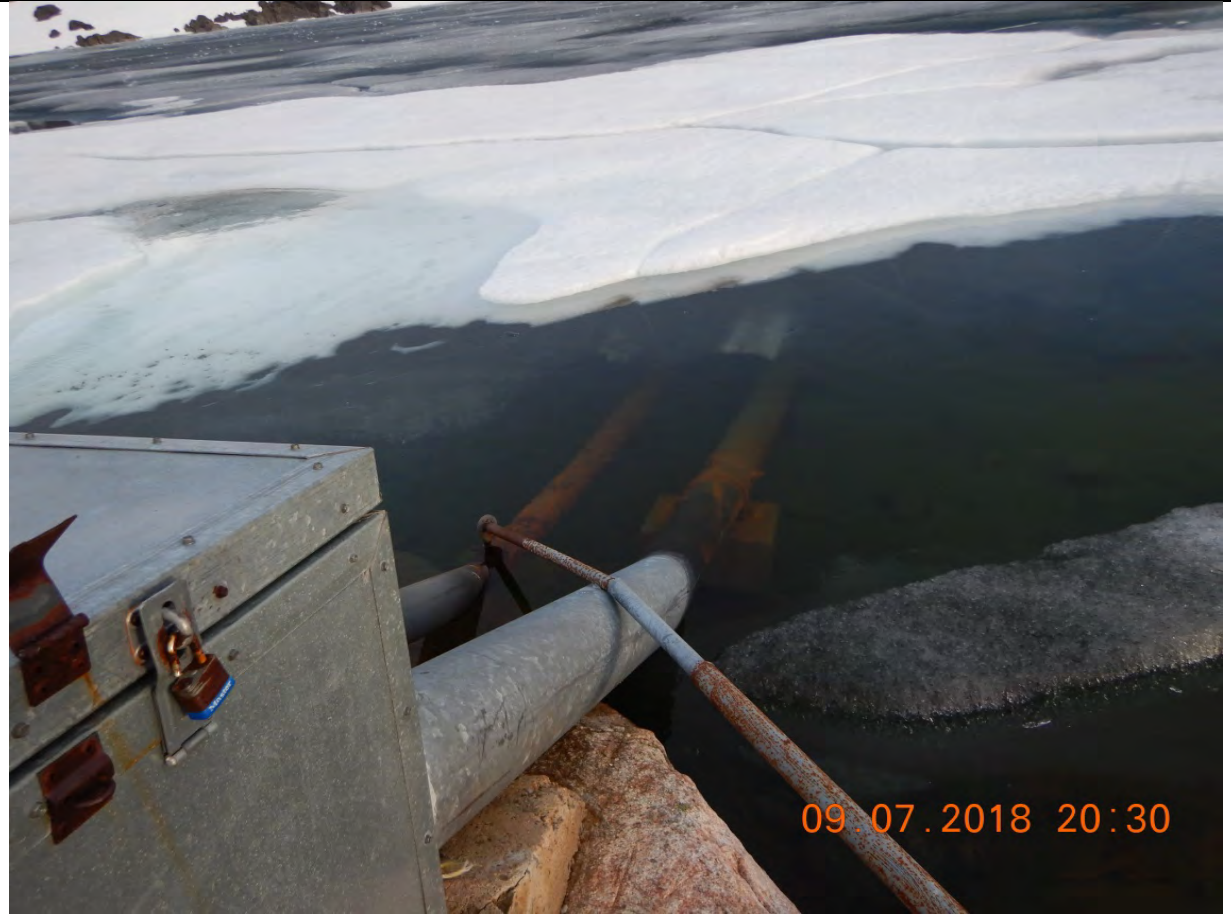
Photo 4

8. During the inspection WRO Monteith did observe rusting of the pipe at Tee Lake below grade of the water table. (Photo 4).
9. Monitoring Station Cap-1 was observed at the water fill station.

Description: Rusting of intake pipes below grade of the potable water source table

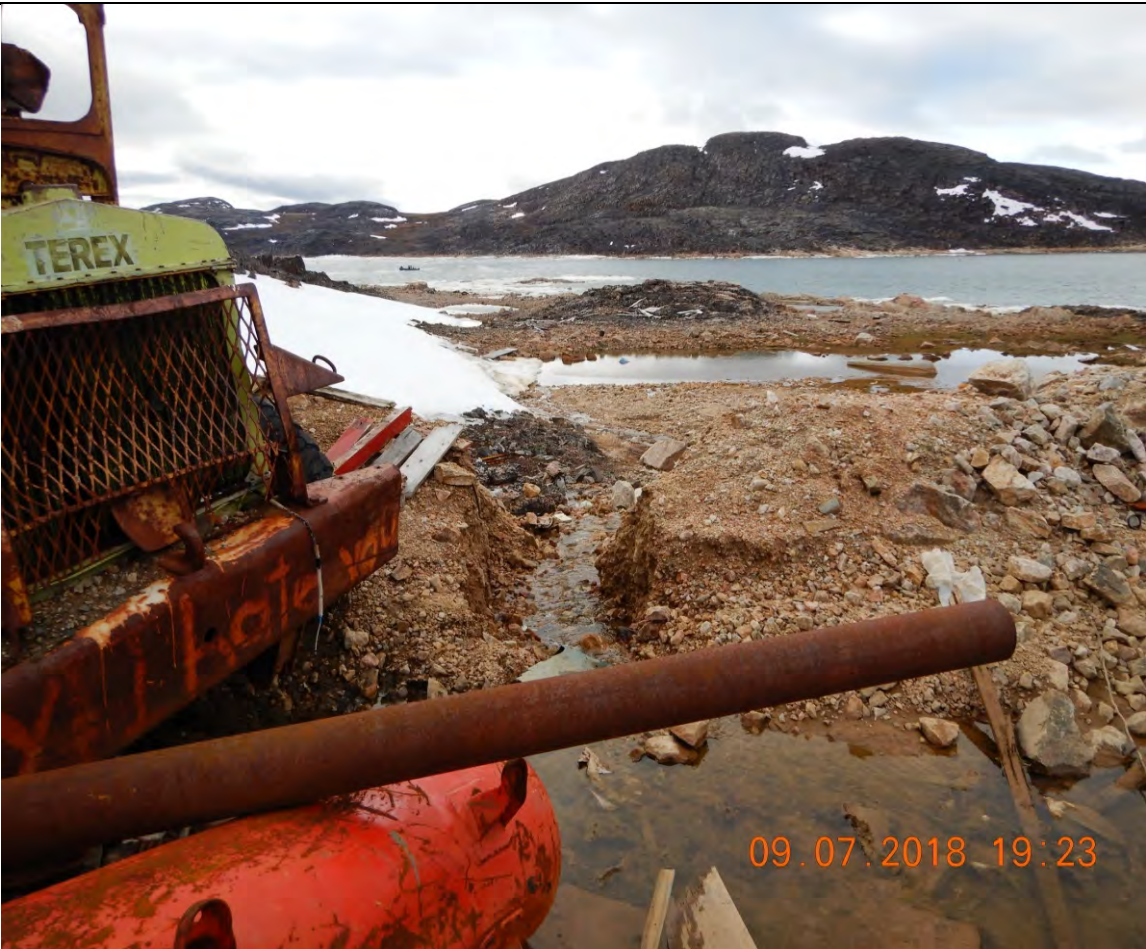
Photo 5

20. Metal Storage Area has three parts to it. Snowmobiles and ATV's appear to be segregated. The bulk metal waste comprised of old vehicles has numerous waste batteries, propane tanks and waste oil within this site. A berm was set up around this bulk waste area to mitigate any leachate from entering the ocean. The wall on the south side of this area appears to have eroded, and has compromised its intended purpose, contrary to Part D: Item 10

(photo 5).

Description: erosion of the containment wall to mitigate any leachate from the bulk metal section has eroded, and compromised its intended purpose.

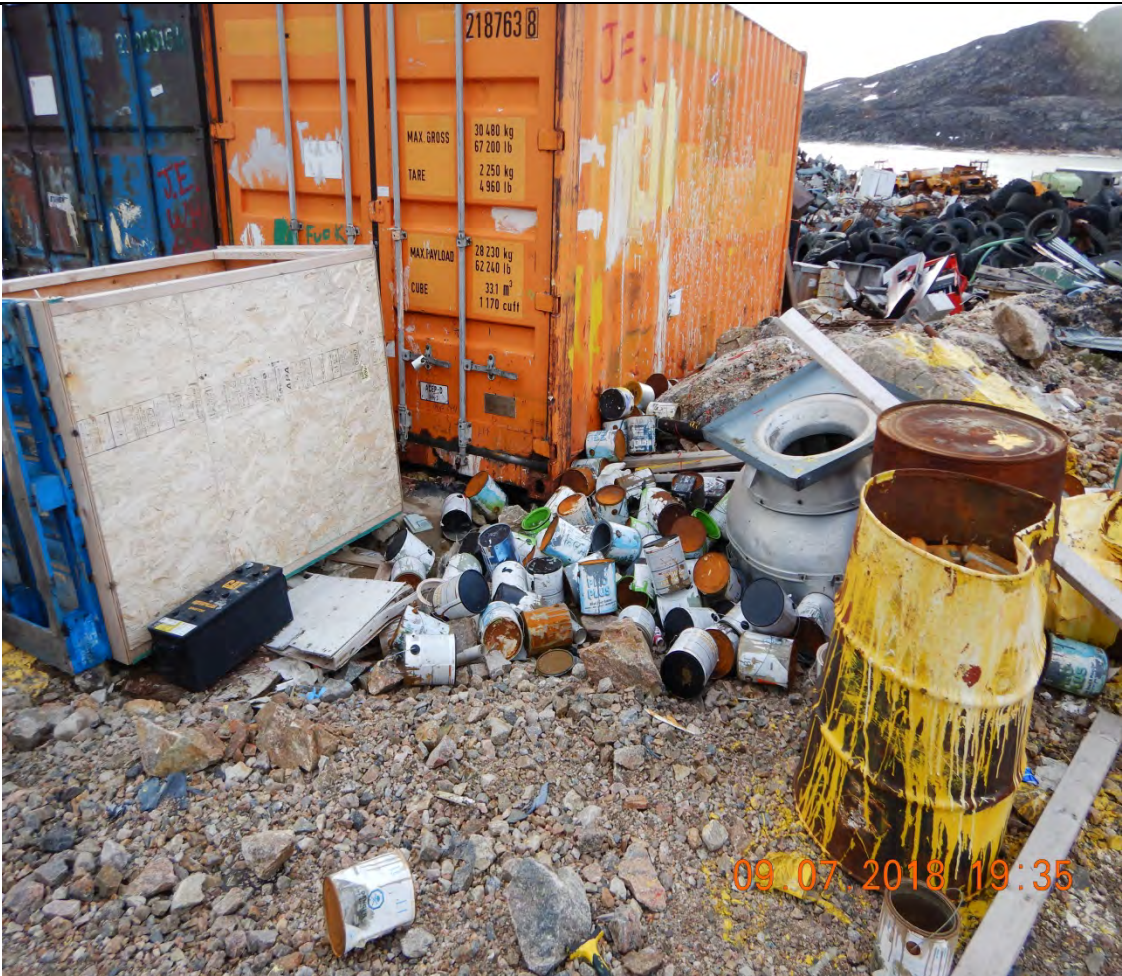
Photo 6

23. The hazardous waste area has a couple of sea cans which may have hazardous waste within them, but at the time of the inspection, both were closed and locked. Paint cans litter the outside of the sea cans, waste batteries, and waste oil drums were also observed out in the open near the hazardous Waste Disposal area (photo 6). No signage was observed around these sites. If rainwater gets in contact with the hazardous wastes around the sea cans, the hazardous wastes can migrate downgrade to the bulk metals section, and escape into the ocean through the compromised mitigation wall.

Description: 2x hazardous waste sea cans with paint cans, vehicle battery exposed to the elements
