WATER LICENCE INSPECTION FORM

Licensee	Licensee Representative
Hamlet of Cape Dorset	Bhabesh Roy
Licence No. / Expiry	Representative's Title
3BM-CAP1925	Municipal Engineer
Land / Other Authorizations	Land / Other Authorizations
Date of Inspection	Inspector
02/07/2020	Joseph Monteith
Activities Inspected	
<input type="checkbox"/> Camp	<input type="checkbox"/> Drilling
<input type="checkbox"/> Roads/Hauling	<input type="checkbox"/> Mining
	<input type="checkbox"/> Construction
	<input checked="" type="checkbox"/> Other: Potable Water Source, Waste Water Treatment, and Solid Wastes
	<input type="checkbox"/> Reclamation
	<input type="checkbox"/> Fuel Storage
	<input type="checkbox"/> Other:

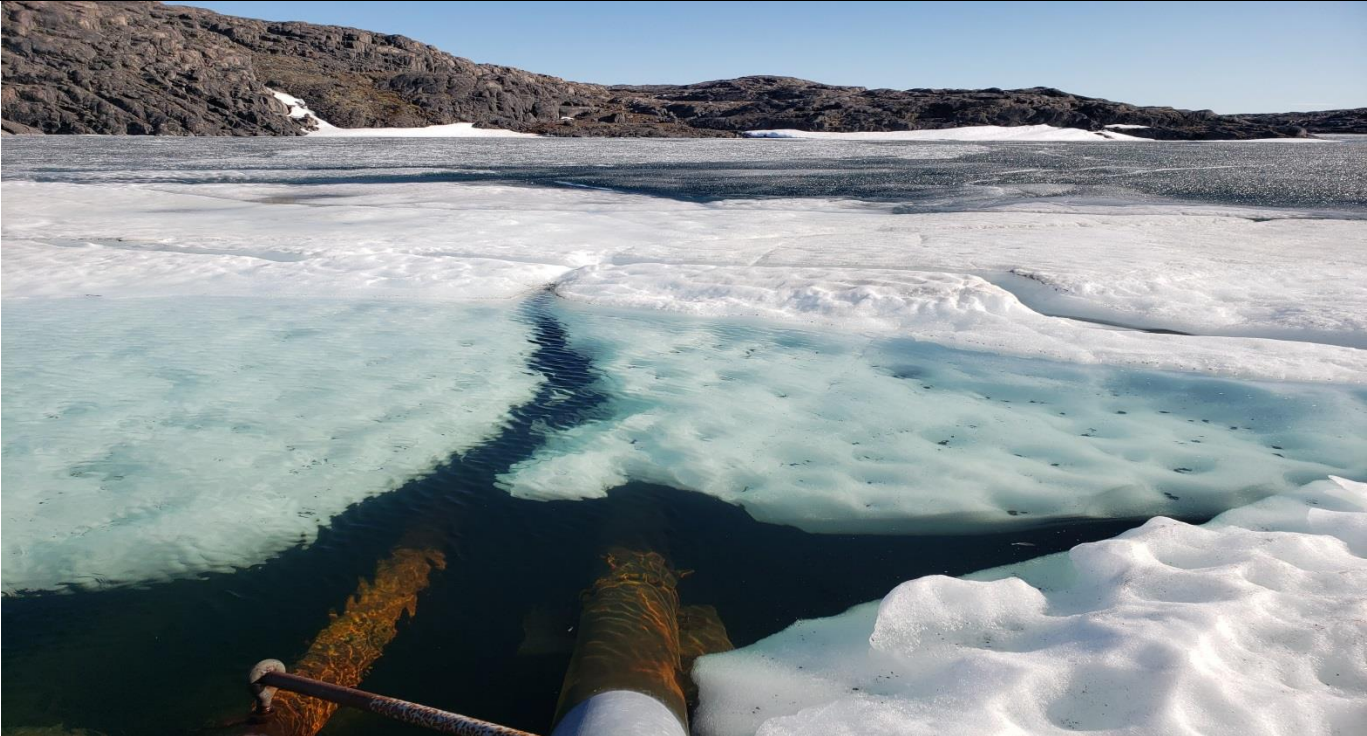
Date	Camera	Inspector	
June 30, 2020	Nikon Coolpix	Joseph Monteith	
Photo Log #	Location		
Photo 1	Kimmirut, NU

7. During the inspection WRO Monteith did observe rusting of the pipe at Tee Lake below grade of the water table. (Photo 1).
8. Monitoring Station Cap-1 was observed at the water fill station.
9. The length of piping from the potable water source to the truck fill station is approximately 1,318.93 metres (1.3km) as measured from GoogleEarth (photo 2).
10. The Hamlet water fill station was observed. No water metre was observed at the time of the inspection.

Description: Tee Lake: 2x water withdrawal pipes

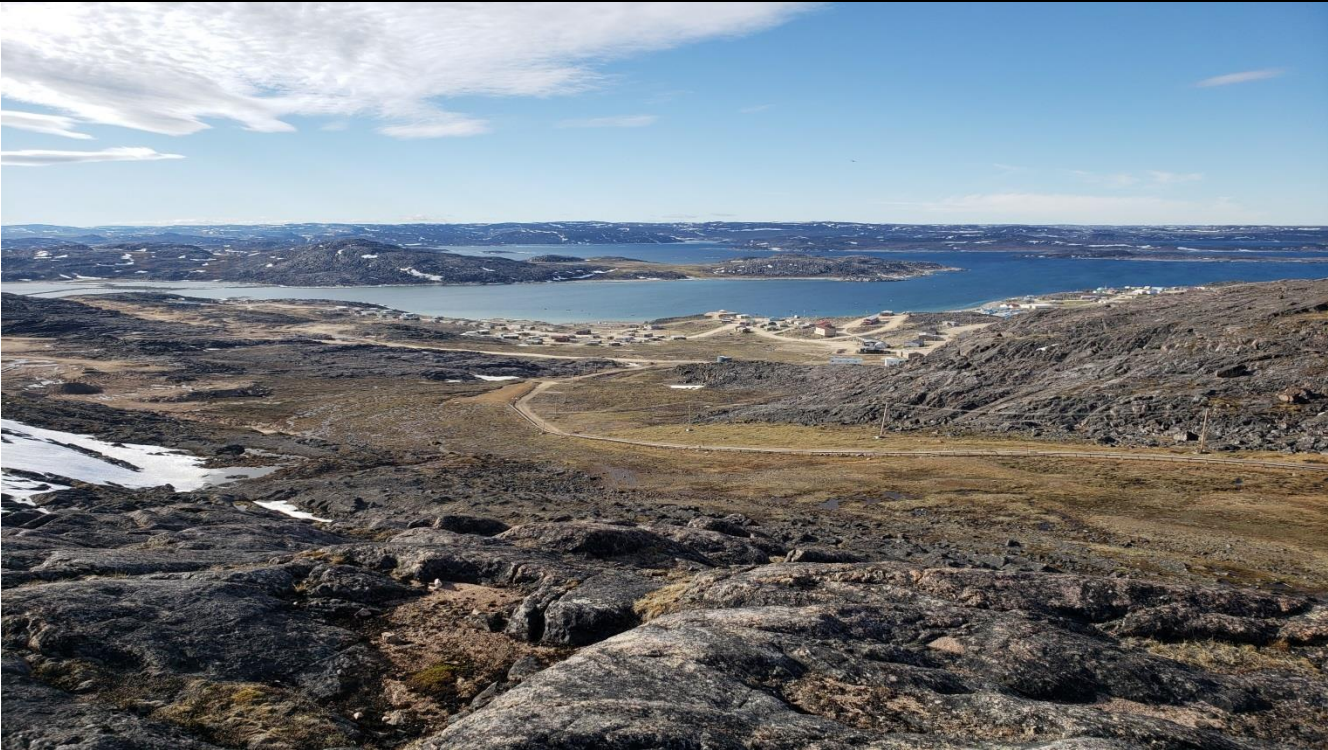
Photo 2	Kimmirut
---------	----------

Description: Pipe Line from water source to water treatment plant. No concerns

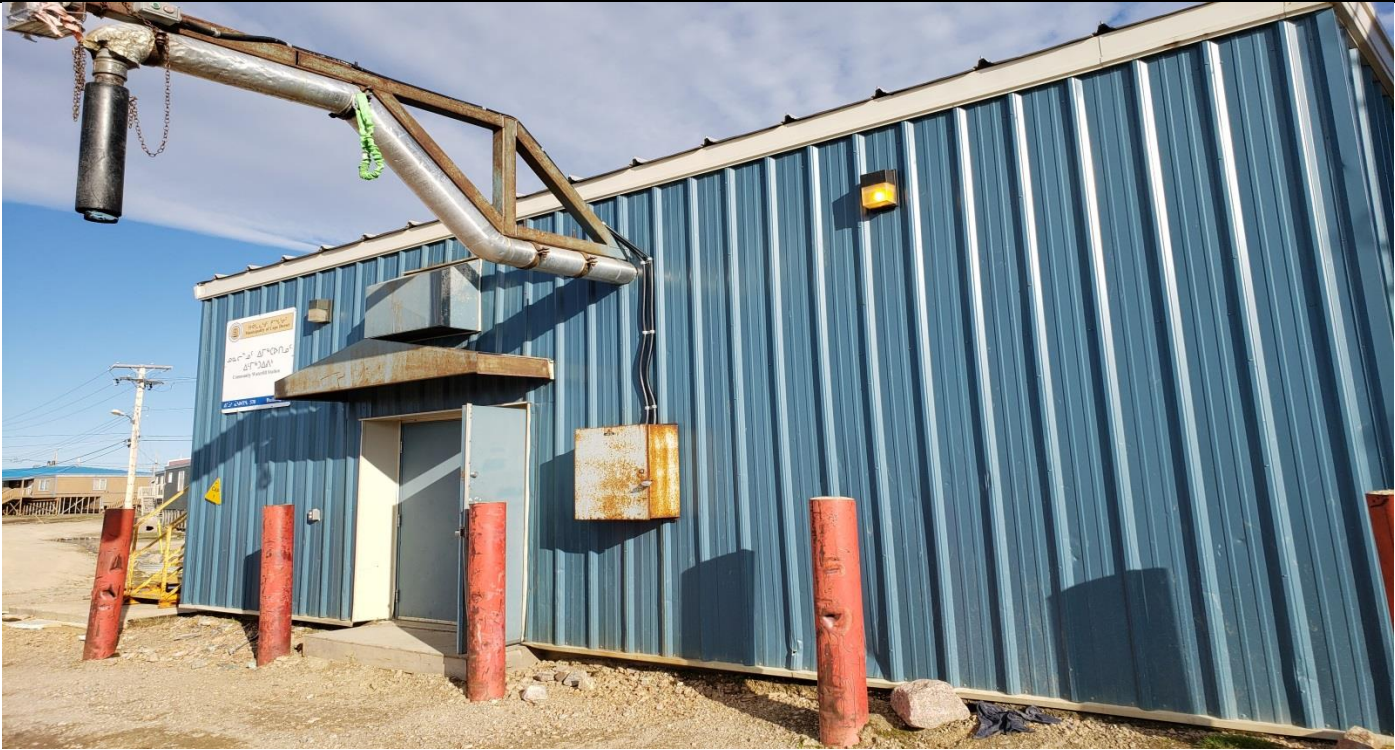
Photo 3

Description: Water Treatment Plant

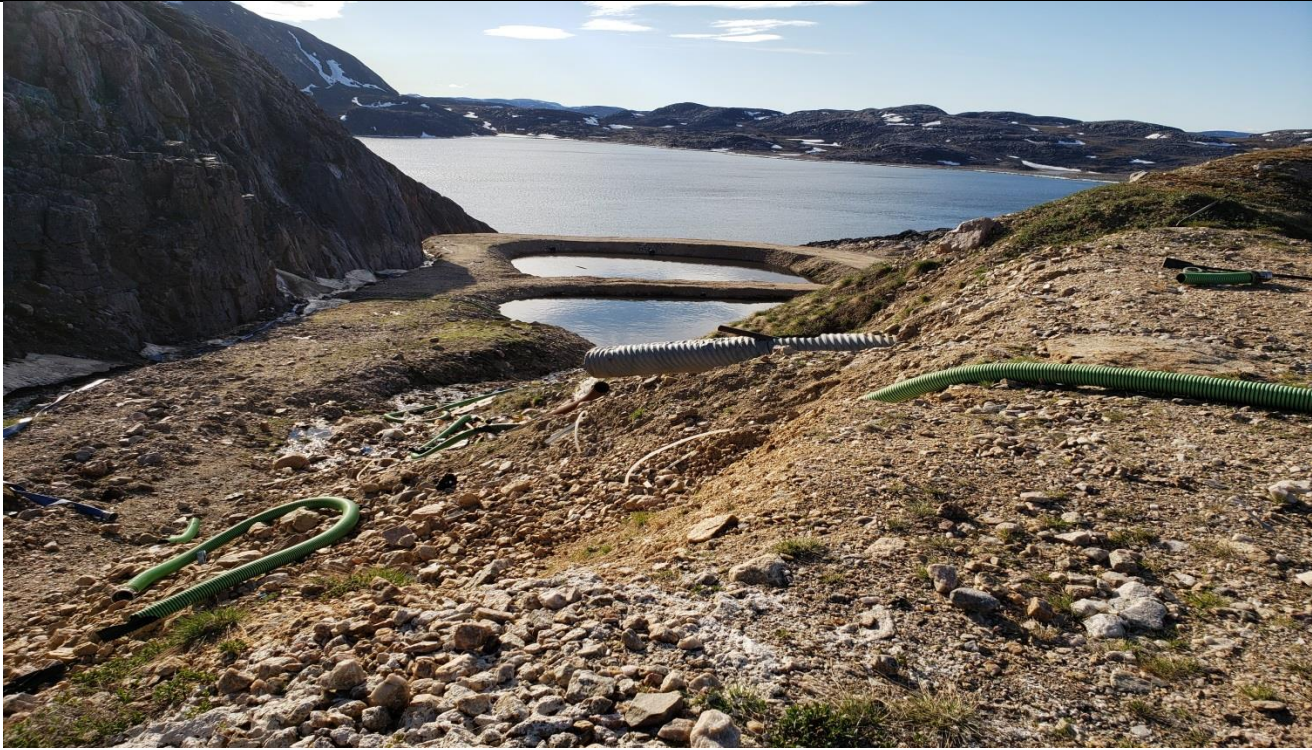
Photo 4

11. At the time of the inspection the sewage lagoon, a 3 tiered cell sewage lagoon much like a sump pit was in-use and appeared to be operating as intended(Photo 4). The top two cells have culverts to maintain sufficient freeboard. The third and lowest cell has a couple of culverts to maintain a freeboard, but if the intent of the sewage lagoons is to settle all suspended solids and decant at specific times of the year, this lagoon isn't doing that. As each cell fills up, it drains into the next cell. But once at the bottom cell, the intent should be to hold the waste, and decant after notifying the inspector. The current method if intended is to always maintain a freeboard, and allow waste to flow out at the culverts when the cells are filled to the culvert line. After the third and lowest cell, the run off has approximately 100 metres counting the distance from the top of the cell wall to the ocean. A drainage ditch was created along the south side of the lagoon, to divert any runoff from Nungait Mountain and the solid waste facility. This drainage ditch has a monitoring station titled CAP-3. The drainage ditch also showed signs of overflow from the sewage lagoon cells (Photo 3). An Emergency Lagoon was also observed at the time of the inspection.

12. The freeboard for highest upper cell was at the level of the culvert, which is approximately 1 metre from the top of the sewage lagoon cell wall. The second cell also had a culvert which appeared to be an overflow culvert to maintain the 1 metres freeboard on the lagoon. The cell wall on the second tier middle lagoon was not even in height. The culvert may have been installed to maintain the 1 metre freeboard, but in other areas of the walls, the freeboard was below 1 metre (Photo 2). The corner of cell 2 appeared to have no lining, and waste was leaking through to the third tier by exfiltration. Monitoring Station Cell-4 should be here, but the sign was down. The third and last cell was full to the lower culverts spilling out. No 1 metre freeboard on the lower cell with sewage table at the lower culvert.

Description: Cell 3 full, overflows into already full Cell 2, which then spills into Cell 3 through a spill way culvert. Cell 3 full, spilling out uncontrolled out of the 3 cell lagoon.

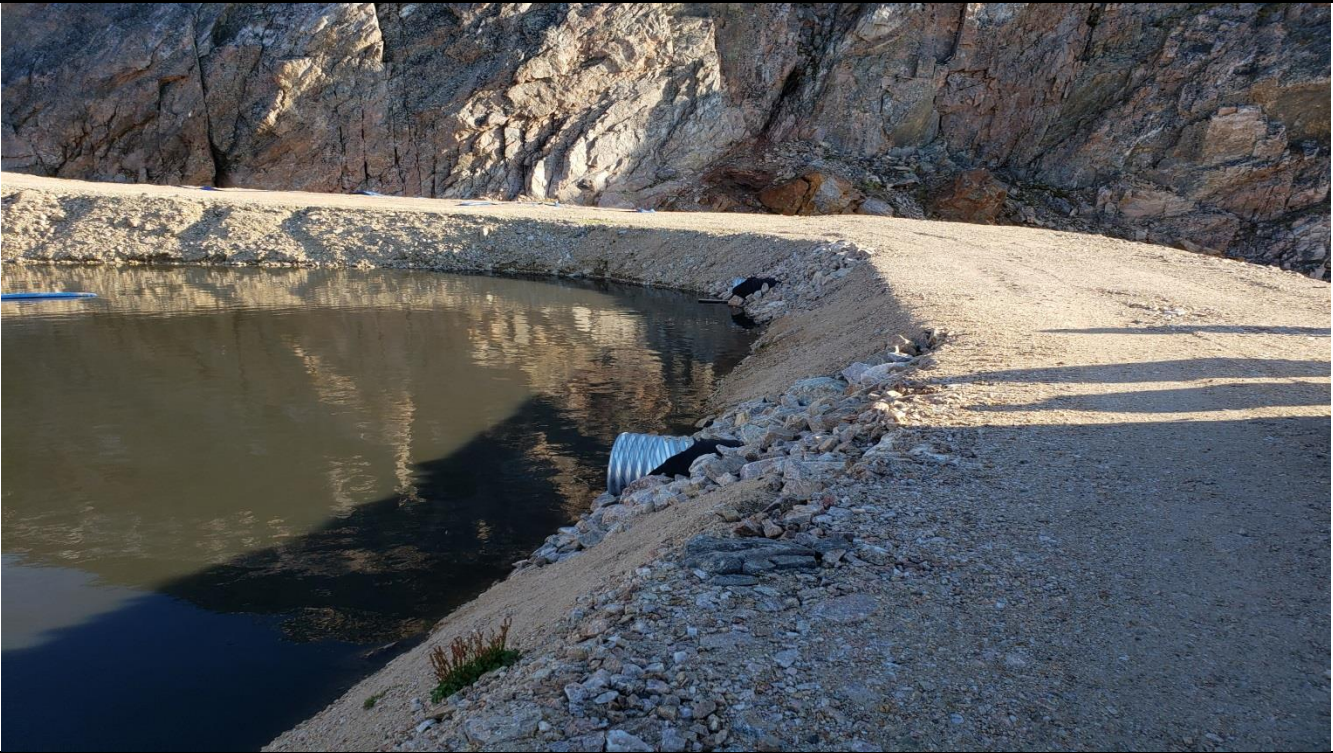
Photo Log #1	Location
Photo 4	Kimmirut

Description: Cell 3 full, and spilling out the overflow culvert. An uncontrolled discharge of waste.

Description: The uncontrolled discharge of sewage down the spill way has caused erosion and sedimentation. A spill report was requested and submitted to the NT\NU Spills line.

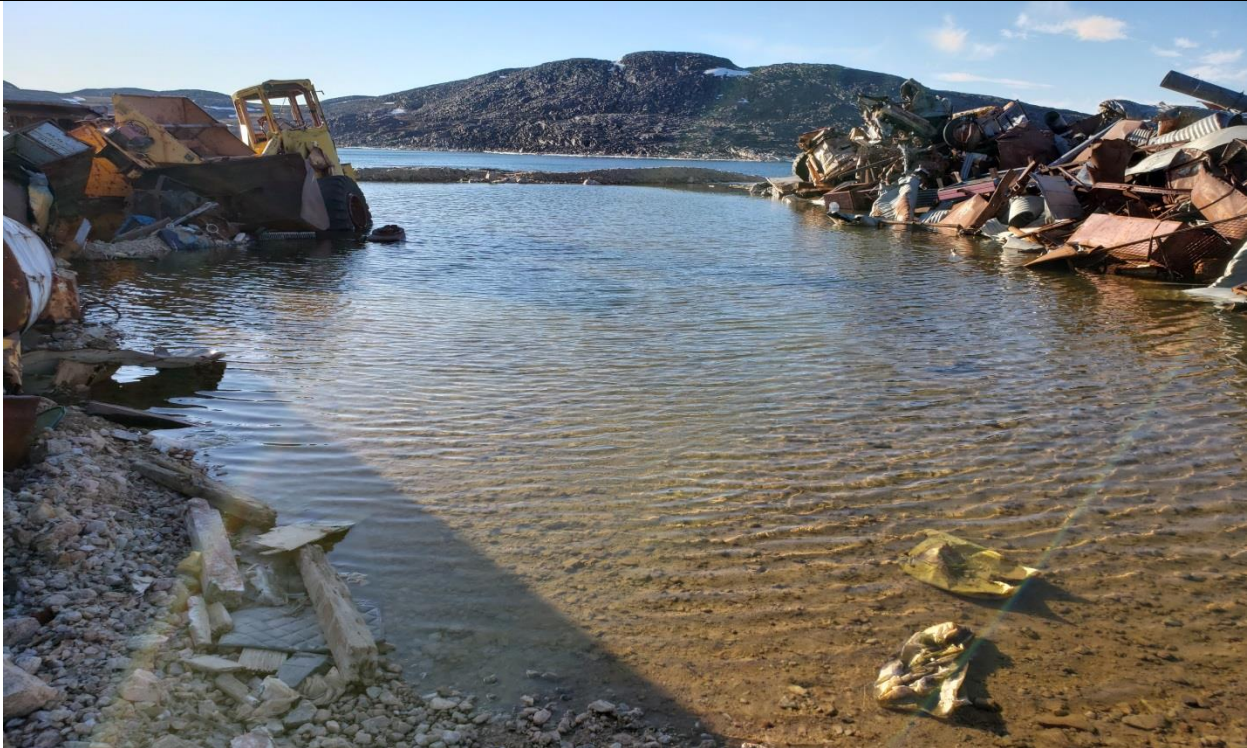
Photo 6

18. Metal Storage Area has three parts to it. Snowmobiles and ATV's appear to be segregated. The bulk metal waste comprised of old vehicles has numerous waste batteries, propane tanks and waste oil within this site. A berm was set up around this bulk waste area to mitigate any leachate from entering the ocean. The wall on the south side of this area appears to have eroded, and has compromised its intended purpose, the project is contrary to Part D: Item 9 (photo 6).

Description: A berm rebuilt into the solid waste facility is full, and over flowing. The water being built up has to be tested, and if found to have contaminants treated before being released.

- Repair of the wall at the Solid Waste Facility was not requested, and has resulted in the accumulation of surface water. The accumulated water will have to be tested, and if found to have contaminants, be treated before being released. The intention of Part D: Item 10 is to implement appropriate erosion and diversion control methods to prevent the entry of water into the facility and to prevent the retention of water to minimize surface water accumulation in the facility. In regards to Part D: Item 6, the licensee was not compliant on this dam.

- Test the bermed water inside the solid waste facility, and provide results to the inspector, and submit results in 2021 Annual Report.
- The Licensee is reminded to remain diligent to prevent wastes from entering water, and the environment.

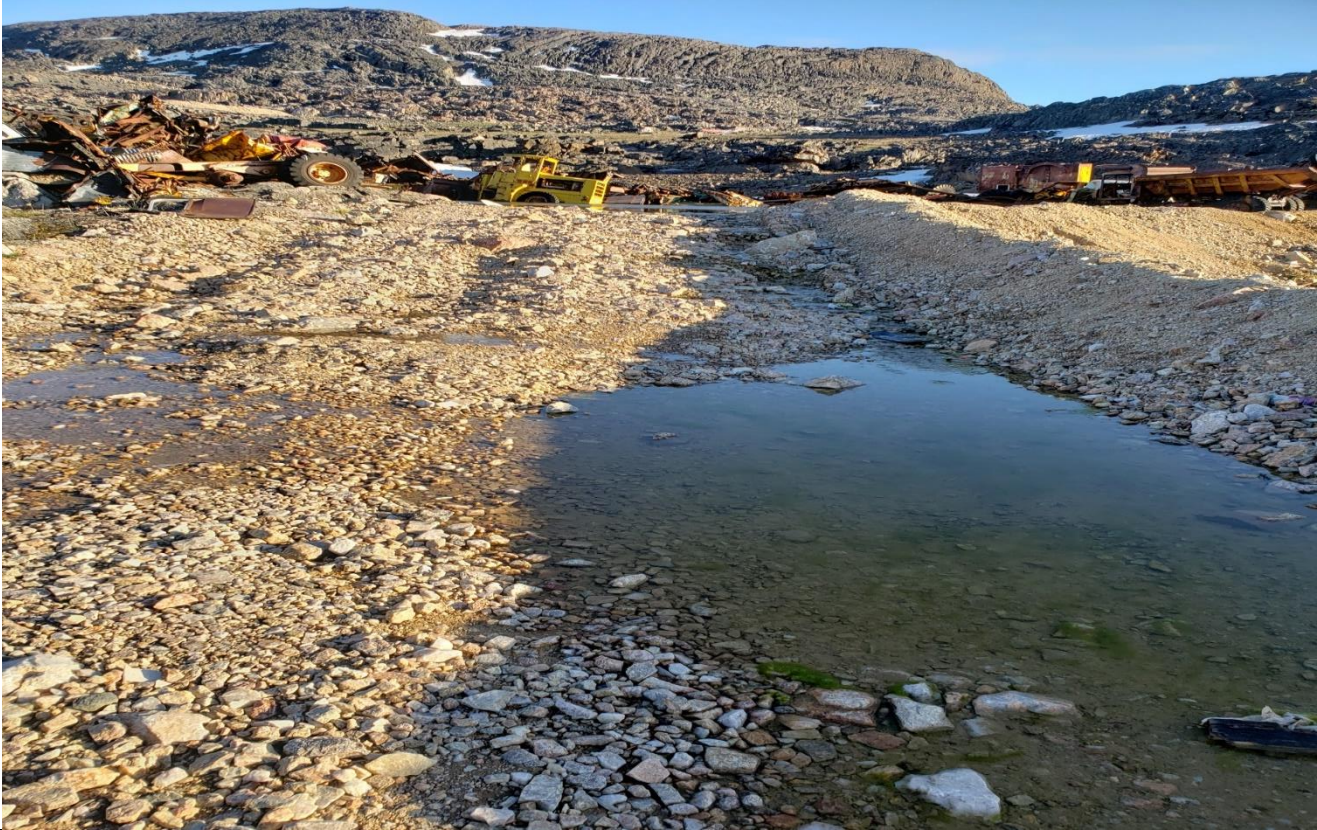
Photo 7

Description: A berm rebuilt into the solid waste facility is overflowing. The water being built up has to be tested and treated if found to have contaminants before being released.

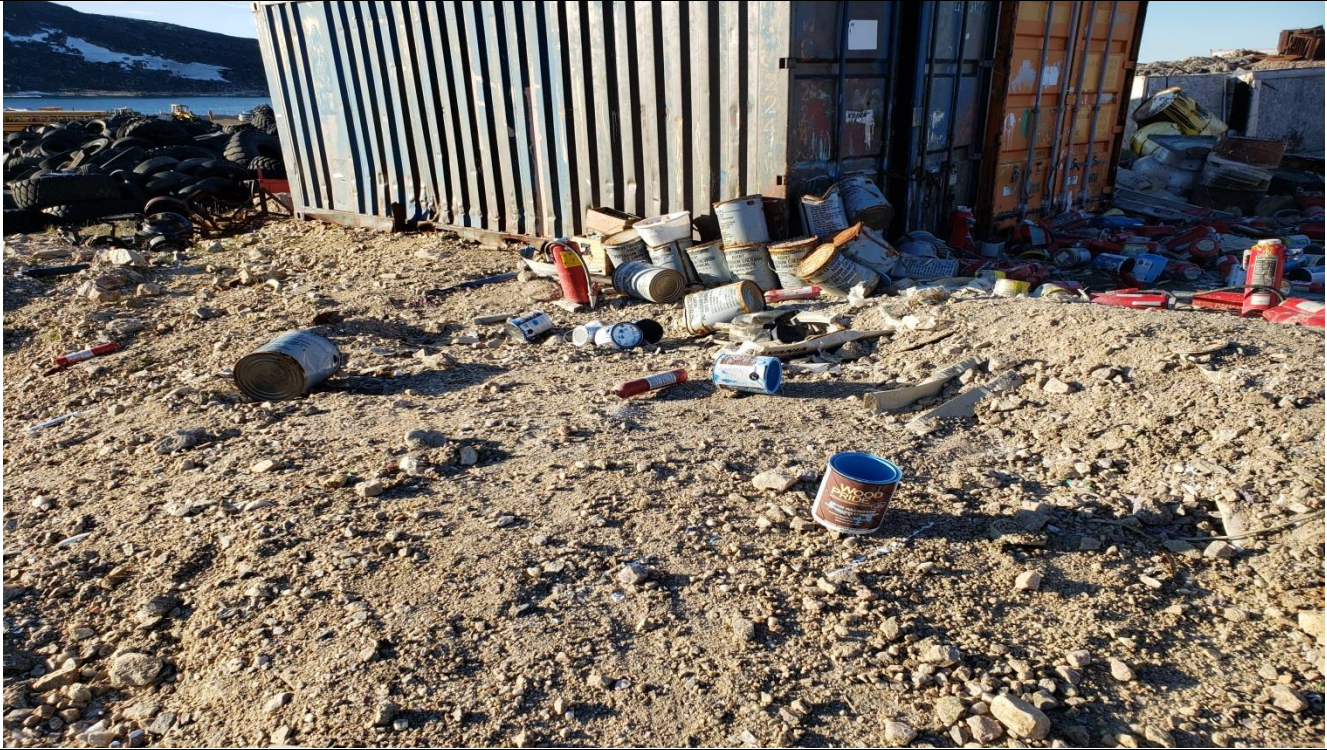
Photo 8

Description: stored paint cans outside to the outside elements gets kicked around and litter the grounds of the solid waste facility

- Send hazardous waste to a proper Hazardous Waste Facility to free up room in the current Hazardous Waste Facility. Keep copies of Hazardous Waste Manifest for verification purposes.

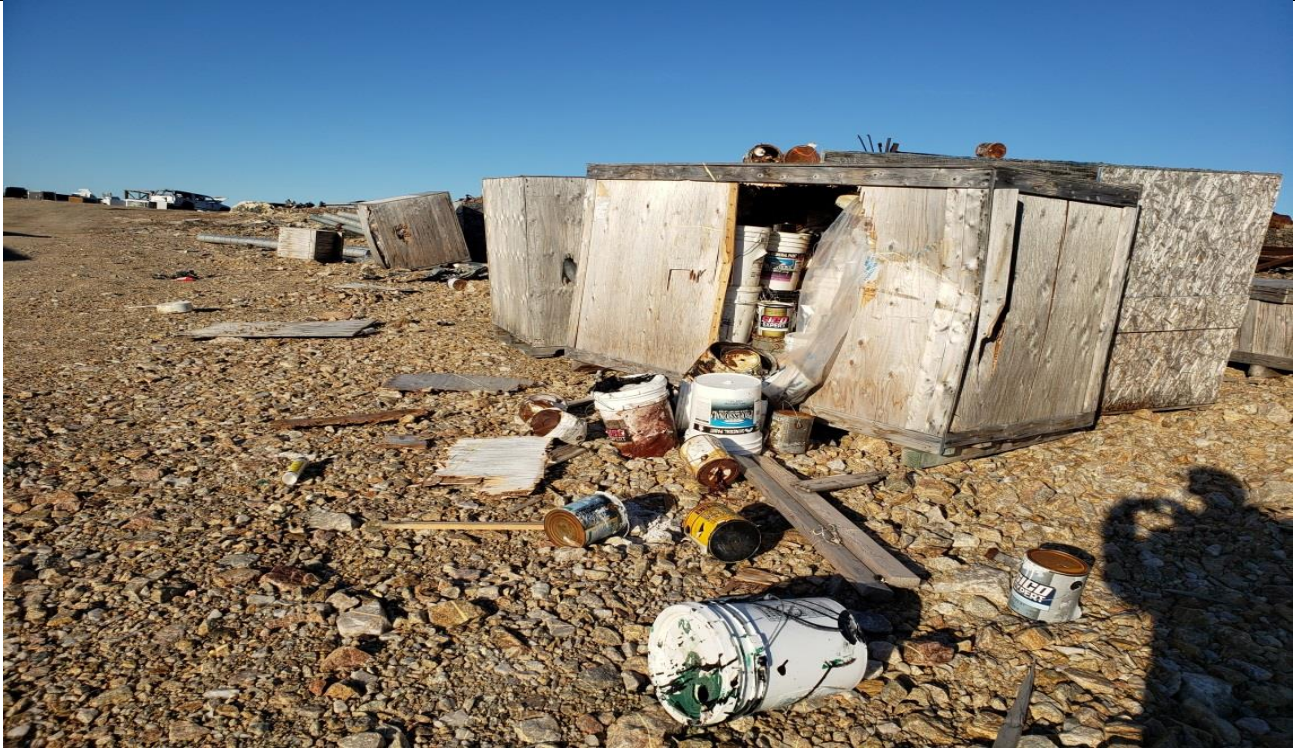
Photo 9

Description: Suspected vandalism of the solid waste facility, littering and exposing hazardous waste paint cans to the external elements

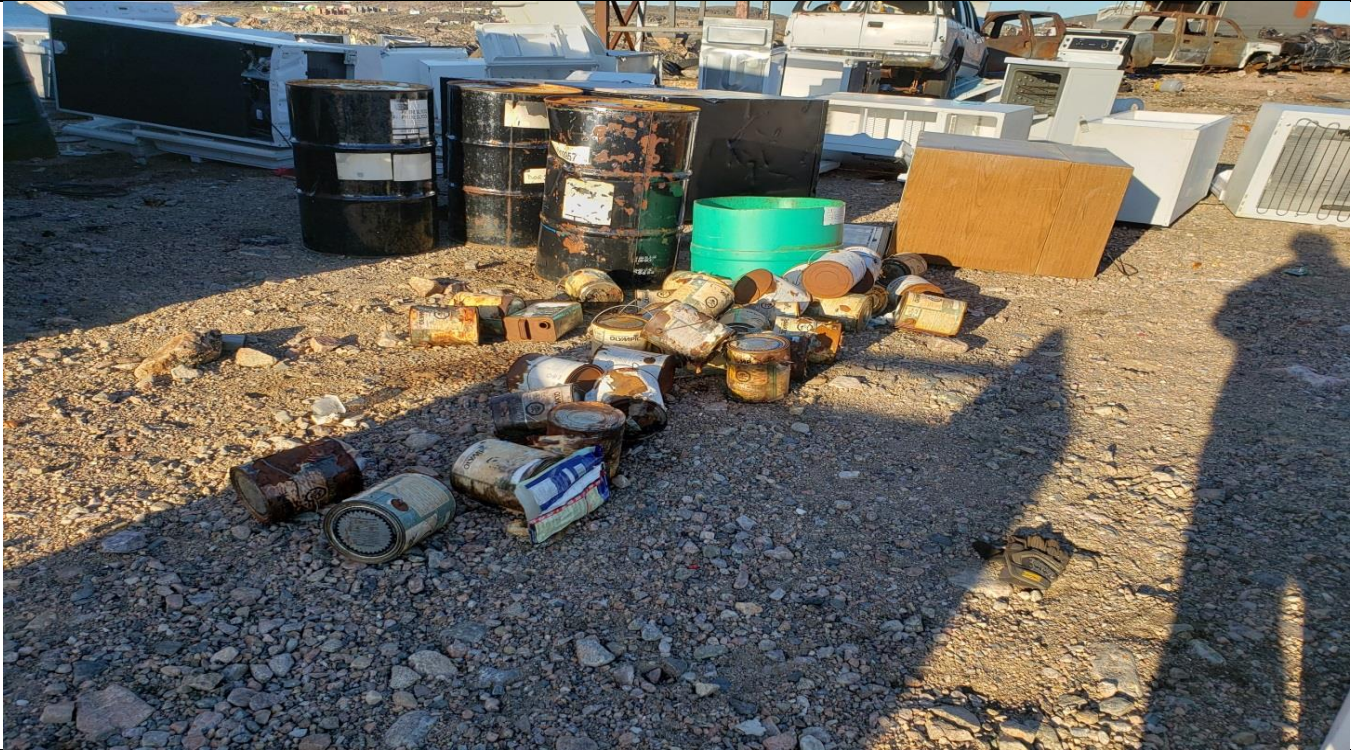
Photo Log
Photo 11

Description: old paint cans litter the the ground of the solid waste facility

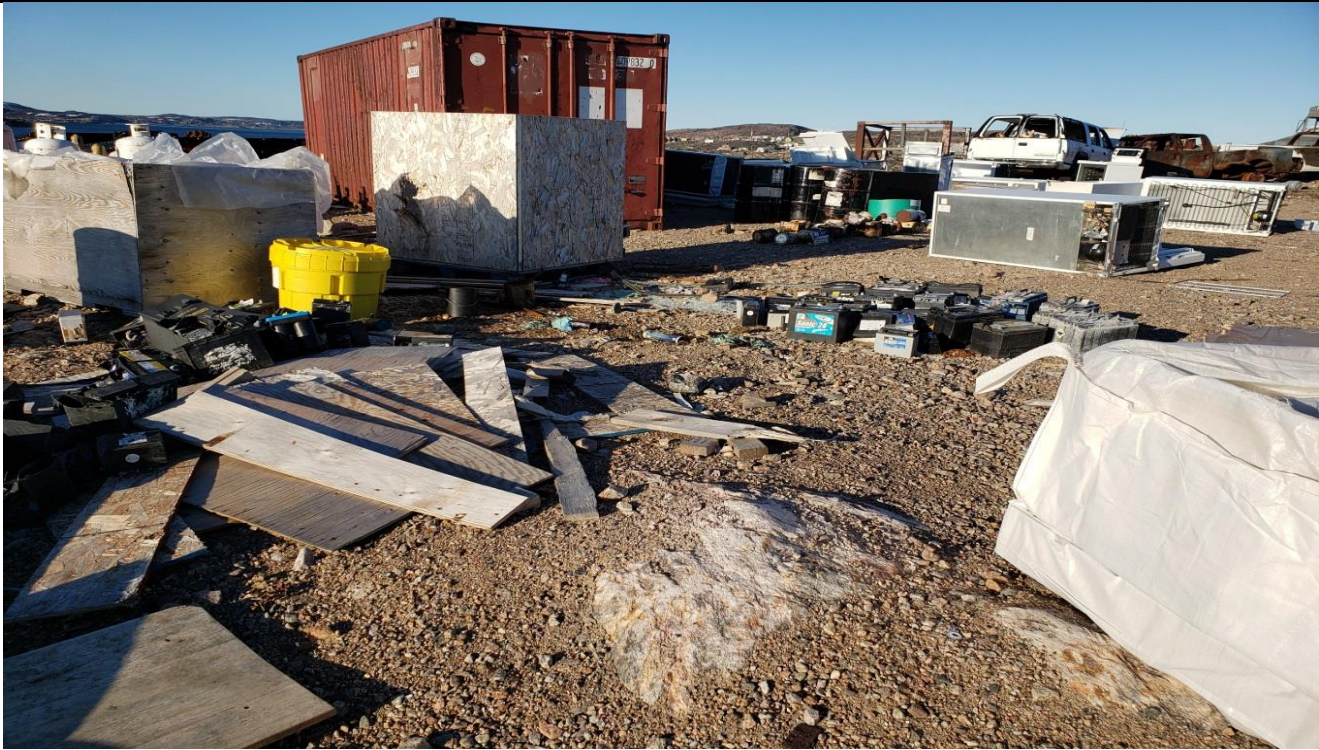
Description: some hazardous waste stored outside, exposed the outside elements. Batteries exposed to the outside elements

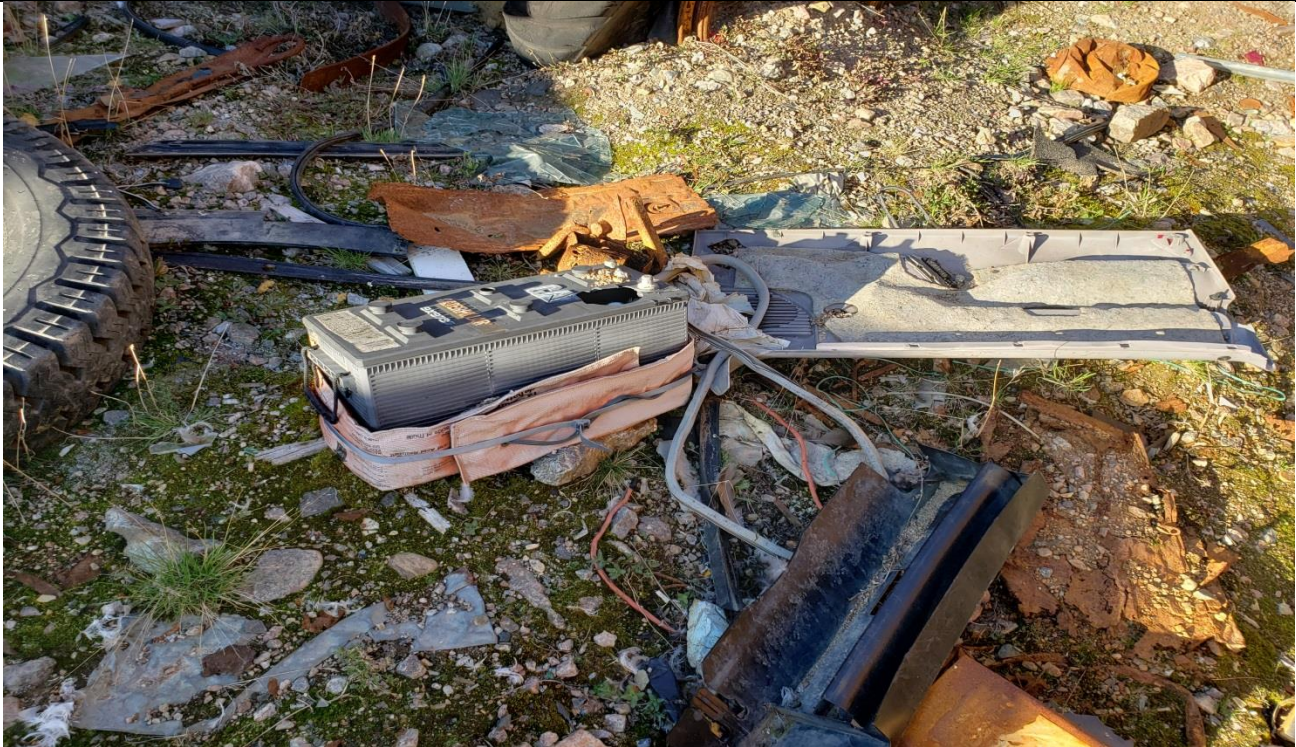
Photo Log
Photo 12

Description: A battery found in the solid waste facility.

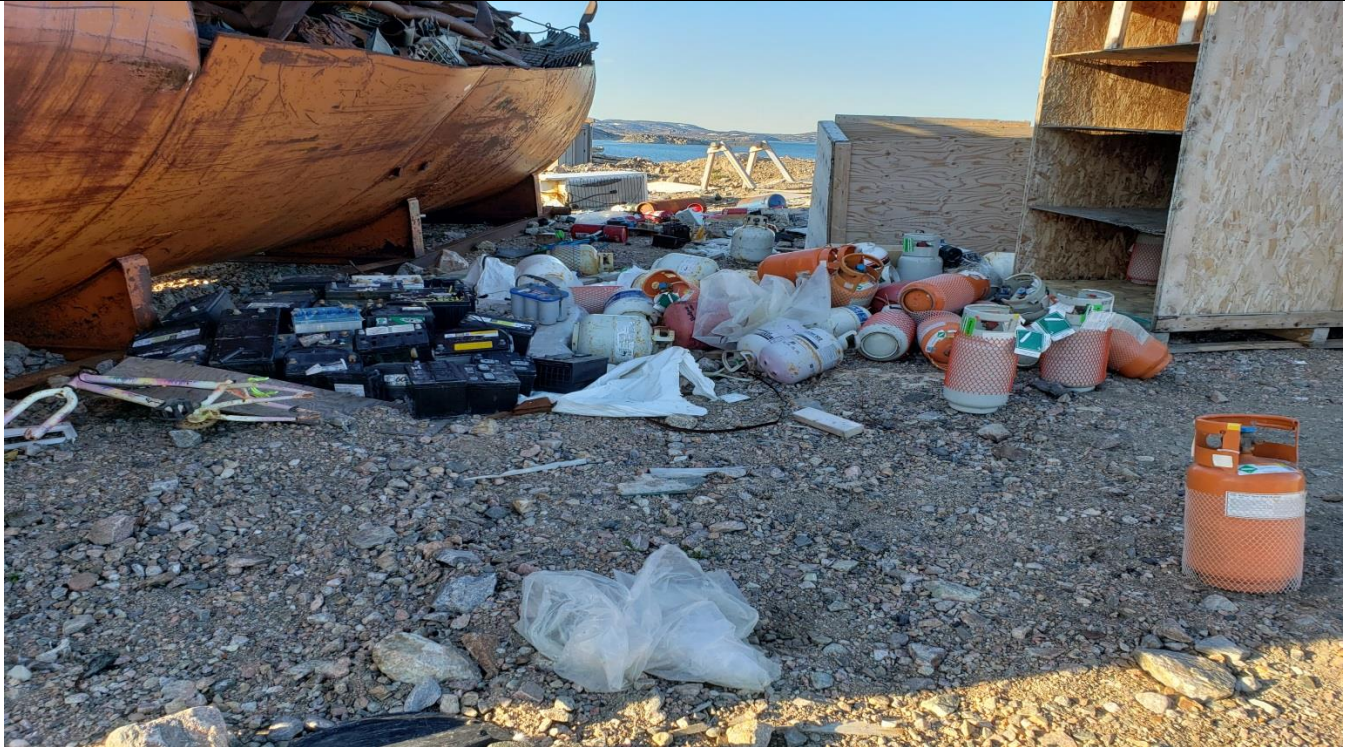
Photo Log
Photo 13

Description: Hazardous waste batteries exposed to the outside elements

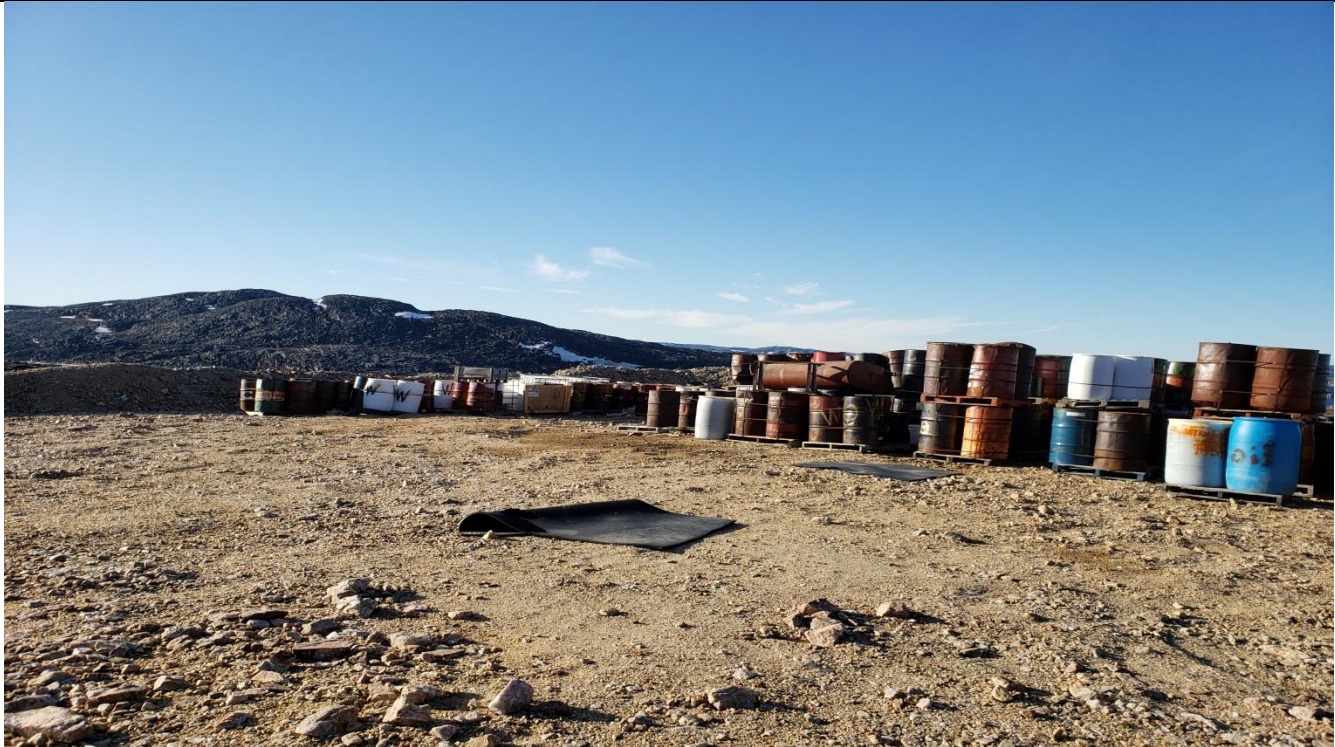
Photo Log
Photo 14

Description: 3 walled, non-engineered berm for storage of drums of hazardous waste.

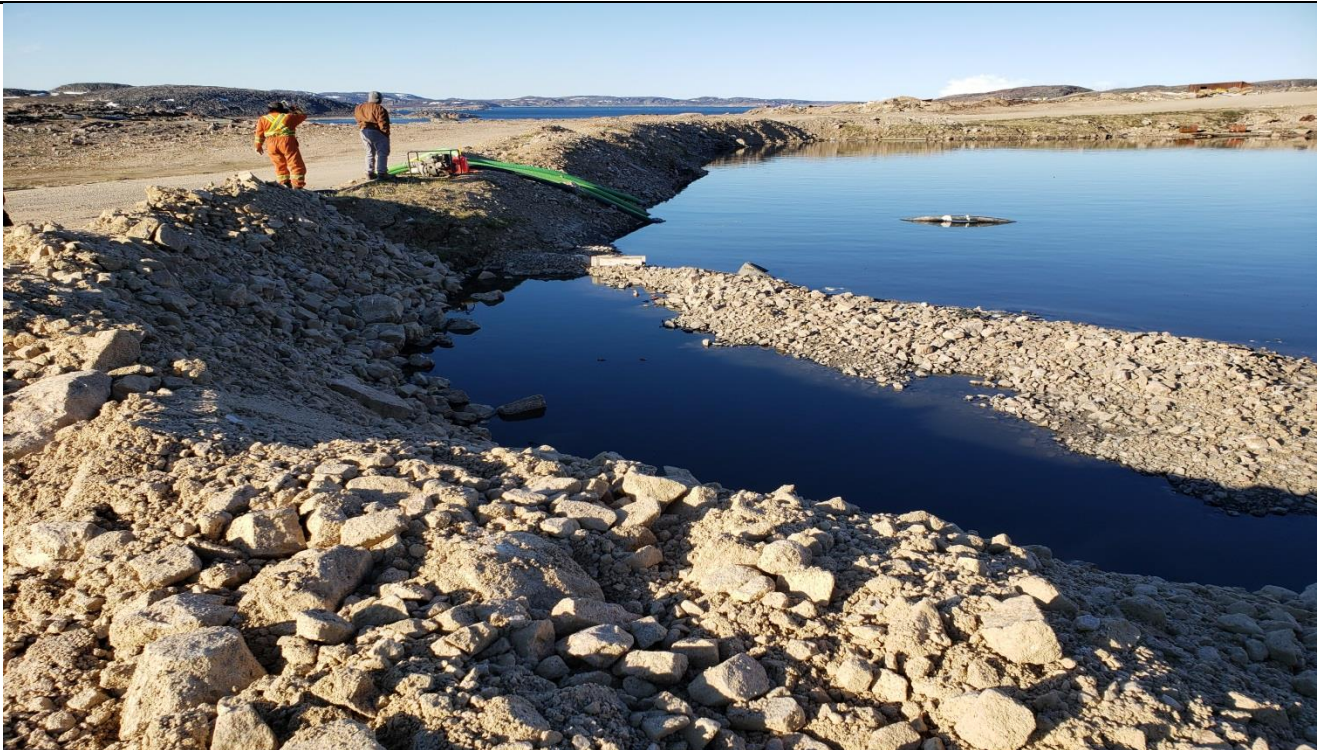
Photo Log
Photo 15

Description: Walls of the emergency sewage lagoon was repaired, and 1 metre freeboard is maintained.

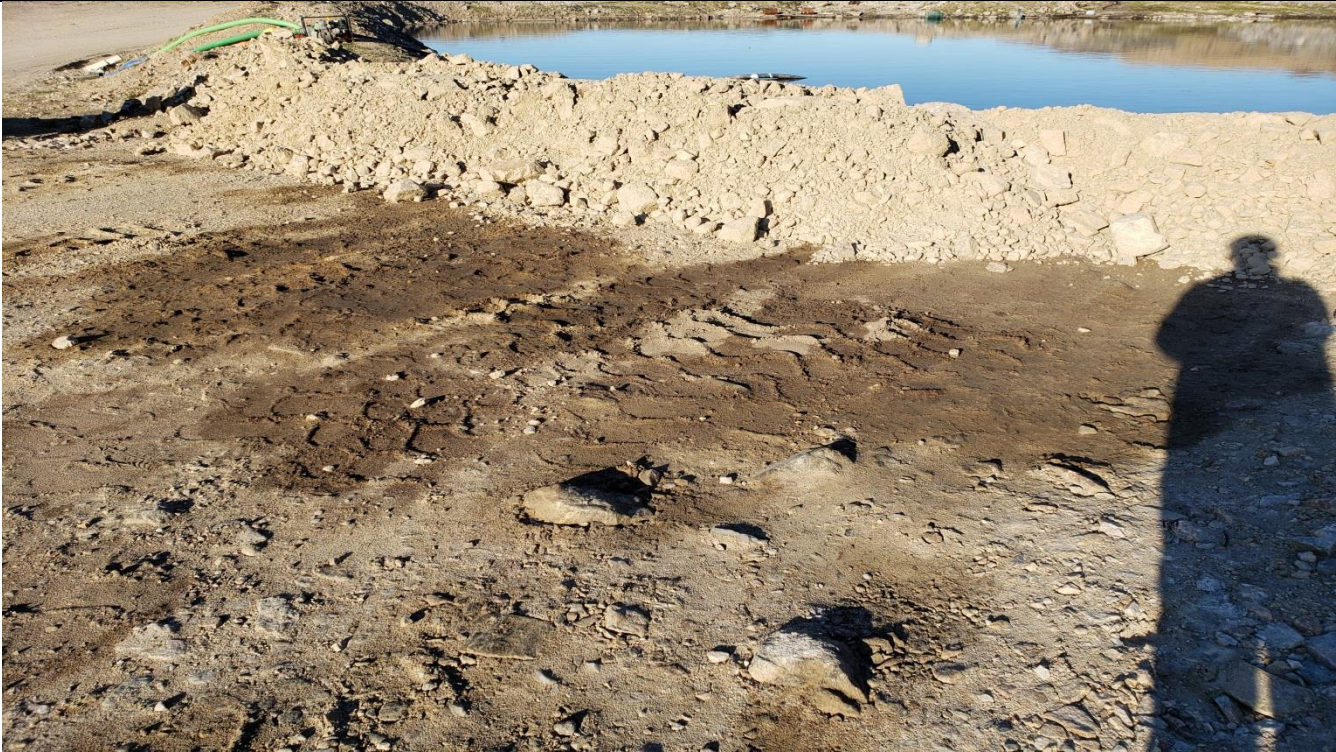
Photo 16

13. The emergency lagoon appears to have been built to capture run off from the 3 tier lagoon, but showed signs of recent use. Hoses litter the area, and must have been used to decant the emergency lagoon, and had shown signs of past overflow from run-off water. Across the road from this emergency lagoon was berm walls constructed to capture the run off that had entered the emergency lagoon, overflow, and also where they would decant from the emergency lagoon. A monitoring station listed as CAP-5 sign was also observed there. The emergency Lagoon is approximately 171 metres away from the high water mark of the ocean.

Description: Unreported spill at the emergency lagoon. A spill report submission was requested, and clean up. Walls of emergency sewage lagoon repaired, and 1 metre free board now maintained.

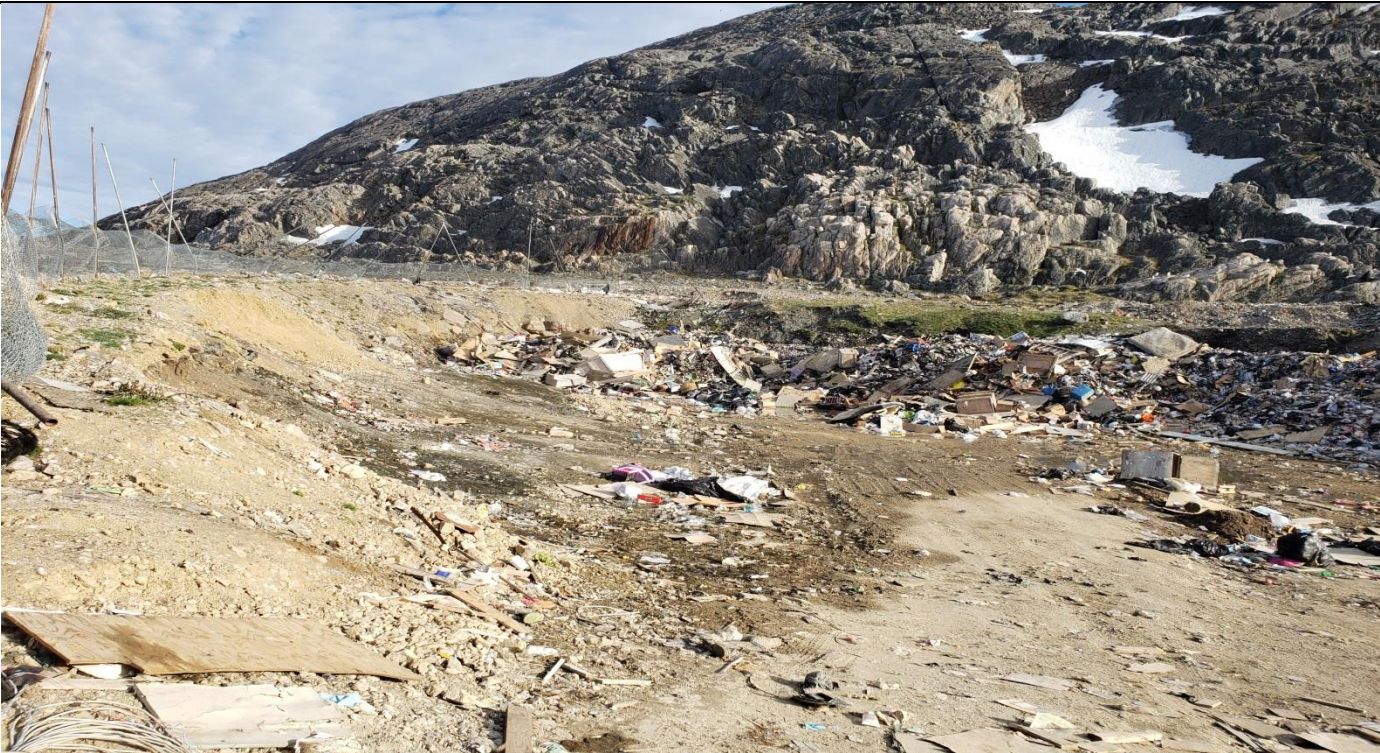
Photo 17

16. The open pit burning has fencing along the top of the pit, along the north east side of the pit. Probably to capture windblown garbage as the prevailing winds comes from the North West. The fencing is damaged. The approximately 4 metre high posts that support the fencing is bent out of shape, and the fencing itself is folded outwards from the post, and doesn't appear to be operating as intended.

Description: Fencing at the burn and cap section of the solid waste facility. Fencing condition has deteriorated, and needs to be repaired.

- Repair to the fencing on the north east side open pit burning may mitigate any windblown garbage from blowing away and impacting any water bodies. Erection of another fence on the North West side may mitigate garbage from entering the sewage lagoon cells and compromising its capacity.
