WATER LICENCE INSPECTION FORM

Licensee	Licensee Representative
Hamlet of Cape Dorset	Bhabesh Roy
Licence No. / Expiry	Representative's Title
3BM-CAP1925	Municipal Engineer
Land / Other Authorizations	Land / Other Authorizations
Date of Inspection	Inspector
July 29, 2021	Joseph Monteith
Activities Inspected

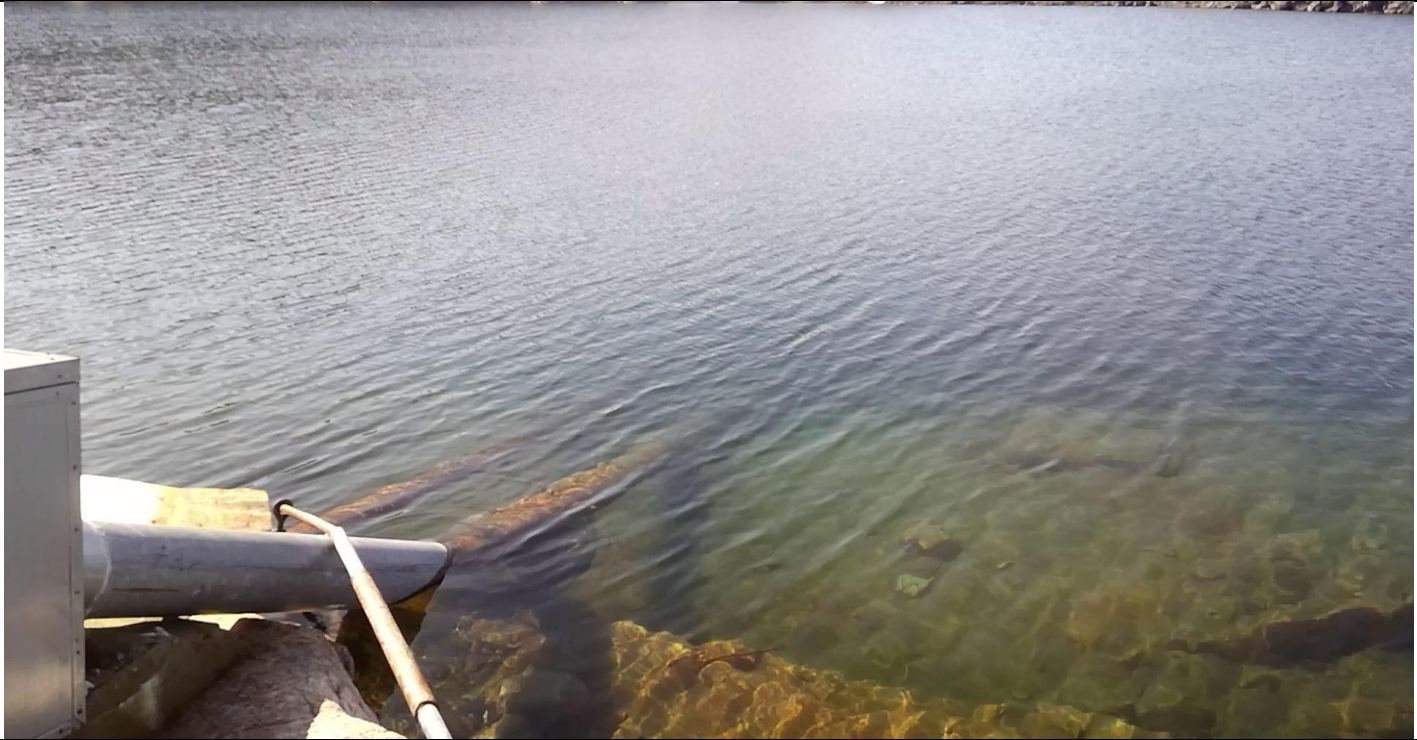
Date	Camera	Inspector
July 29, 2021	Nikon Coolpix	Joseph Monteith
Photo Log #	Location	
Photo 1	Cape Dorset, NU

5. During the inspection WRO Monteith did observe rusting of the pipe at Tee Lake below grade of the water table. (Photo 1).
6. Monitoring Station Cap-1 was observed at the water fill station.
7. The length of piping from the potable water source to the truck fill station is approximately 1,318.93 metres (1.3km) as measured from Google Earth (photo 2).
8. The Hamlet water fill station was observed. No water meter was observed at the time of the inspection.
9. Water Usage Records were emailed to WRO Monteith by Grant Scott, Interim Senior Administrative Officer, Hamlet of Cape Dorset. The report shows 41, 169m³ was withdrawn from Tee Lake(photo 12).

Description: Tee Lake: 2x water withdrawal pipes

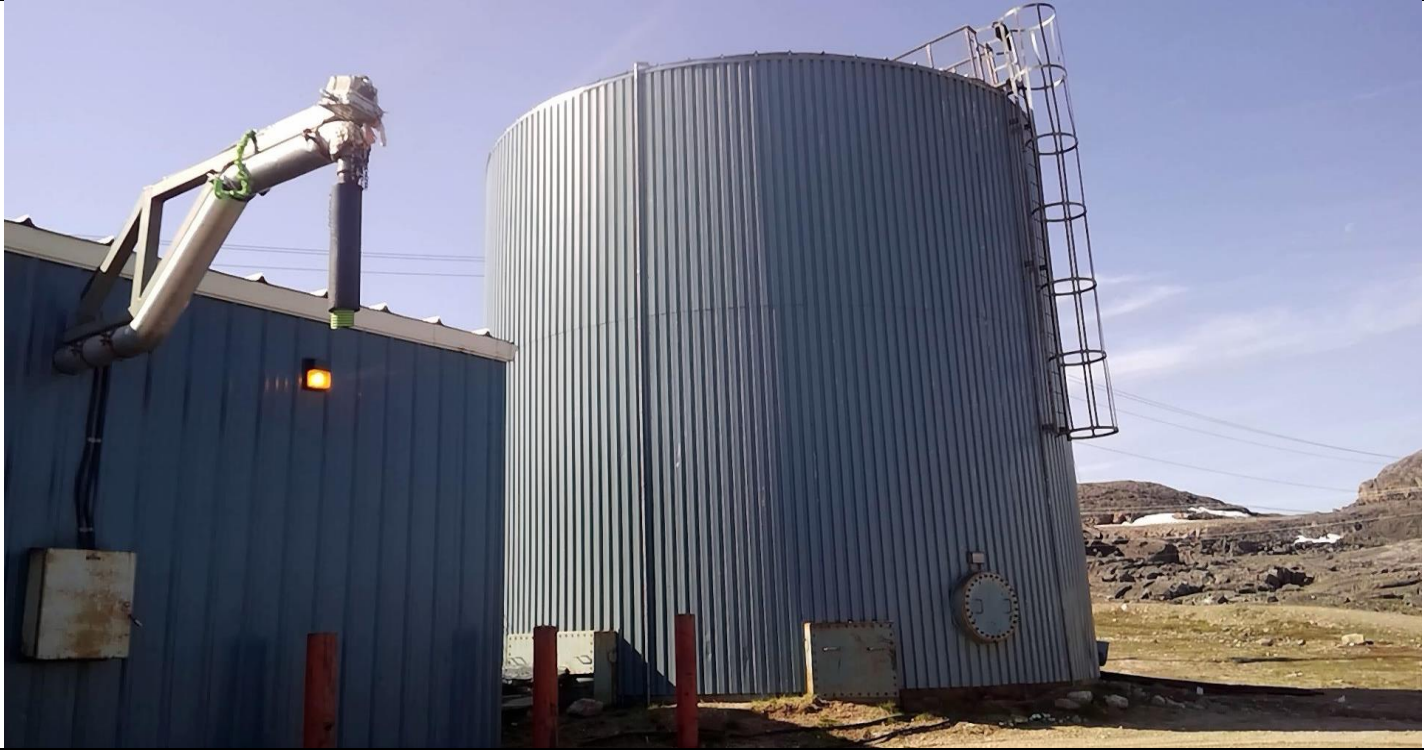
Photo Log #1	Location
Photo 3	Kimmirut

Description: Water Treatment Plant

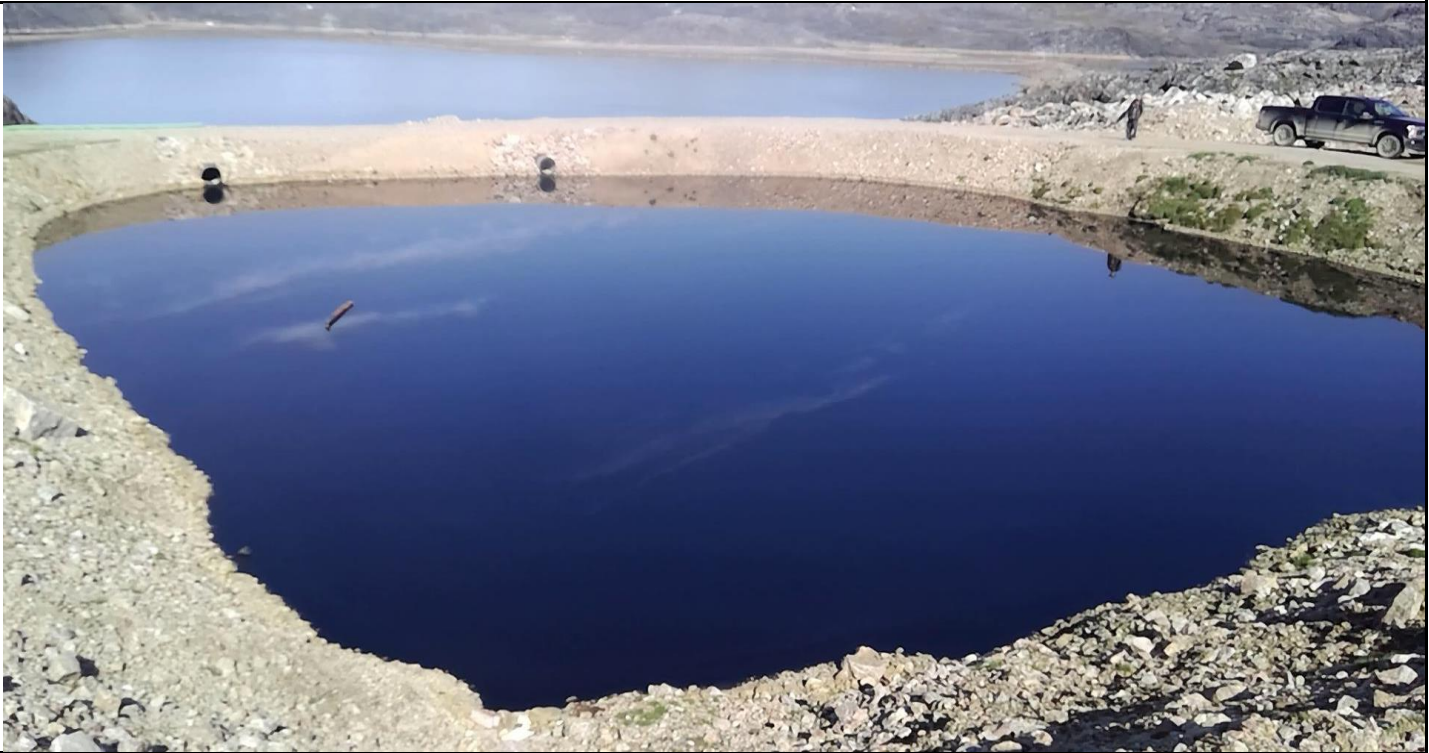
Photo Log #1	Location
Photo 5	Kimmirut

Description: Cell 3 full, and spilling out the overflow culvert. An uncontrolled discharge of waste.

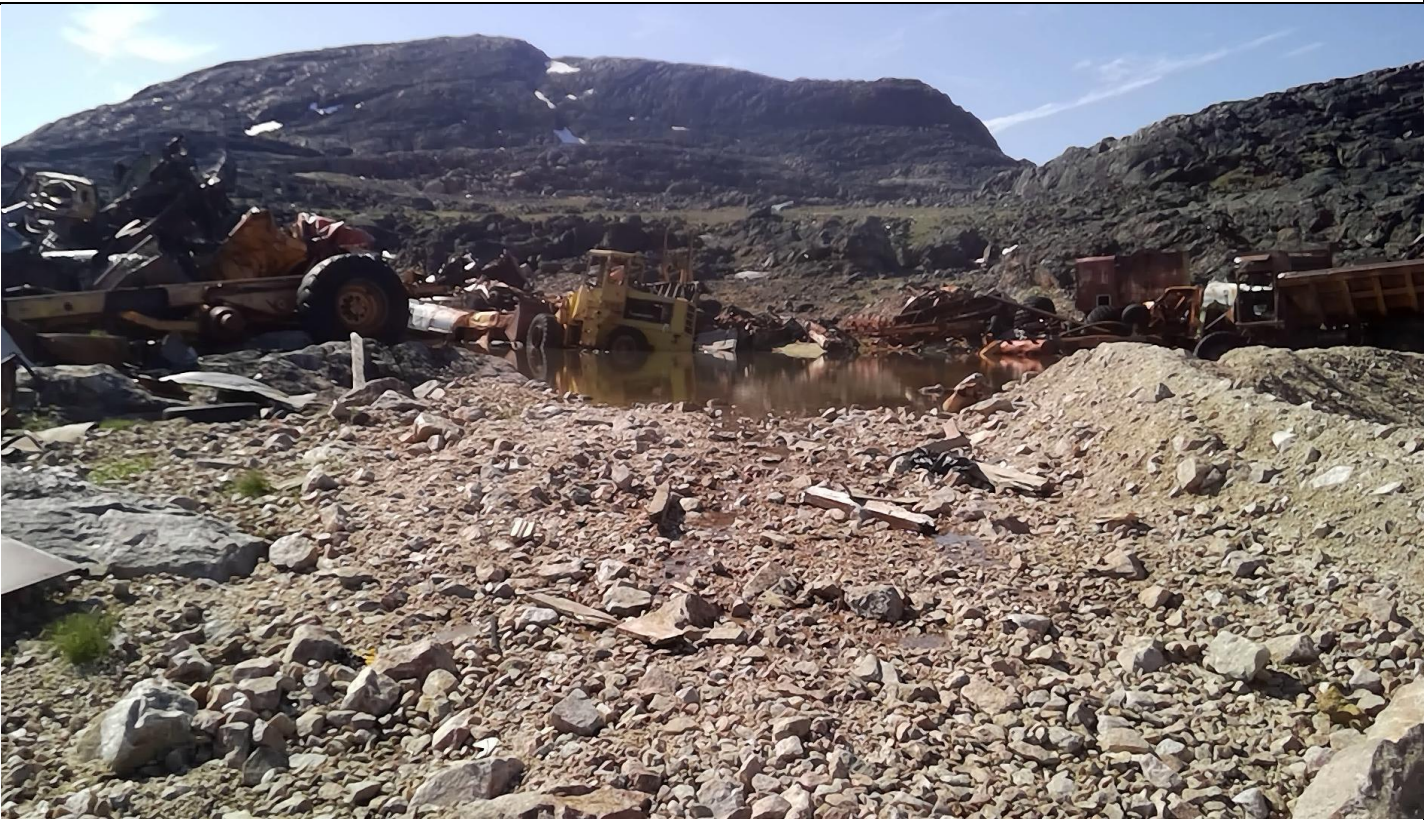
Photo 7

Description: A berm rebuilt into the solid waste facility is overflowing. The water being built up has to be tested and treated if found to have contaminants before being released.

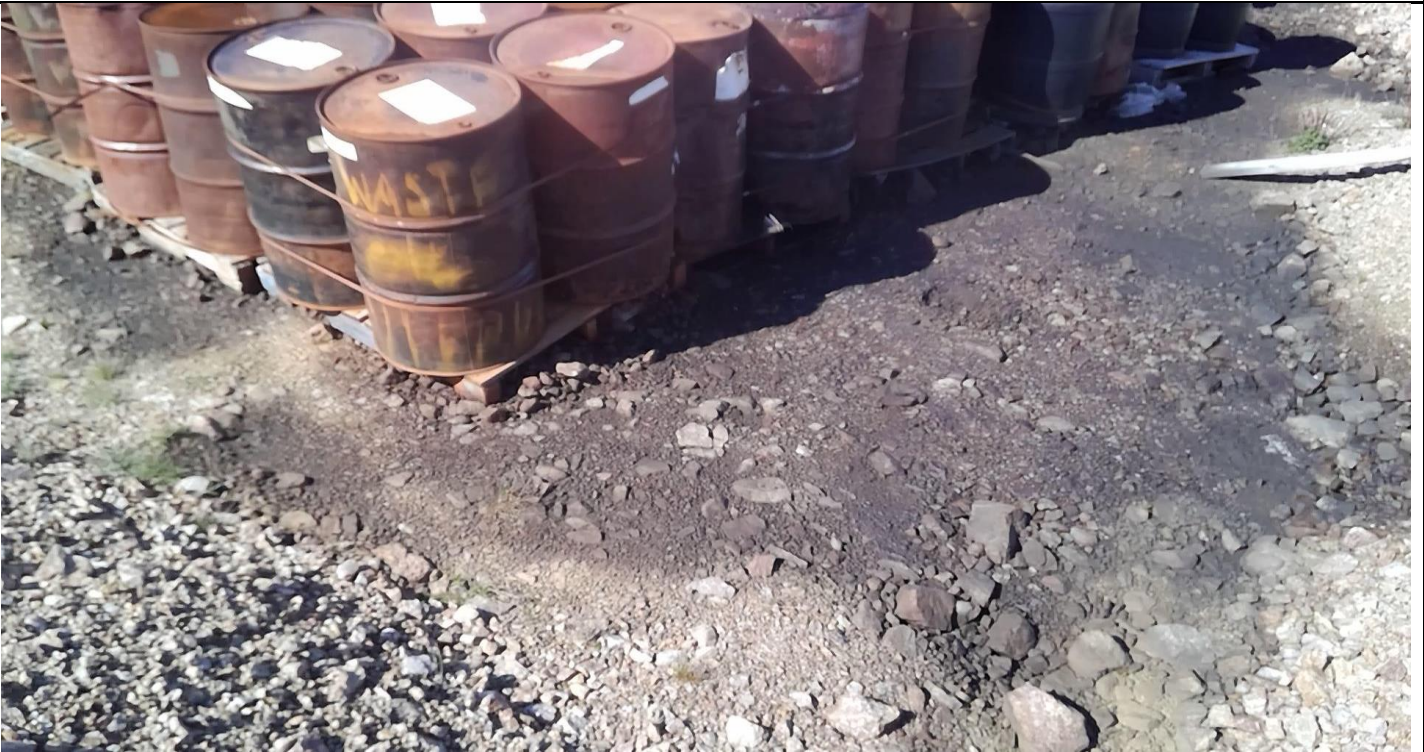
Photo 8

Description: Observable spill within the 3 walled berm for hazardous waste drums.
