REF: 040527 NUB 3CAP0207
Sewage Spill Follow-up - 1 TAE

Re: Cape Dorset Lagoon/ Sewage Spill Follow up, May 5, 2004

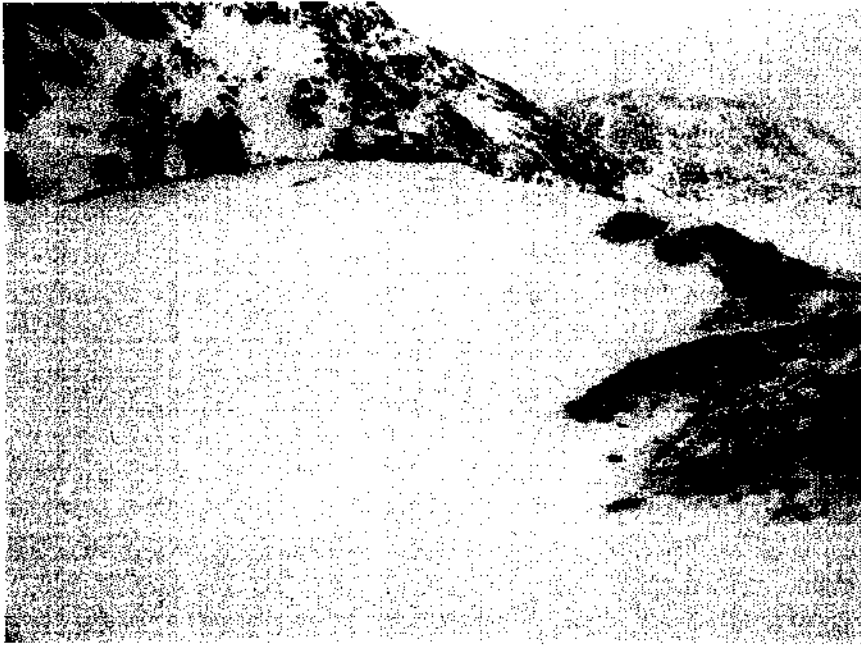
that the 3-celled lagoon is in imminent danger of overflowing and washing out as soon as the spring melt begins. The first cell is close to the level of the overflow culvert (Figure 1) while the second cell is full above the overflow culvert and has surpassed the surface of the berm in one area (Figure 2 and Figure 3). The sewage that has overflowed from cell one is flowing along the diversion channel on the mountain side of cell two. This overflow from cell one has produced a large build up of ice that is moving down the side of cell two (Figure 4). It appears that this sewage shall both erode the side of cell two and possibly flow along the mountain side, by-passing the third cell entirely. The situation could potentially result in a catastrophic failure of cells two and three of the lagoon.

Figure 1. The berm in the first cell of the new Sewage Lagoon in Cape Dorset.

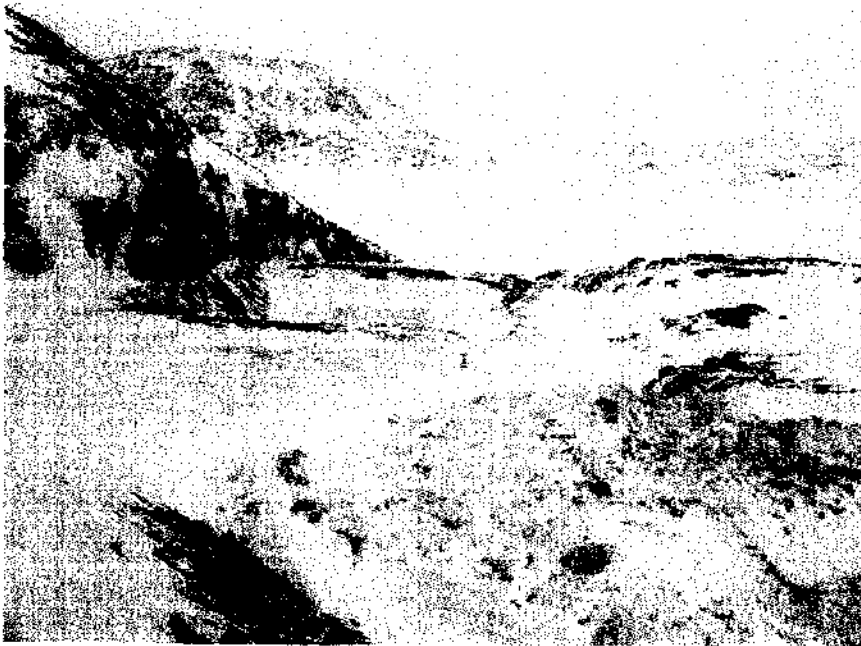
Figure 2. The second and third cells of the Cape Dorset Sewage Lagoon with the second cell full to overflowing.
