WATER LICENCE INSPECTION FORM

Licensee	Licensee Representative
Hamlet of Chesterfield Inlet	John Ivey
Licence No. / Expiry	Representative's Title
3BM-CHE1523/ May 14 <sup>th</sup> 2023	Chief Administrative Officer
Land / Other Authorizations	Land / Other Authorizations
--	--
Date of Inspection	Inspector
September 21 <sup>st</sup> 2021	Atuat Shouldice
Activities Inspected	
<div><input type="checkbox"/> Camp<input type="checkbox"/> Drilling<input type="checkbox"/> Mining<input type="checkbox"/> Construction<input type="checkbox"/> Reclamation<input type="checkbox"/> Fuel Storage</div> <div><input type="checkbox"/> Roads/Hauling<input checked="" type="checkbox"/> Other: Waste Disposal Facility<input checked="" type="checkbox"/> Other: Water Treatment Facility</div>

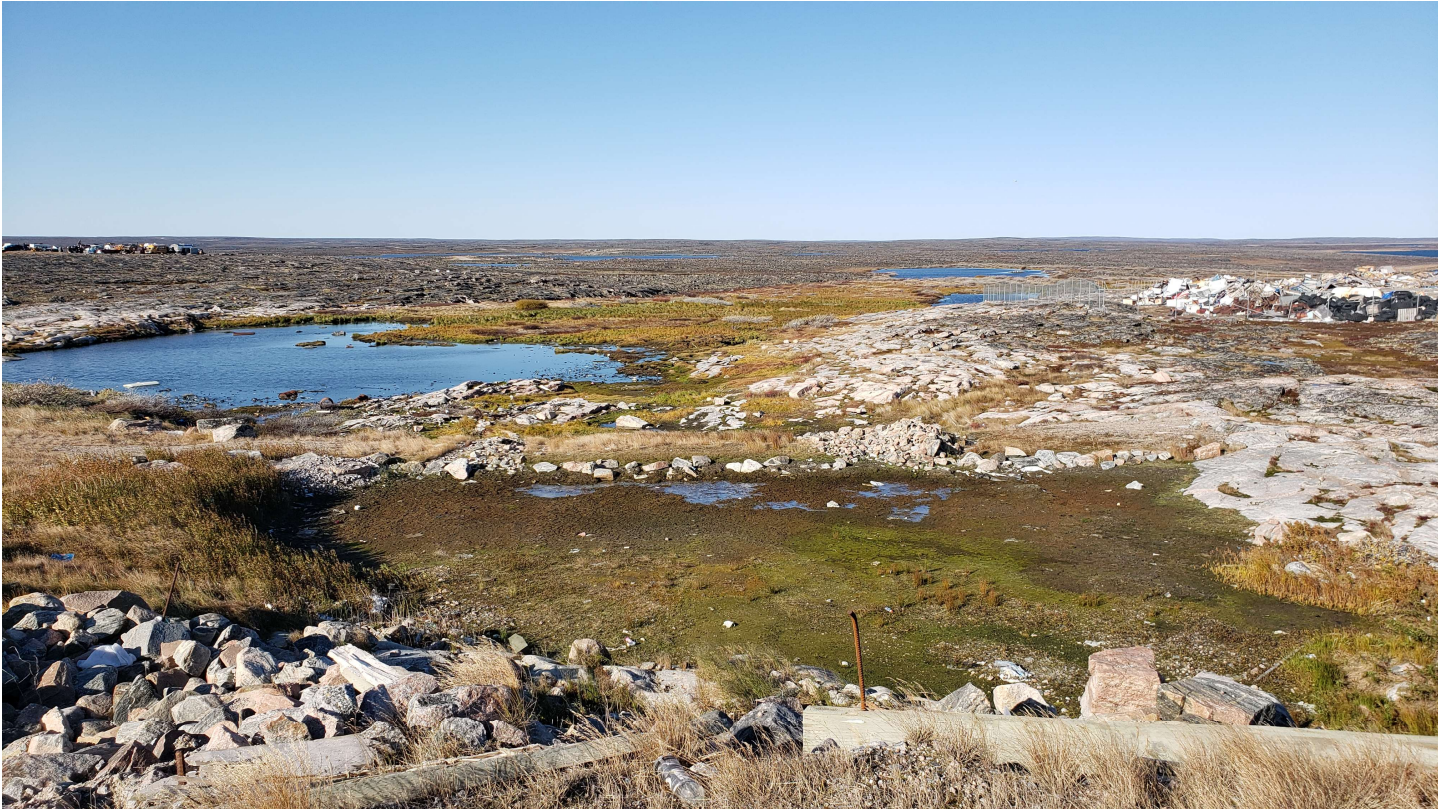
Date:	Licence No.:	Camera/Model:	Inspector:
September 21 <sup>st</sup> , 2021	3BM-CHE1523	Samsung S9	RMO Shouldice
Photo #:		Location:	
2		Sewage Holding Cell

4. Sewage is directed to the Sewage Disposal Facility. The facility consists of a holding cell which allows solids to settle out before flowing into a tundra wetland (photo 2).

Description:			
Sewage discharge to wetland treatment.

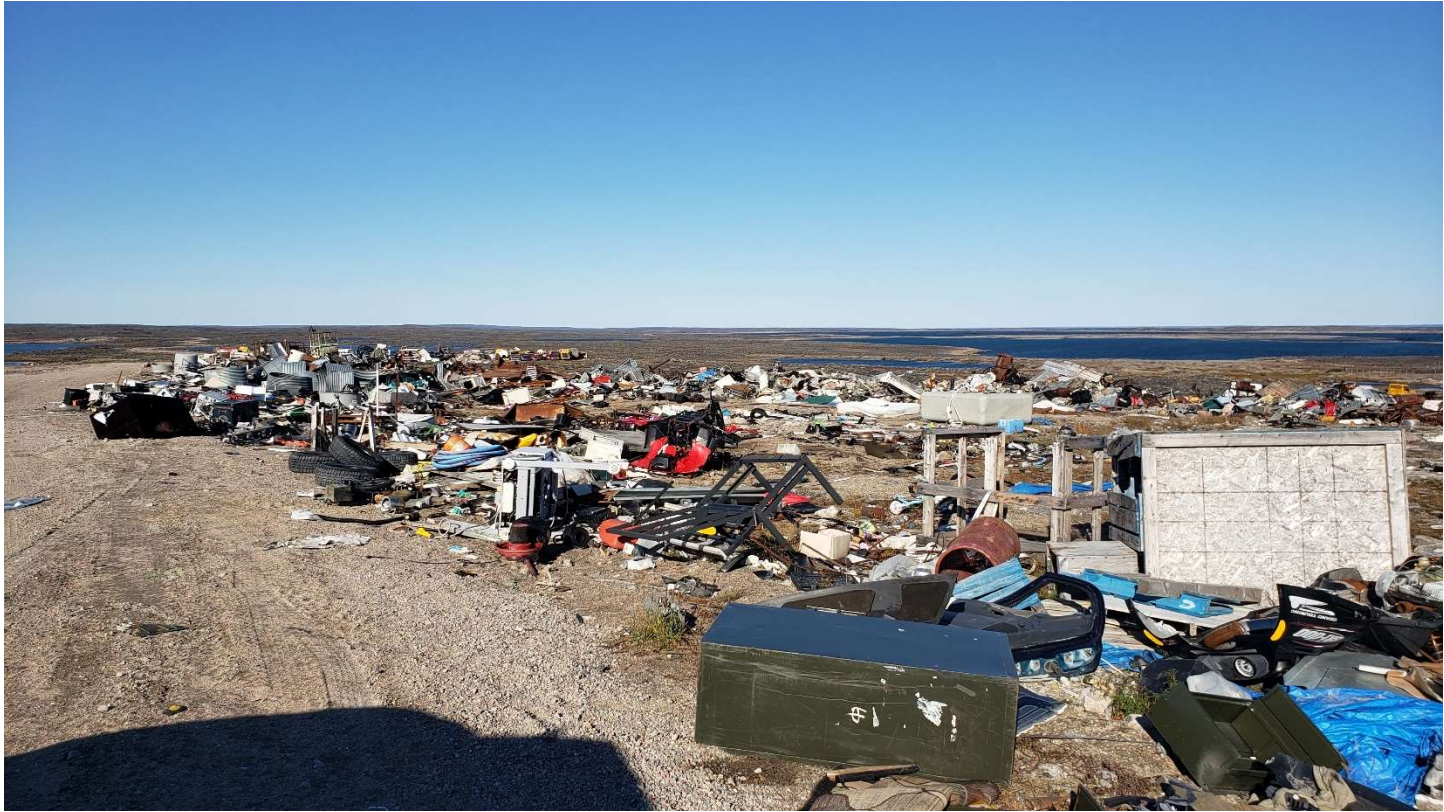
Date:	Licence No.:	Camera/Model:	Inspector:
September 21st 2021	3BM-CHE1523	Samsung S9	RMO Shouldice
Photo #:		Location:	
1		Bulky Waste Area

7. Waste in Bulk Storage Area is well segregated (photo 5).

**Description:**  
Road dividing domestic waste (right) and bulk waste (left), image facing North-West.
