**Water Management Inspection - July 18, 1997**

## MUNICIPAL WATER USE INSPECTION FORM

Clyde River - July 18, 1997

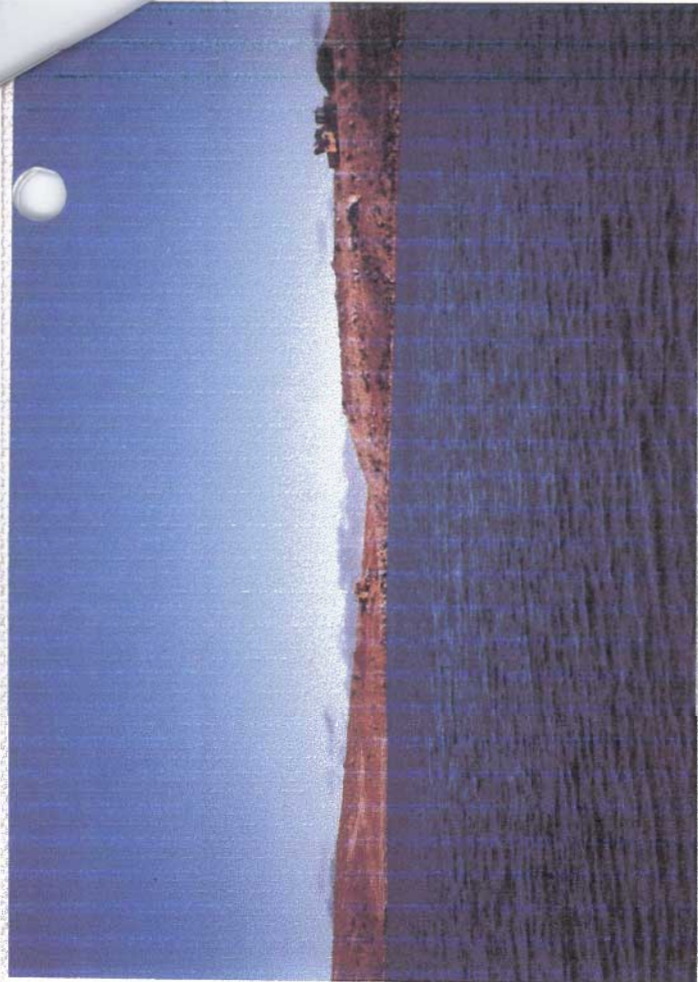
1. Water Lake. Construction in background is for truckfill station.
2. Present waste disposal site.
- 3-4. Abandoned waste disposal site.
- 5-6. 2 views of the new sewage lagoon.
- 7-8. Sewage discharge point. Arrows denote areas where there is berm permeability.
9. Waste oil storage area after vandals set it ablaze.

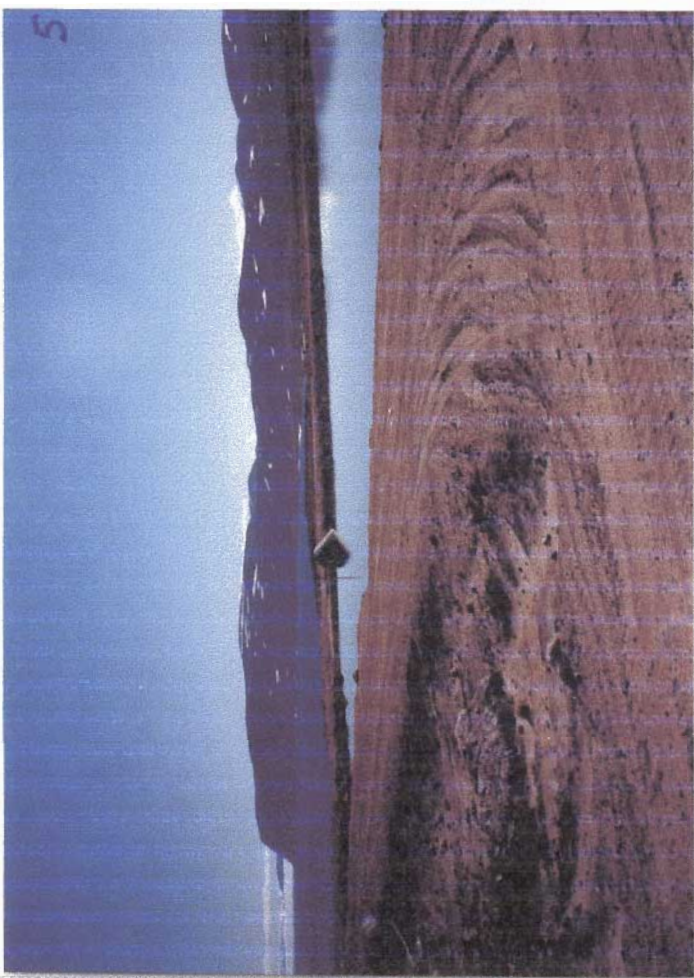
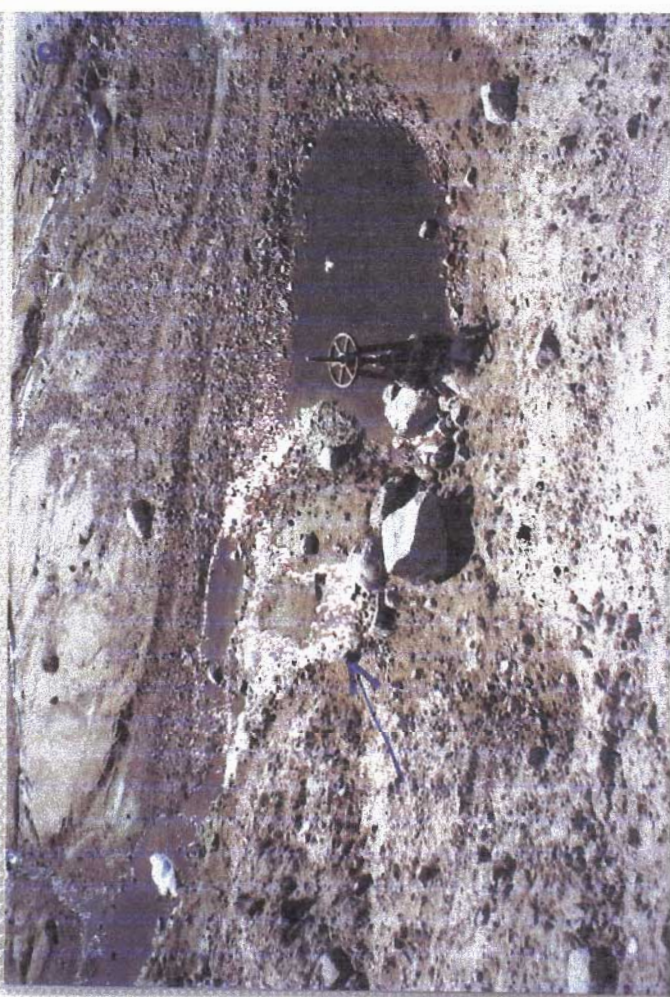
Note 1. The lagoon was designed as a 365-day retention system. In June, the level of the lagoon was reduced by siphoning in order to provide additional volume for the summer months.

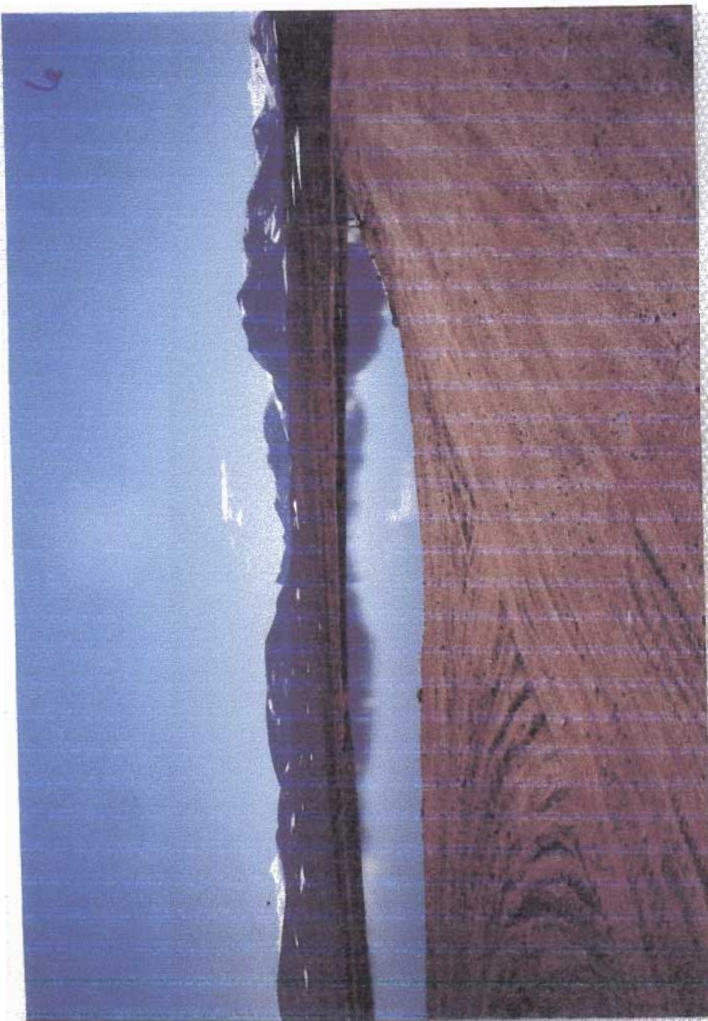
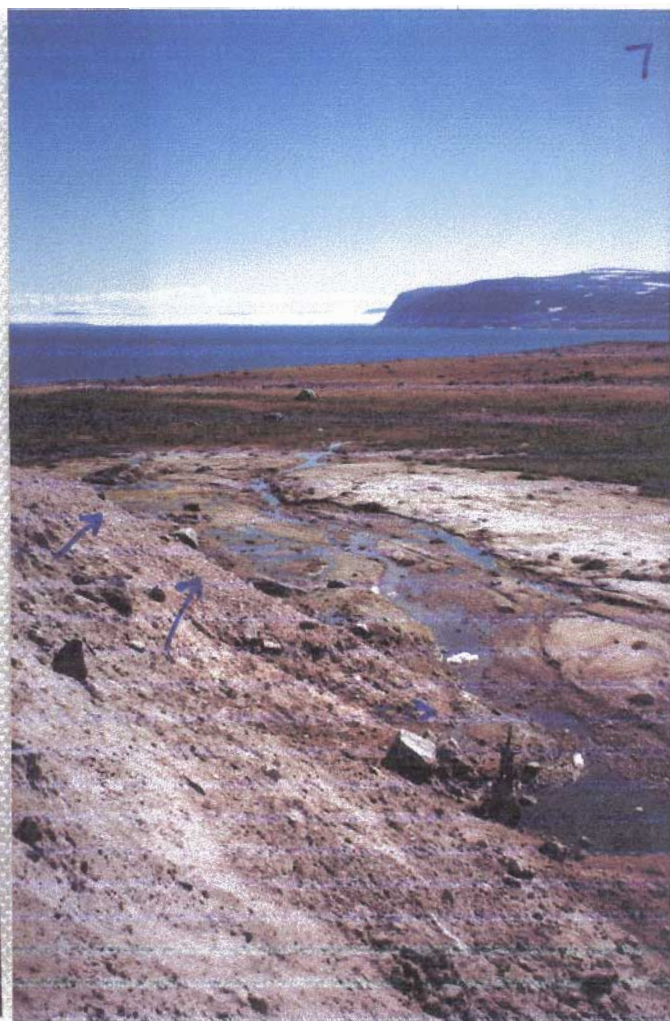
Of more serious concern are the numerous areas of seepage along the south end of the lagoon. At least 6 separate seepage areas were noted. As the lagoon is not designed to operate in this manner, this poses structural stability problems for this facility. In conversation w/ Rich Armstrong (MACA, Igahuit) he noted that funds have been identified to reinforce this portion of the lagoon by adding additional material. The use of bentonite to seal the berms was also discussed.

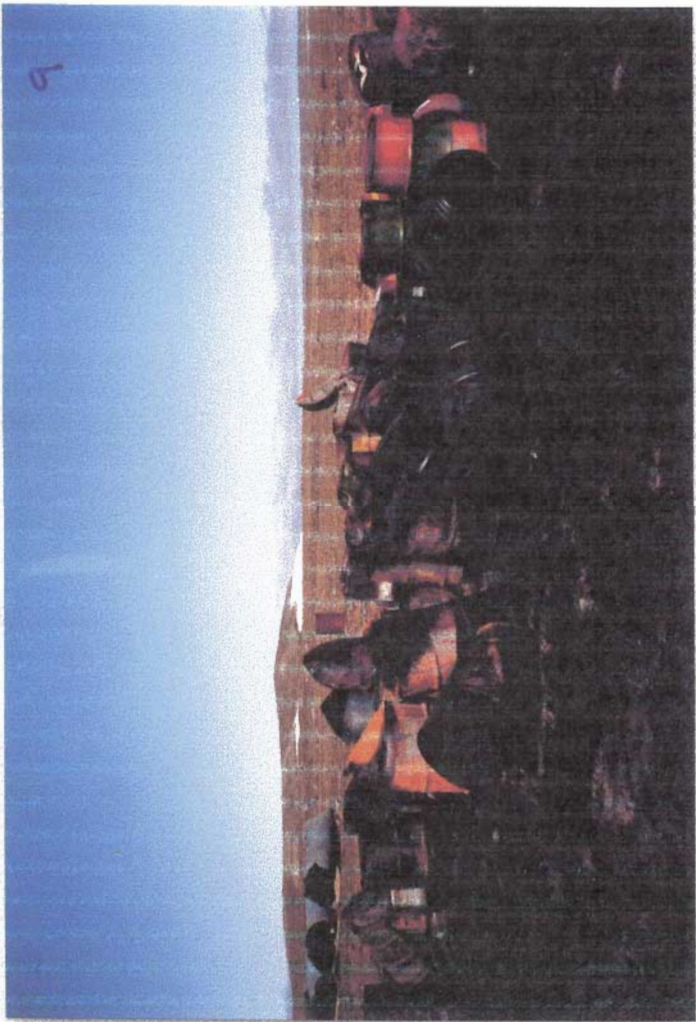
Note 2. Approximately 3 weeks ago some vandals, in an attempt to rupture a cylinder of compressed gas at the dump, set a large fire using waste oil and a fire. The fire department responded and put out the fire. The area is heavily stained and several ruptured drums of waste oil sit open and exposed to the environment. As the Hamlet does not have spare drums into which this oil could be transferred, further pollution is just a matter of time.
