WATER LICENCE INSPECTION FORM

Licensee	Licensee Representative
Hamlet of Clyde River	David Arreak
Licence No. / Expiry	Representative's Title
3BM-CLY1419	Forman
Land / Other Authorizations	
None	
Date of Inspection	Inspector
October 6, 2017	Jonathan Mesher
Activities Inspected	
<input checked="" type="checkbox"/> Camp/Municipality	<input type="checkbox"/> Drilling
<input type="checkbox"/> Roads/Hauling	<input type="checkbox"/> Mining
	<input type="checkbox"/> Construction
	<input type="checkbox"/> Reclamation
	<input type="checkbox"/> Fuel Storage
	<input type="checkbox"/> Other:

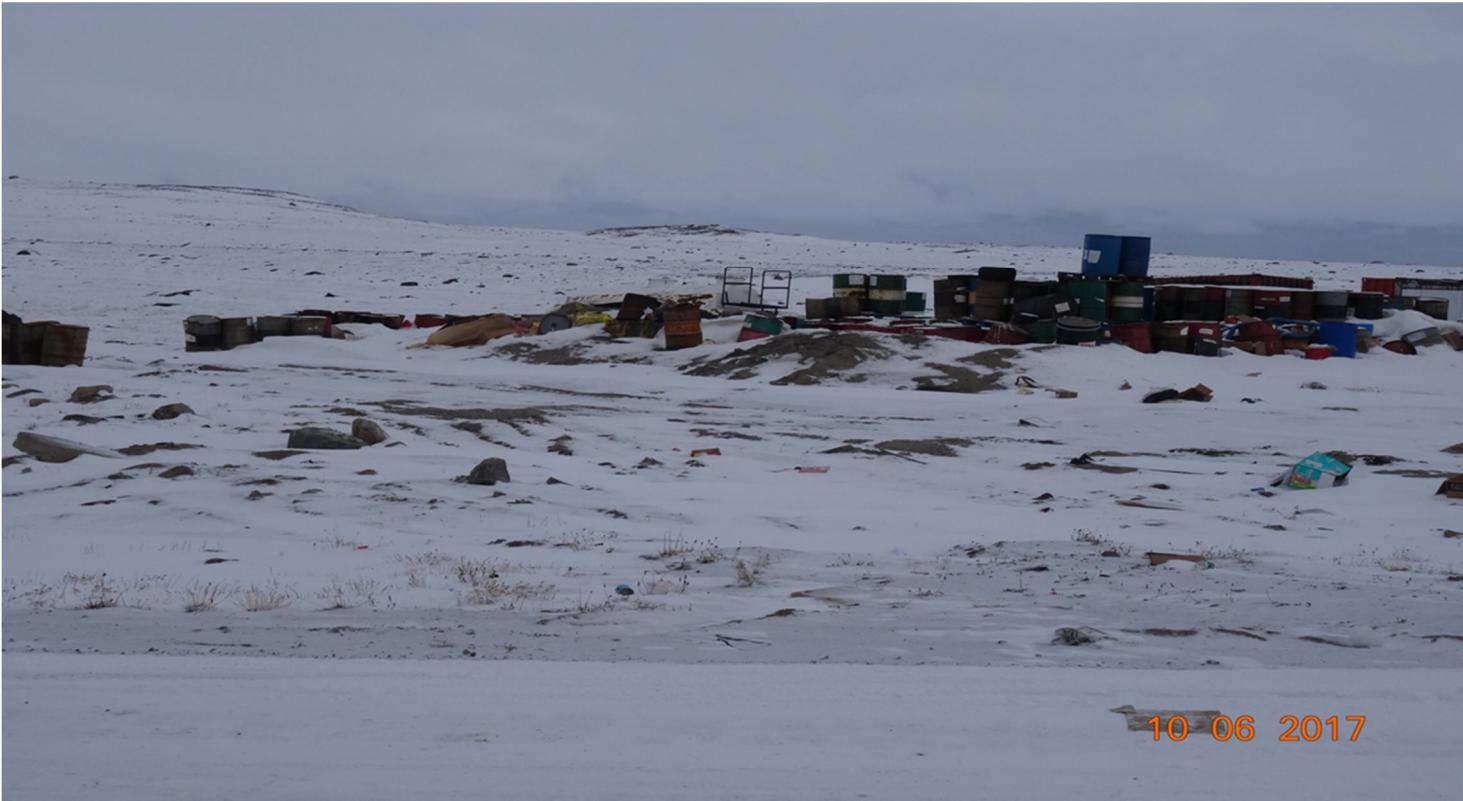
12. Hazardous materials and waste are being segregated in a berm near the solid waste disposal facility.
13. The Licensee’s storage of hazardous waste has been noted as a concern in the 2016 inspection report.

ii. While comparing photos from 2016 and 2017 inspections, it was evident that the licensee has placed material within this facility after the 2016 inspection. See figure 1 and 2 below for comparison of the hazardous waste storage area.

Figure 1: Hazardous waste storage during the 2017 inspection.

iii. The inspector is requesting the Licensee develop a plan to address INAC’s concerns with the licensee’s storage of hazardous waste.
14. Batteries are being stored in a contained sea can in anticipation for transportation to a southern disposal facility reducing possible risk of this waste entering water.

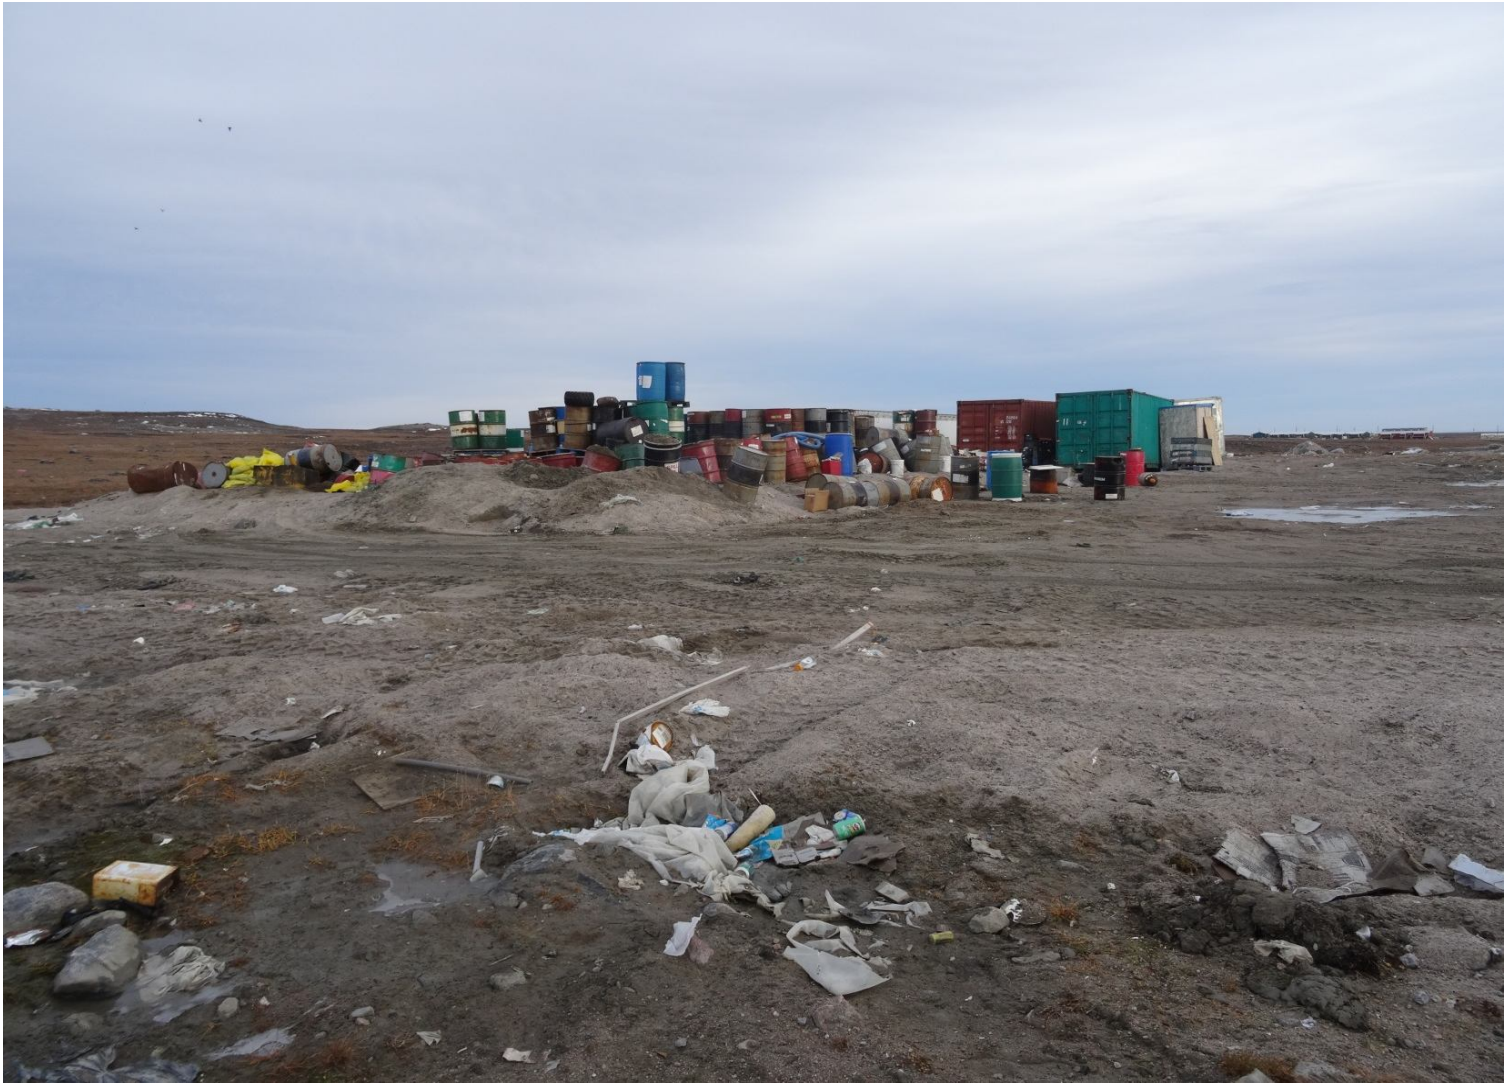
i. In the 2016 inspection report the inspector requested that no additional hazardous waste be placed in the segregated area until the capacity issue is addressed.

Figure 2: Hazardous waste storage during the 2016 inspection.
