WATER LICENCE INSPECTION FORM

Licensee	Licensee Representative
Hamlet of Clyde River	Bhabesh Roy , Johnathan Paulluq, Moe Kuluguqtuk
Licence No. / Expiry	Representative's Title
3BM-CLY1419 Renewal Licence	Municipal Engineer – GN- C&GS , Acting Senior Administration Officer, acting Hamlet foreman
Land / Other Authorizations	Land / Other Authorizations
Date of Inspection	Inspector
14/08/2018	Joseph Monteith
Activities Inspected	
<input type="checkbox"/> Camp	<input type="checkbox"/> Drilling
<input type="checkbox"/> Roads/Hauling	<input type="checkbox"/> Mining
	<input type="checkbox"/> Construction
	<input type="checkbox"/> Reclamation
	<input type="checkbox"/> Fuel Storage
	<input checked="" type="checkbox"/> Other: Potable Source, Waste Disposal Facility, Solid Waste Facility, General Conditions , water crossing (LUP N1999X0043)
	<input type="checkbox"/> Other:

Photo Log

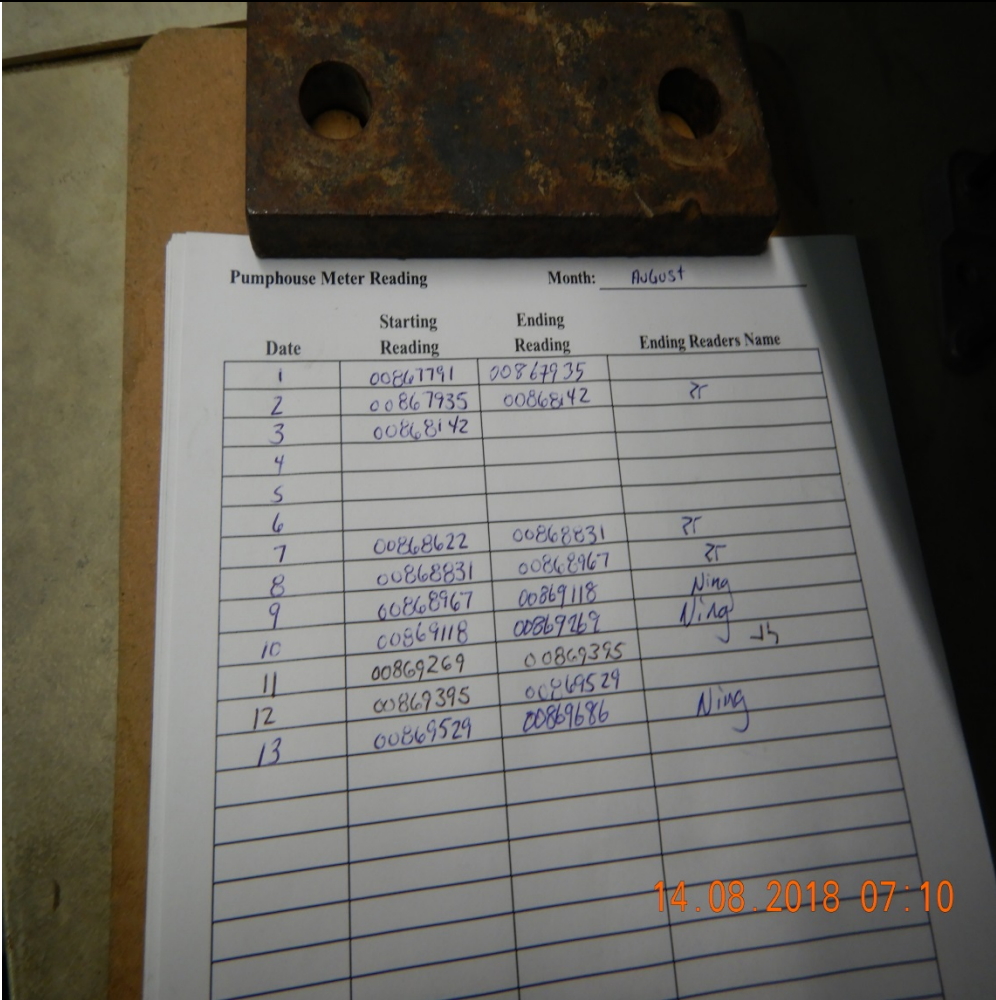
Photo Log	Location
Photo 2	Clyde River

4. The pump house has a flow meter, and it measured 008696868m³ (See photo 1) at the time of the inspection. WRO Monteith also photographed the Pump Meter Reading log book for August 2018 which had 13 entries for the month of August. On August 1, 2018 the records show a reading of 867791m³. On August 13, which was the day of inspection, the log showed a reading of 869686m³ (see photo 2).

Description: Water Usage Logs – Same as Water Usage Meter

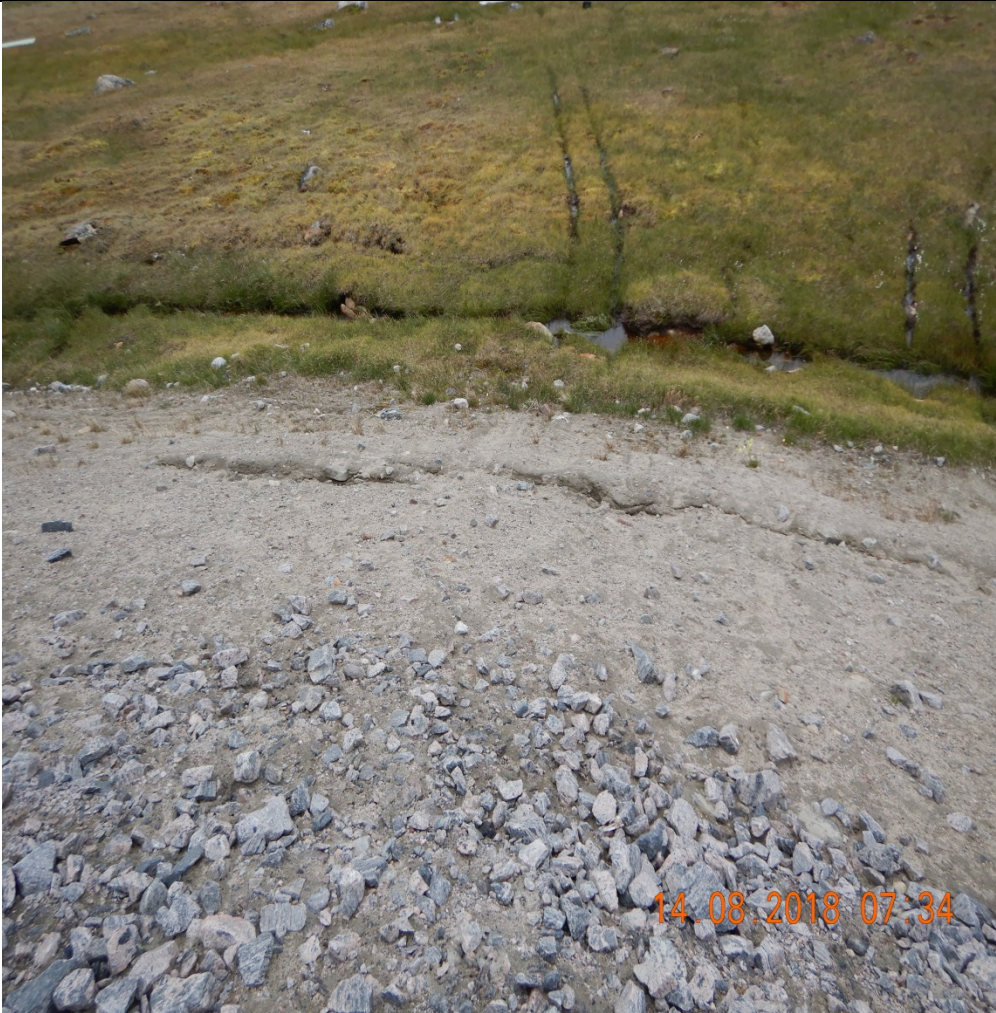
Photo Log	Location
Photo 3	Clyde River

7. At the time of the inspection, the sewage lagoon was in-use. The walls were operating as intended, no signs of leakage, but some slumping or erosion were observed on the west side of the lagoon walls (See photo 3). The lagoon has two cells; the first is the original lagoon with a capacity of 11,600m³, the other cell forms as an extension from the original lagoon, with no listing for the amount of sewage it can store. No issues were observed during the course of the inspection
8. At the time of the inspection, Bhabesh Roy, and Moe Kuluguqtuk conducted as a part of their monitoring sampling program.

Description: base of sewage lagoon walls appears to be slumping

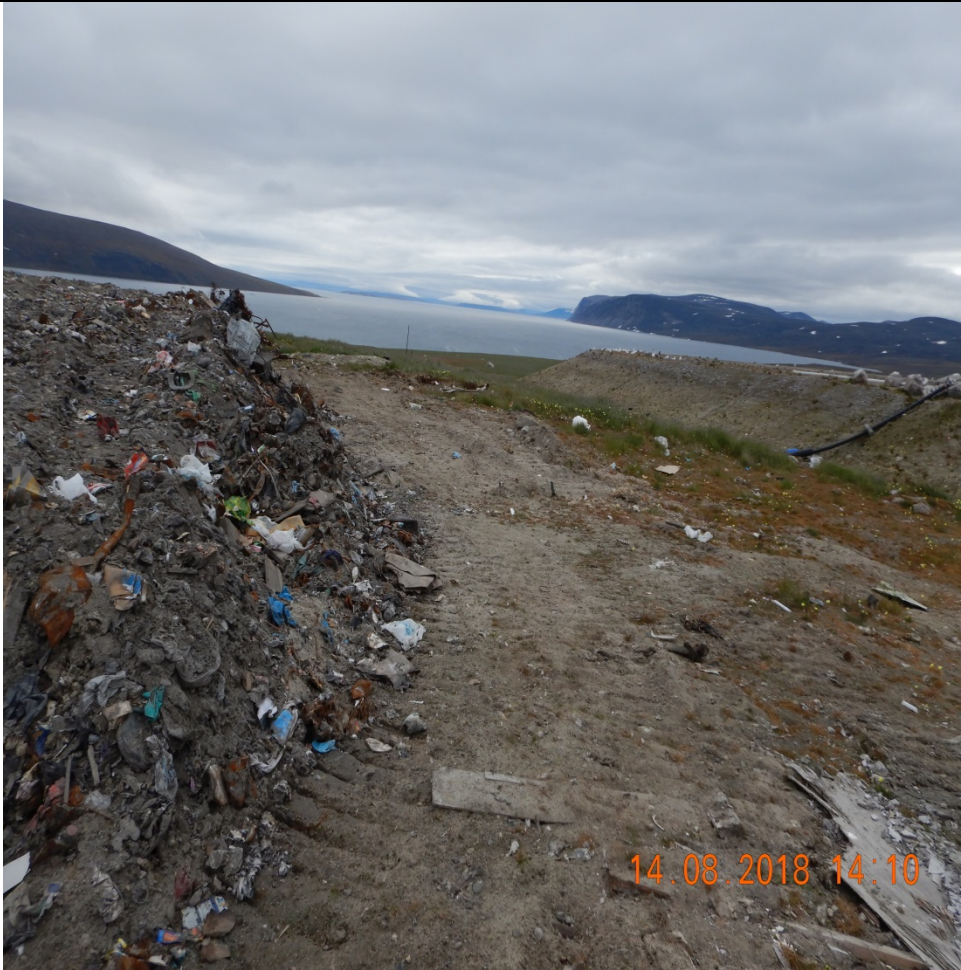
Photo Log	Location
Photo 4	Clyde River

10. The fencing, which is approximately 1.5 metres high, is damaged in some parts on the north side of the fire pit. The fencing only covers a portion of the fire pit portion and should have more fencing put in to mitigate any garbage from blowing across the environment into any fresh water, the ocean, or compromising the capacity of the sewage lagoon (see photo 4).

Description: Fire Pit – No fencing on East Side, wind may blow ash and debris out of area onto the environment, the ocean, and to the sewage lagoon

- Erect fencing to finish off the fencing surrounding half the burn and cap section of the Solid Waste Facility.

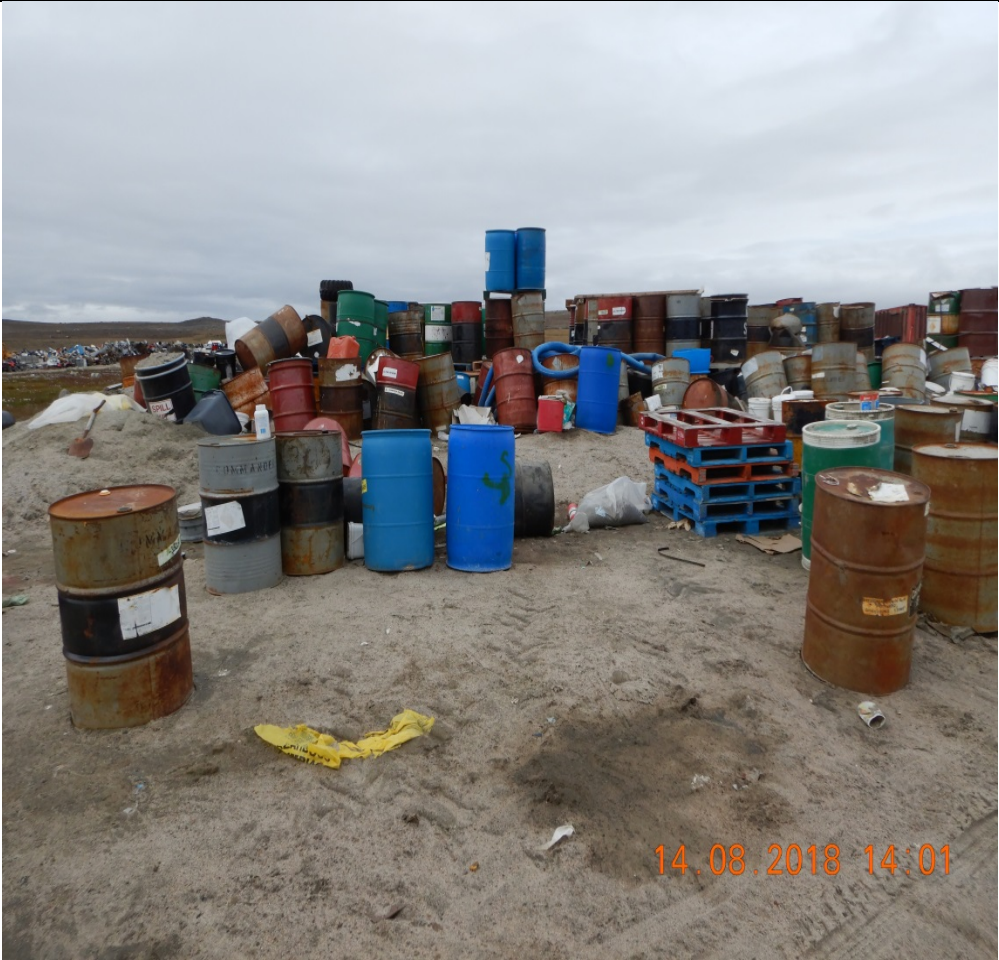
Photo 5

13. The Hazardous Waste Section contains a few sea cans(full), a bermed area full of waste oil drums, some packaged ready for delivery, waste oil drums on the inside and outside of the berm, spilling its leaked contents onto the ground all around the area. Some of the sea cans are left open to the environment (See photo 5). The exposure of hazardous wastes outside berms, and outside of sea cans is violations of the licence, and should be considered a spill. Deployment of Spill Contingency Plans and reporting the spills to the spills line hasn’t been occurring.

Description: Hazardous Waste Berm – overfilled with waste oil drums. Waste oil drums deposited outside of bermed area. Signs of spills on ground outside of the bermed area.

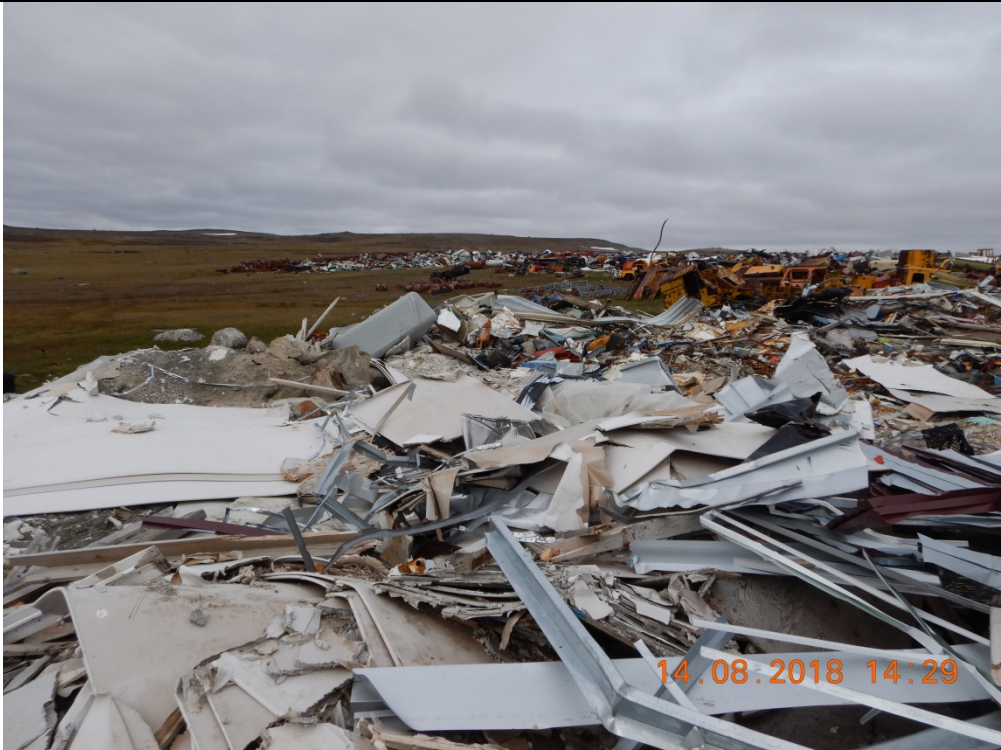
Photo 6

12. There is no berm to contain any leachate coming from bulk metal section of the land farm. Contaminants may migrate with rain water contaminating the environment on its migration down slope to the ocean (See photo 6).

Description: the outer extent of bulk metal section of land farm, no berm to mitigate any potential deposit of wastes onto environment
